TRUCKEE-TAHOE AIRPORT Pavement Evaluation Study Pavement Maintenance/Management Plan

NOVEMBER, 2011 (UPDATED DECEMBER 2014)

**TRUCKEE TAHOE AIRPORT
PAVEMENT EVALUATION STUDY
PAVEMENT MAINTENANCE/MANAGEMENT PLAN**

*Prepared by:
Reinard W. Brandley
Consulting Airport Engineer*

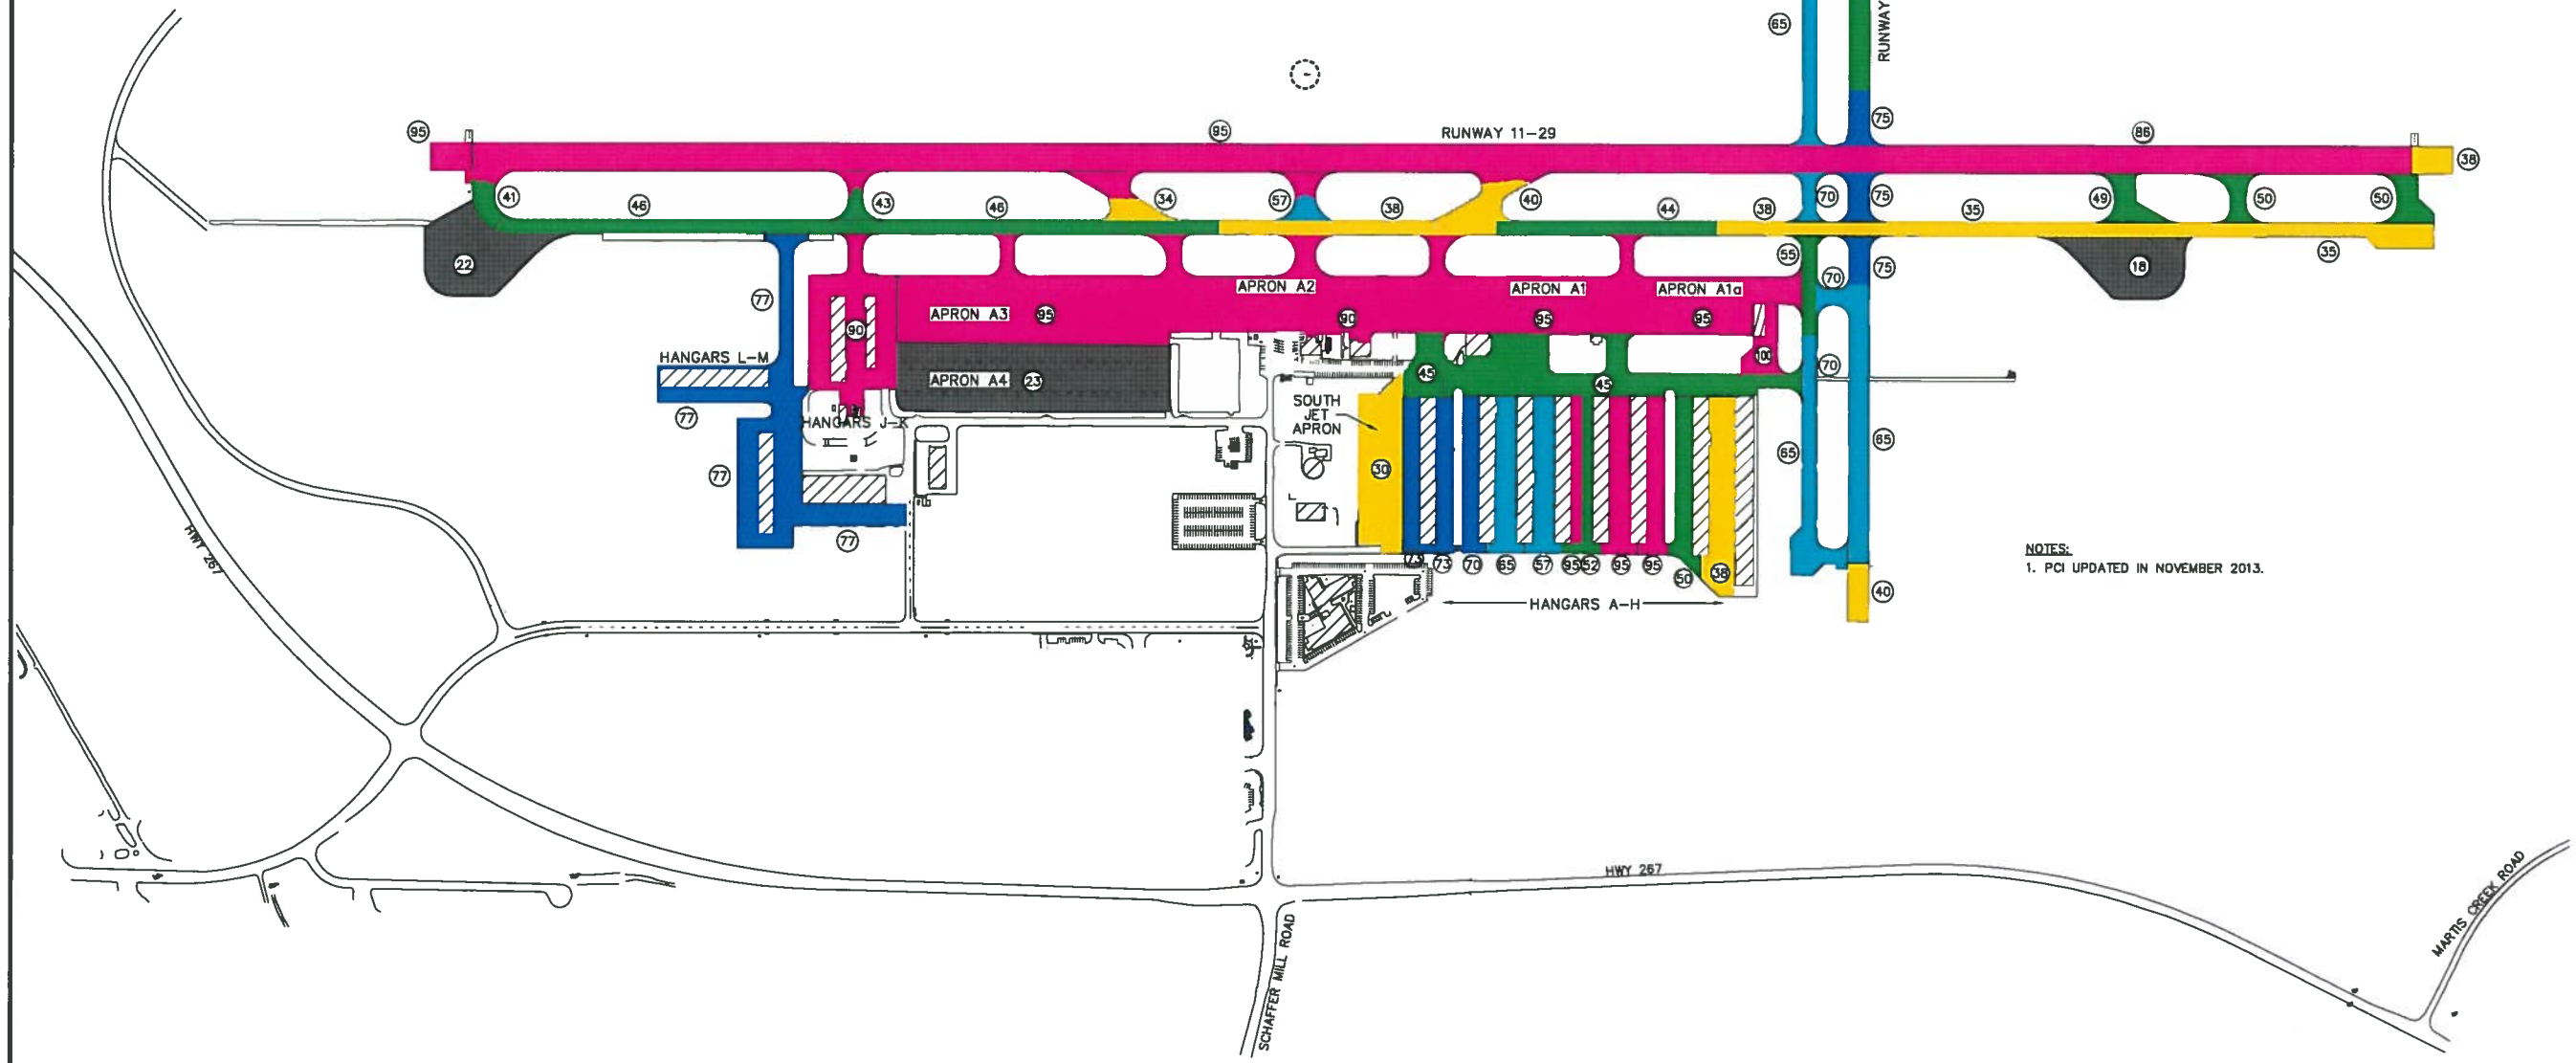
The ASTM Standard provides a relationship between Pavement Condition Index (PCI) and pavement rating. On Plates No. 2-1a and 2-1b the rating system is indicated as a color legend and the rating of each segment of pavement is indicated by color. The PCI of each segment is also indicated adjacent to each segment of the pavement. It will be noted that in 2013 most pavements at the airport range from the “fair” to “excellent” condition. The South Jet Apron and Portions of Taxiway A are rated as “poor”, and Apron A4 and run-up areas at Taxiways B and H are rated “very poor”.

Pavement Condition Index (PCI) values for each section of pavement were determined in 2011. Updated PCI values for all pavement sections were determined in the 2013 update study, including new and existing sections. The original (2011) PCI values and updated (2013) PCI values are included in this updated report to show how much they have changed as a result of two more years of use or after rehabilitation or reconstruction of the pavement sections.

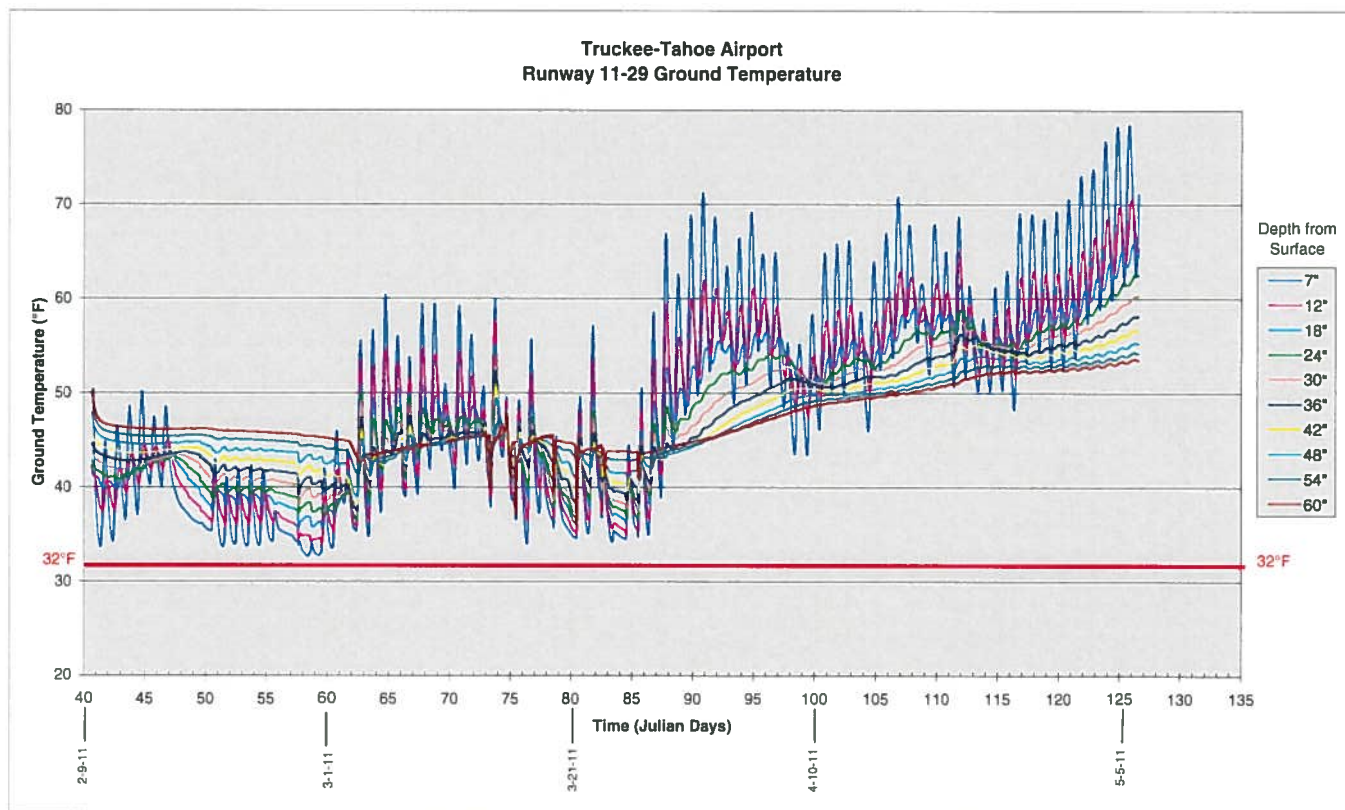
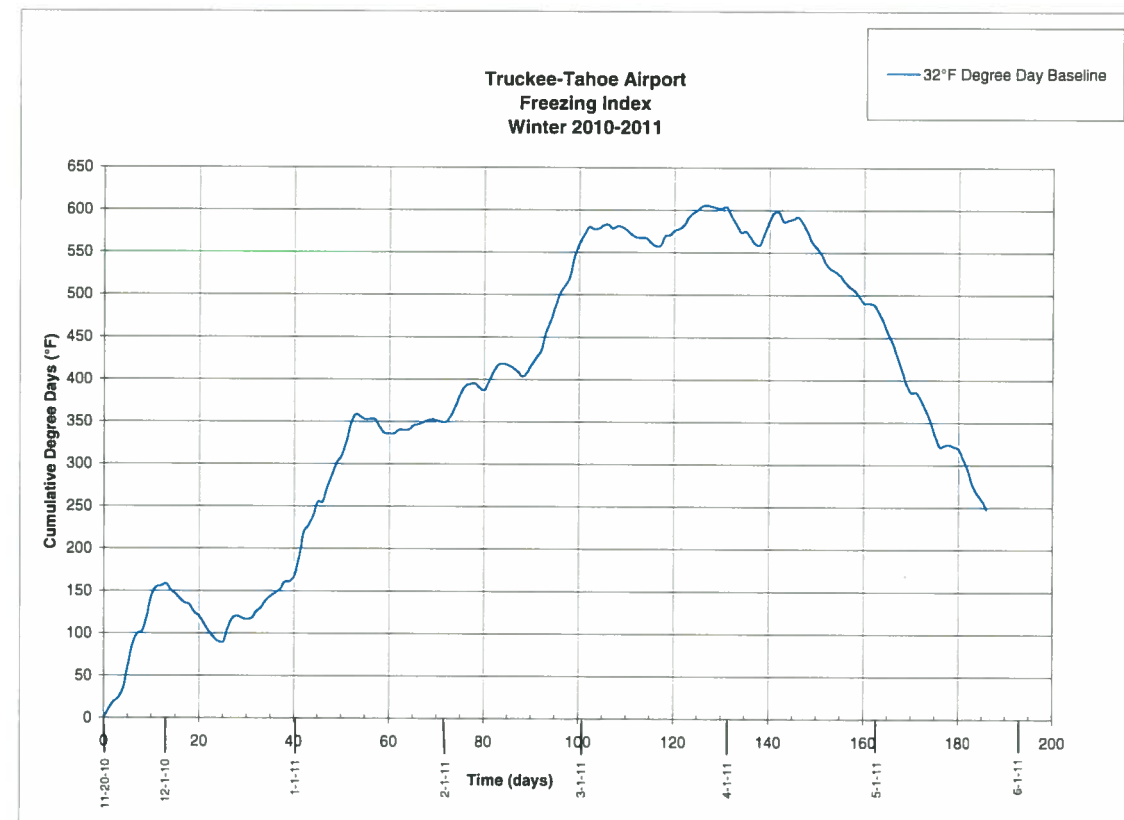
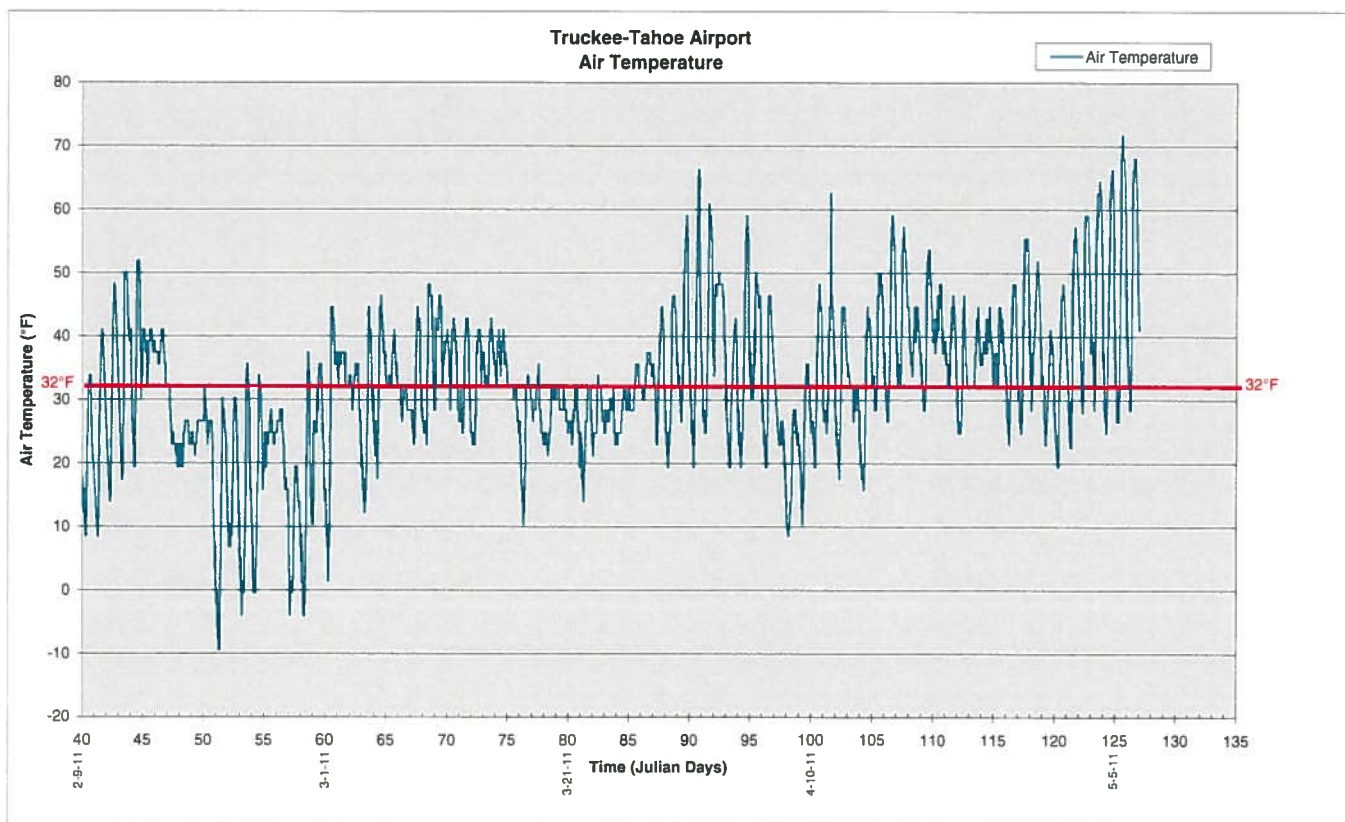
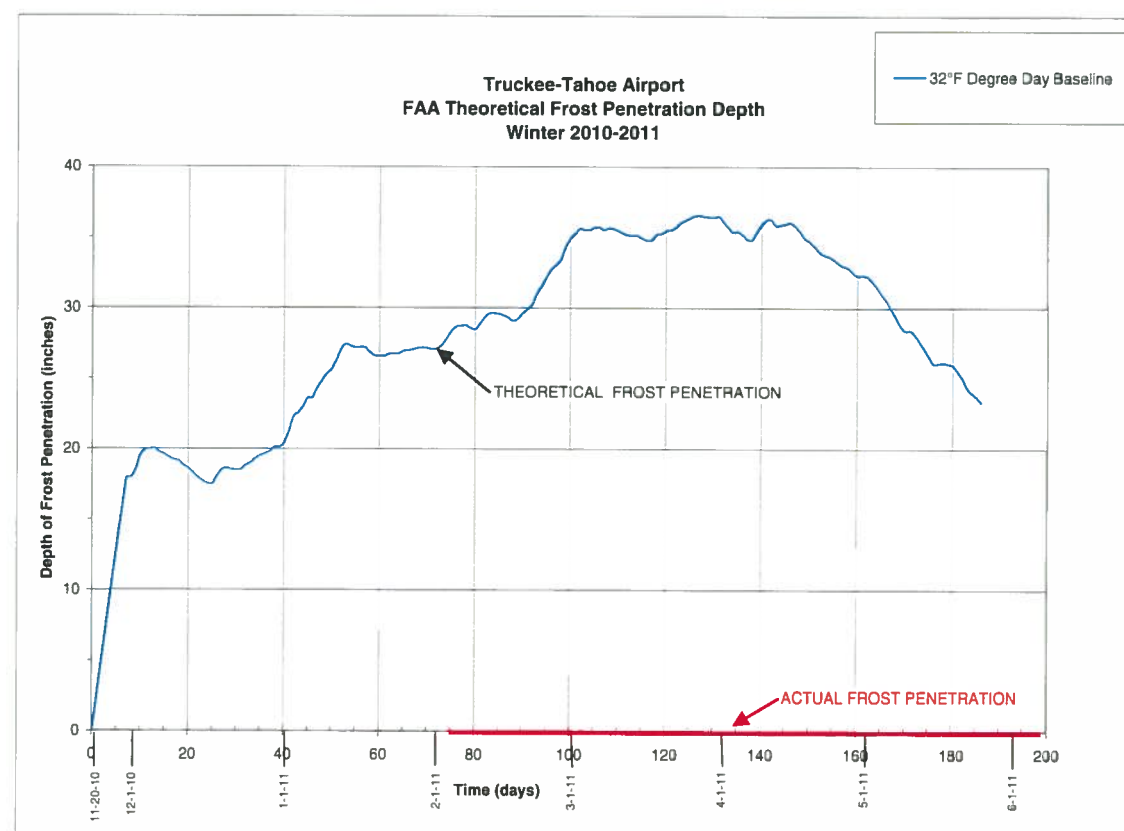
PLATE NO. 2-3 - FROST PENETRATION STUDY

Experience at other airports in the Sierra Nevada Mountains indicates that frost penetration under a dark colored pavement is significantly less than that indicated by the freezing index; whereas, the frost penetration under a white reflective painted surface can be greater than that indicated by the freezing index. In order to determine the depth of frost penetration at Truckee Tahoe Airport a series of thermocouples were installed at various depths below the pavement surface on a section of Runway 11-29 located west of Taxiway G. Gauges were installed at depths of every 6 inches beginning at the depth of 6 inches and extending to 5 feet below the pavement surface. These gauges were installed on February 9, 2011. When the hole was drilled through the pavement for installation of the gauges, it was noted that there was no frost in any of the subgrade or subsoil materials that existed below a depth of 11 inches from the surface. The existing temperature data at each gauge were recorded hourly starting after installation. The results of these readings are shown on the Runway 11-29 Ground Temperature chart on Plate No. 2-3. Air temperature during that same period was also recorded and is also shown on Plate No. 2-3.

These data confirm information that the office of Reinard W. Brandley obtained from Lake Tahoe Airport 20 years ago. At the Lake Tahoe Airport the depth of frost penetration under a 10-foot wide solid white reflective painted surface extended to 45 inches. As an experiment a series of 6-inch wide black stripes were painted on this pavement to form a “zebra” pattern of 6-inch white and 6-inch black. Even in the middle of the winter the painting of these black stripes caused the frozen soil to melt and the surface of the runway, which had heaved 12 inches, to settle back to original grade. This research led to F.A.A. adoption of “zebra” striping as a standard for cold climate areas.

While there was no frost penetration under the pavements at Truckee Tahoe Airport after February 9, 2011, there probably will be some frost penetration at

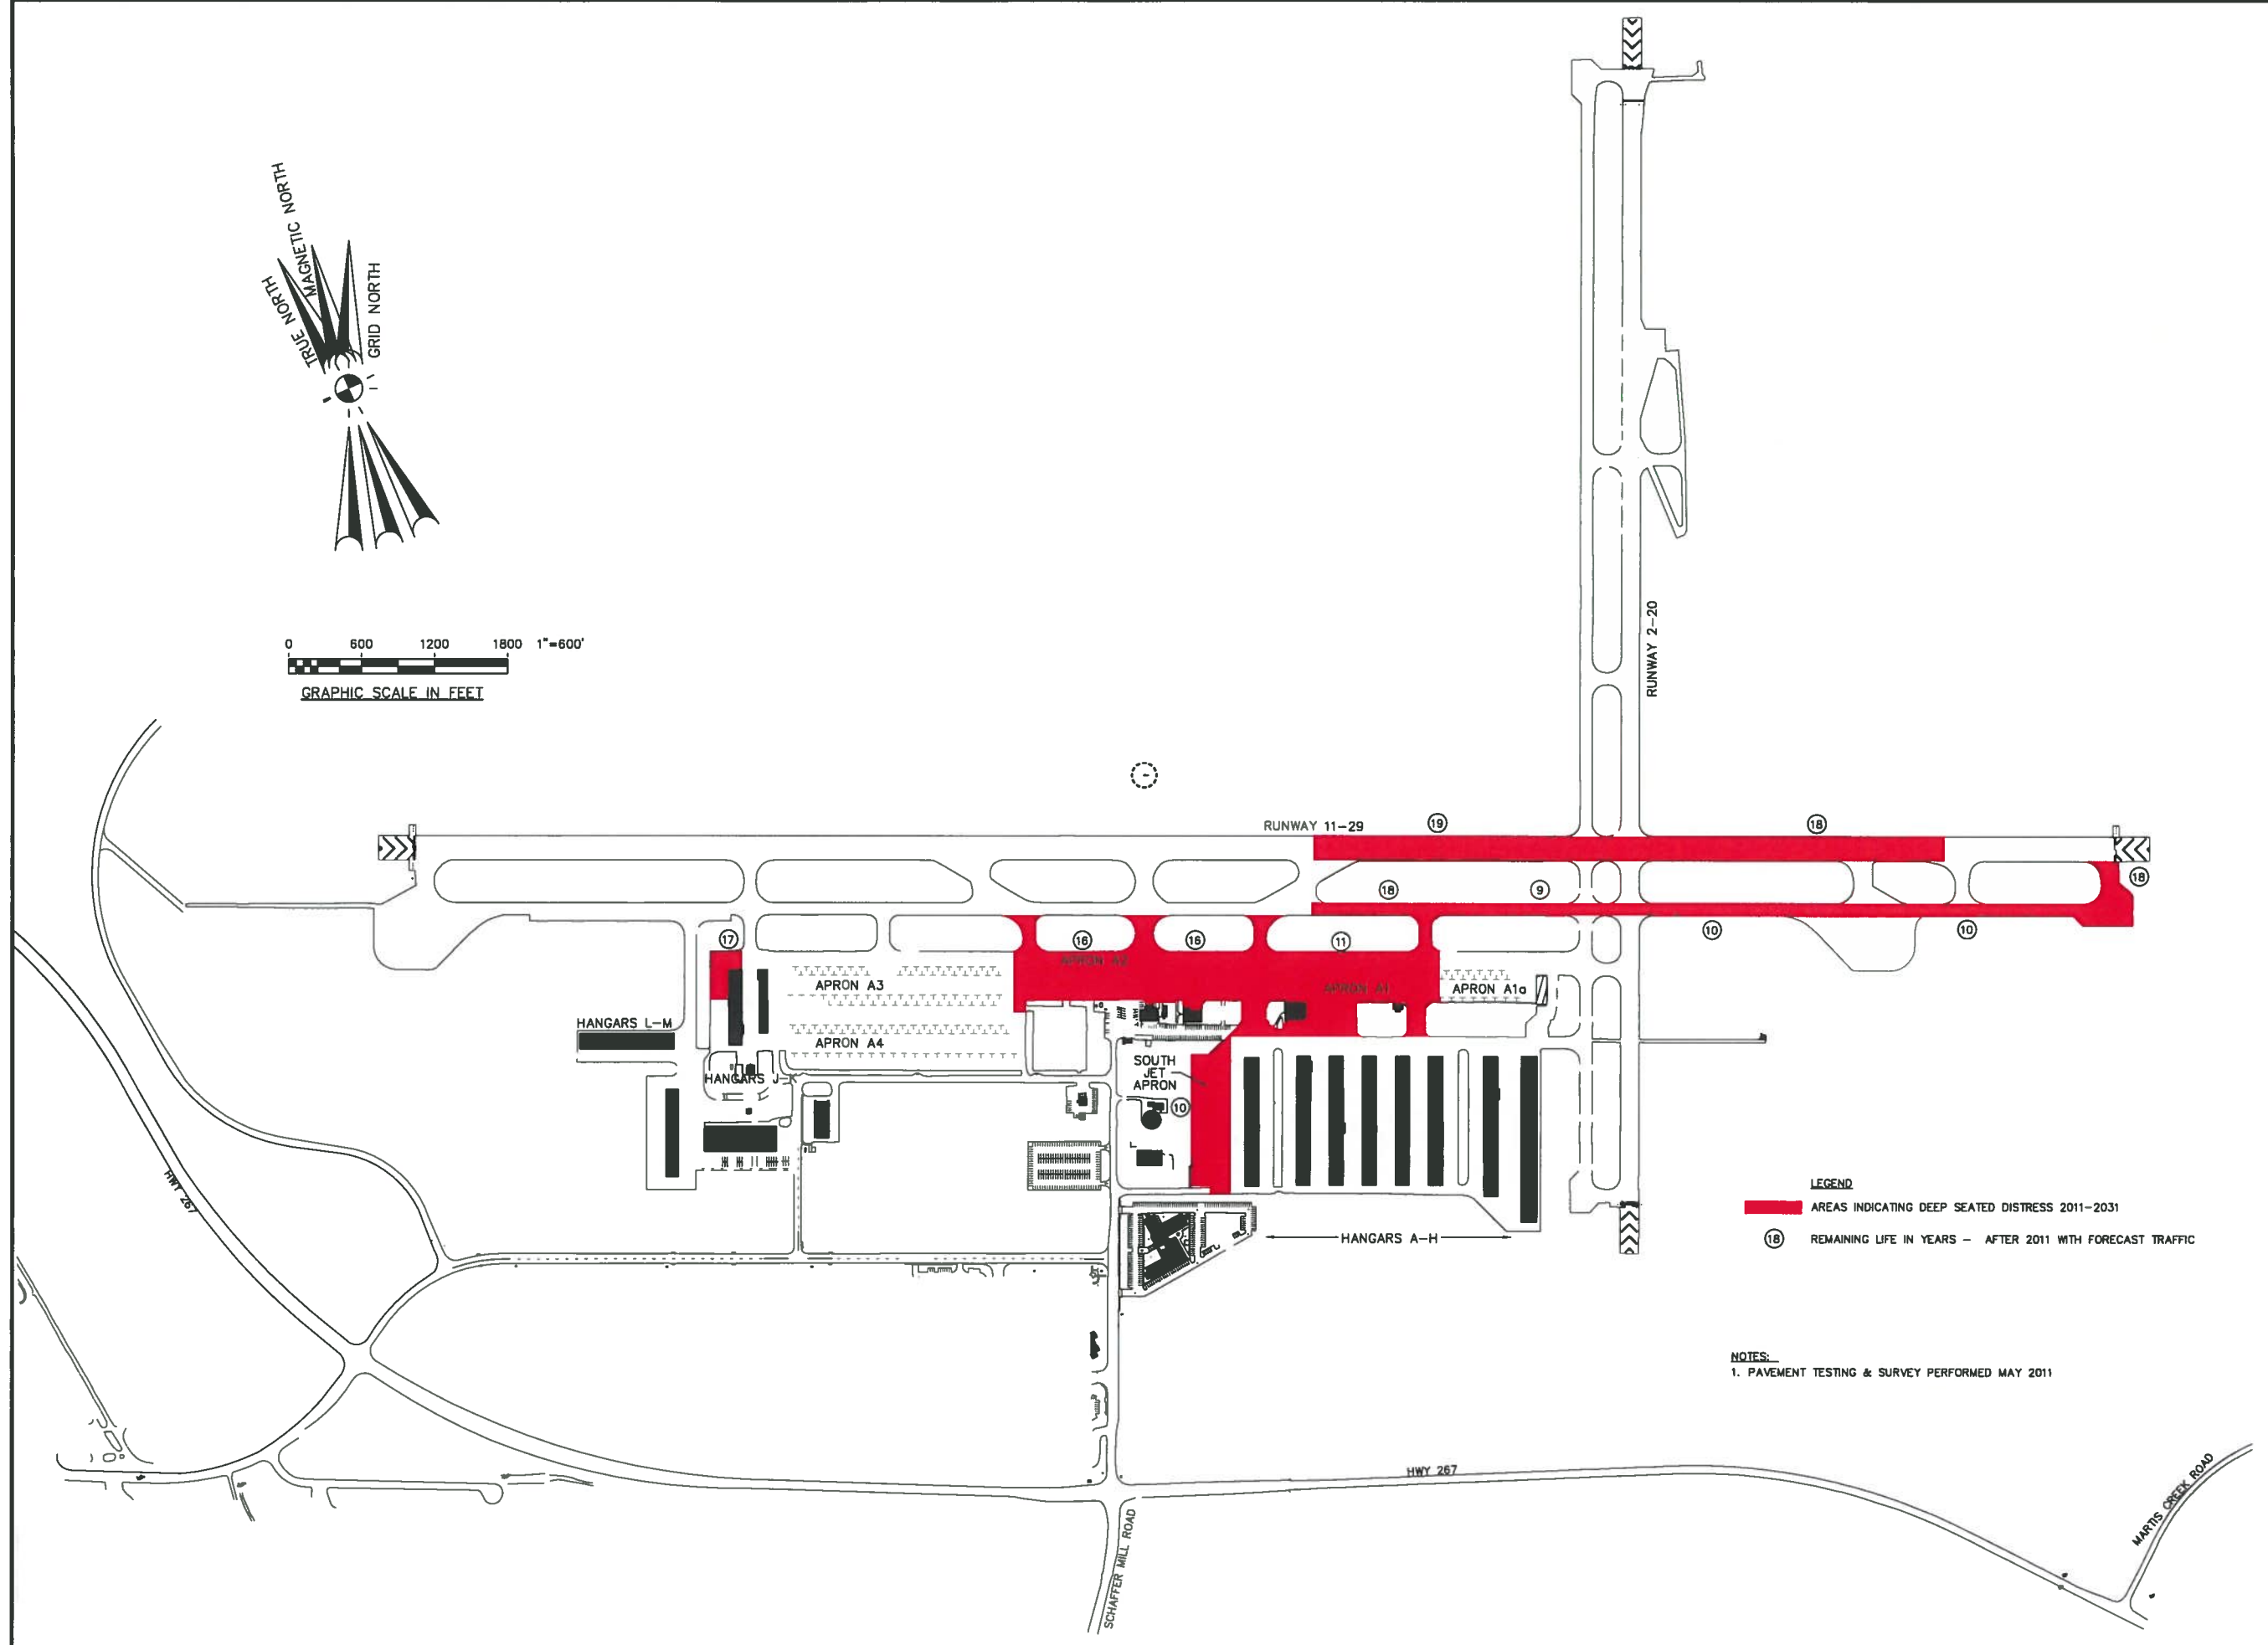
- LEGEND**
- AREAS INDICATING DEEP SEATED DISTRESS 2011-2031
 - Ⓢ REMAINING LIFE IN YEARS - AFTER 2011 WITH FORECAST TRAFFIC
