MEETING DATE: October 24, 2014
TO: Board of Directors
FROM: Bill Quesnel PE, District Engineer
SUBJECT: Draft *Utilities Maintenance Plan*

Utilities Maintenance Plan

Truckee Tahoe Airport District

October 2014

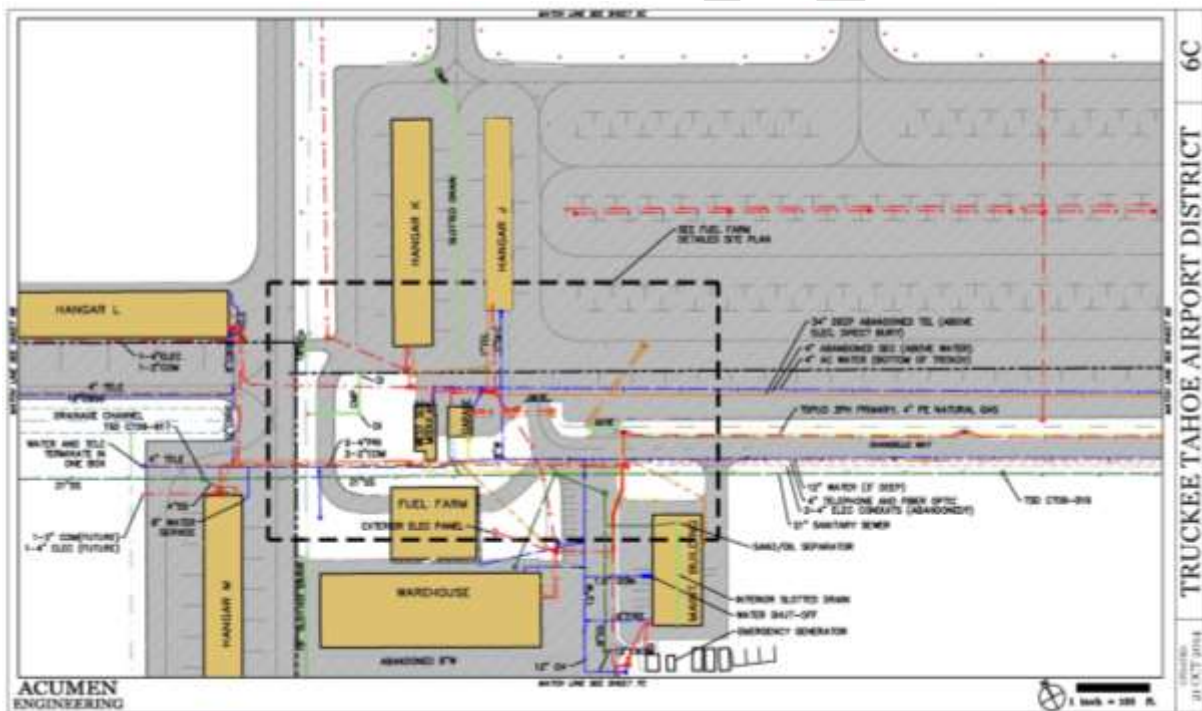
Sample System Map Page

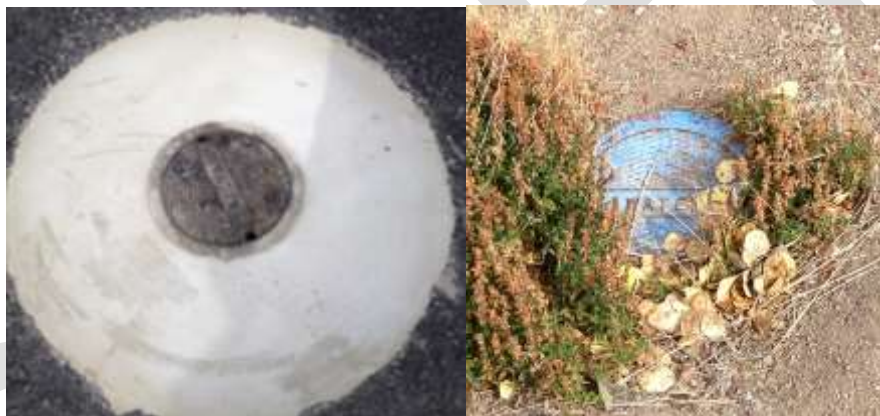
Water System Valves

2. All mainline, fire hydrant and building service valve boxes should be cleaned and the valves exercised at least bi-annually. This preventative maintenance effort will ensure the valves are accessible and functional when circumstances require. If a building's shutoff valve cannot be located, a new valve should be installed.

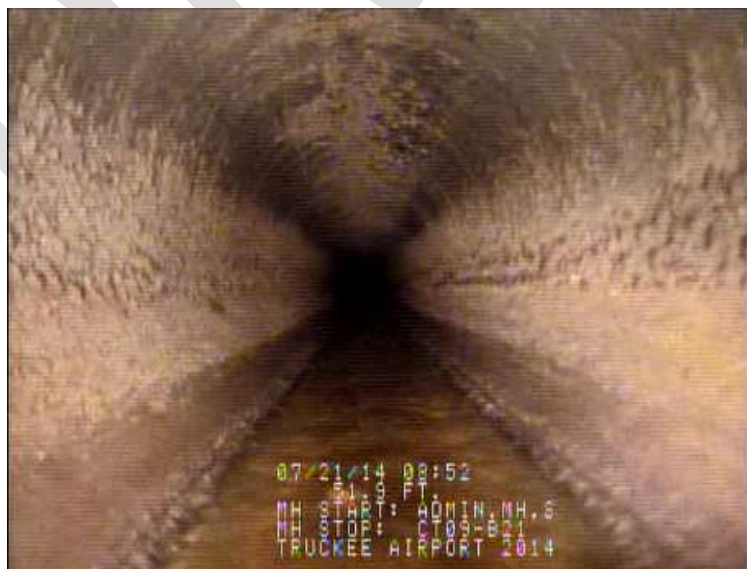
Interior of sanitary sewer pipe serving Administration Building

1. No sanitary sewer infrastructure replacement is proposed, the condition of the pipelines and manholes is considered good to very good.
2. All building cleanouts should be located, repaired as necessary and a box installed to provide protection from damage and ease in locating.

3. The entire system should be cleaned on a bi-annual interval to reduce the possibility of a Sanitary Sewer Overflow (SSO).
4. The grease trap and sand/oil separator pre-treatment vaults should be cleaned on an as-needed basis based on an annual visual inspection and as required by the TSD.

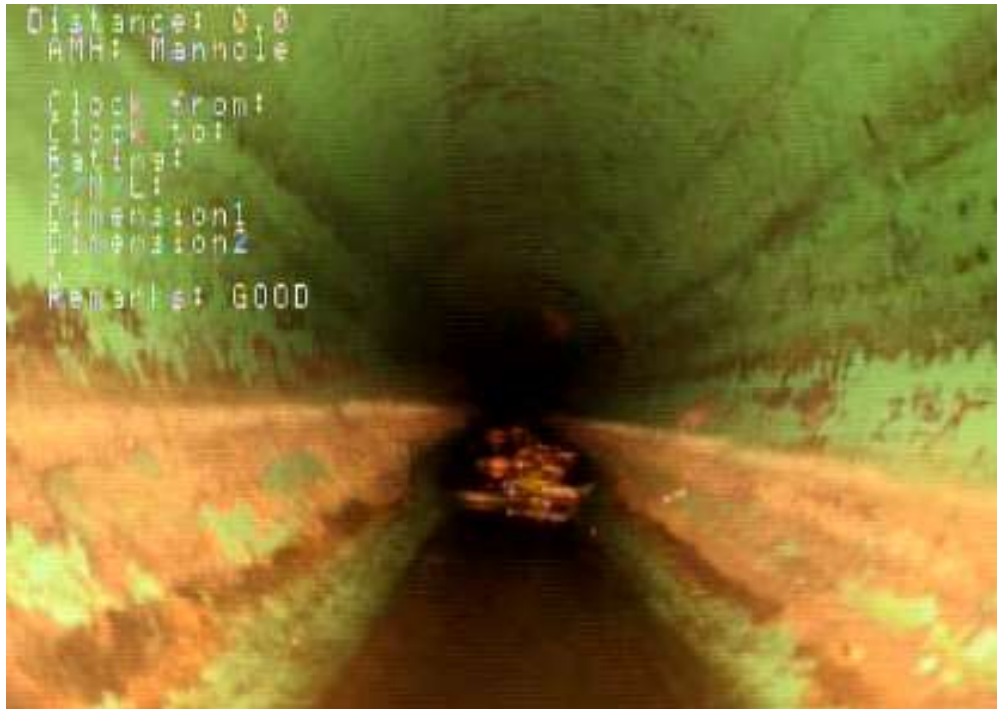
Interior of sanitary sewer pipe serving Vehicle Maintenance Building

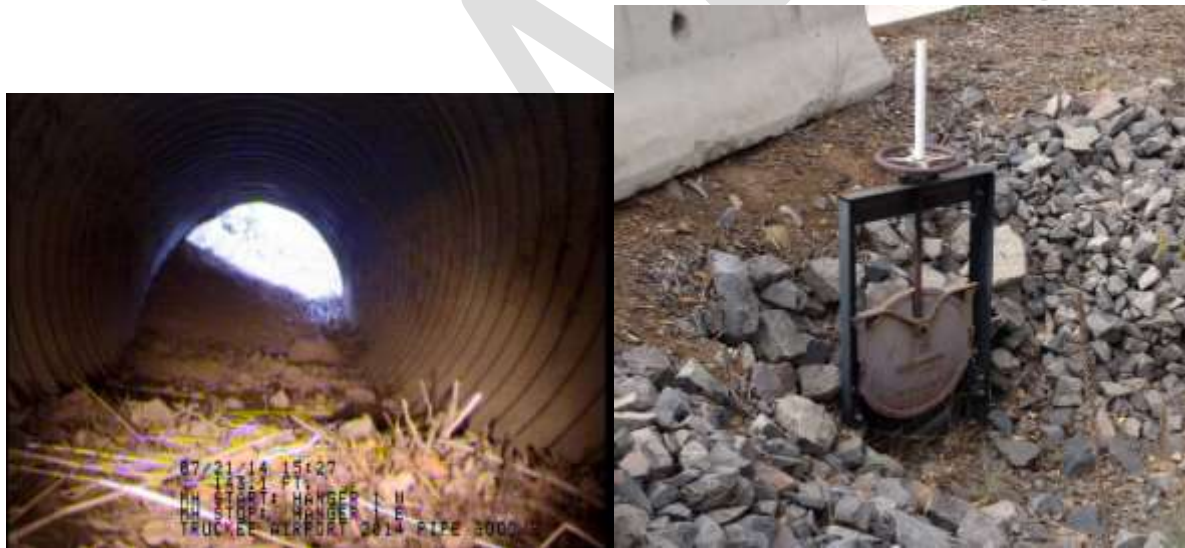
Storm Drain Pipe and Slide Gate

1. No storm drain infrastructure replacement is proposed. The condition of the pipelines and drainage inlets is considered good to very good with the exception of the slotted drain between Hangar Buildings G and H which is planned for replacement in 2015 when that taxilane is reconstructed. The condition of the remaining infrastructure should be assessed whenever repairs to the overlying pavement are planned.
2. The pipe and drainage swale network should be inspected annually and cleaned of rocks and sediment when necessary to maximize flow capacity. Accumulated sediment and

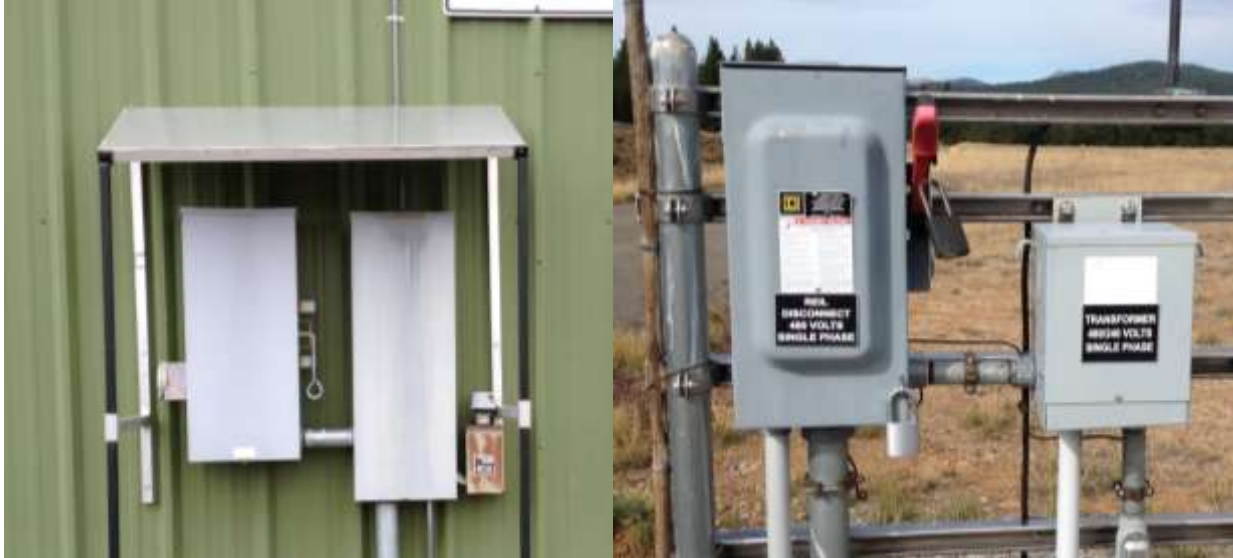
Power Distribution Panels

1. No power distribution infrastructure replacement is proposed
2. The receptacle capacity issues on the ramp light poles should analyzed and repairs/upgrades made.
3. All at-grade pull-boxes should be inspected at least annually, prior to snow removal activity, to confirm the lids are secure and that the conductors are accessible.
4. Label the exterior of all above-ground panels and sub-panels with the operating voltage, source of the power and the building/system served. The information, other than voltage, can be attached to the inside of the panel door if security concerns warrant. Individual breakers should identify the fixture(s) supplied by each circuit. Note: Staff must be trained and equipped with the appropriate Personal Protective Equipment (PPE) before working on any electrical panel or enclosure when the conductors are exposed.

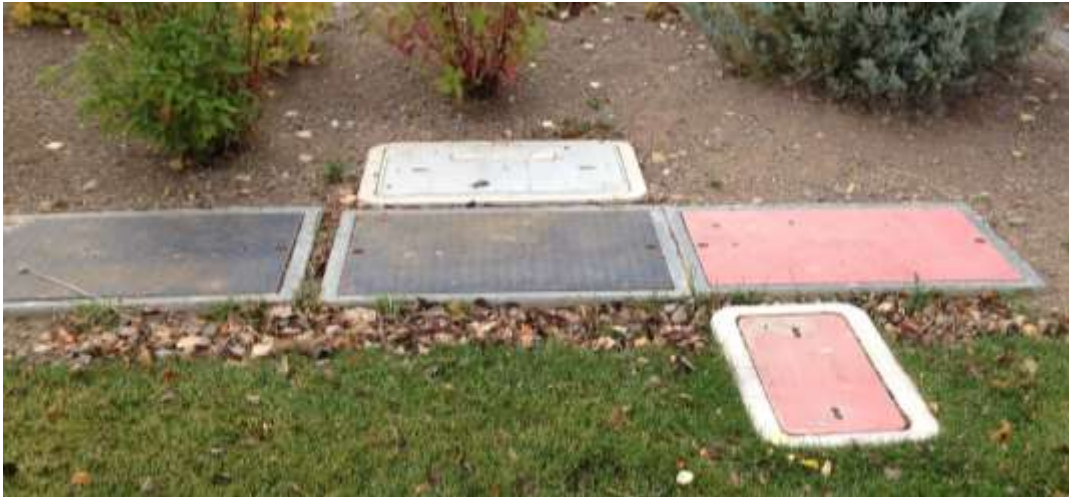
Communication and Power Pull-Boxes

1. No communication infrastructure replacement is proposed
2. All at-grade pull-boxes should be inspected at least annually, prior to snow removal activity, to confirm the lids are secure and that the cables are accessible.
3. Label all cables entering and leaving at-grade pull-boxes with the building/system served.
4. Label all above-ground enclosures, inside or outside the cabinet, with the building/system served
