MEETING DATE: October 24, 2014  
TO: Board of Directors  
FROM: Bill Quesnel PE, District Engineer  
SUBJECT: Draft *Utilities Maintenance Plan*

# **Utilities Maintenance Plan**

Truckee Tahoe Airport District

Acumen Engineering

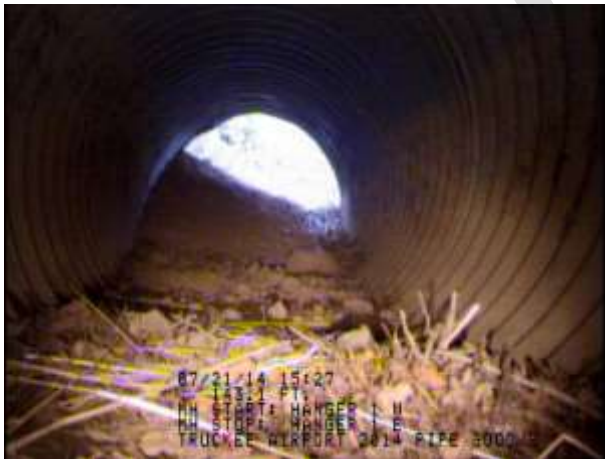
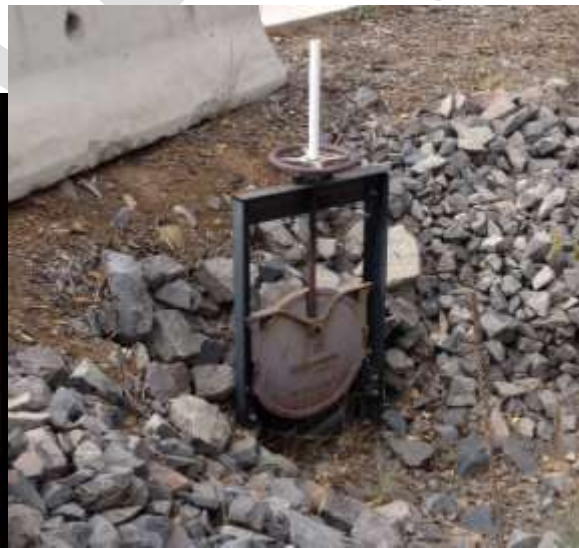
Storm Drain Pipe and Slide Gate

1. No storm drain infrastructure replacement is proposed. The condition of the pipelines and drainage inlets is considered good to very good with the exception of the slotted drain between Hangar Buildings G and H which is planned for replacement in 2015 when that taxilane is reconstructed. The condition of the remaining infrastructure should be assessed whenever repairs to the overlying pavement are planned.
2. The pipe and drainage swale network should be inspected annually and cleaned of rocks and sediment when necessary to maximize flow capacity. Accumulated sediment and
