FACILITIES MAINTENANCE PLAN

AUERBACH
ENGINEERING CORP

**Facilities Maintenance Plan
Truckee Tahoe Airport District
October 2020 - FINAL**

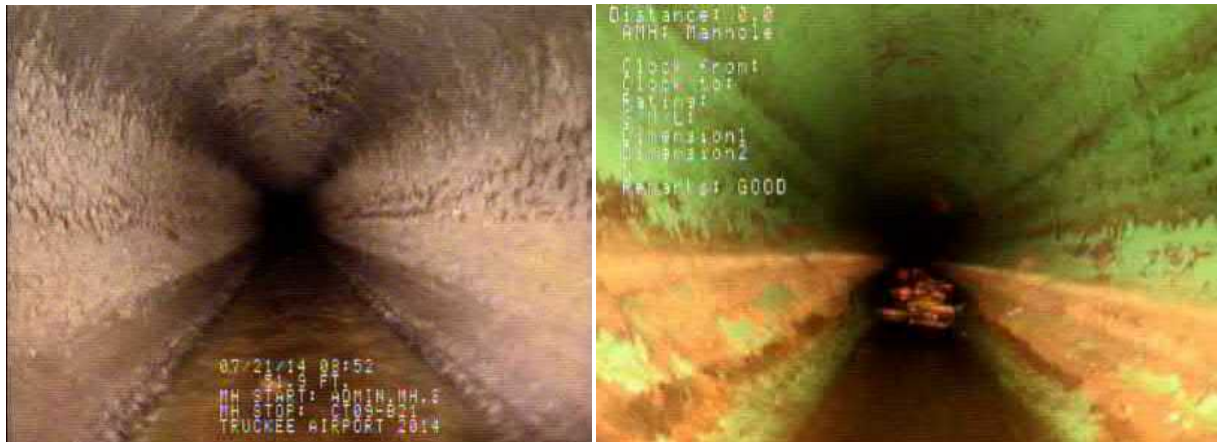
The previously described 2014 video inspection of a portion of the system showed the pipelines were in good structural condition with no apparent cracks, shear breaks or lateral off-sets. However, access to some pipelines was difficult due to missing building cleanouts and/or partial blockage caused by solids deposition (both rocks/dirt and waste) and the majority of the pipelines exhibited a build-up of FOG (fats, oils and grease) and/or other non-human waste on the walls or flowline. The EAA septic tank was cleaned in 2018. Visual inspection of the tank in 2014 did not indicate a degraded condition and the respective leach field reportedly functioned properly, i.e. no backups or surface daylighting of effluent. The glider port is served by an on-site septic system that was constructed and is operated/maintained by the concessionaire.

Figure 9-4 and Figure 9-5. 2014 Interior of Sanitary Sewer Pipes Serving Administration Building (left) and Vehicle Maintenance Building (right)

Suggested Sanitary Sewer System Improvements and Maintenance:

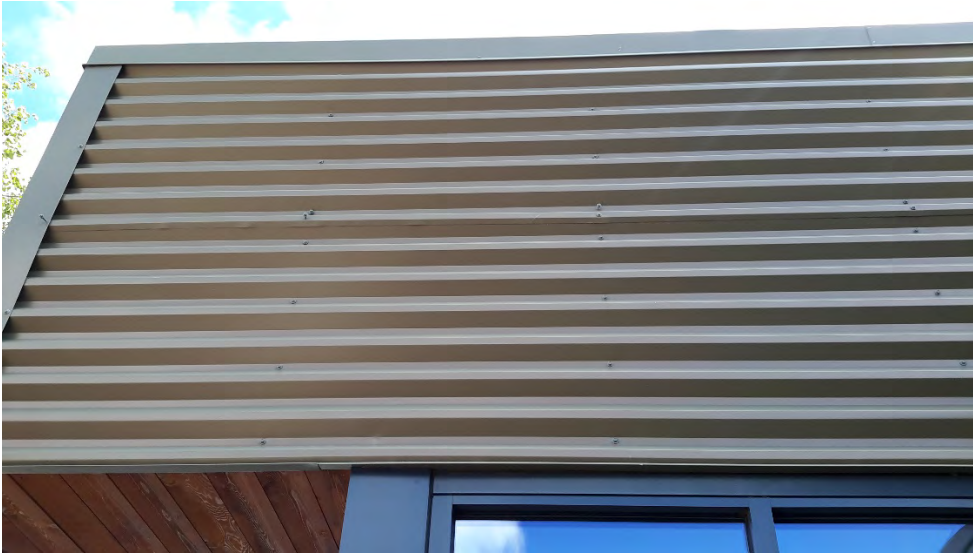
Figure 10 Building 2 - loose screws in fascia - south side at west flat roof

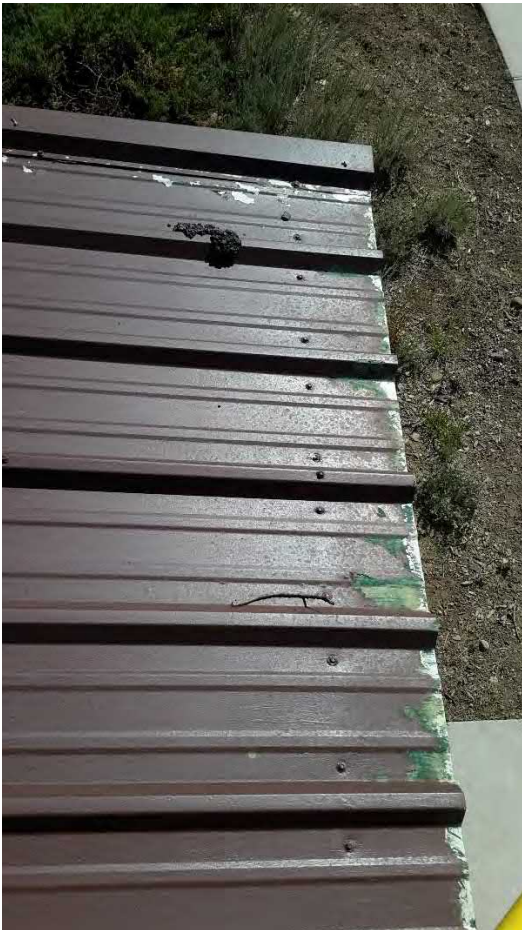
Figure 11 Building 3 - paint missing / corrosion at eave

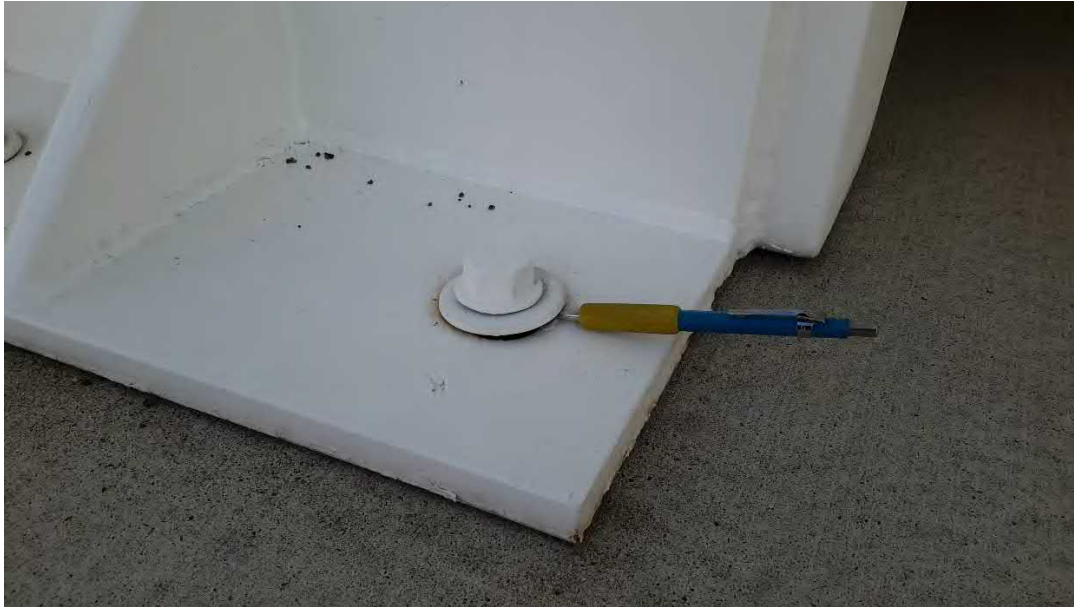
Figure 14 Building 5 - bolts at southwest foot are loose.

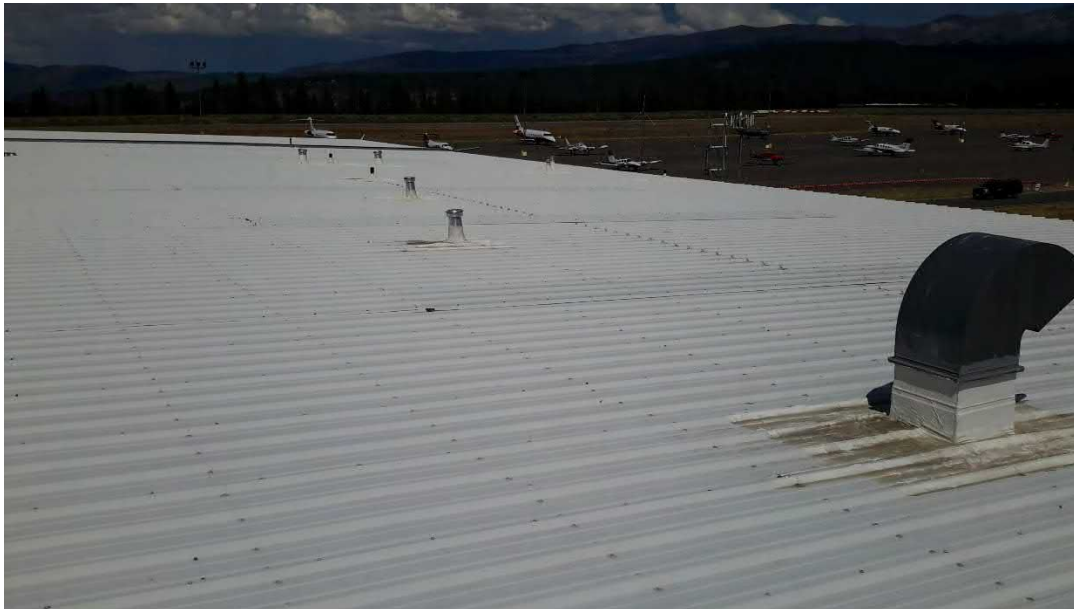
Figure 15 Building 7 - skylight patches

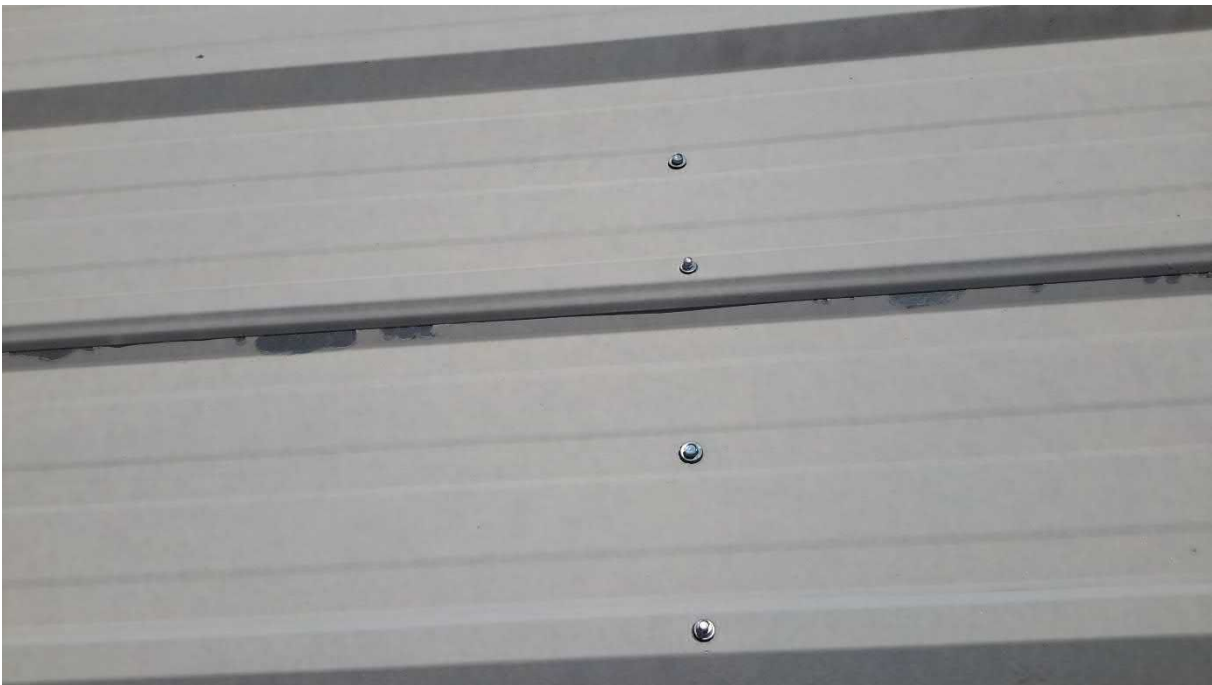
Figure 17 Building 8 - paint flaking on roof panels

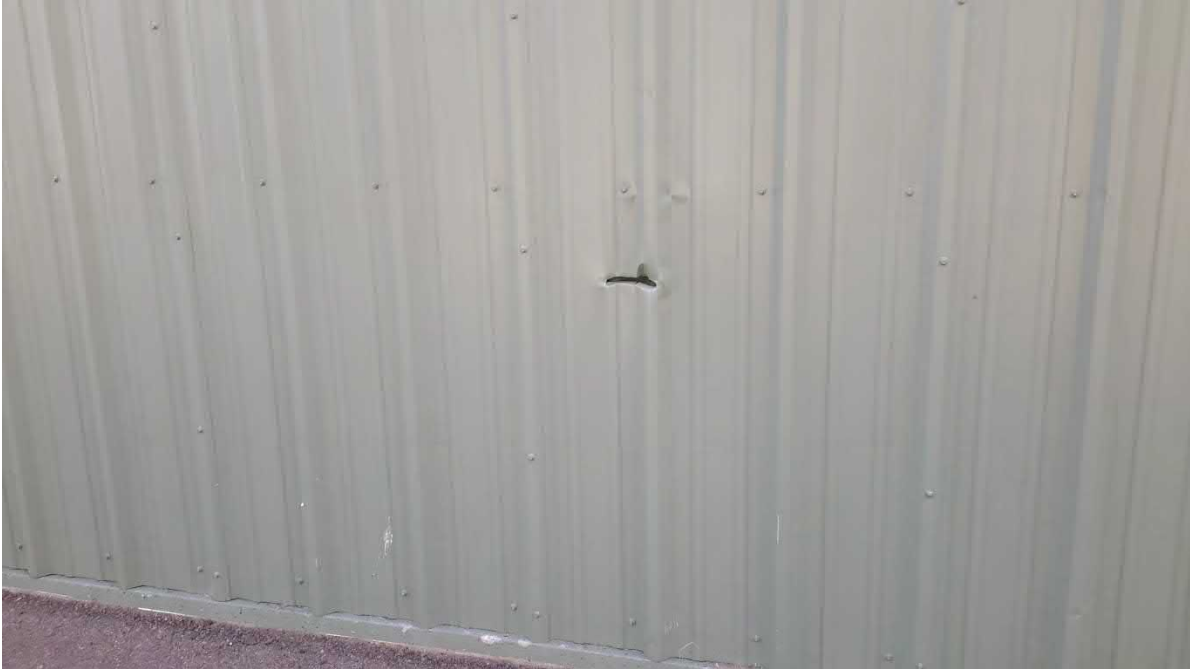
Figure 19 Building 8 - puncture hole - west side

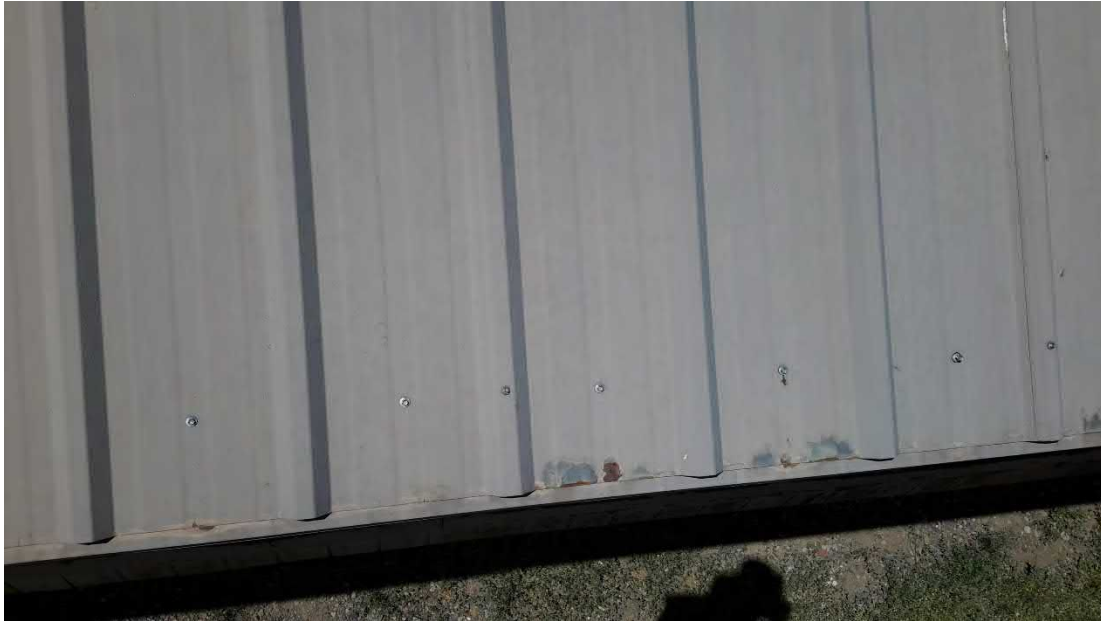
Figure 20 Building 9 - paint peel and corrosion on east eave

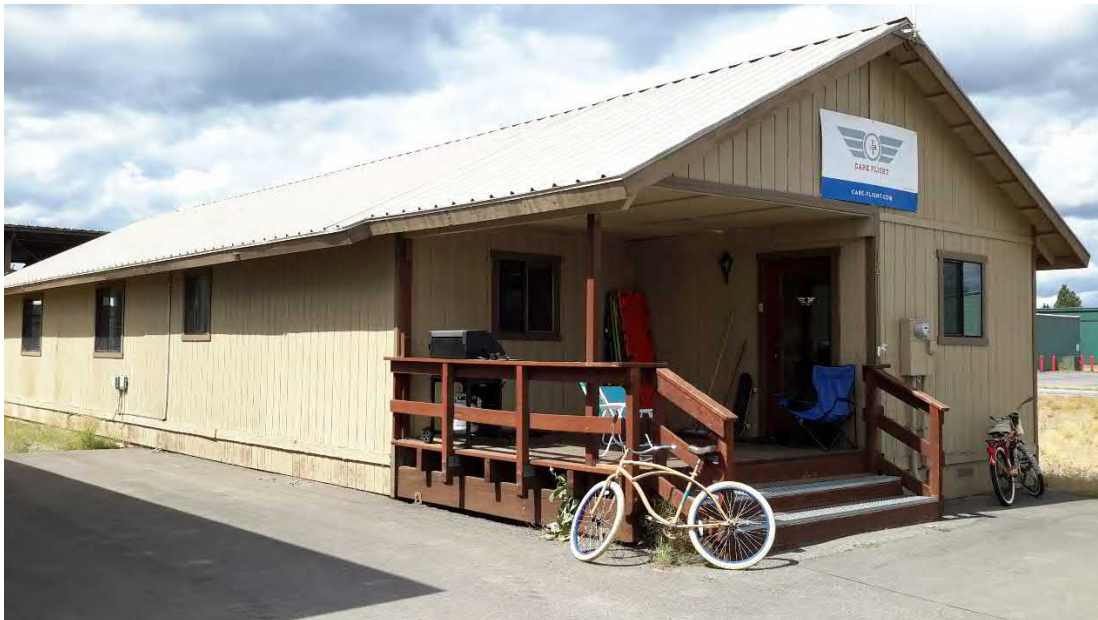
Figure 21 Building 9 - skirt board needs protective paint

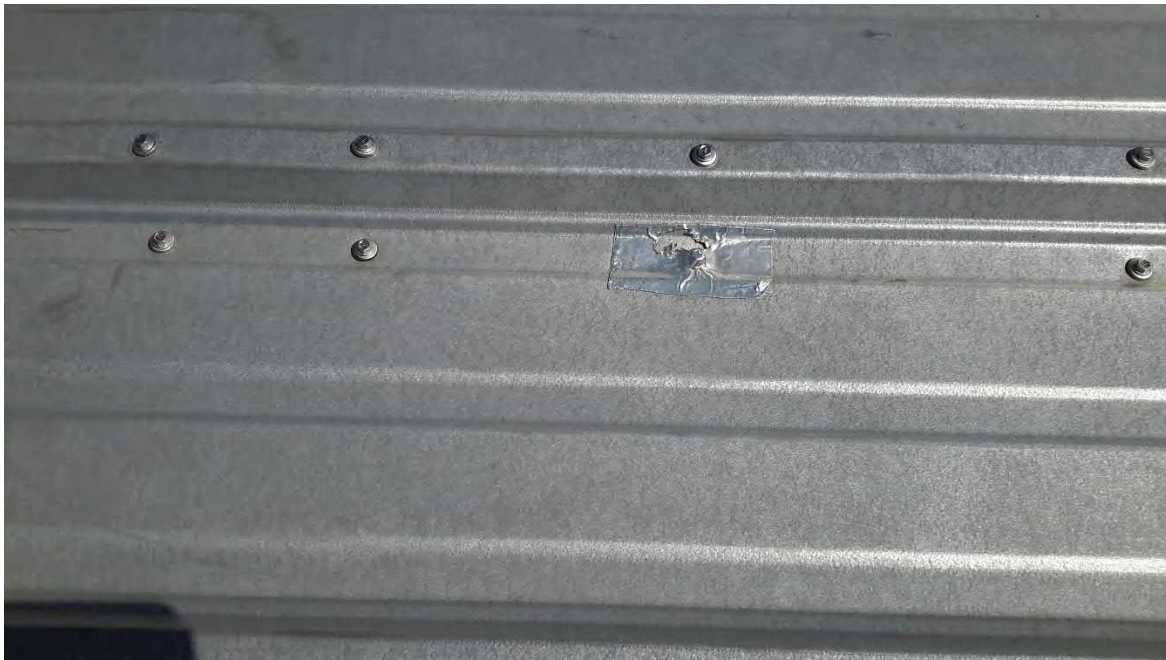
Figure 25 Building 10 - foil-faced adhesive patches damaged

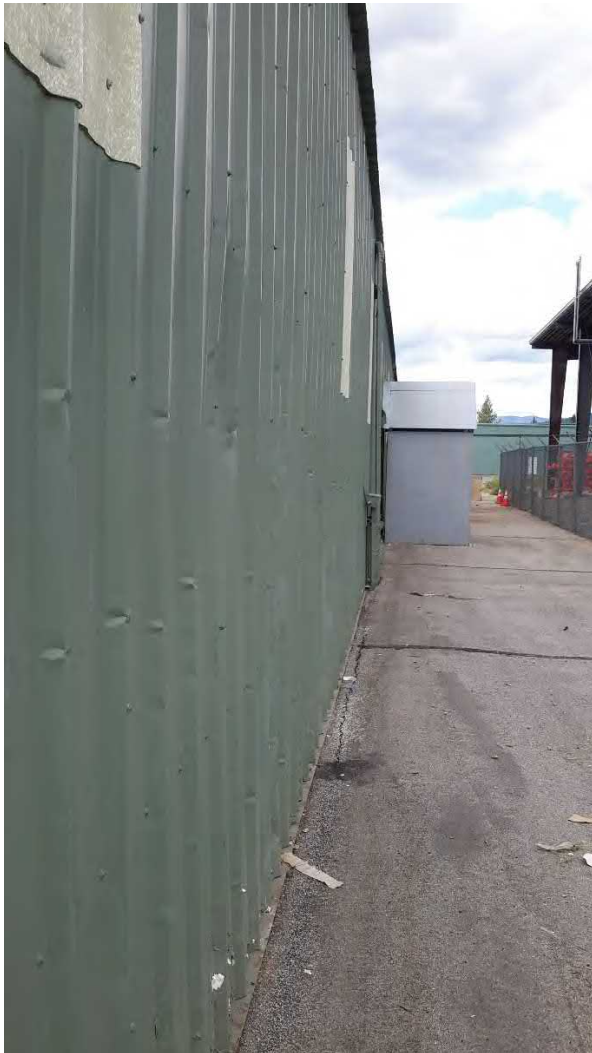
Figure 30 Building 11 - panel damage on north side

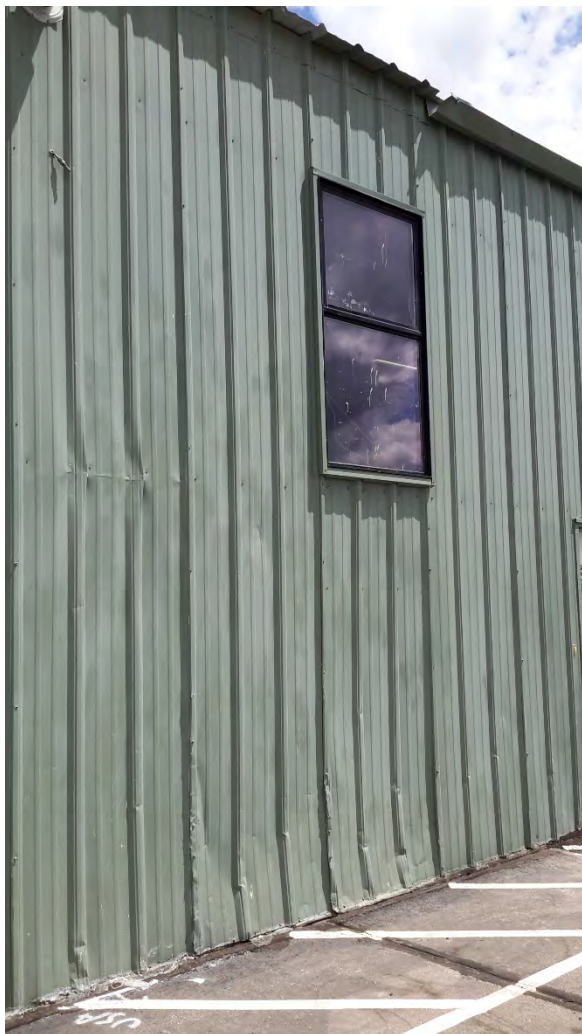
Figure 34 Building 11 - wall panel damage on south side from snow, ice and/or vehicles

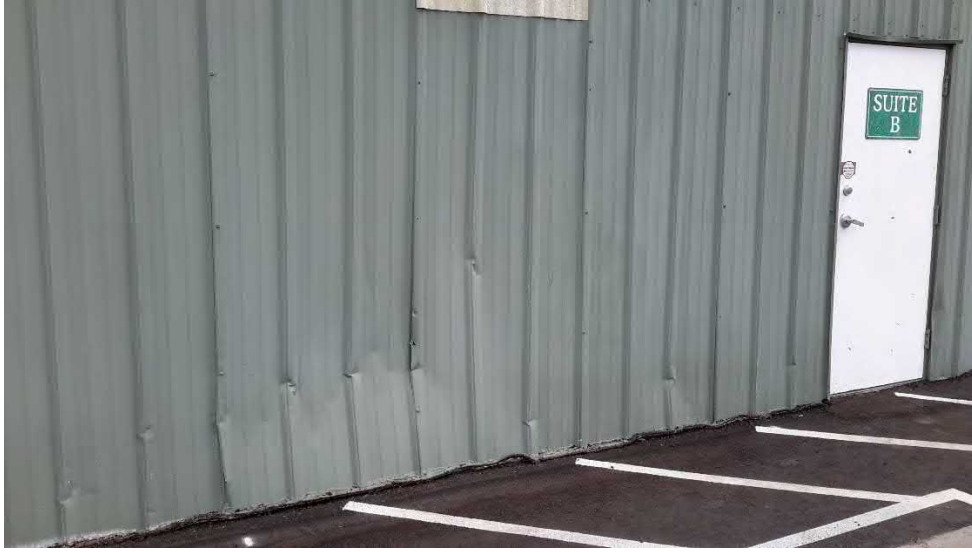
Figure 35 Building 11 - wall panel damage on south side from snow, ice and/or vehicles

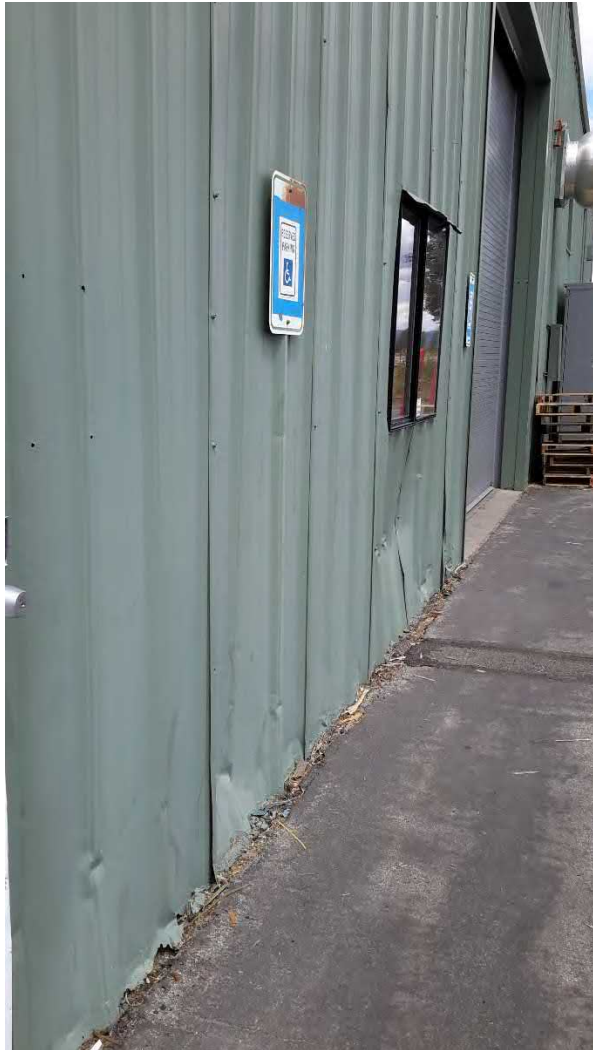
Figure 36 Building 11 - wall panel damage on east side from snow, ice and/or vehicles

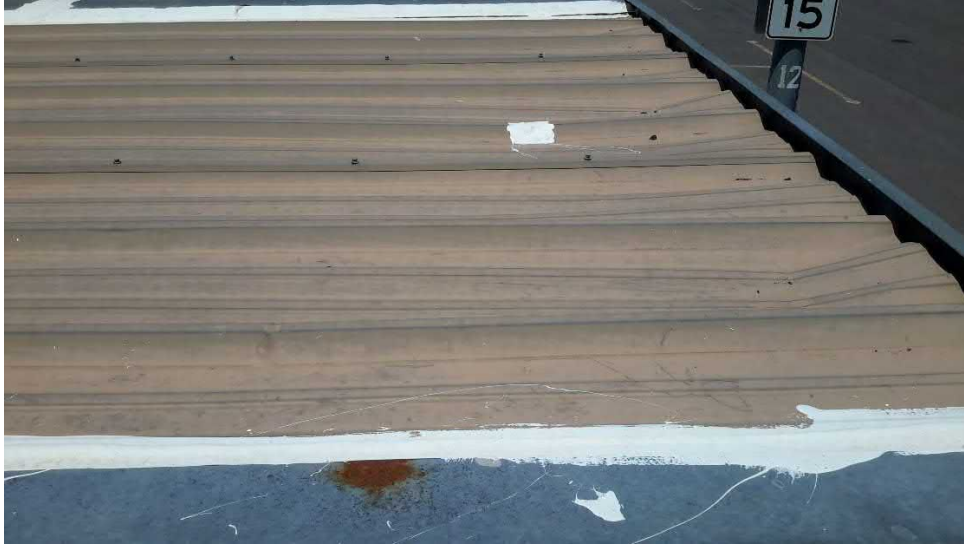
Figure 40 Building 12 - roof damage from snow and ice

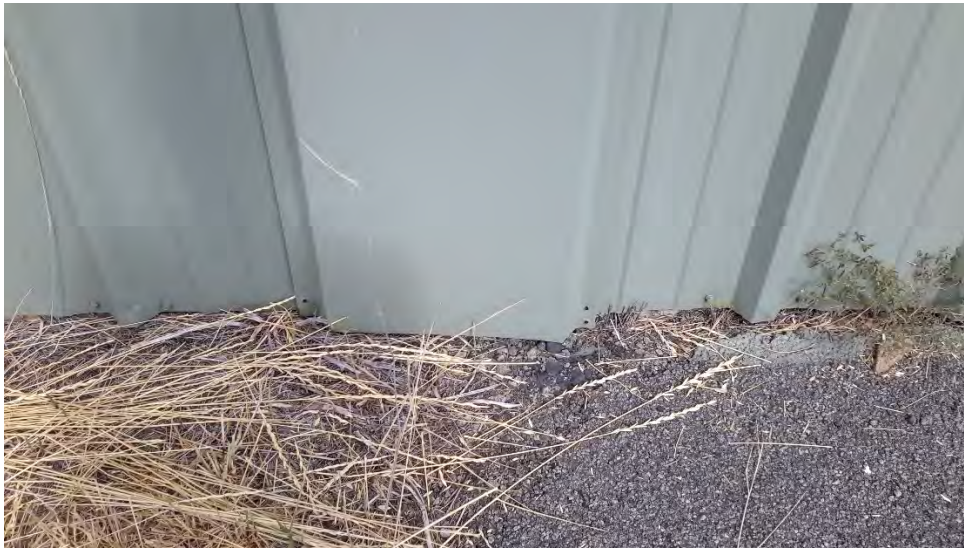
Figure 41 Building 12 - wall panel fasteners missing at base, east side

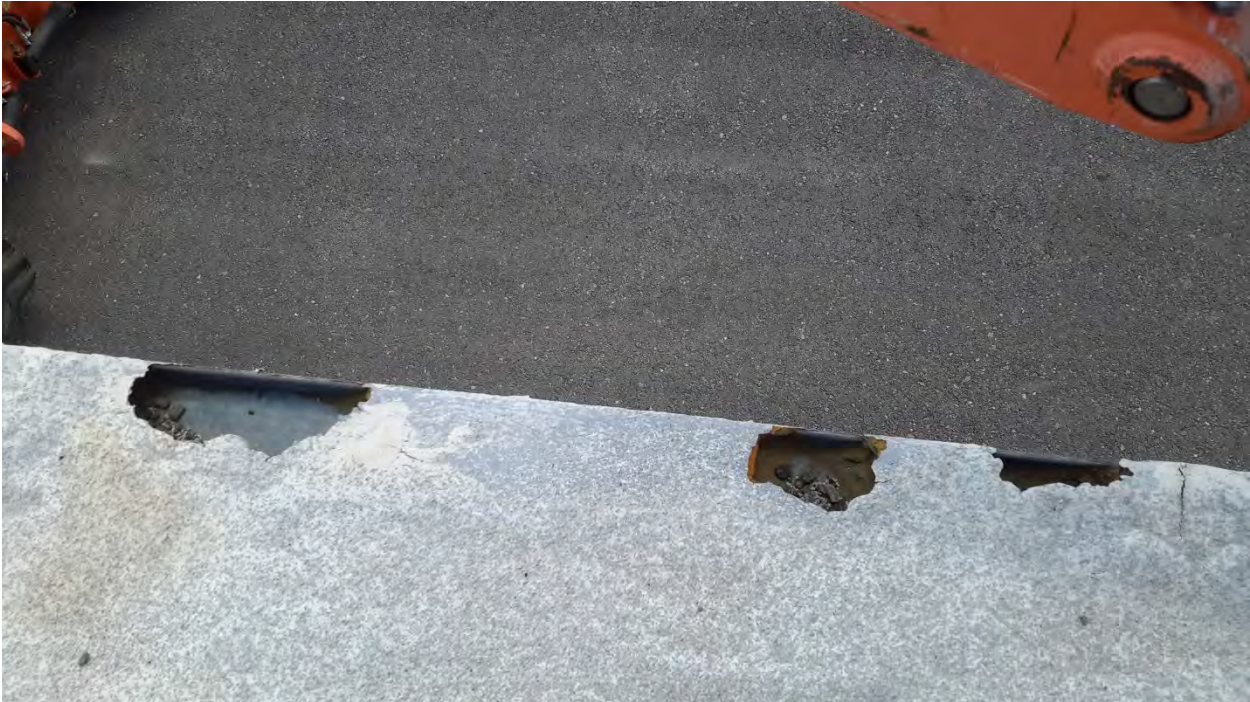
Figure 45 Building 13 - numerous holes in roof

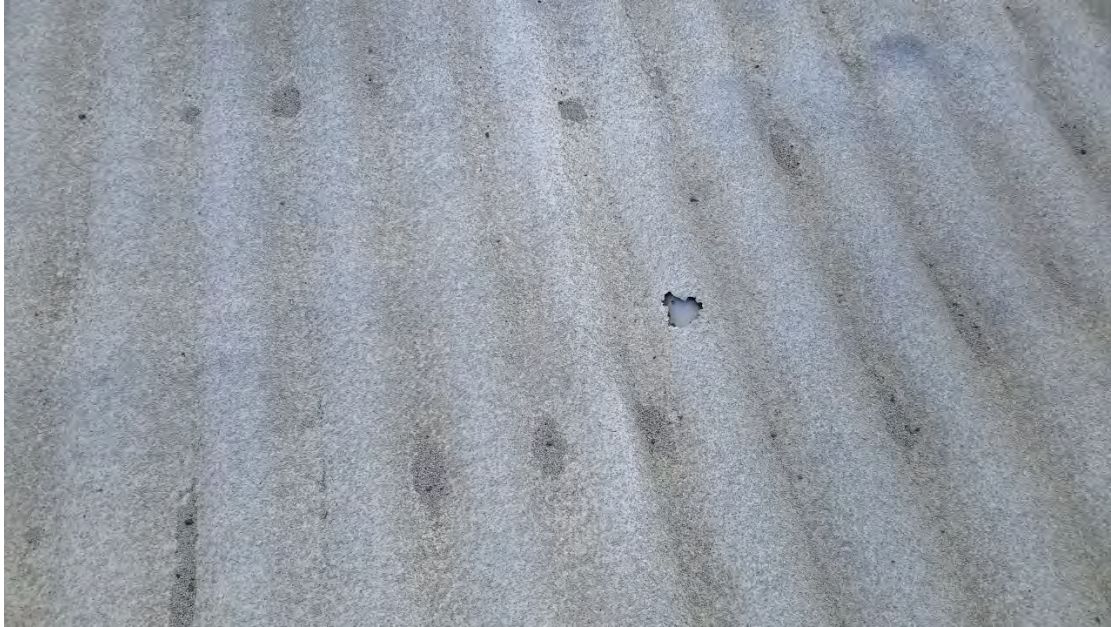
Figure 46 Building 13 - holes in roof, foam below coating damaged

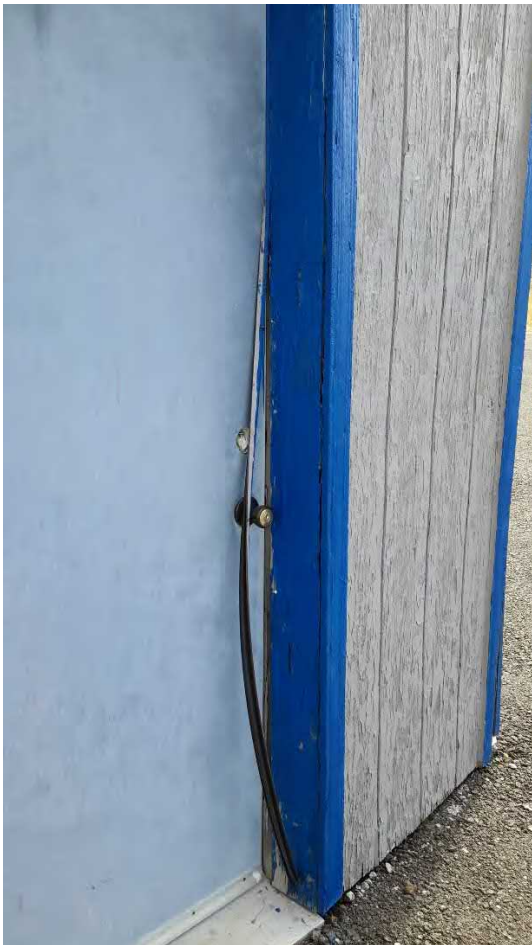
Figure 47 Building 13 - flaking paint, door weather-stripping, door trim damaged

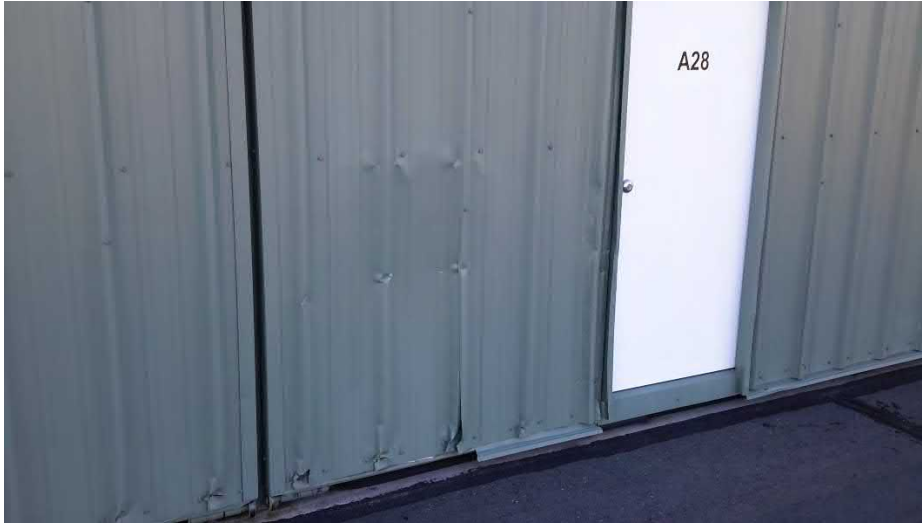
Figure 59 Hangar A - wall panel damage along west side

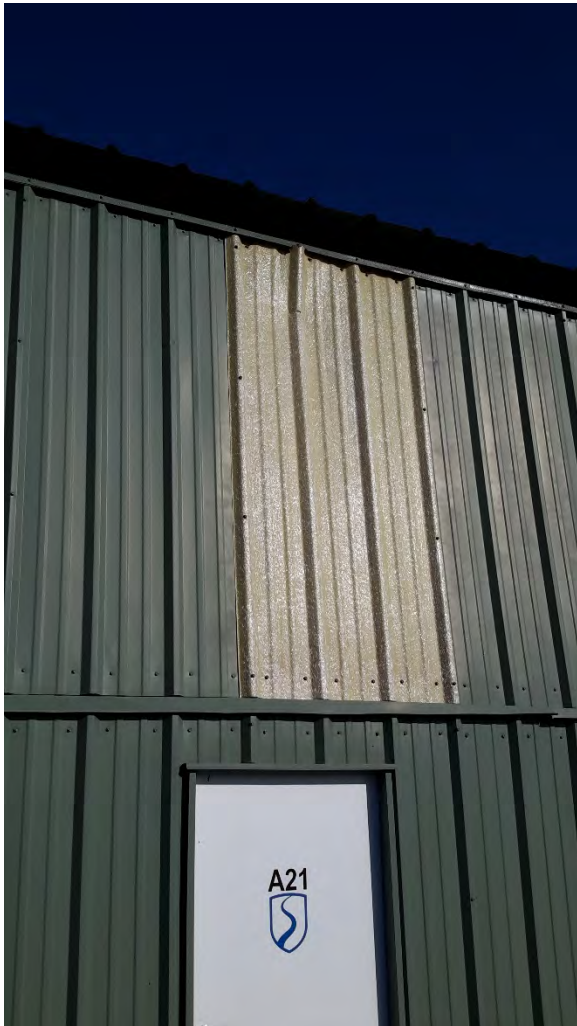
Figure 60 Hangar A - translucent panel damage - east side

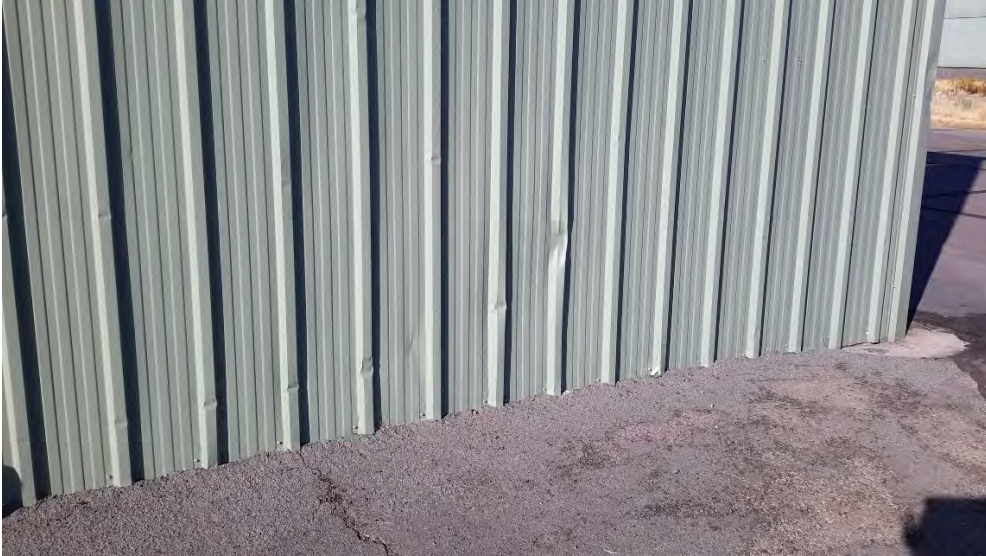
Figure 64 Hangar B - wall panel damage on north end from snow and ice

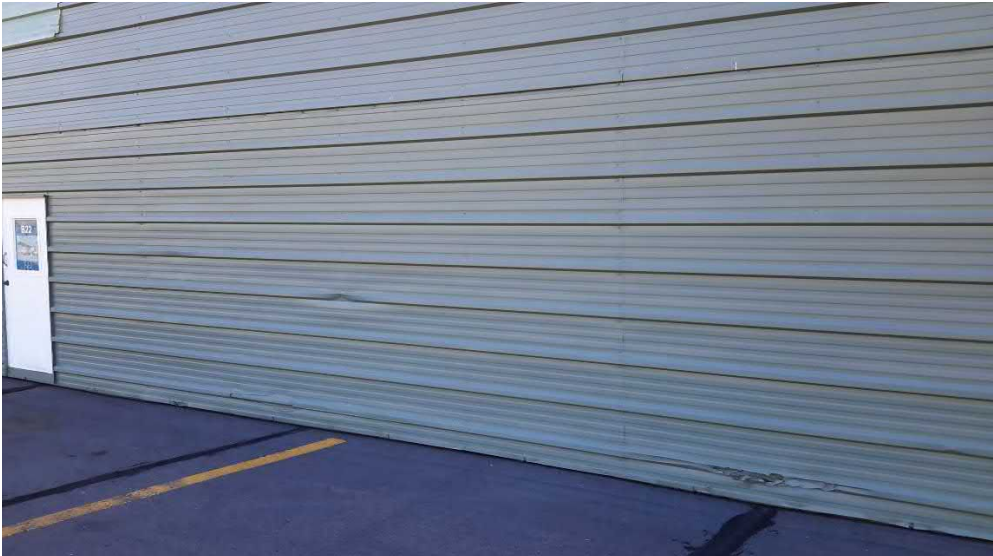
Figure 65 Hangar B - wall panel damage on west side (B22)

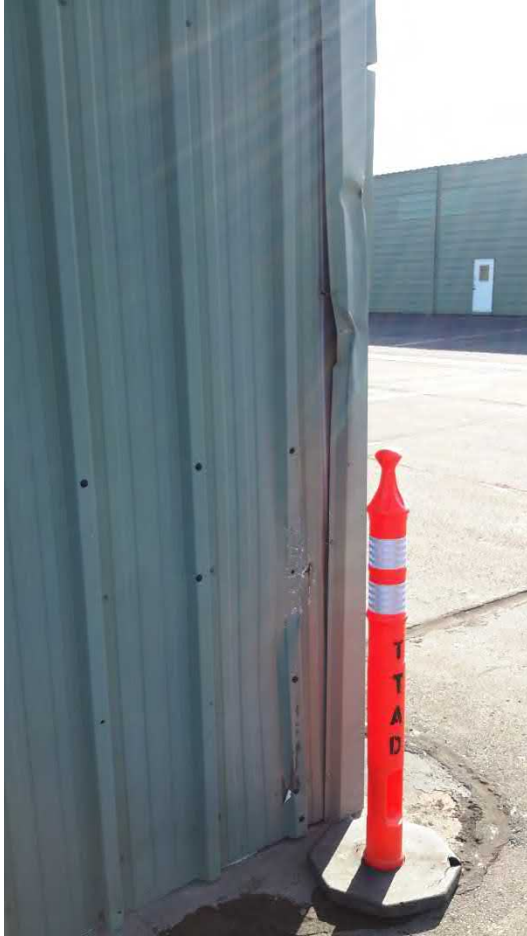
Figure 66 Hangar B - siding damage - south east corner

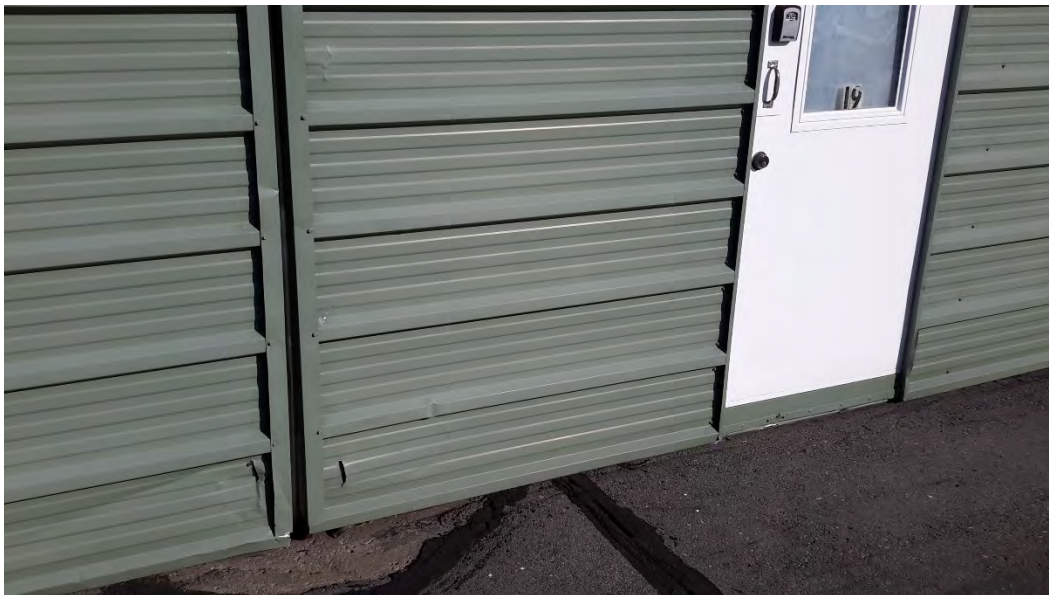
Figure 67 Hangar B - Panel damage - east side

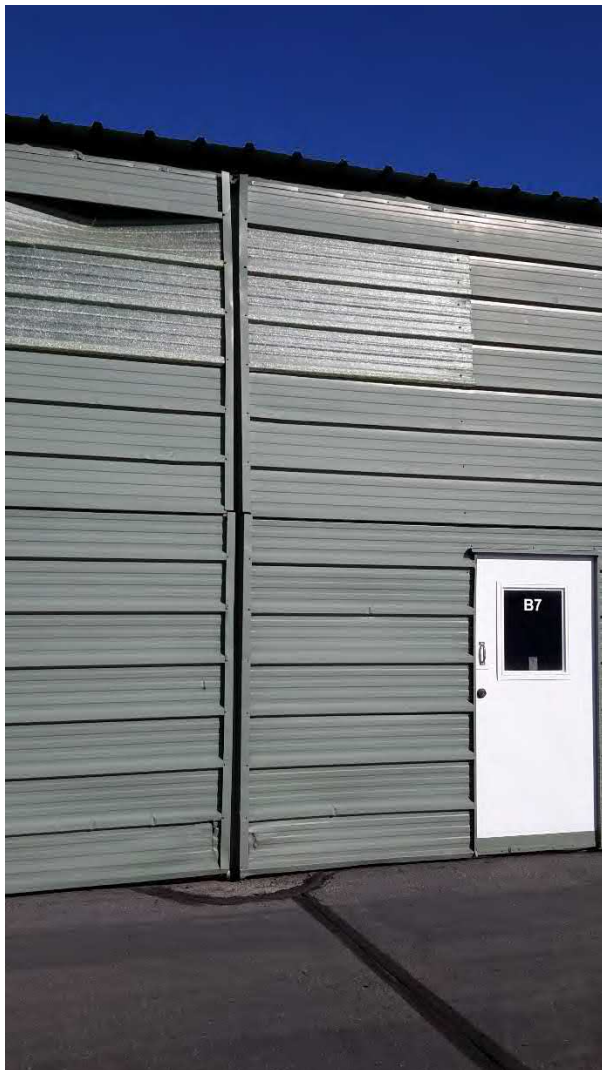
Figure 69 Hangar B - translucent panel damage - east side

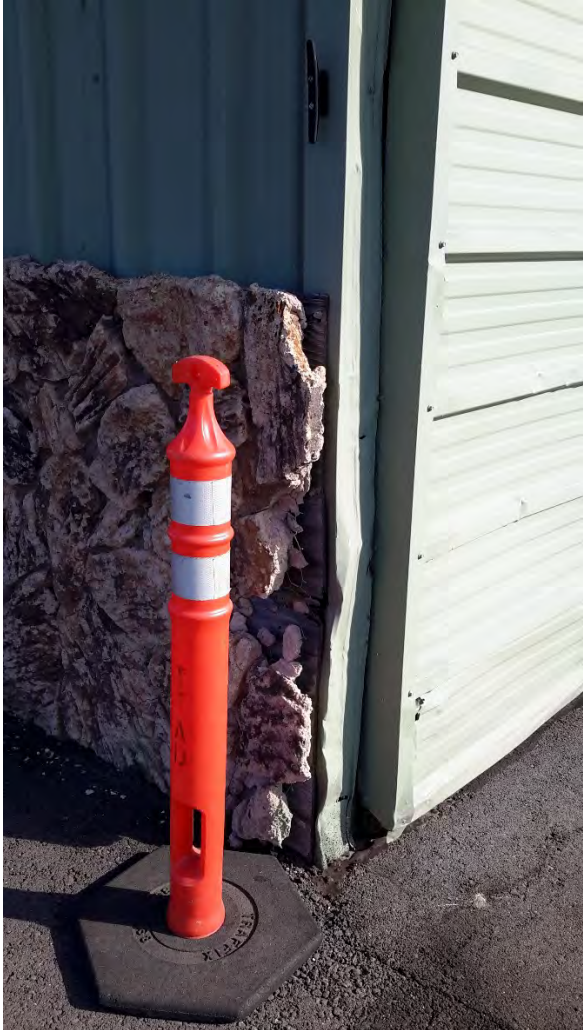
Figure 76 Hangar C - wall panel damage - south east corner

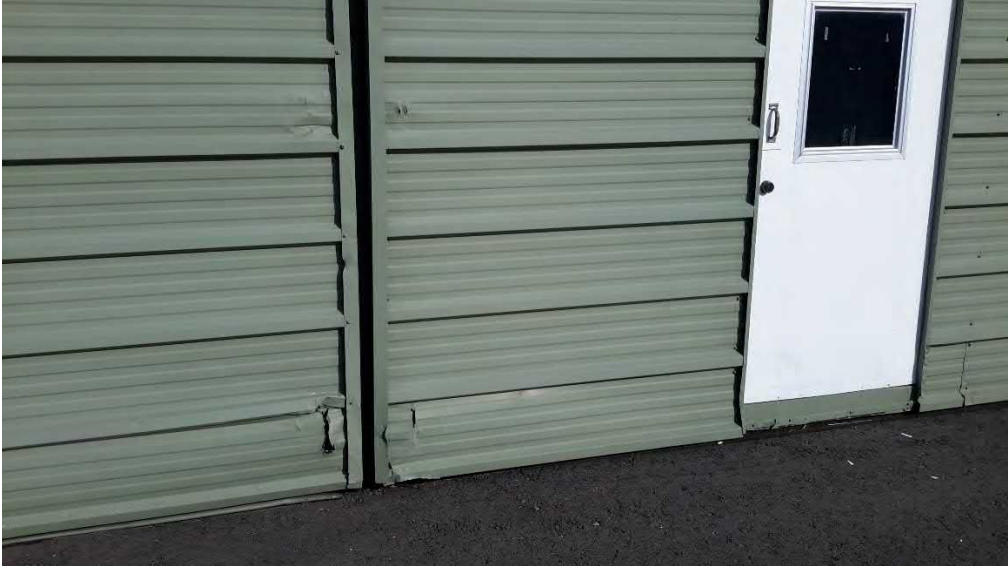
Figure 77 Hangar C - wall panel damage - east side (C13)

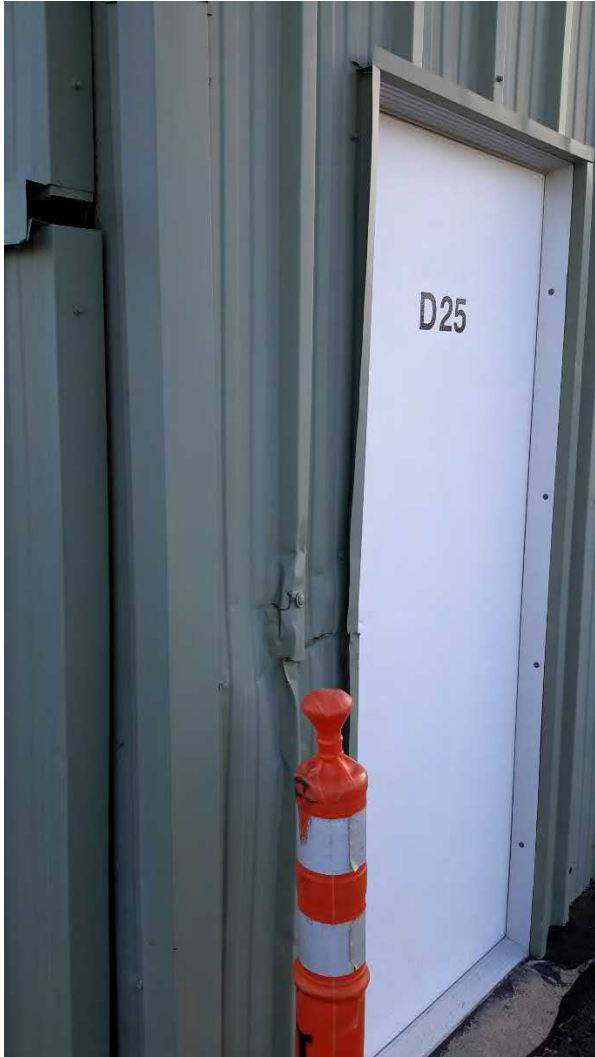
Figure 81 Hangar D - wall panel damage at south west corner

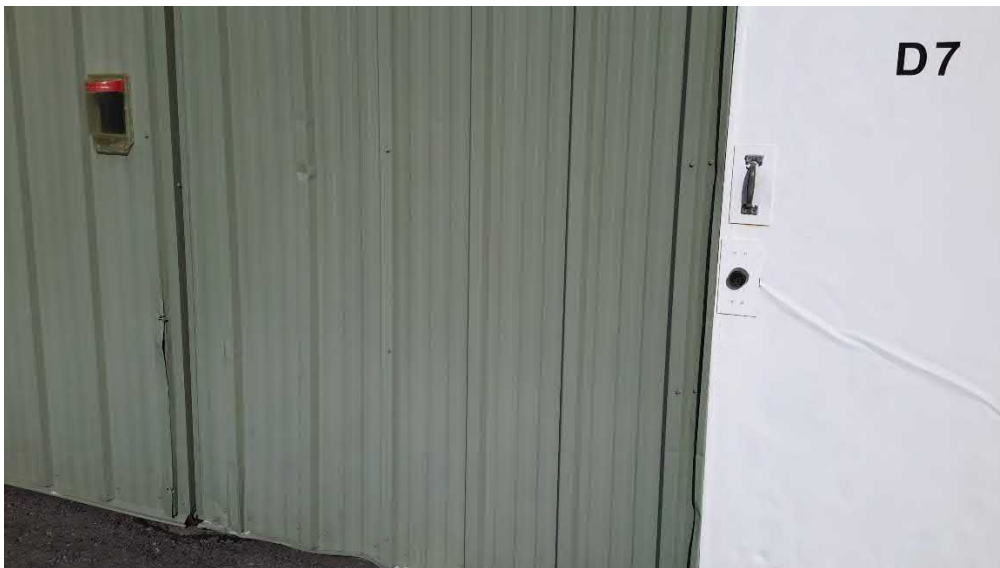
Figure 82 Hangar D - door panel damage (D9)

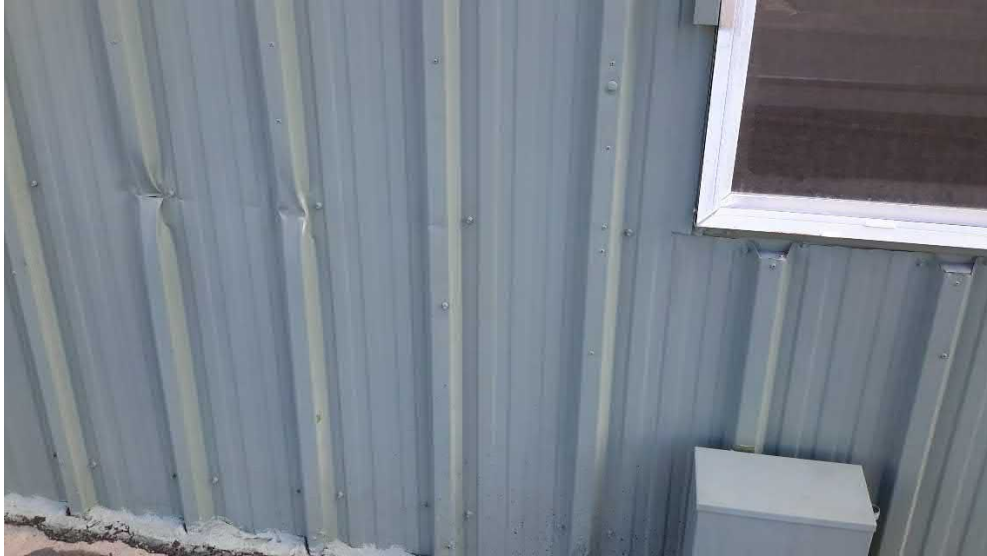
Figure 91 Hangar E - south wall window trim missing, wall panel damage

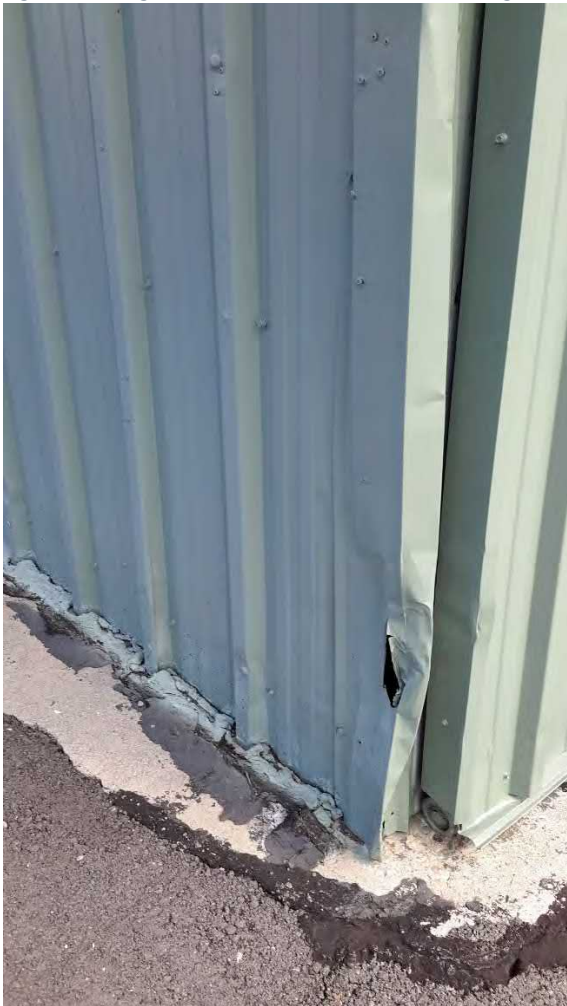
Figure 92 Hangar E - wall panel damage at south east corner

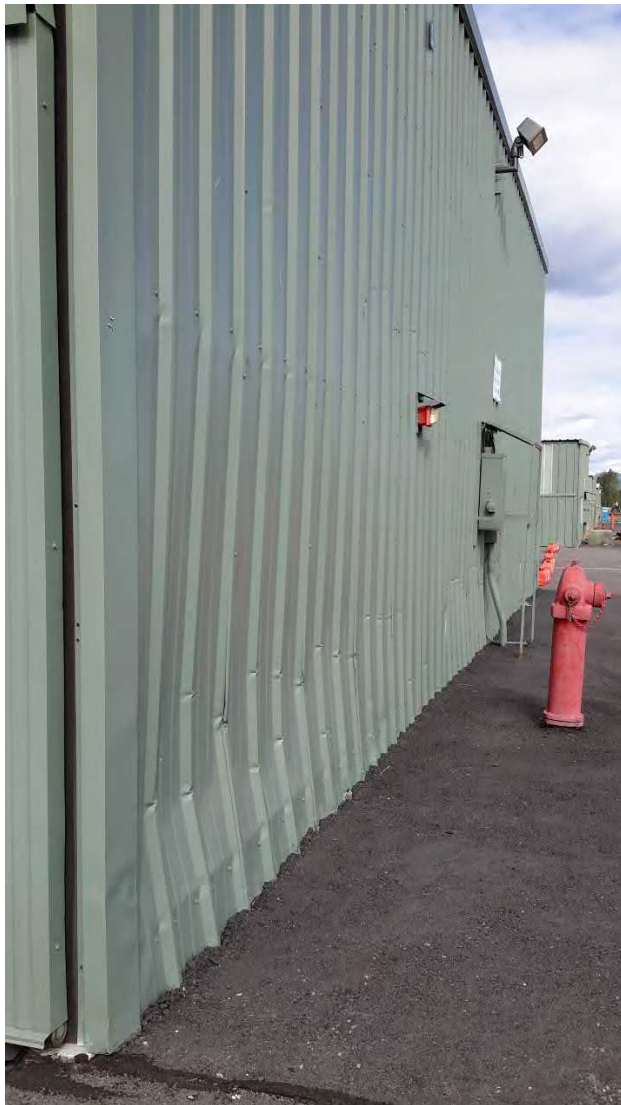
Figure 97 Hangar F - wall panel damage on north end from snow and ice

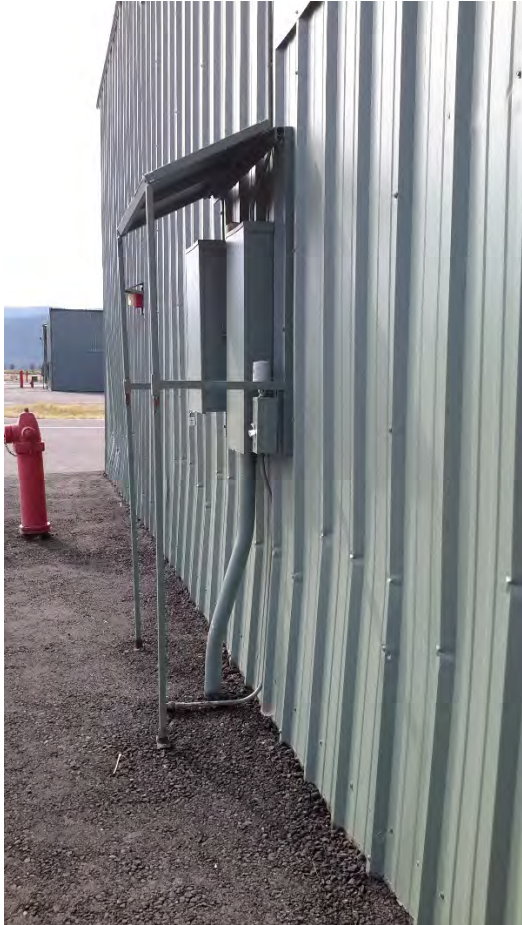
Figure 98 Hangar F - wall panel damage on north end from snow and ice

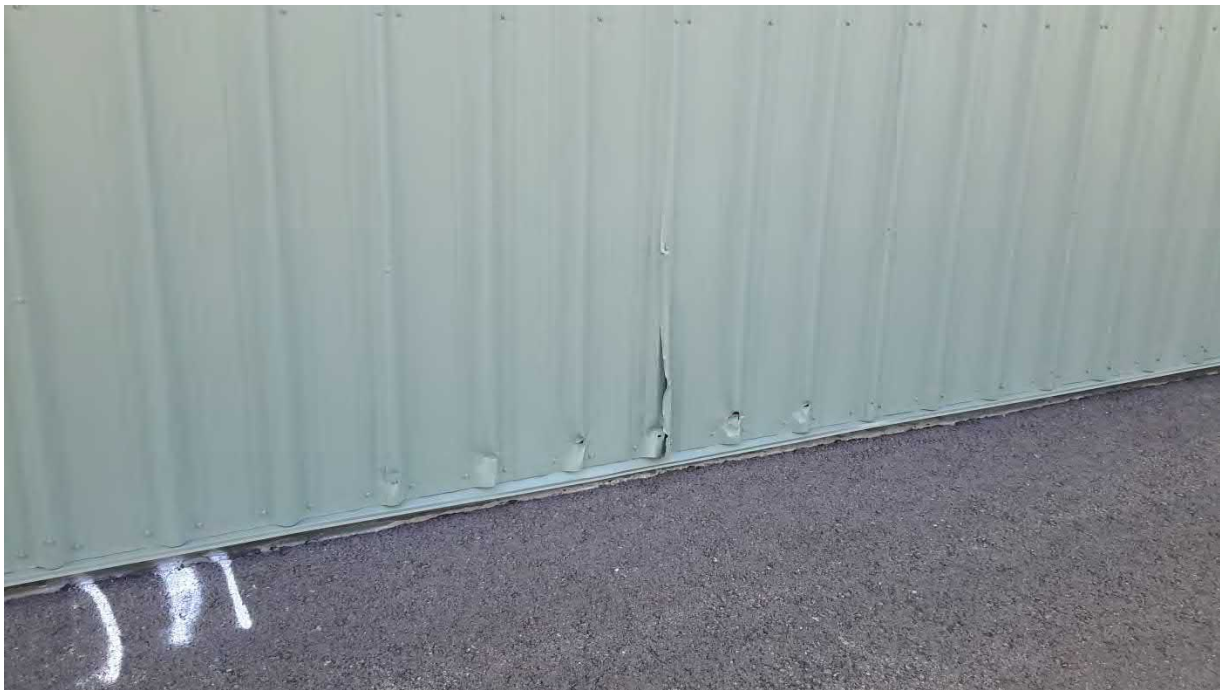
Figure 99 Hangar A - door panel damage (F2)

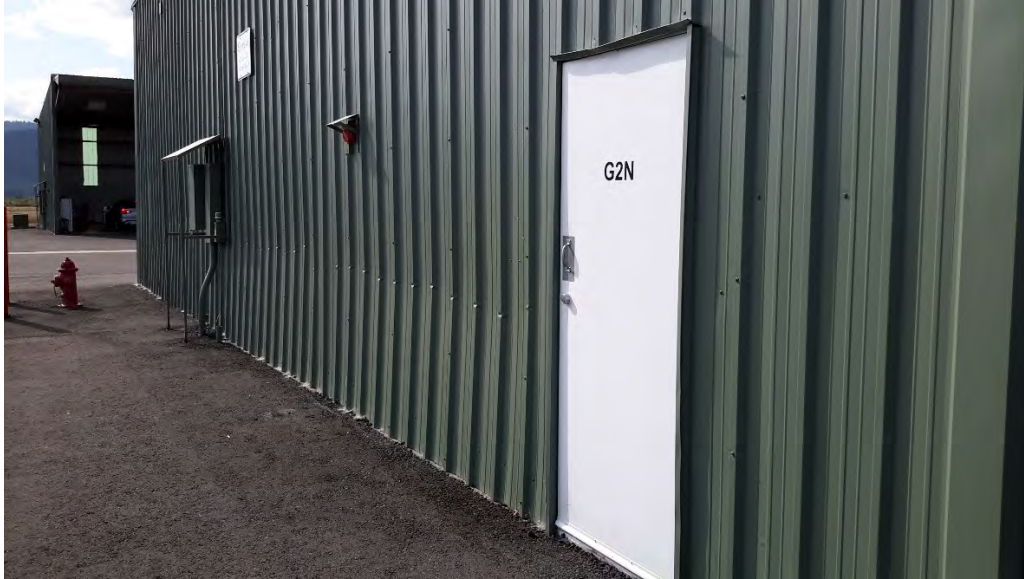
Figure 103 Hangar G - wall panel damage on north end from snow and ice
