FACILITIES MAINTENANCE PLAN

AUERBACH
ENGINEERING CORP

**Facilities Maintenance Plan
Truckee Tahoe Airport District
October 2020 - FINAL**

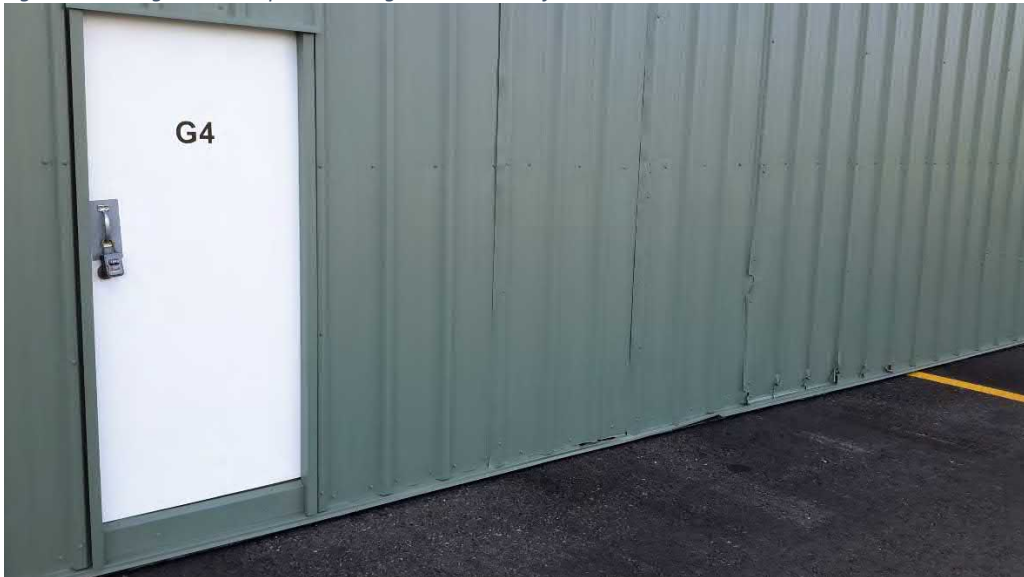
Figure 104 Hangar G - door panel damage (G4)

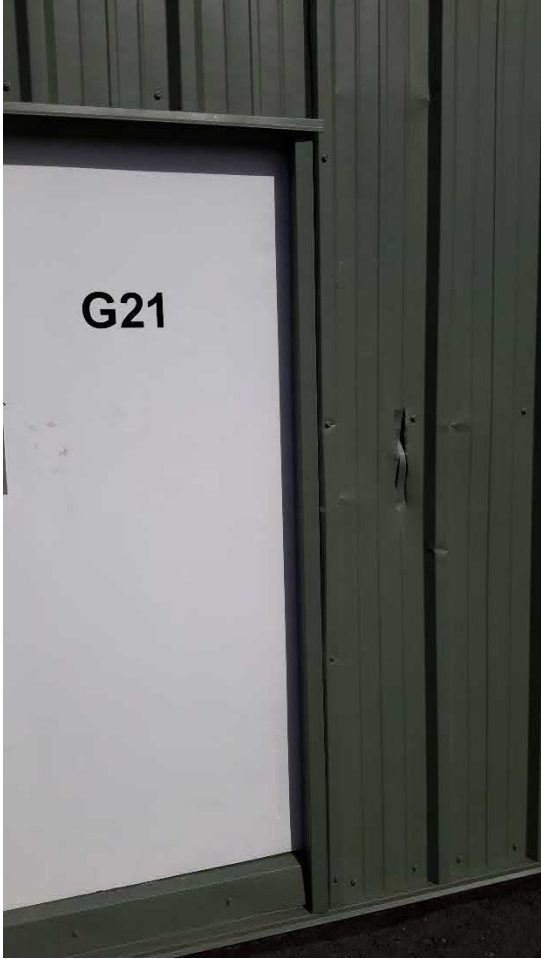
Figure 105 Hangar G - door panel damage (G21)

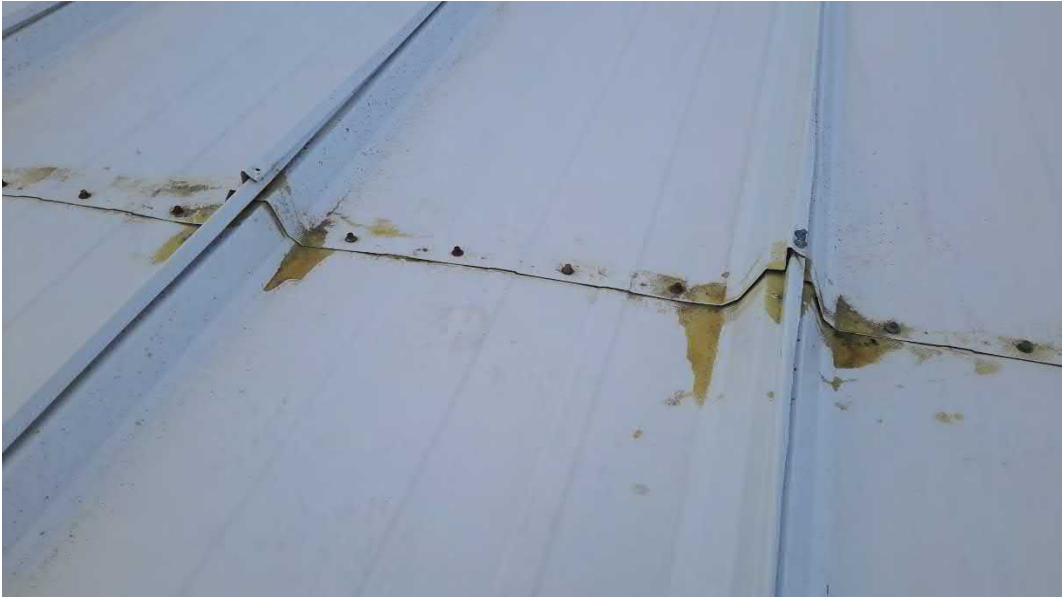
Figure 106 Hangar H - screws missing and loose at midline lap joint

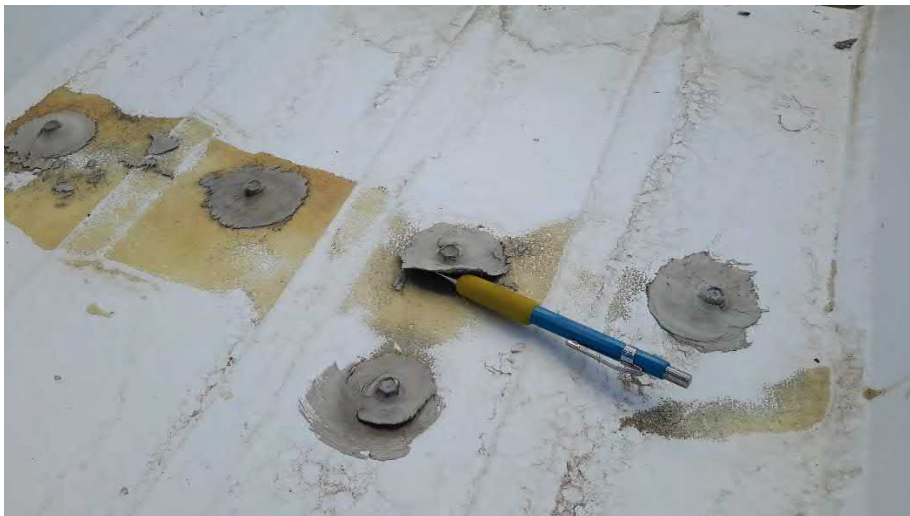
Figure 109 Hangar H - leak patch on low end (east side) failing, screws loose

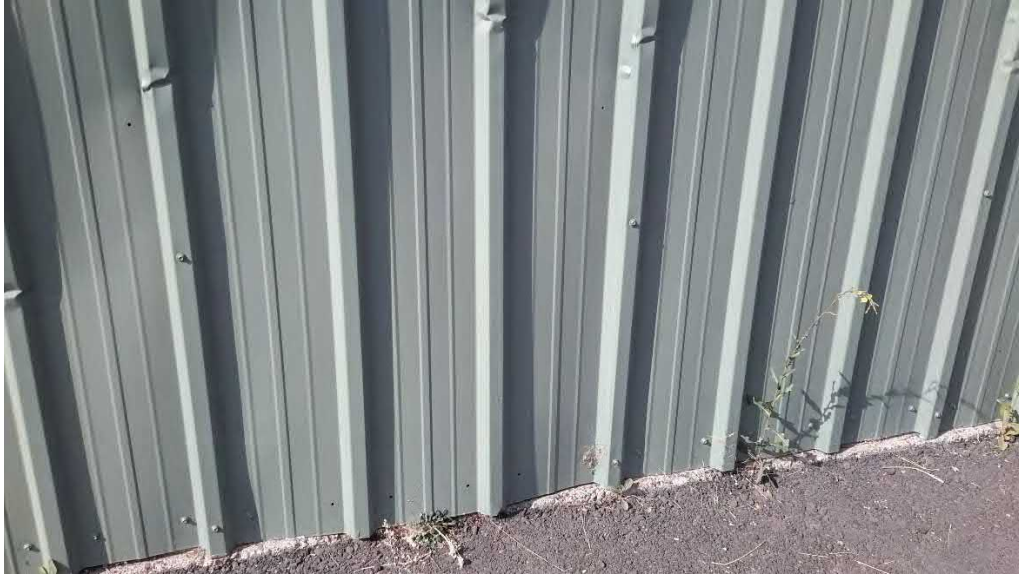
Figure 112 Hangar H - panel fasteners are missing at base of north wall

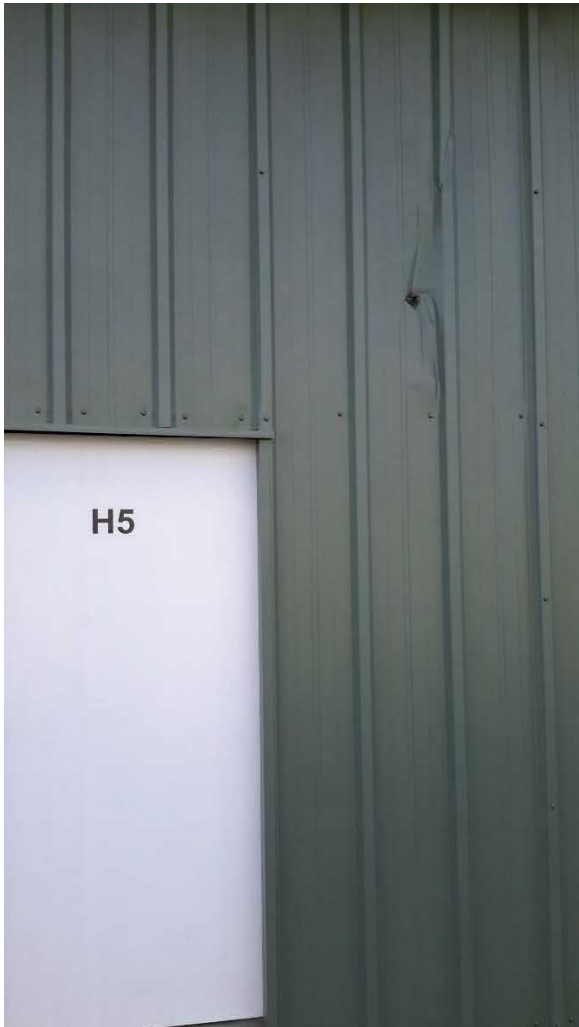
Figure 113 Hangar H - wall panel puncture (H5)

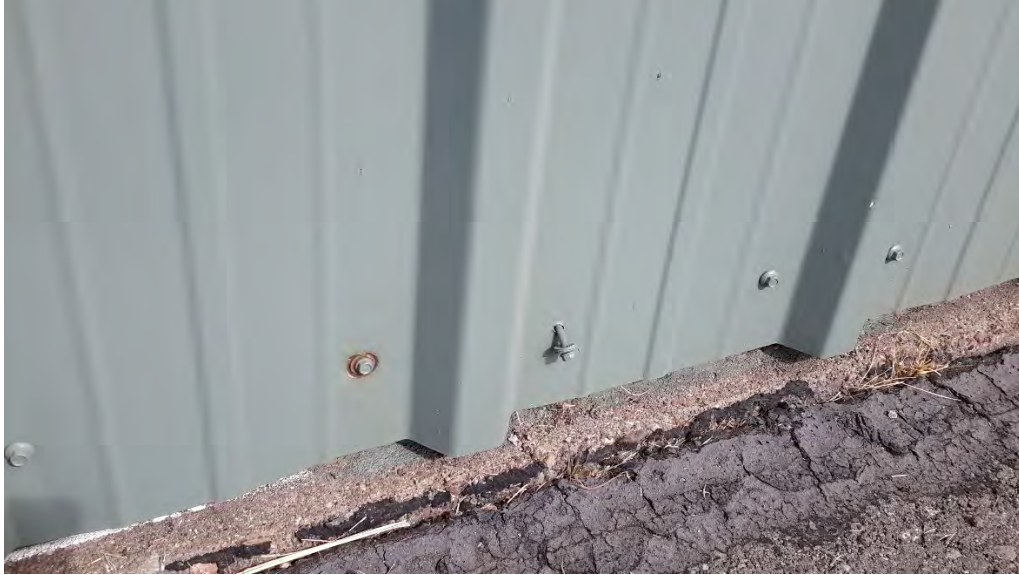
Figure 114 Hangar H - east side panel fasteners show signs of rust and are loose

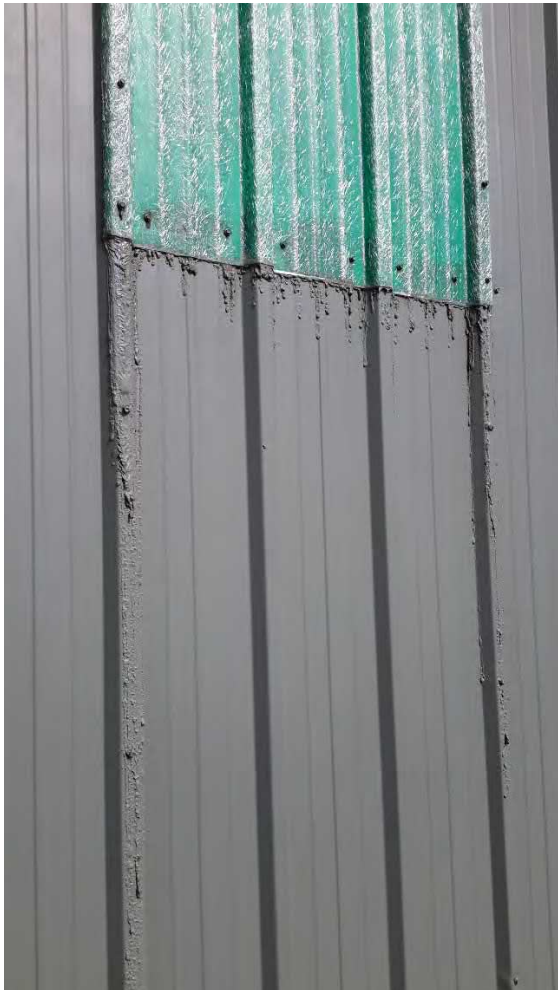
Figure 115 Hangar H - sealant to translucent panels, east side, poor installation

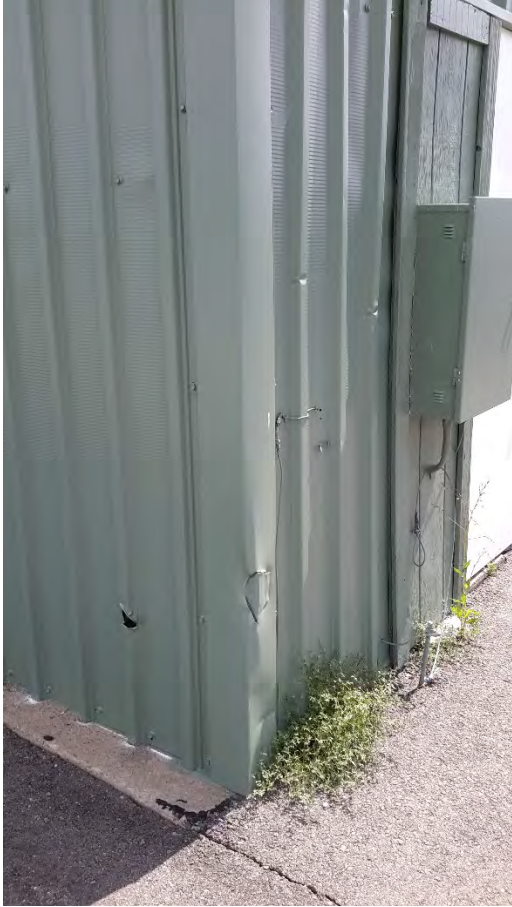
Figure 119 Hangar J - wall panel damage on south west corner

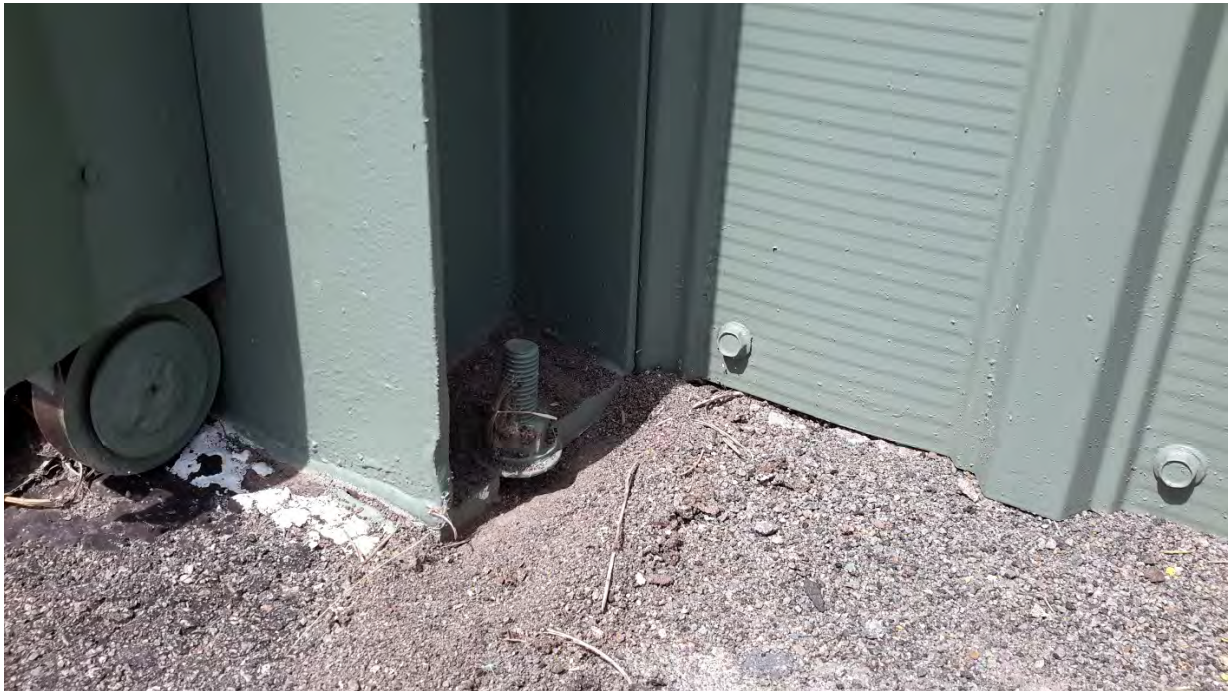
Figure 120 Hangar J - column anchor bolt mis-placed

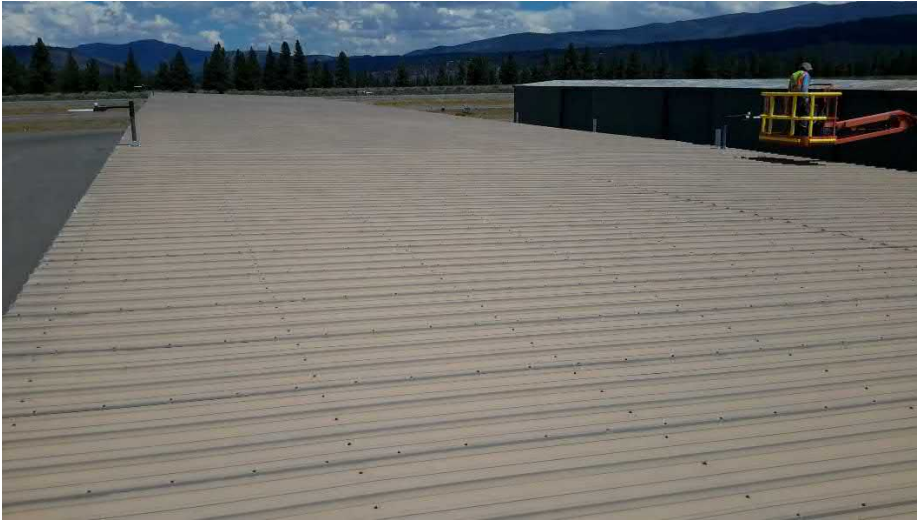
Figure 121 Hangar K - paint coat is badly worn

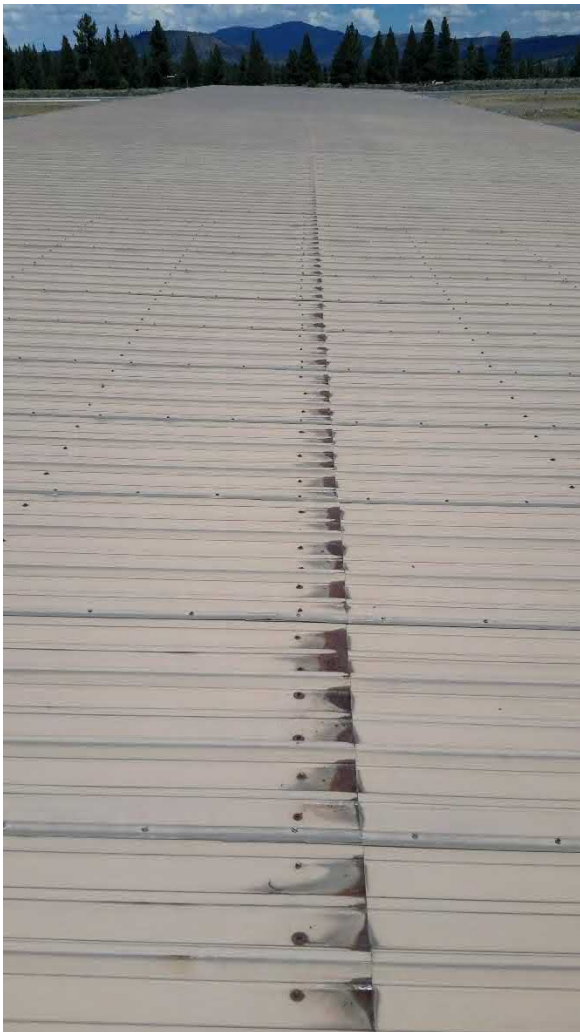
Figure 122 Hangar K - areas of rust and corrosion on roof

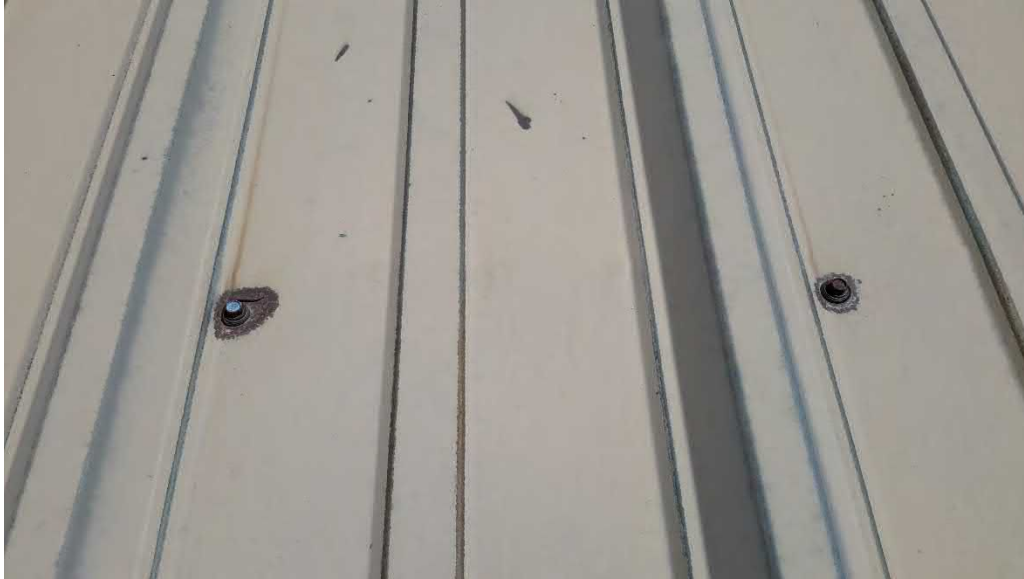
Figure 123 Hangar K - neoprene washers disintegrating and rust at screws

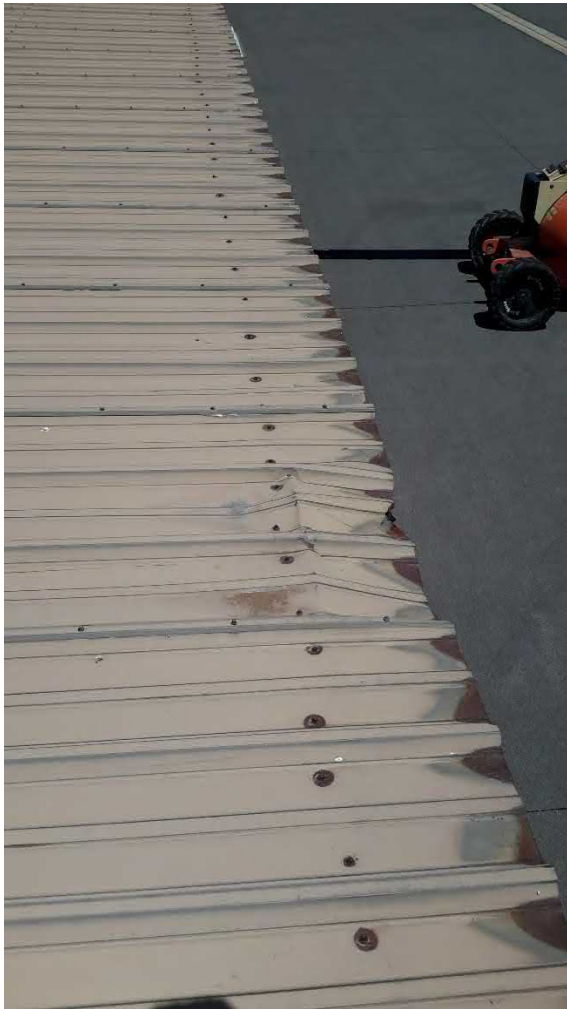
Figure 124 Hangar K - damage to low side (east side) eave from snow and ice

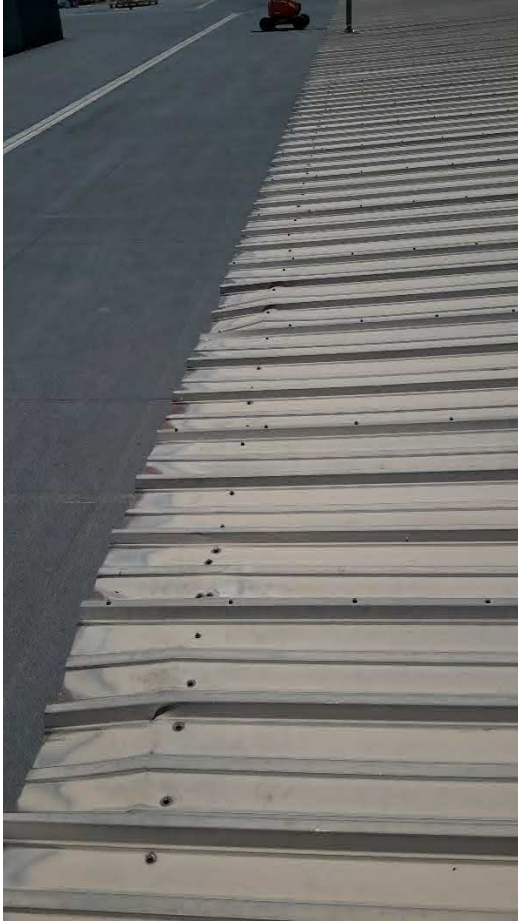
Figure 125 Hangar K - damage to low (east) side roof panels from snow and ice.

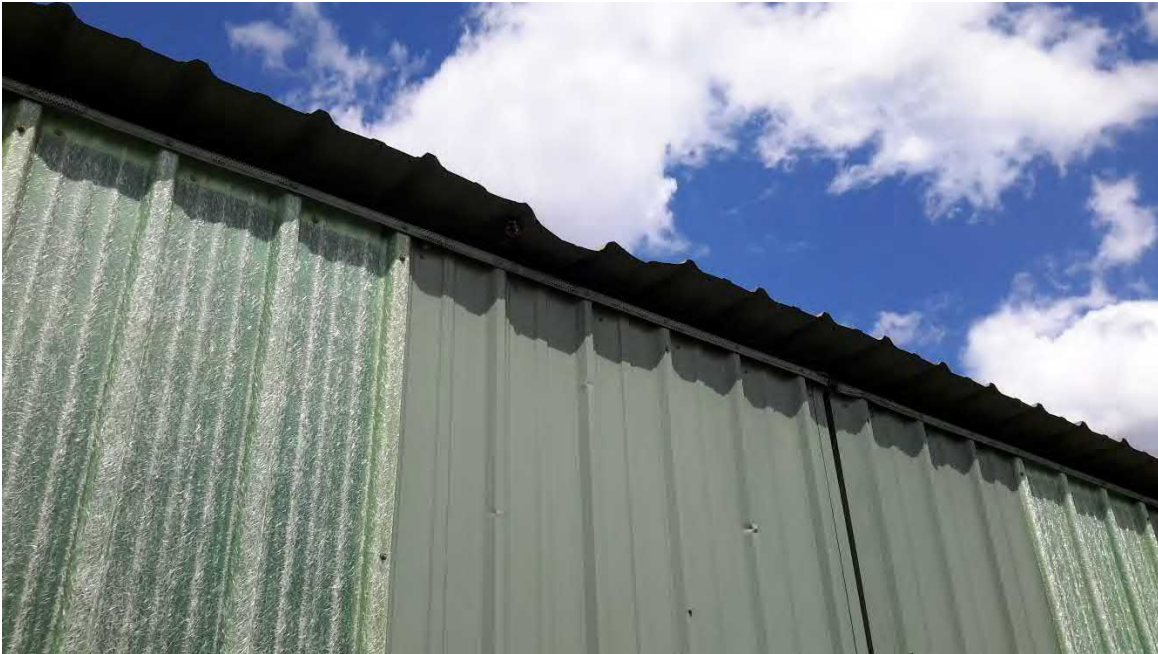
Figure 126 Hangar K - east side eave damage from snow and ice

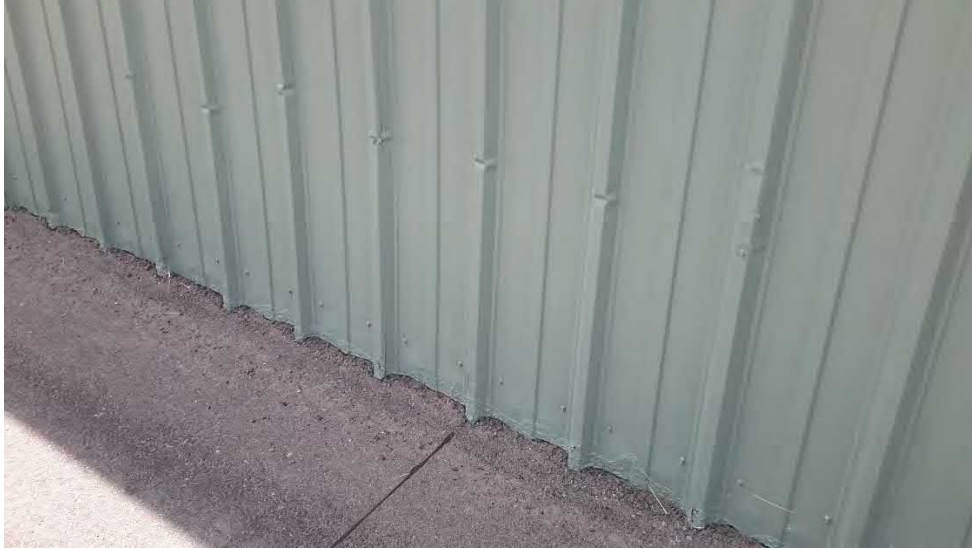
Figure 127 Hangar K - wall panel damage on north end

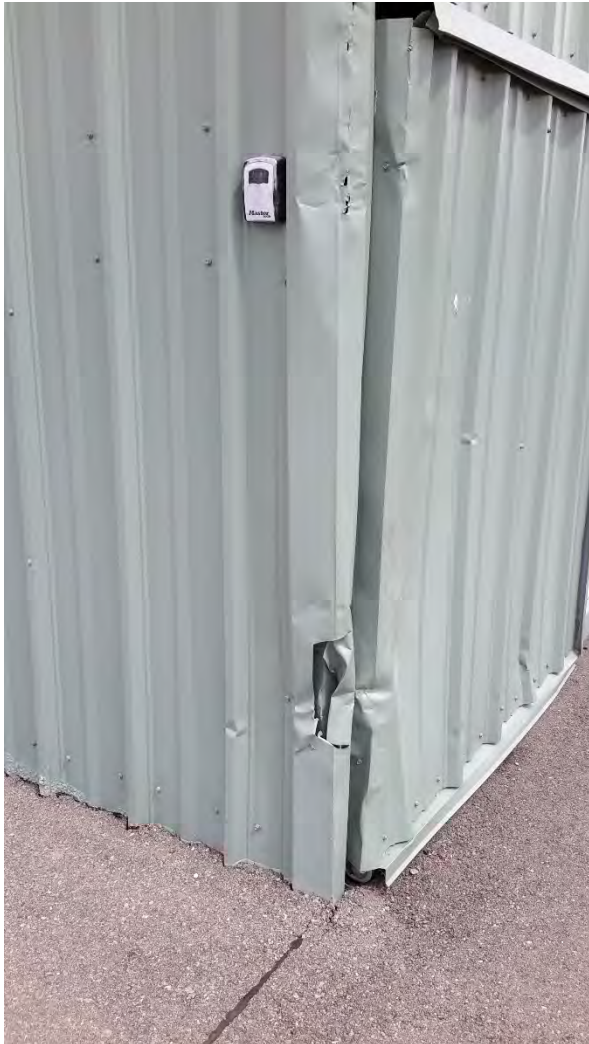
Figure 128 Hangar K - wall panel damage on south east corner

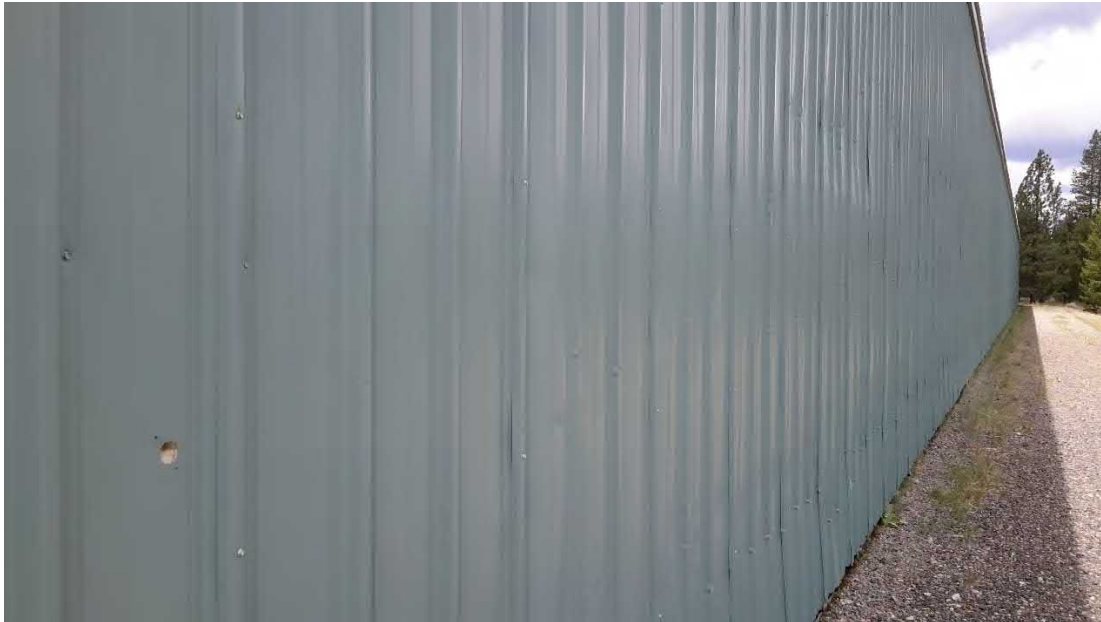
Figure 130 Hangar L - wall panel damage on north side

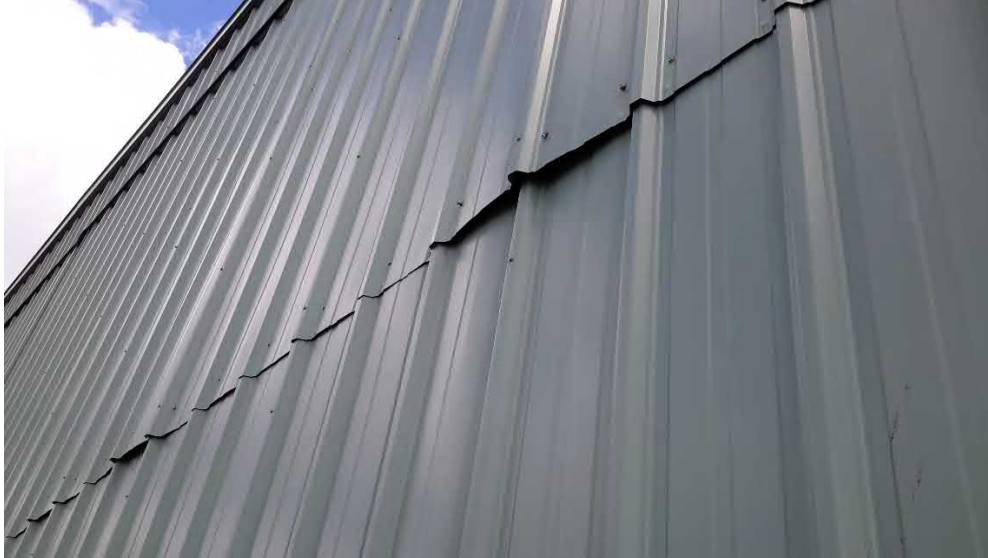
Figure 133 Hangar L - door panel loose and missing fasteners

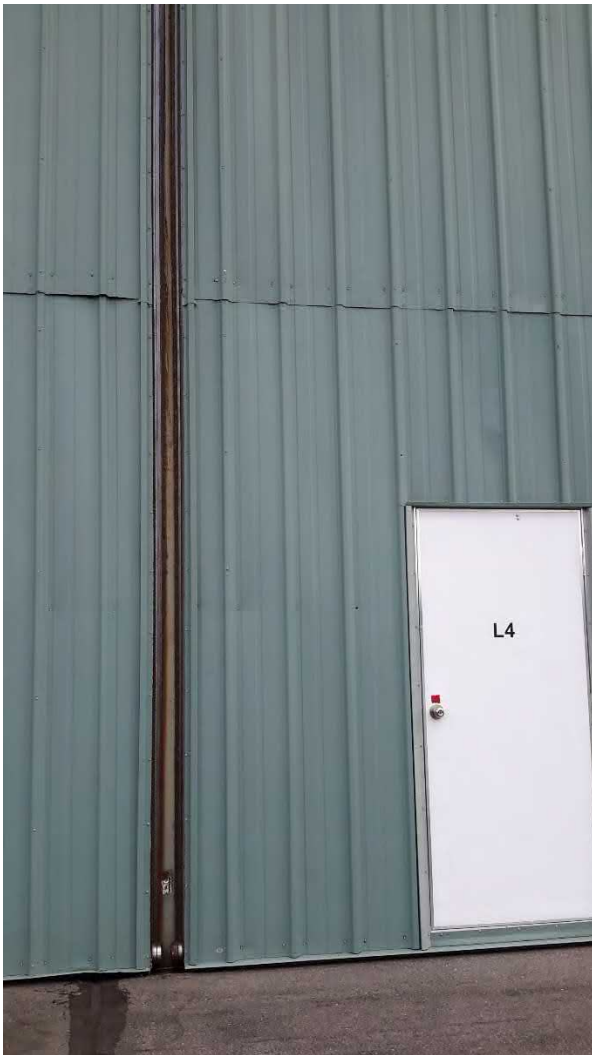
Figure 134 Hangar L - rust at door track / columns

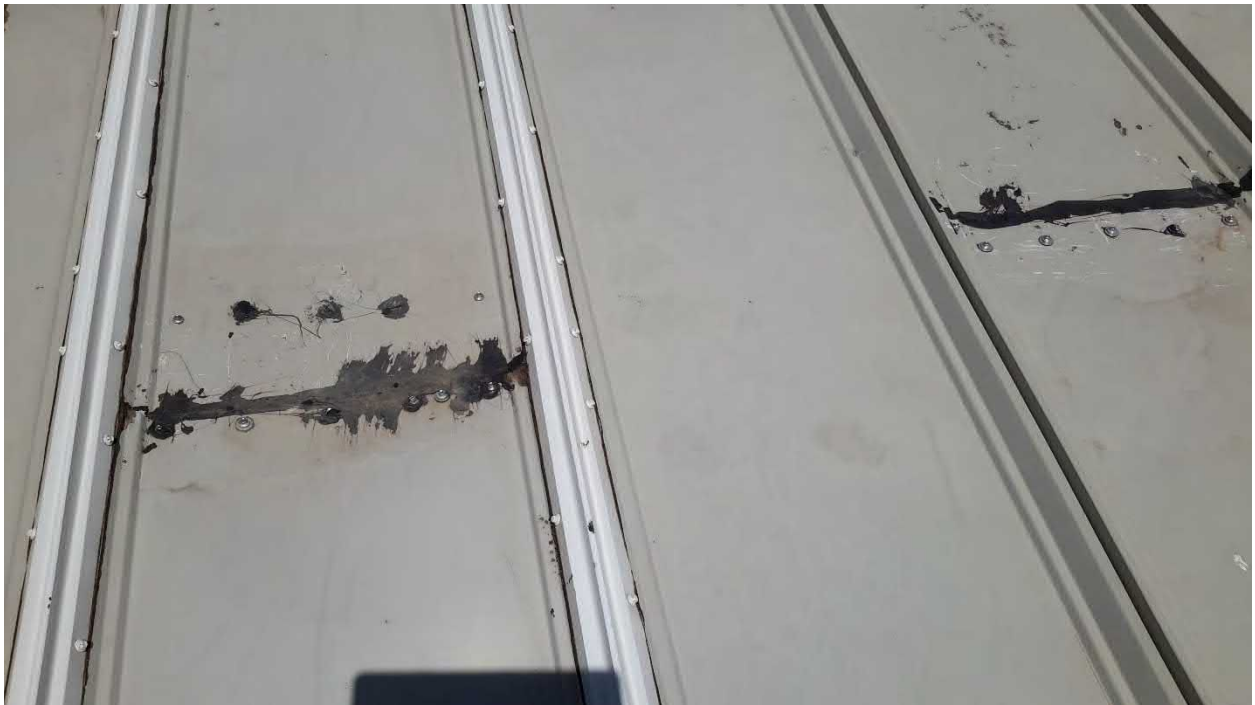
Figure 136 Hangar M - numerous attempts to patch leaks

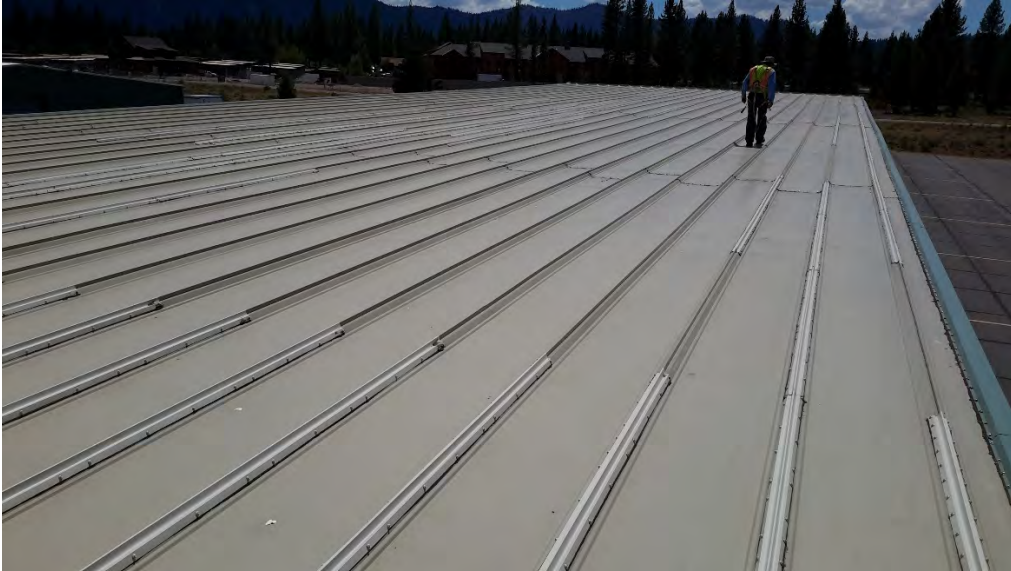
Figure 137 Hangar M - retrofit pieces installed at standing seams to try and fix leaks

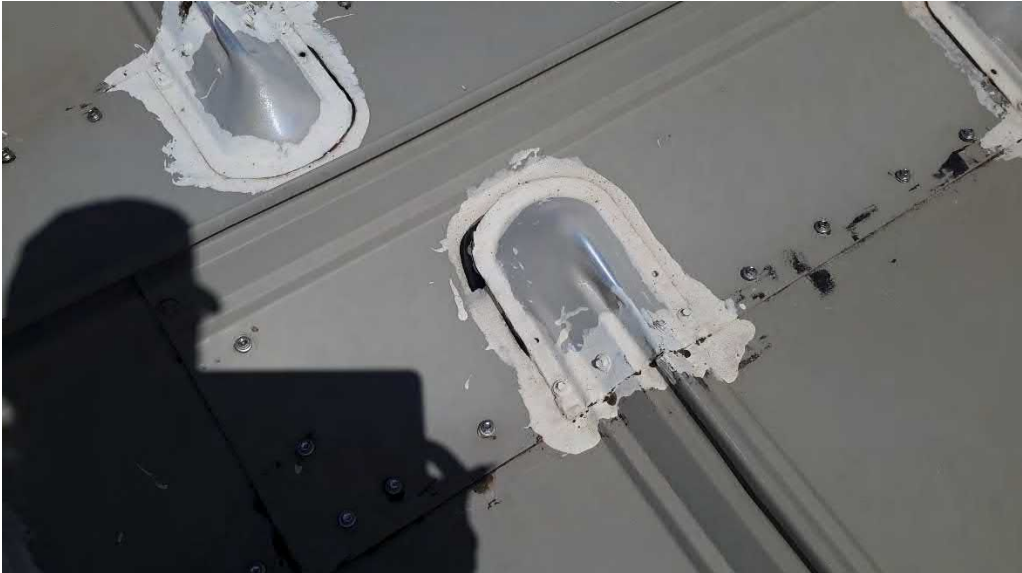
Figure 138 Hangar M - gaskets and sealant loose at ridge line

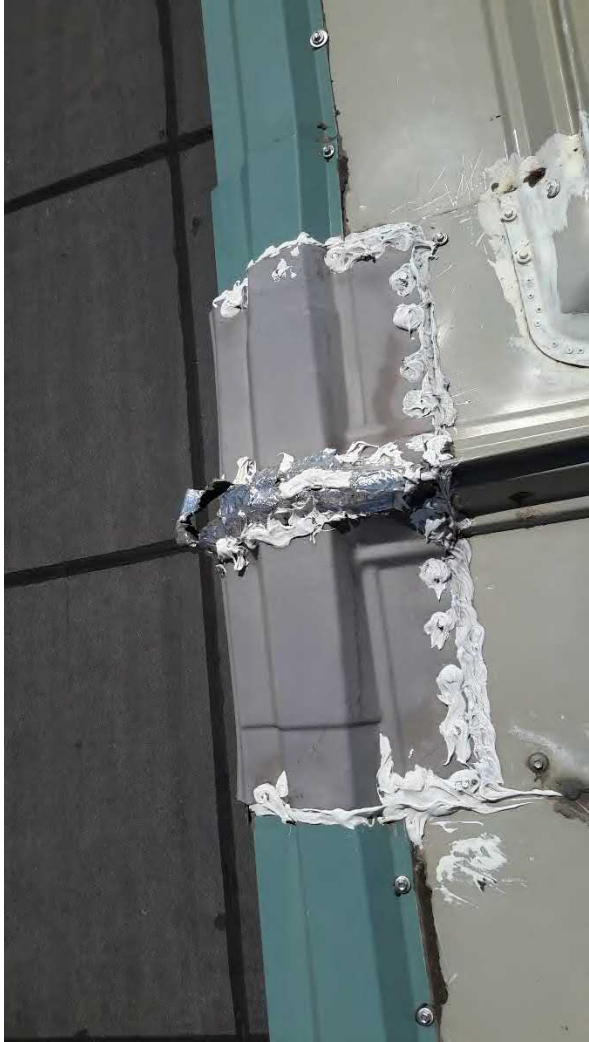
Figure 139 Hangar M - foil and heavy sealant use to try and fix leaks

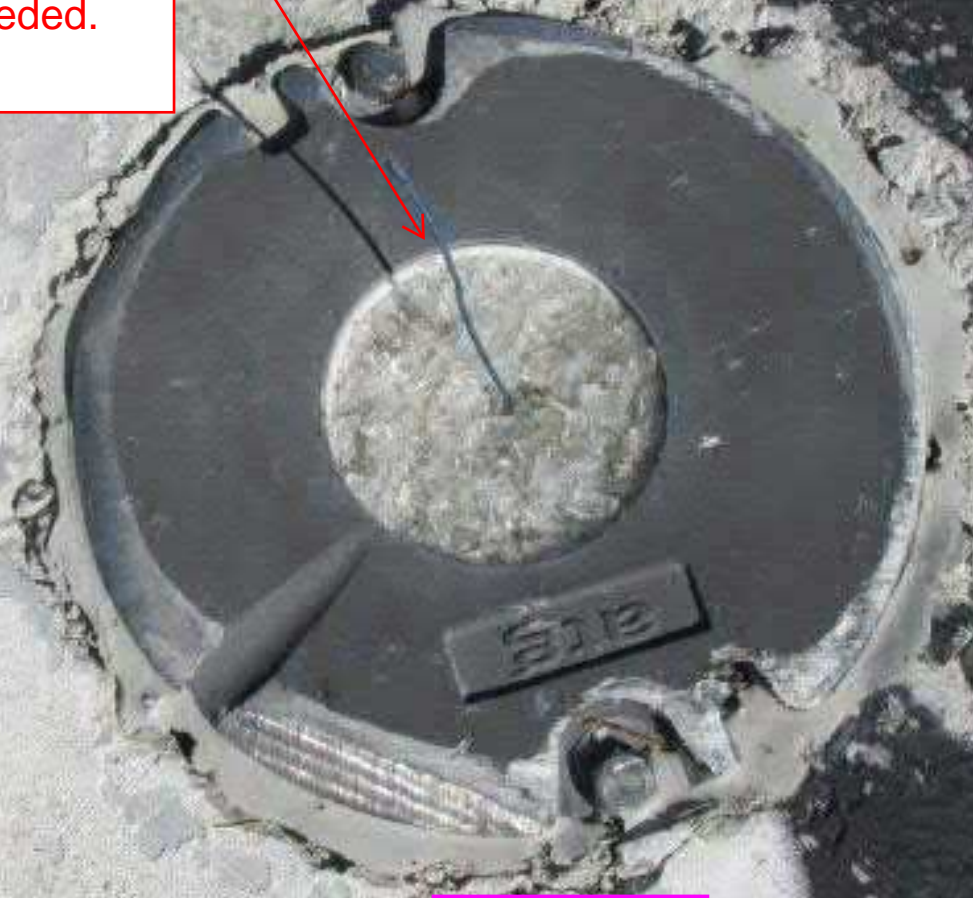
Another damaged LED and lens. Perhaps a different version, or recessing below grade is needed.
