# **TRUCKEE TAHOE AIRPORT Pavement Evaluation Study Pavement Maintenance/Management Plan (PMMP)**

**PREPARED FOR  
TRUCKEE TAHOE AIRPORT DISTRICT**

**JULY 2021**

*Prepared by:  
Brandley Engineering, Inc.*

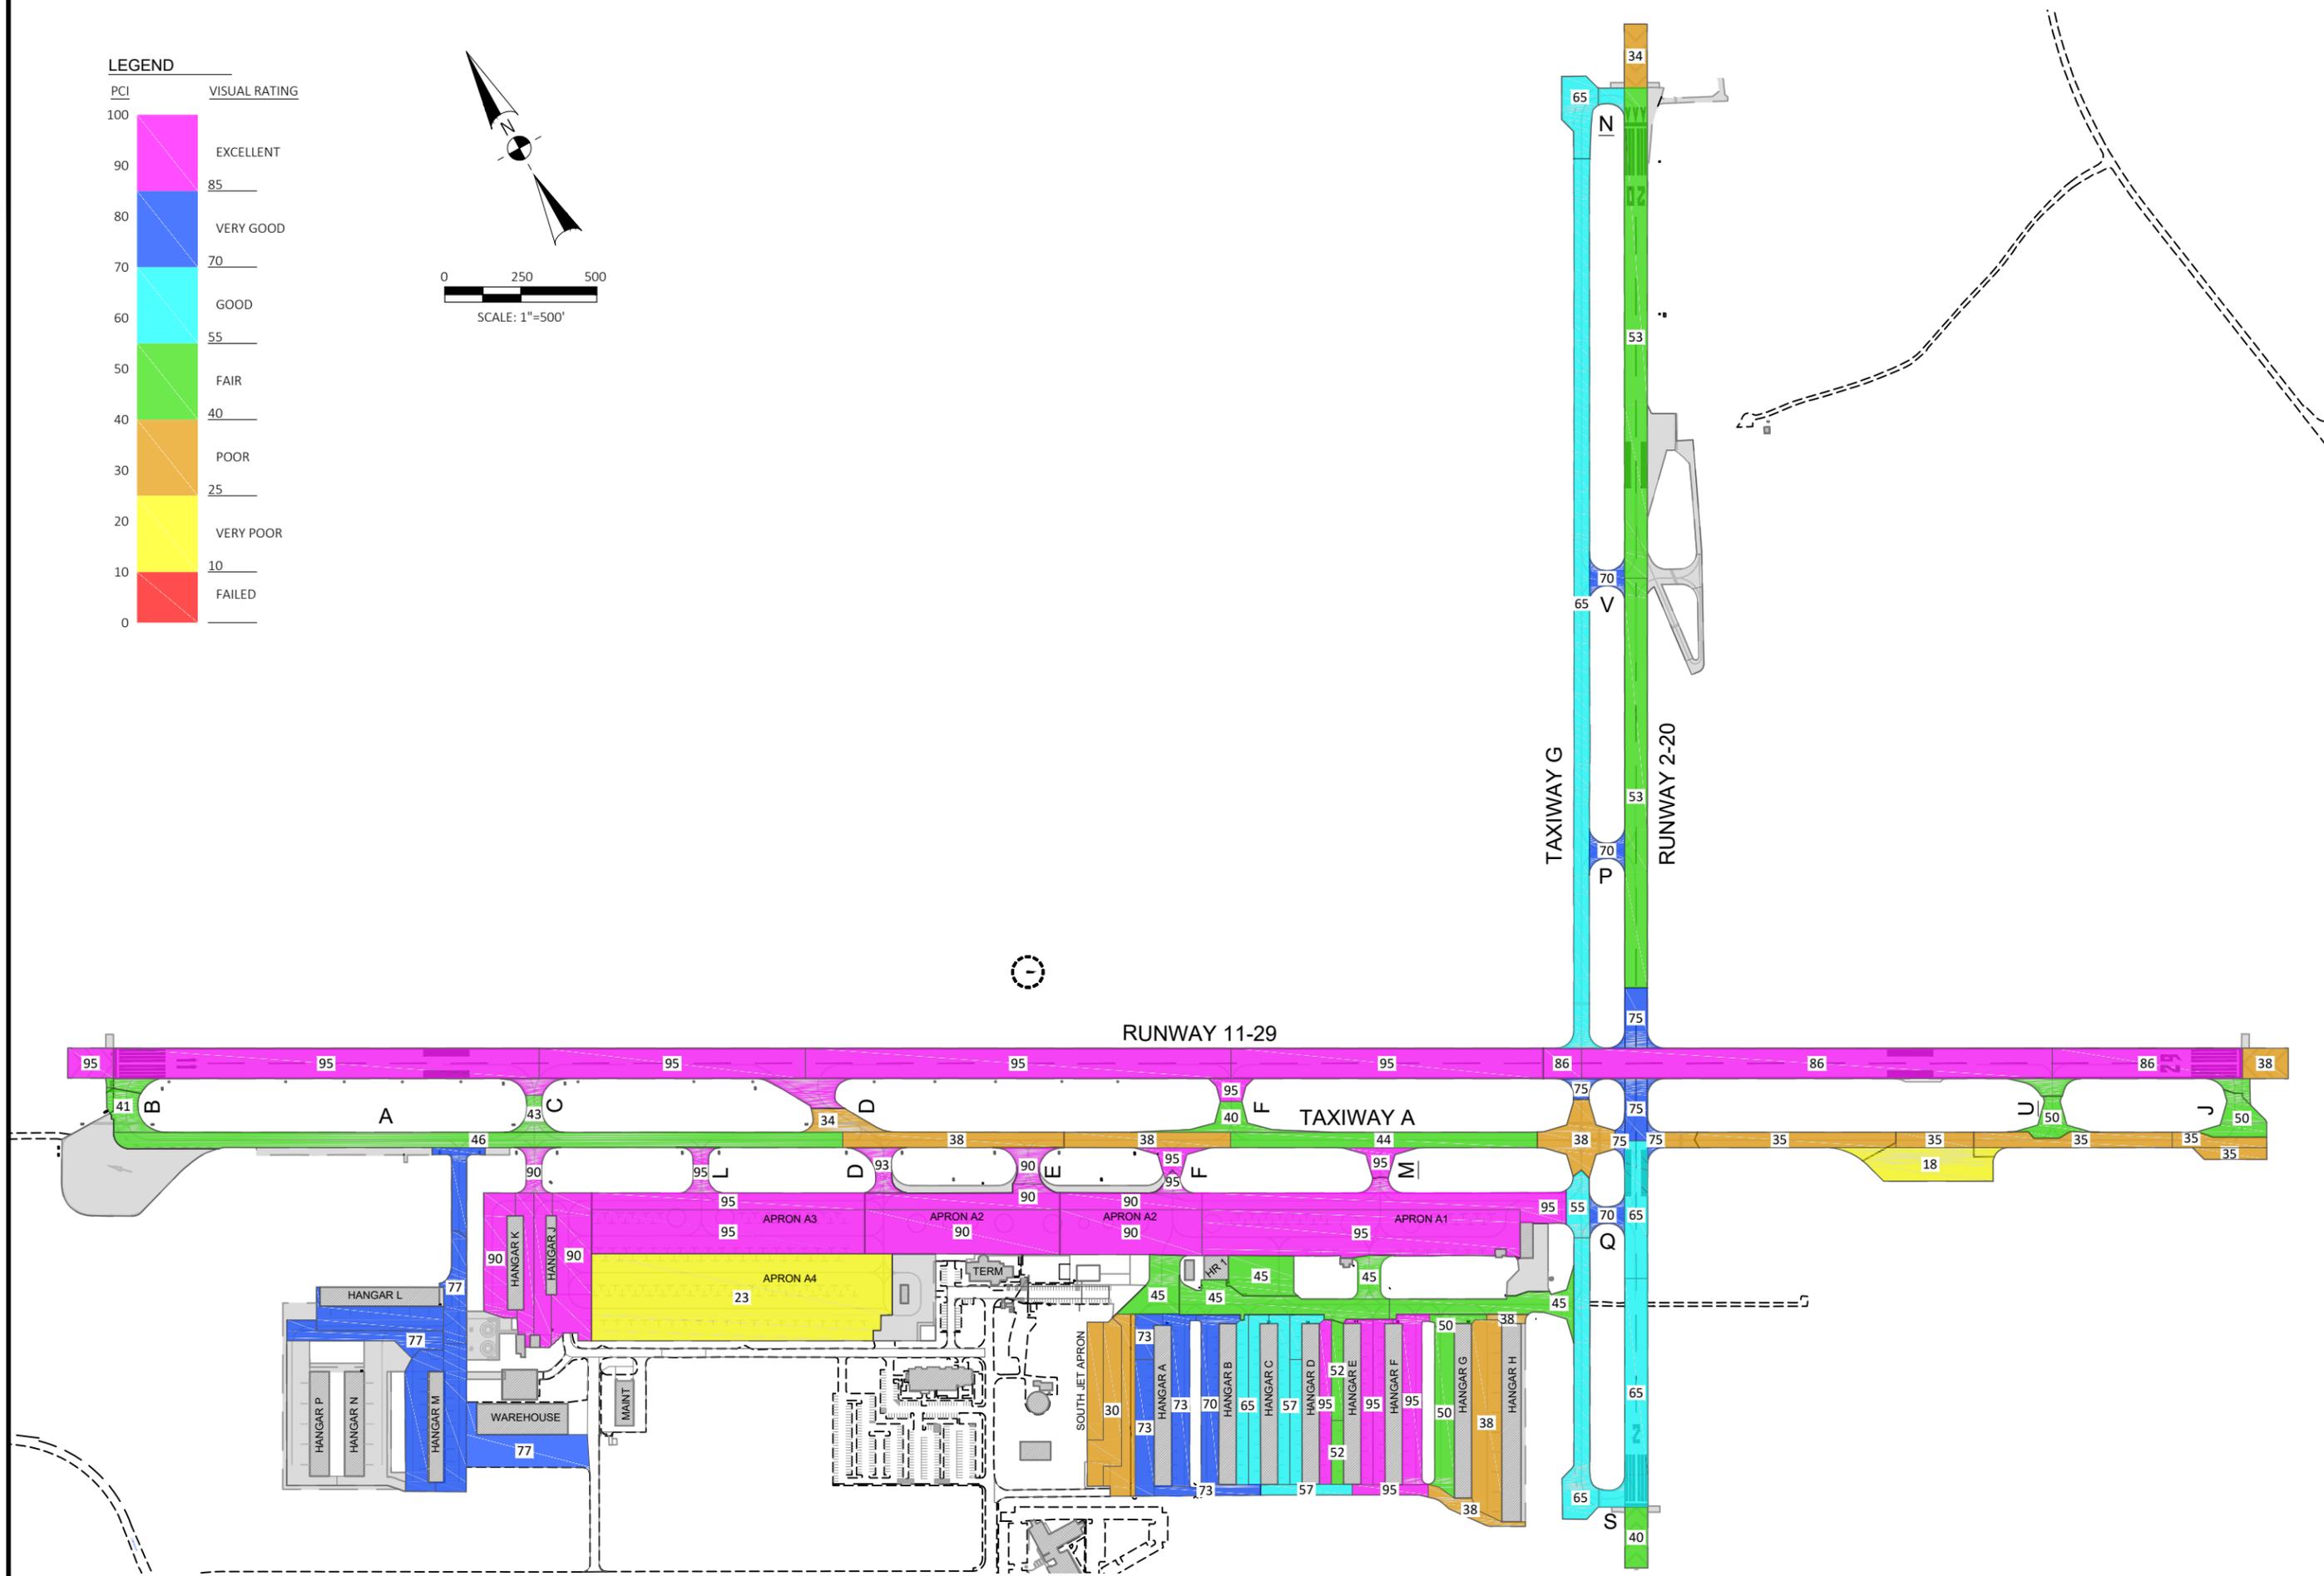
DATE	4/15/2021
DRAWN	KDC
CHECKED	DB
FILE	4004-20-2-2.PCI13
SCALE	1"=500'
PLATE No.	2-2

Pavement condition surveys (PCI) were conducted in 2011, 2013, and 2020. The PCI of each segment of pavement is shown on Plate 2-1 for 2011, Plate 2-2 for 2013, and Plate 2-3 for 2020. The results of this study are summarized in Chapter 5, Table 5-3. The results of this comparison study show that the PCI of any sections that did not have any rehabilitation completed since 2011 have decreased and the sections that had rehabilitation projects completed have increased in PCI. This data indicates that some of the old pavements are experiencing significant surface distress and will require significant surface treatment earlier than deep-seated distress treatment is required.

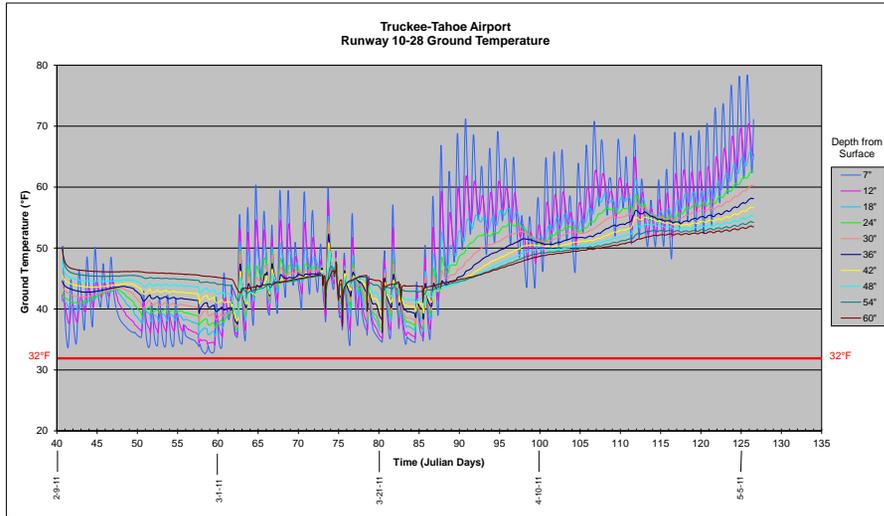
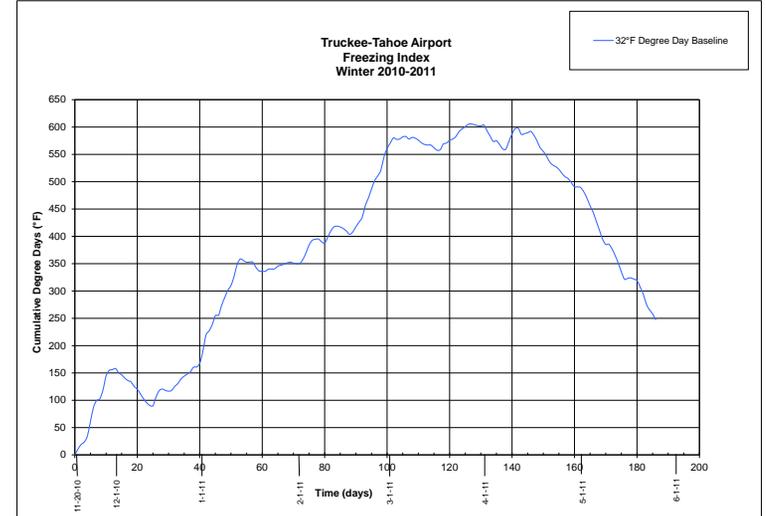
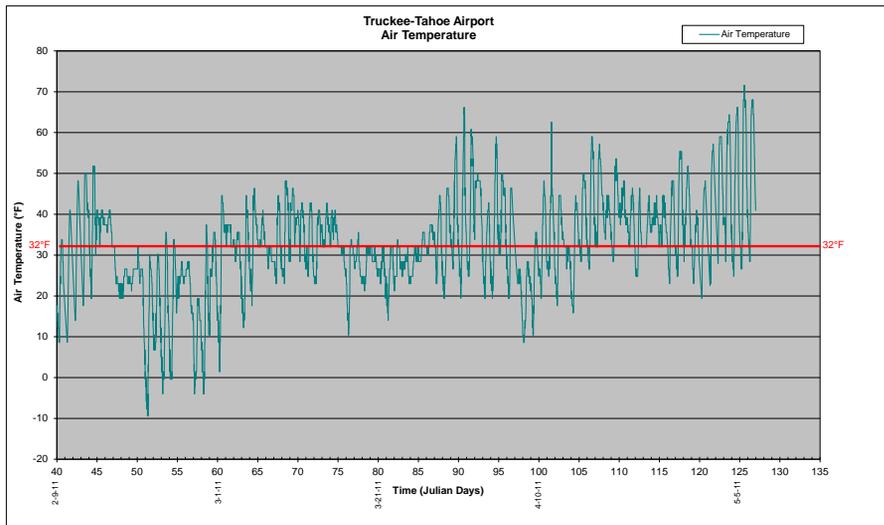
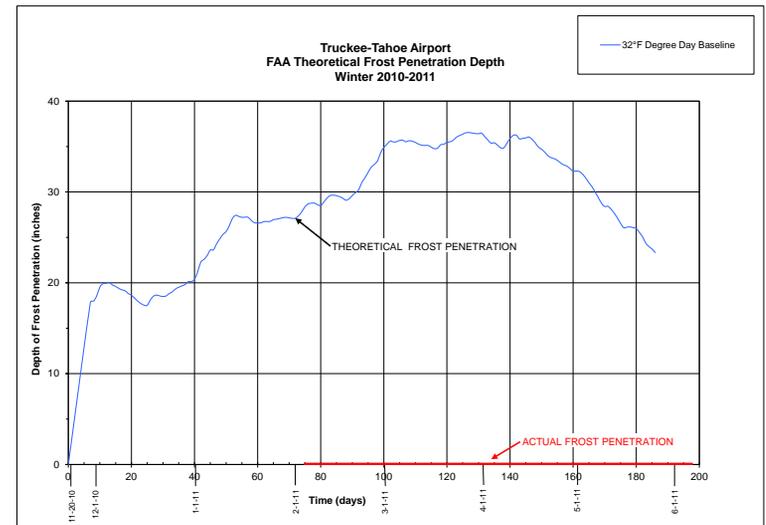
**PLATE NO. 2-5 - FROST PENETRATION STUDY**  
 Data Collection: February 9 -May 5, 2011

In order to determine the depth of frost penetration at Truckee Tahoe Airport a series of thermocouples were installed at various depths below the pavement surface on a section of Runway 11-29 located west of Taxiway G. Gauges were installed at depths of every 6 inches beginning at the depth of 6 inches and extending to 5 feet below the pavement surface. These gauges were installed on February 9, 2011 and then replaced with permanent gauges during the 2012 reconstruction of Runway 11-29. The existing temperature data at each gauge were recorded hourly starting after installation. The results of these readings are shown on the Runway 11-29 Ground Temperature chart on Plate No. 2-5. Air temperature during that same period was also recorded and is also shown on Plate No. 2-5.

While there was no frost penetration under the pavements at Truckee Tahoe Airport after February 9, 2011, it is likely that there will be some frost penetration at sometime in the winter. These gauges have been left in place and are scheduled to be monitored. During the collection of data for the 2020 Pavement Management Plan we requested data from the temperature gauges, and it was learned that the battery had corroded and failed. At this time the data has not been able to be recovered from the datalogger. All data presented in this report is based on the original data collected between 2011 and 2013. During the month of January 2013 there were approximately 20 days that there were freezing temperatures in the base rock 6” below the surface, but the frost never penetrated to the temperature gauge located 12” below the surface.

Mitigation measures should be considered as required, depending on the whether depth of frost penetration ever becomes prevalent. These mitigation measures could include thickening pavement sections to support the heavy aircraft loadings during the spring thaw or restricting use of the airport by the heavier aircraft during the short period of spring thaw.

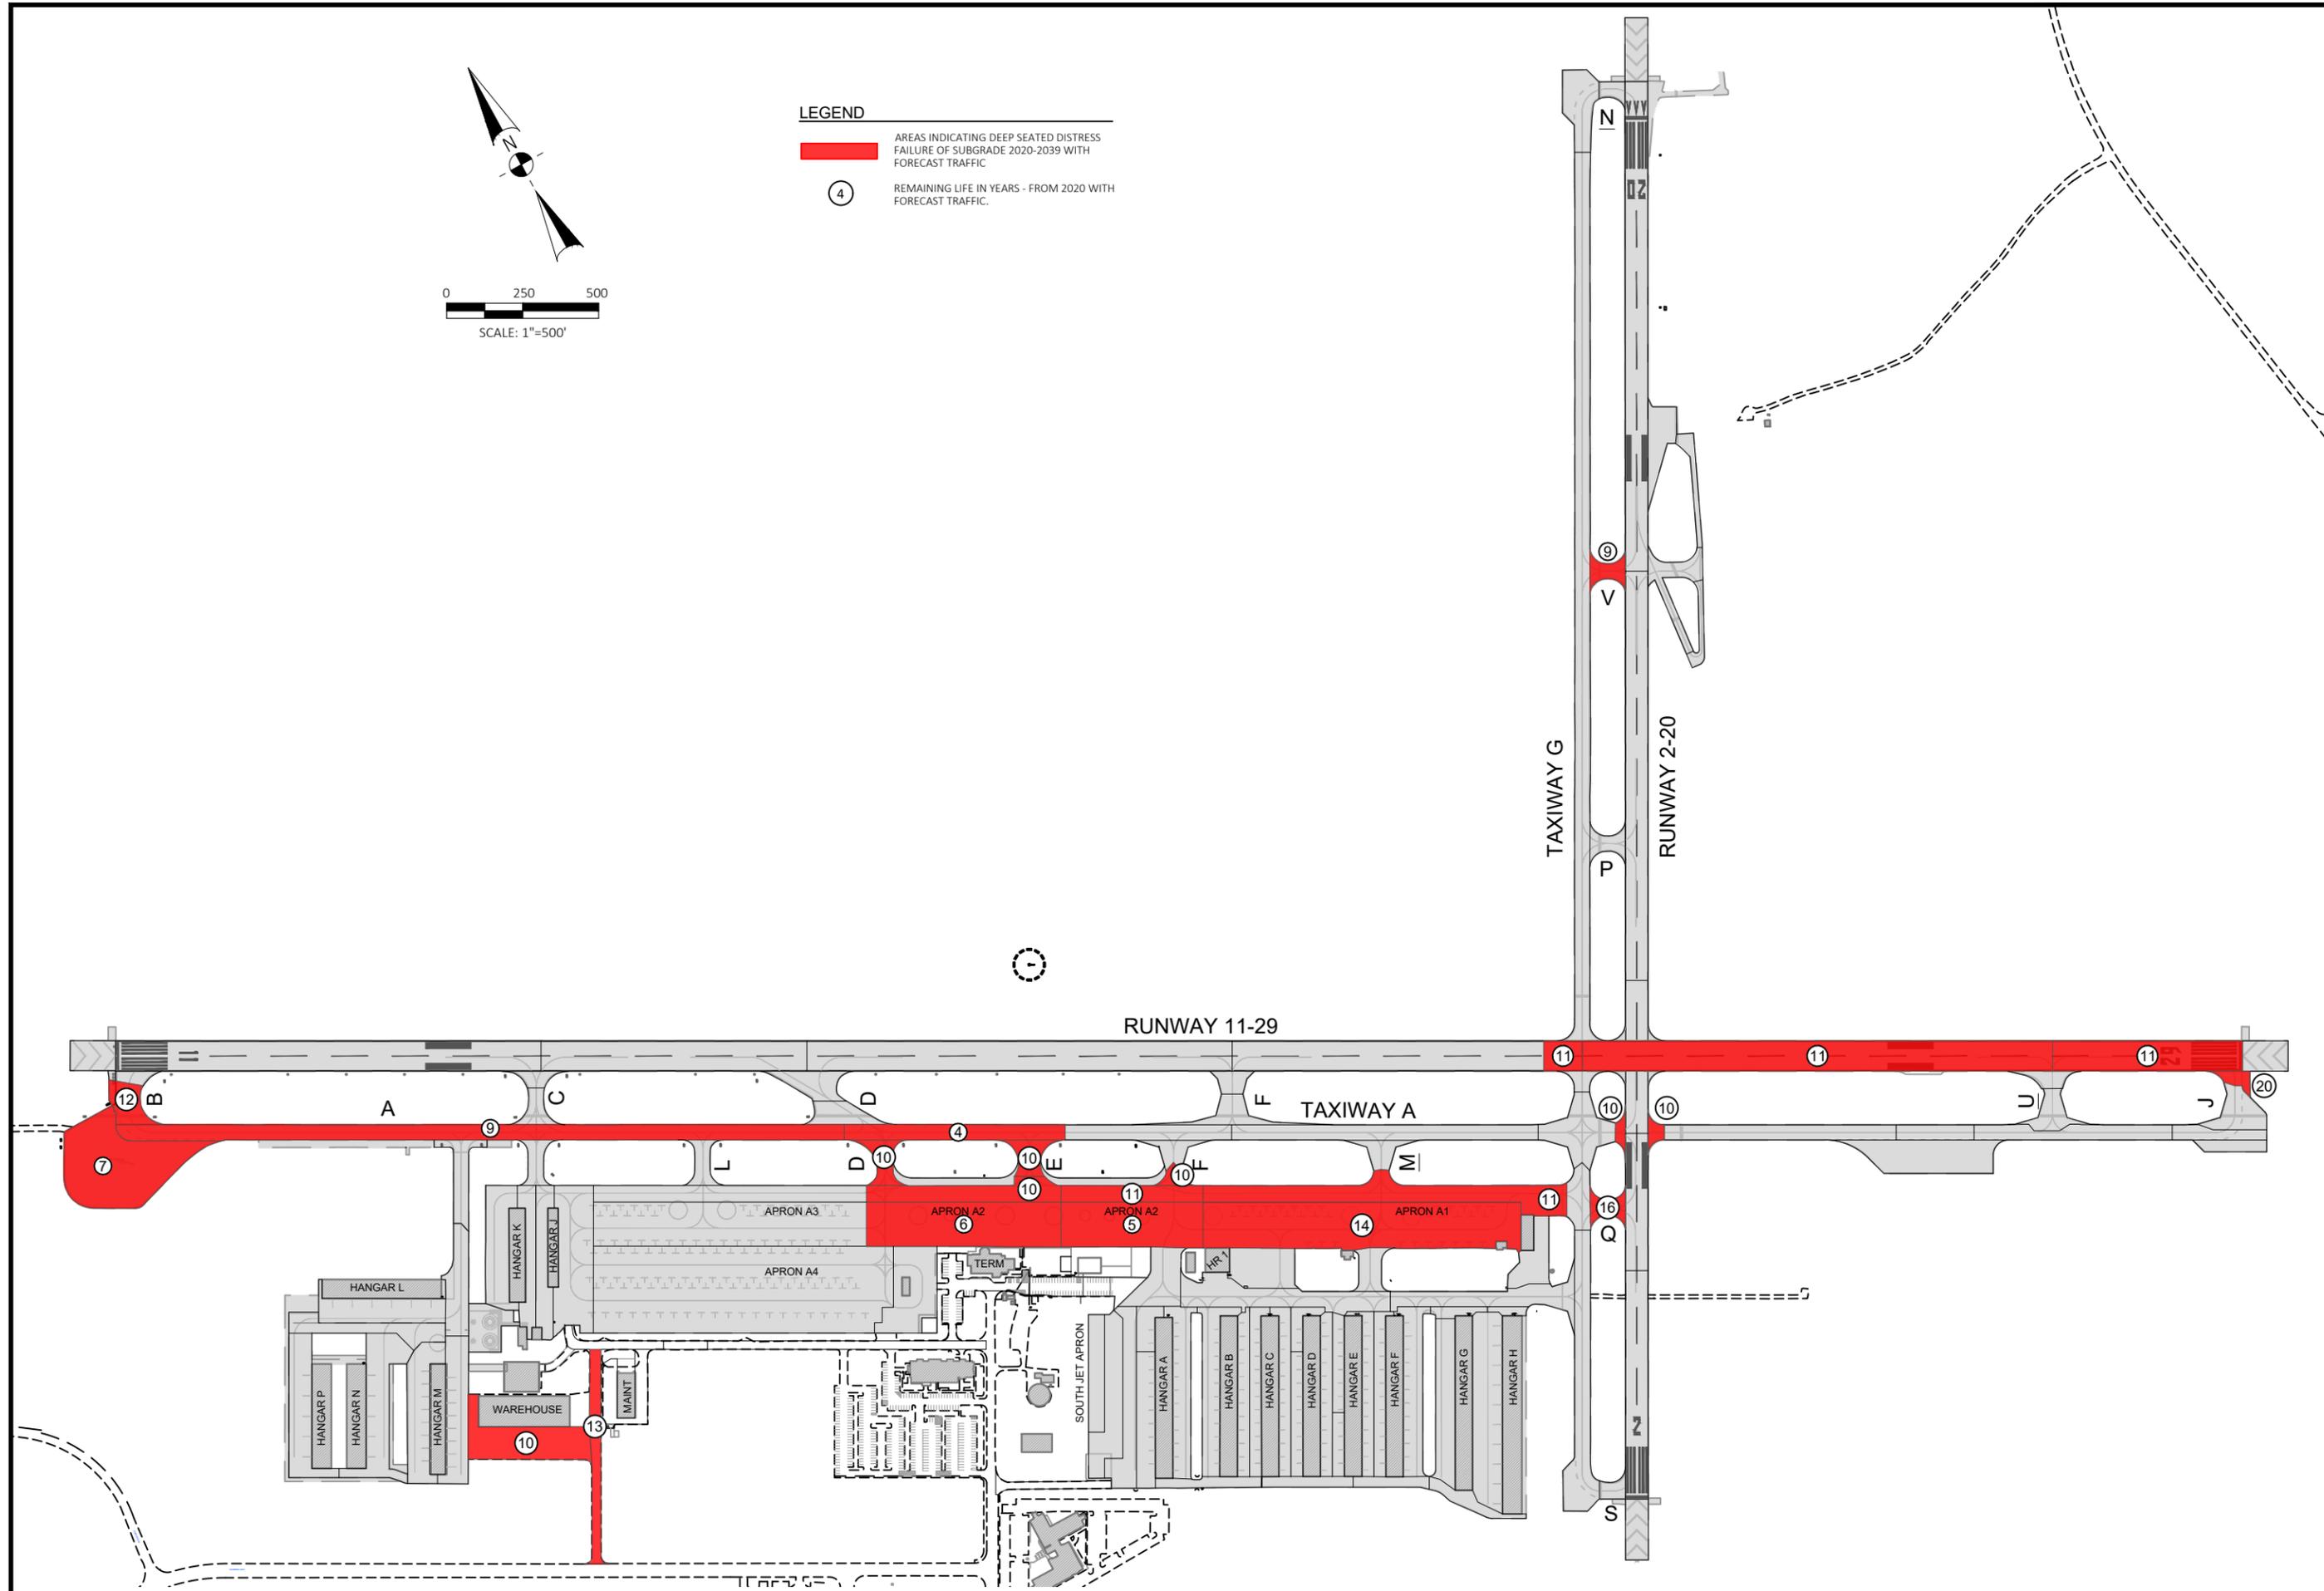
Plate 4-1 shows the remaining life of the pavements expected to fail under deep-seated distress in the subgrade layer using the forecast traffic. The remaining life analysis for the subgrade layer is the critical item for the areas of pavement that have less than 20 years of remaining life. Plate 4-2 shows the remaining life of the pavements expected to fail under deep-seated distress in the subgrade layer using the “enhanced traffic”. The “enhanced traffic” indexes provide information on how the remaining pavement life changes if the number of aircraft operations of aircraft greater than 48,000 lbs. is double that of the “forecast traffic.”

- LEGEND**
- AREAS INDICATING DEEP SEATED DISTRESS FAILURE OF SUBGRADE 2020-2039 WITH FORECAST TRAFFIC
  - 4 REMAINING LIFE IN YEARS - FROM 2020 WITH FORECAST TRAFFIC.

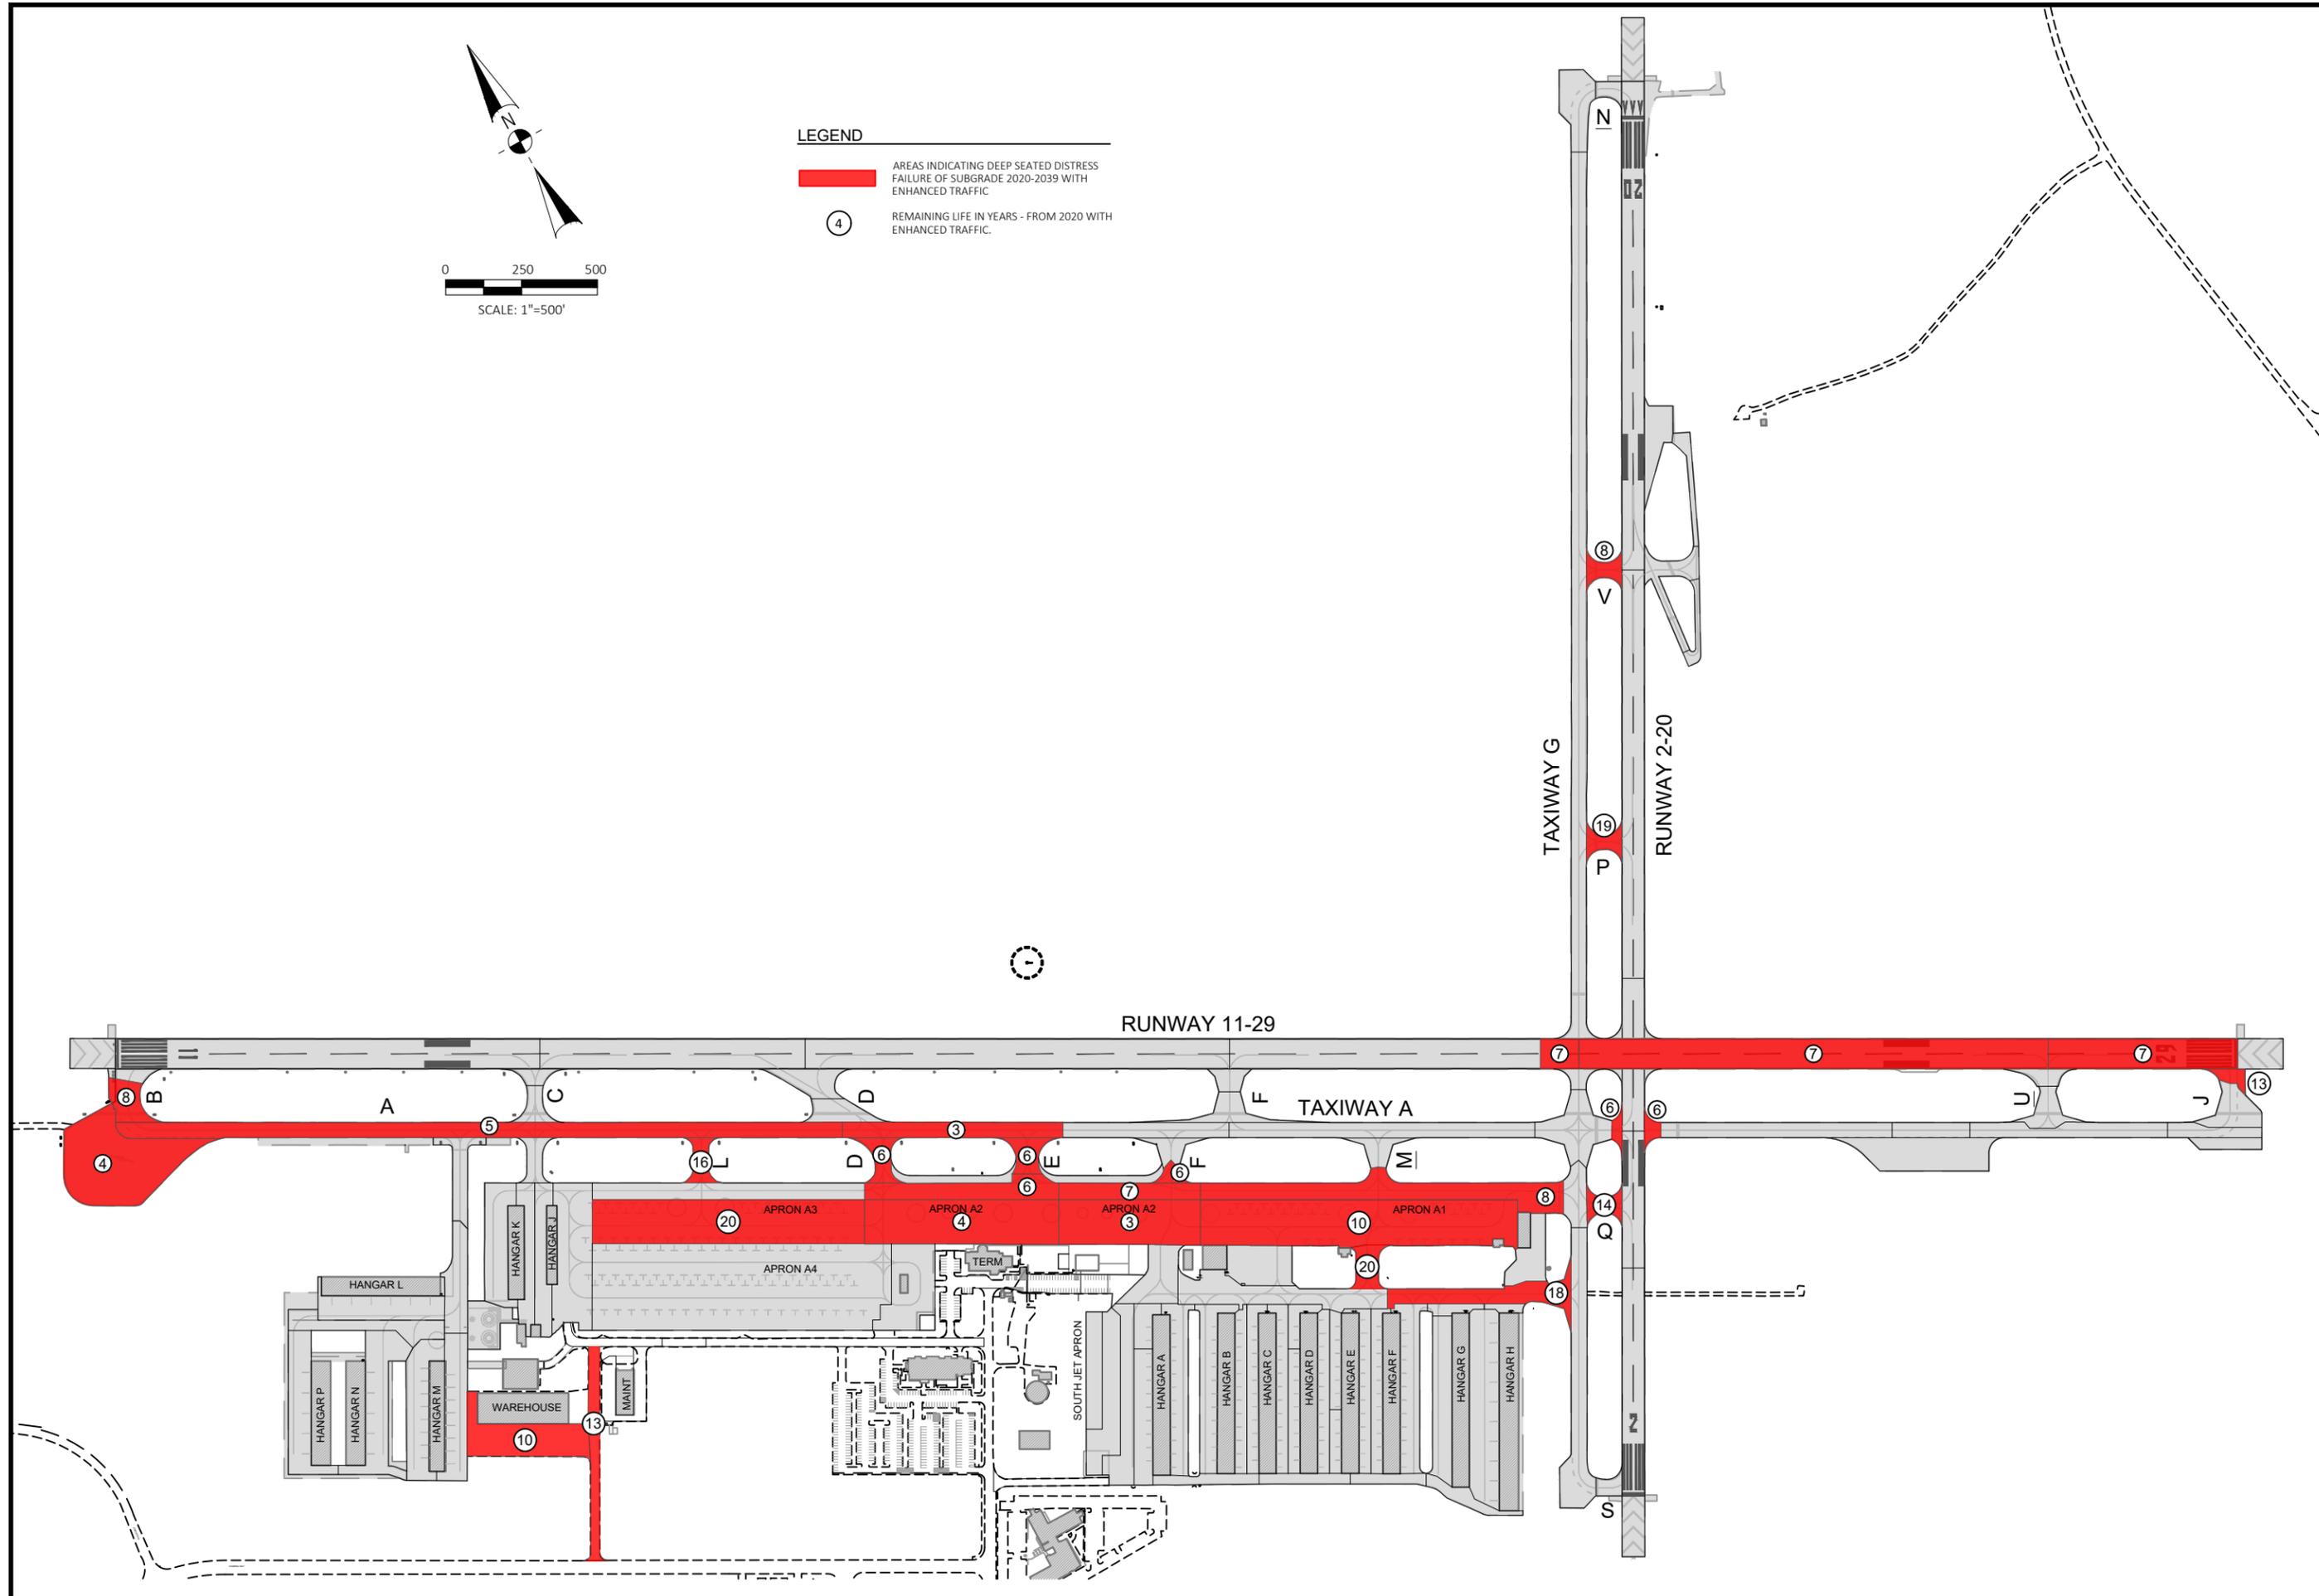
DATE	7/12/2021
DRAWN	KDC
CHECKED	DB
SCALE	1"=500'
PLATE No.	4-2

- AREAS INDICATING DEEP SEATED DISTRESS FAILURE OF SUBGRADE 2020-2039 WITH ENHANCED TRAFFIC
- 4 REMAINING LIFE IN YEARS - FROM 2020 WITH ENHANCED TRAFFIC.

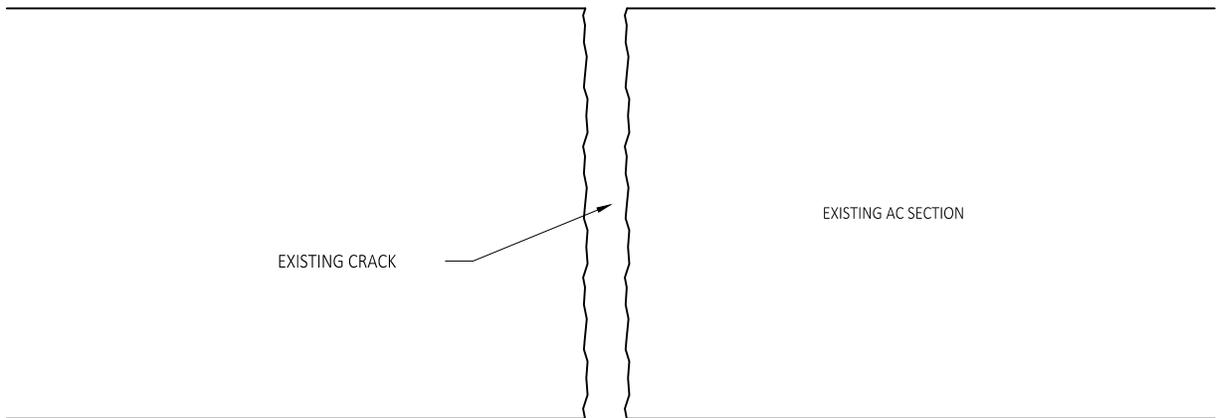
EXISTING CRACK IN PAVEMENT
