TRUCKEE TAHOE AIRPORT Pavement Evaluation Study Pavement Maintenance/Management Plan (PMMP)

**PREPARED FOR
TRUCKEE TAHOE AIRPORT DISTRICT**

**TRUCKEE TAHOE AIRPORT
PAVEMENT EVALUATION STUDY
PAVEMENT MAINTENANCE/MANAGEMENT PLAN (PMMP)**

*Prepared for
Truckee Tahoe Airport District, Truckee, California*

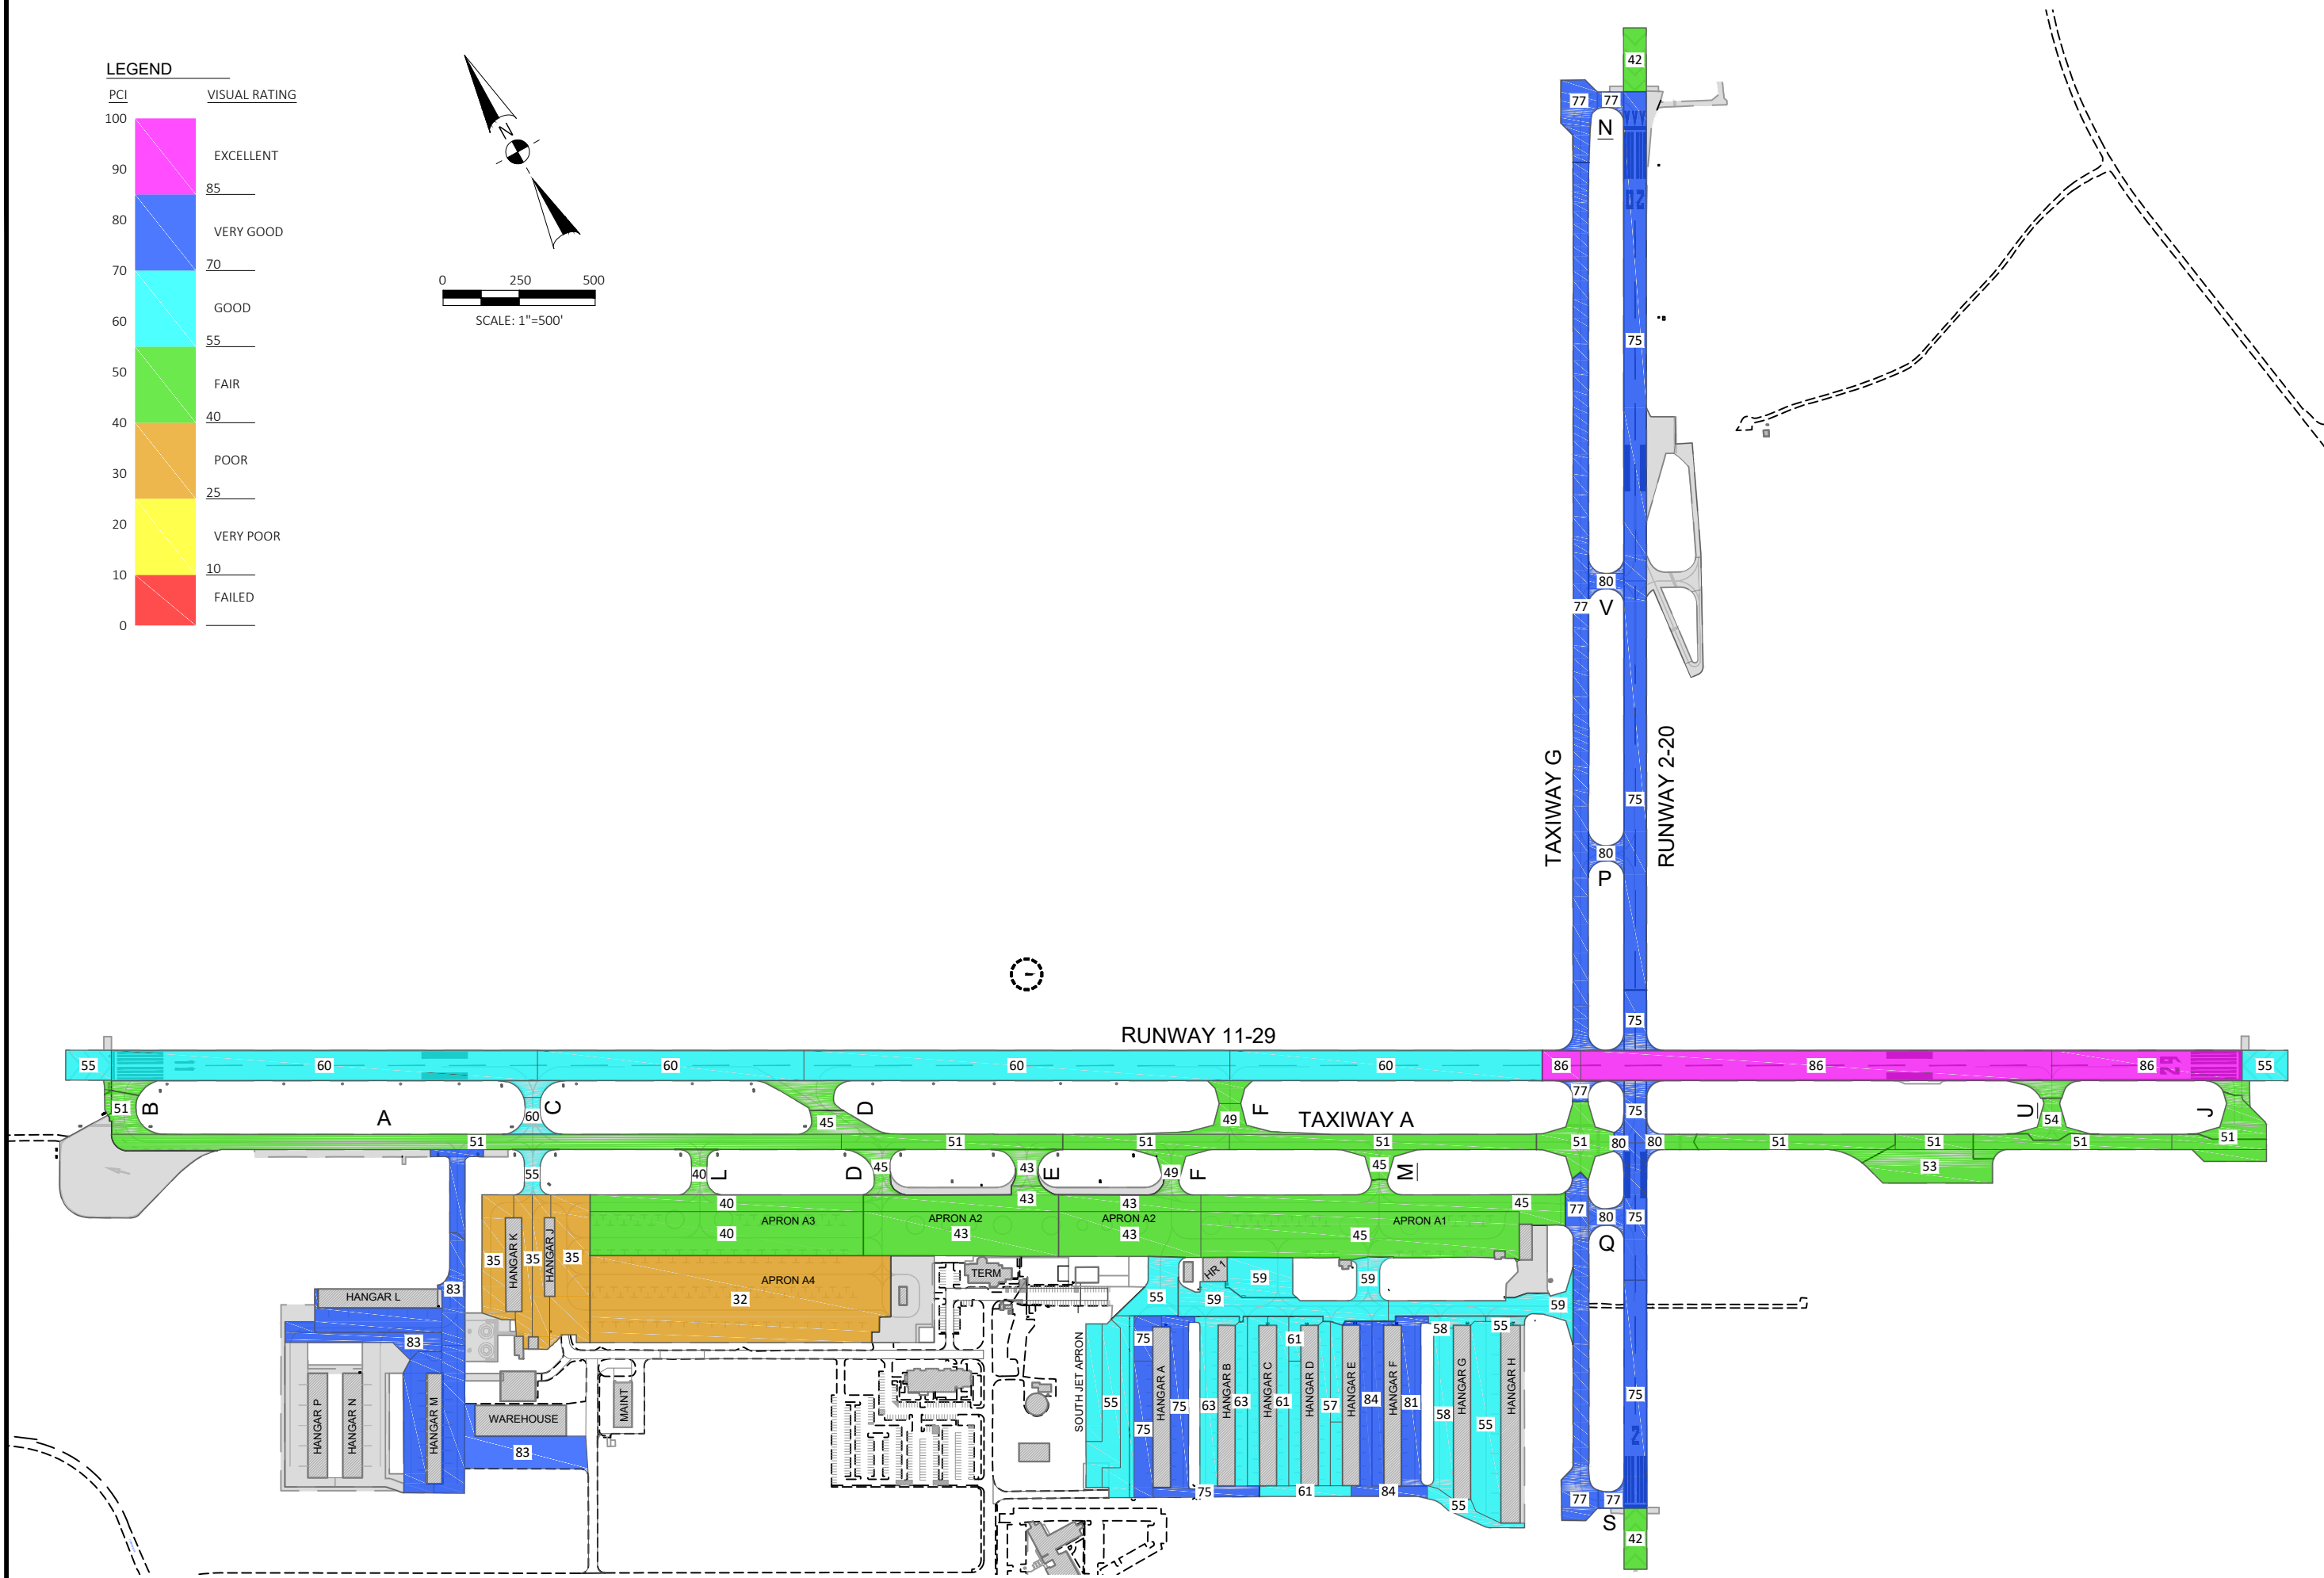
DATE	4/15/2021
DRAWN	KDC
CHECKED	DB
FILE	4004-20-2-1.PCI11
SCALE	1"=500'
PLATE No.	2-1

Pavement condition surveys (PCI) were conducted in 2011, 2013, and 2020. The PCI of each segment of pavement is shown on Plate 2-1 for 2011, Plate 2-2 for 2013, and Plate 2-3 for 2020. The results of this study are summarized in Chapter 5, Table 5-3. The results of this comparison study show that the PCI of any sections that did not have any rehabilitation completed since 2011 have decreased and the sections that had rehabilitation projects completed have increased in PCI. This data indicates that some of the old pavements are experiencing significant surface distress and will require significant surface treatment earlier than deep-seated distress treatment is required.

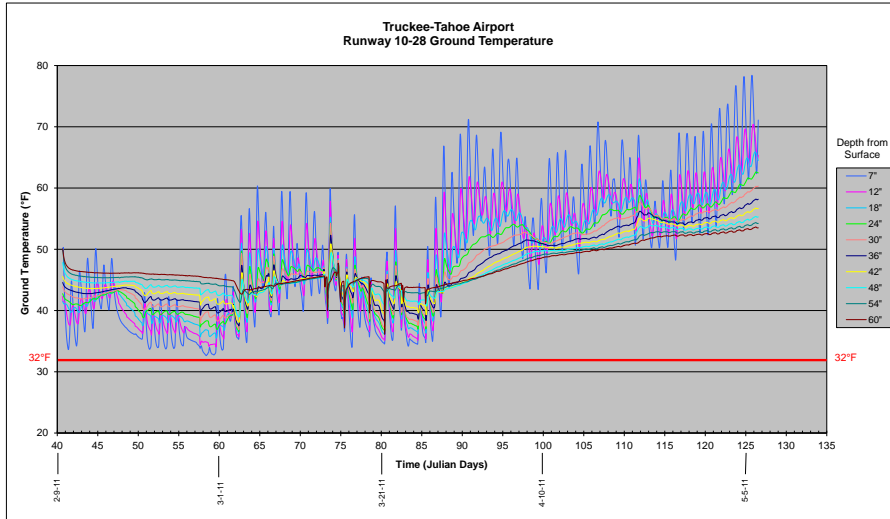
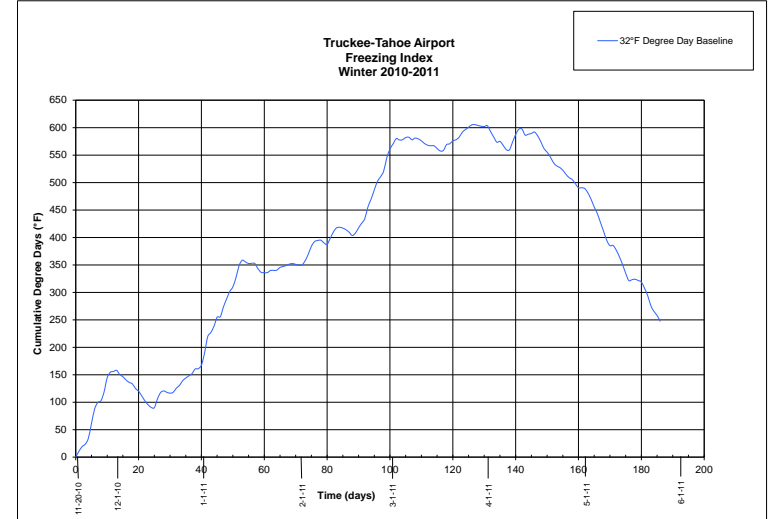
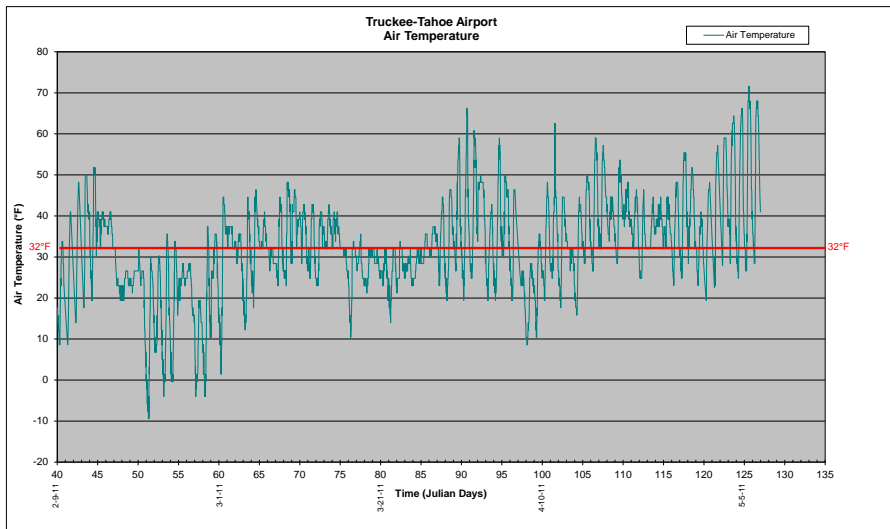
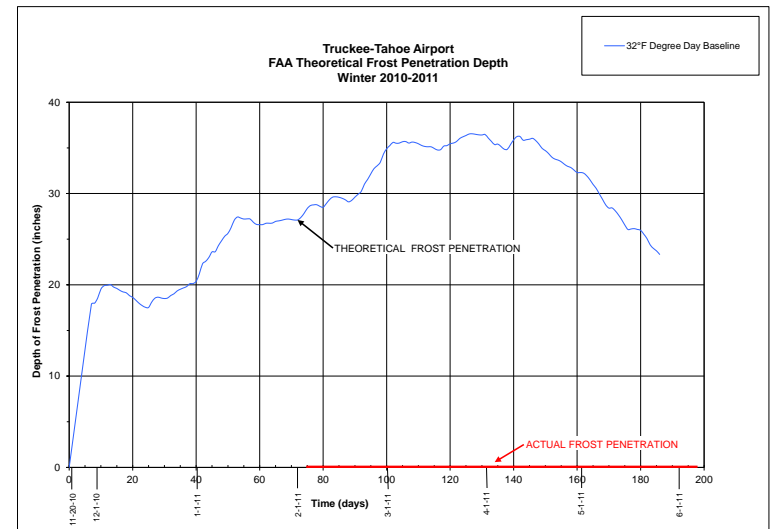
PLATE NO. 2-5 - FROST PENETRATION STUDY
 Data Collection: February 9 -May 5, 2011

In order to determine the depth of frost penetration at Truckee Tahoe Airport a series of thermocouples were installed at various depths below the pavement surface on a section of Runway 11-29 located west of Taxiway G. Gauges were installed at depths of every 6 inches beginning at the depth of 6 inches and extending to 5 feet below the pavement surface. These gauges were installed on February 9, 2011 and then replaced with permanent gauges during the 2012 reconstruction of Runway 11-29. The existing temperature data at each gauge were recorded hourly starting after installation. The results of these readings are shown on the Runway 11-29 Ground Temperature chart on Plate No. 2-5. Air temperature during that same period was also recorded and is also shown on Plate No. 2-5.

While there was no frost penetration under the pavements at Truckee Tahoe Airport after February 9, 2011, it is likely that there will be some frost penetration at sometime in the winter. These gauges have been left in place and are scheduled to be monitored. During the collection of data for the 2020 Pavement Management Plan we requested data from the temperature gauges, and it was learned that the battery had corroded and failed. At this time the data has not been able to be recovered from the datalogger. All data presented in this report is based on the original data collected between 2011 and 2013. During the month of January 2013 there were approximately 20 days that there were freezing temperatures in the base rock 6” below the surface, but the frost never penetrated to the temperature gauge located 12” below the surface.

Mitigation measures should be considered as required, depending on the whether depth of frost penetration ever becomes prevalent. These mitigation measures could include thickening pavement sections to support the heavy aircraft loadings during the spring thaw or restricting use of the airport by the heavier aircraft during the short period of spring thaw.

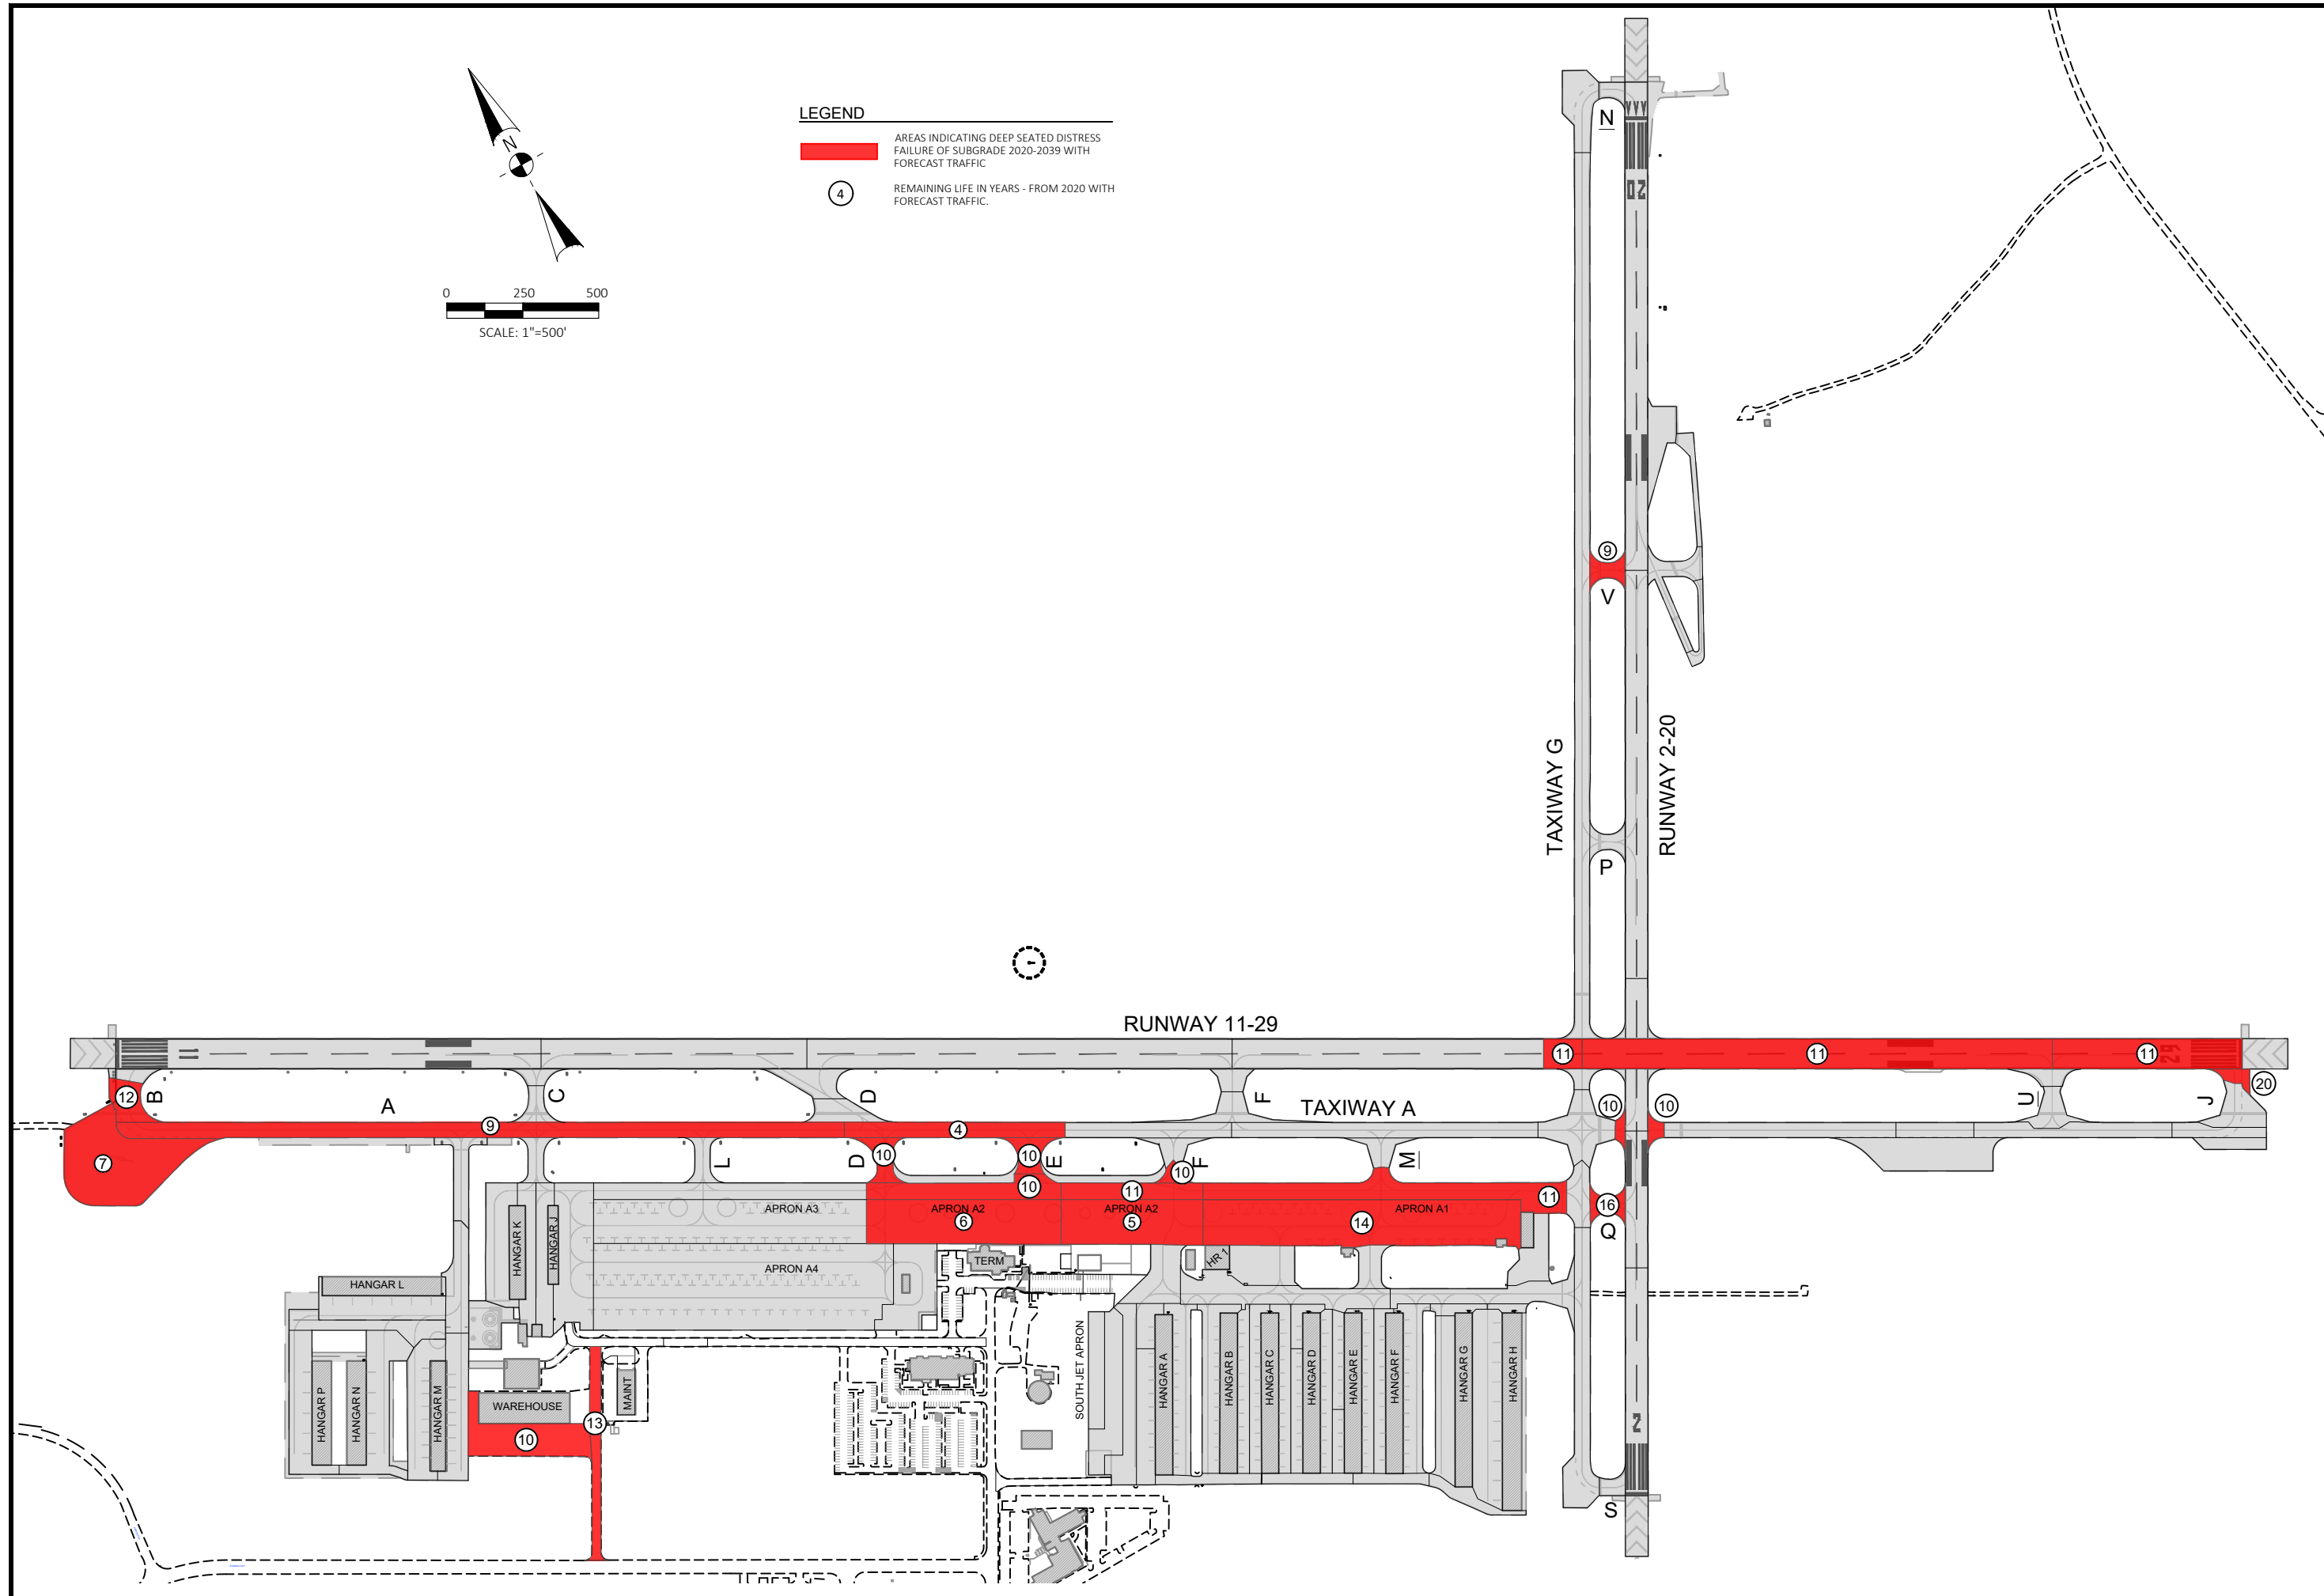
**TRUCKEE TAHOE AIRPORT
2020 PAVEMENT MANAGEMENT PLAN
DEEP SEATED DISTRESS - FATIGUE ANALYSIS
(FORECAST TRAFFIC)**

Plate 4-1 shows the remaining life of the pavements expected to fail under deep-seated distress in the subgrade layer using the forecast traffic. The remaining life analysis for the subgrade layer is the critical item for the areas of pavement that have less than 20 years of remaining life. Plate 4-2 shows the remaining life of the pavements expected to fail under deep-seated distress in the subgrade layer using the “enhanced traffic”. The “enhanced traffic” indexes provide information on how the remaining pavement life changes if the number of aircraft operations of aircraft greater than 48,000 lbs. is double that of the “forecast traffic.”

- LEGEND**
- AREAS INDICATING DEEP SEATED DISTRESS FAILURE OF SUBGRADE 2020-2039 WITH FORECAST TRAFFIC
 - 4 REMAINING LIFE IN YEARS - FROM 2020 WITH FORECAST TRAFFIC.

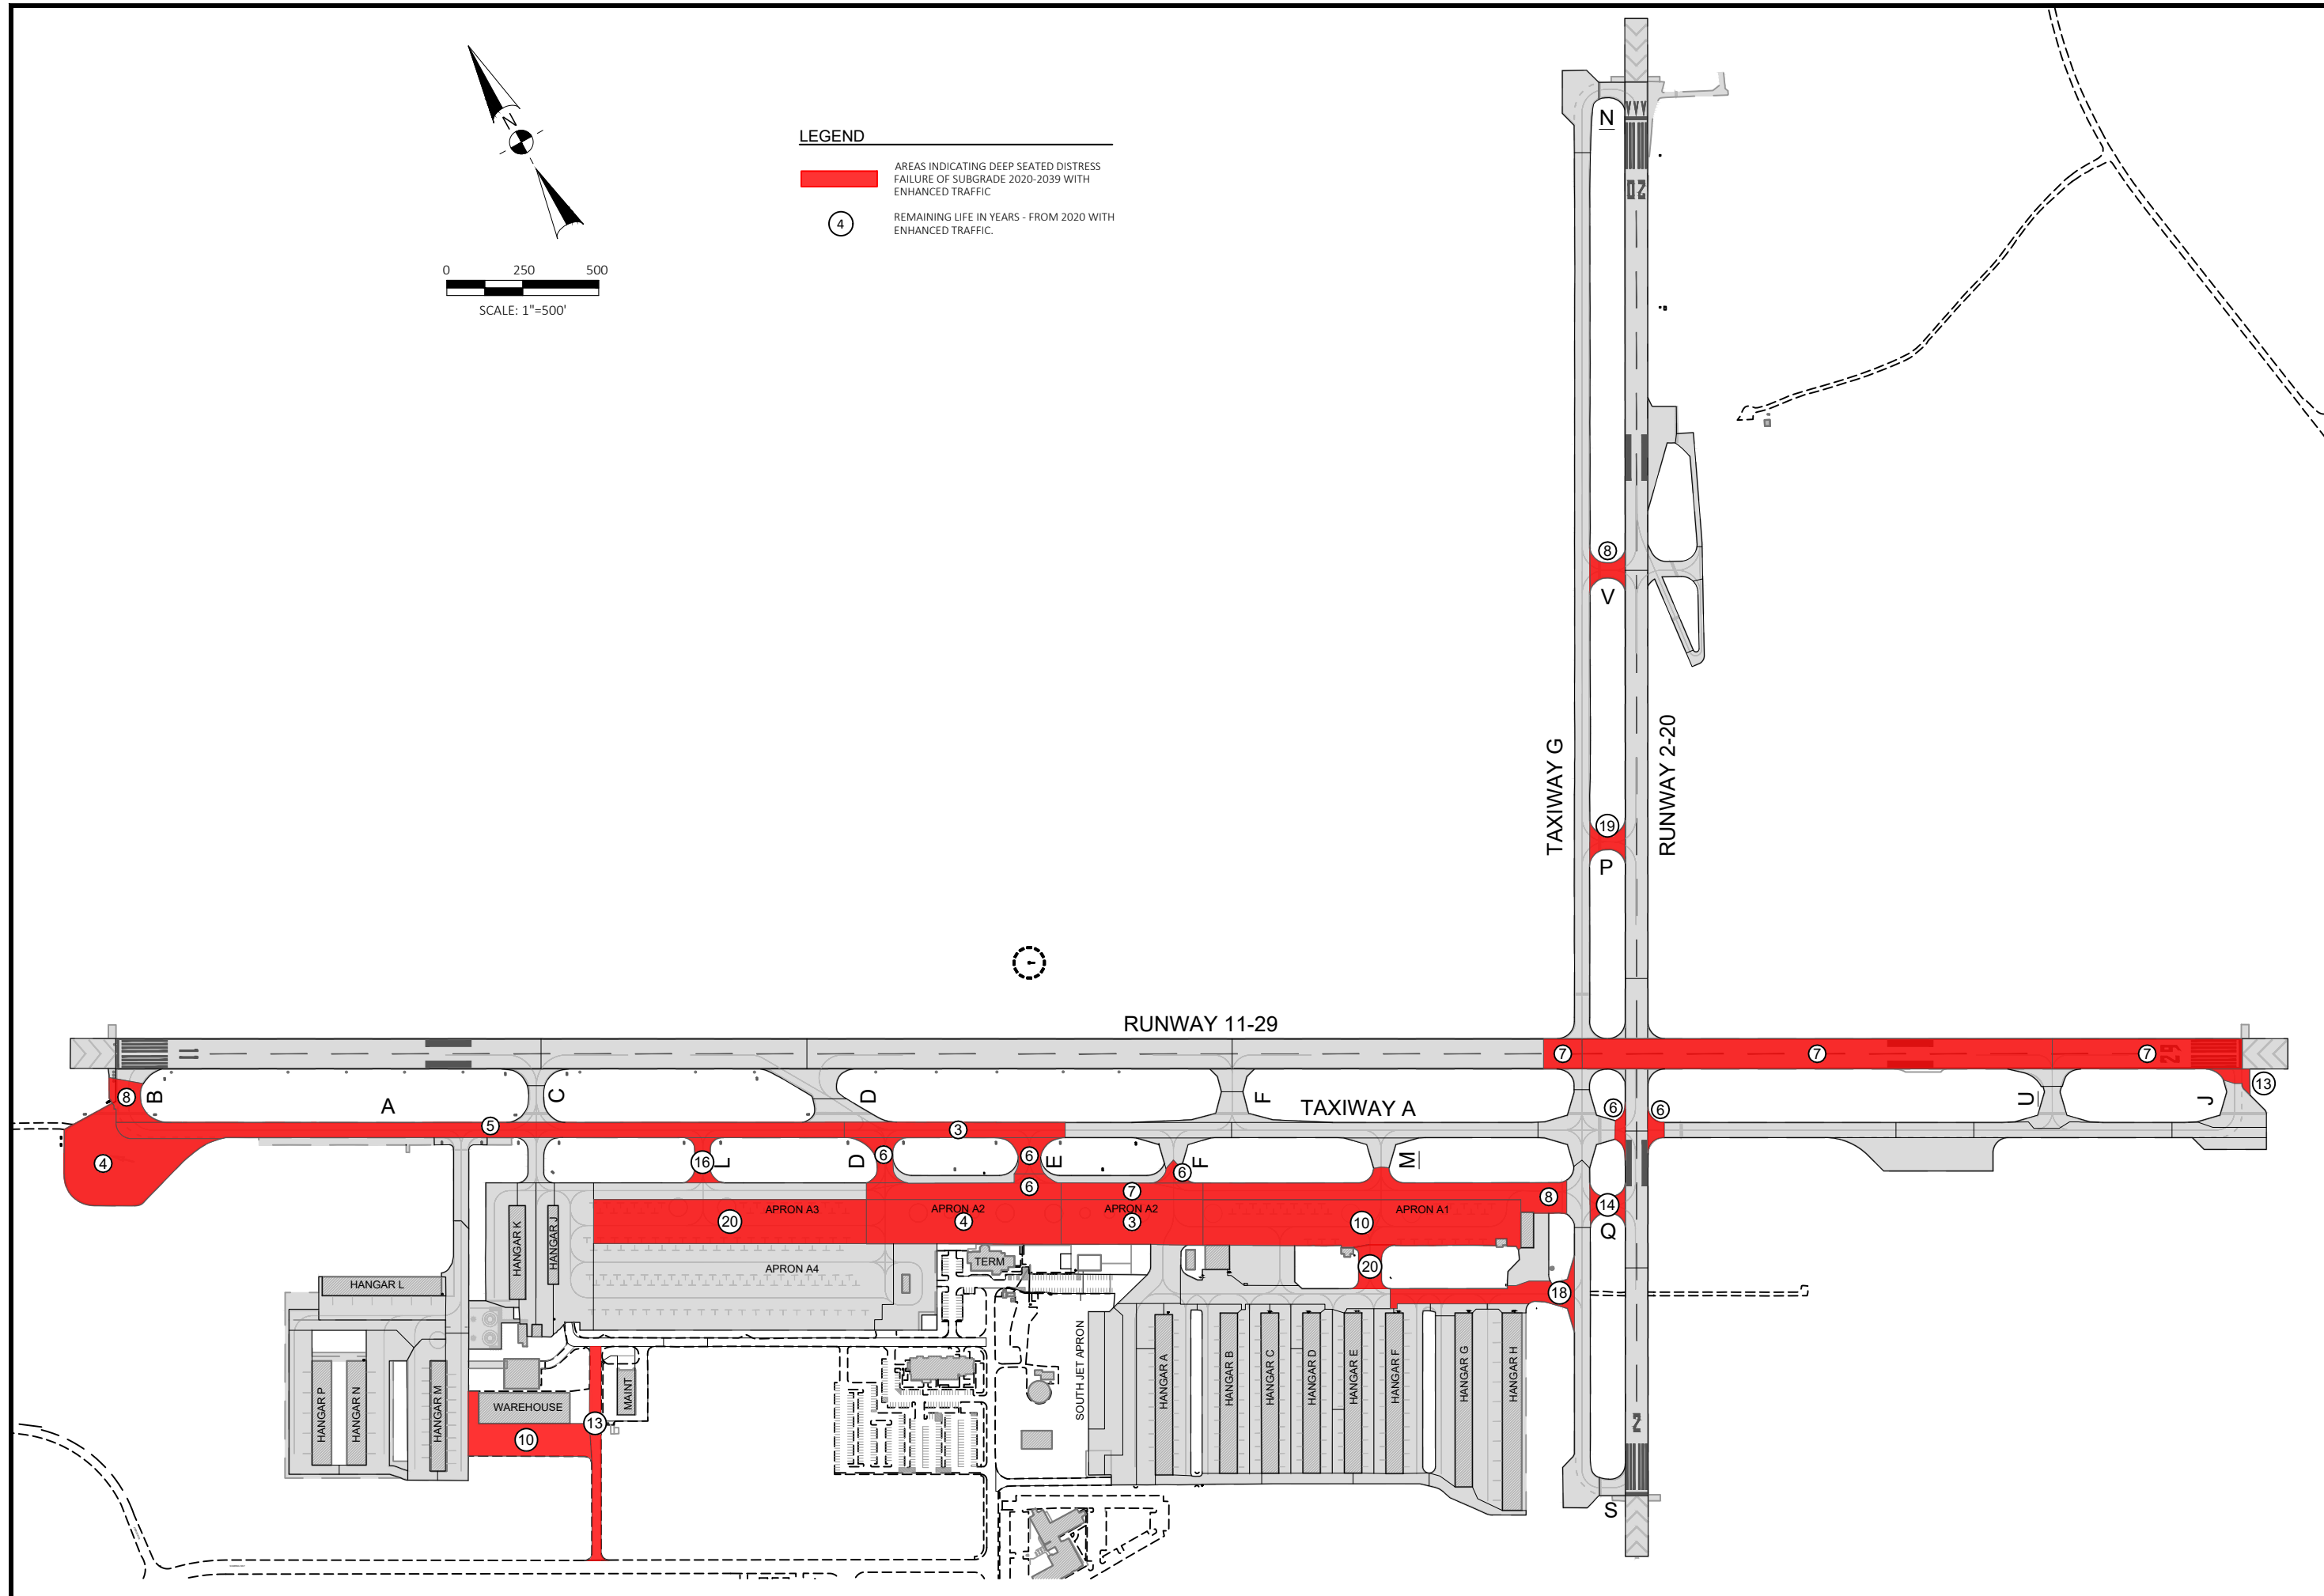
DATE	7/12/2021
DRAWN	KDC
CHECKED	DB
SCALE	1"=500'
PLATE No.	4-2

- AREAS INDICATING DEEP SEATED DISTRESS FAILURE OF SUBGRADE 2020-2039 WITH ENHANCED TRAFFIC
- 4 REMAINING LIFE IN YEARS - FROM 2020 WITH ENHANCED TRAFFIC.

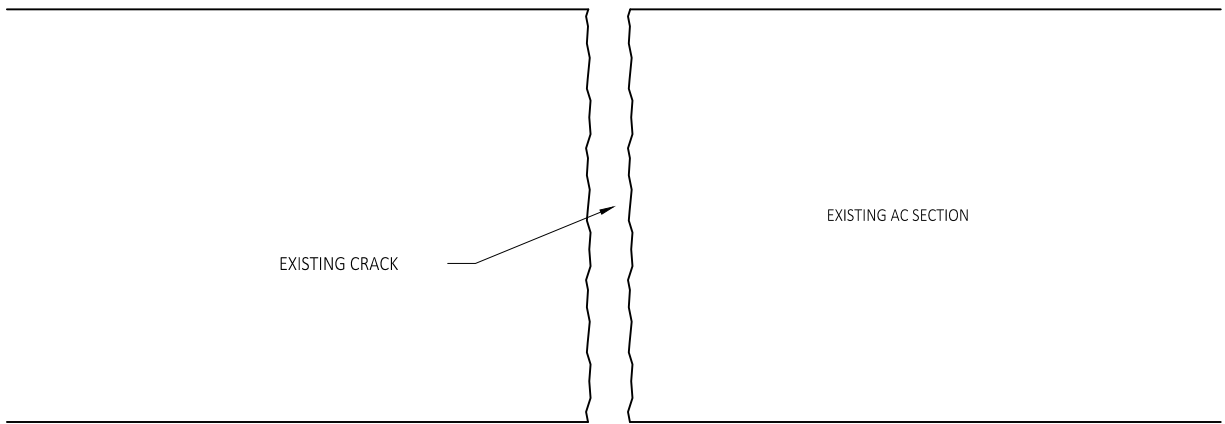
EXISTING CRACK IN PAVEMENT
