March 26 2026 Hangar Update for Board

A summary of the current state of the hangars and our way forward

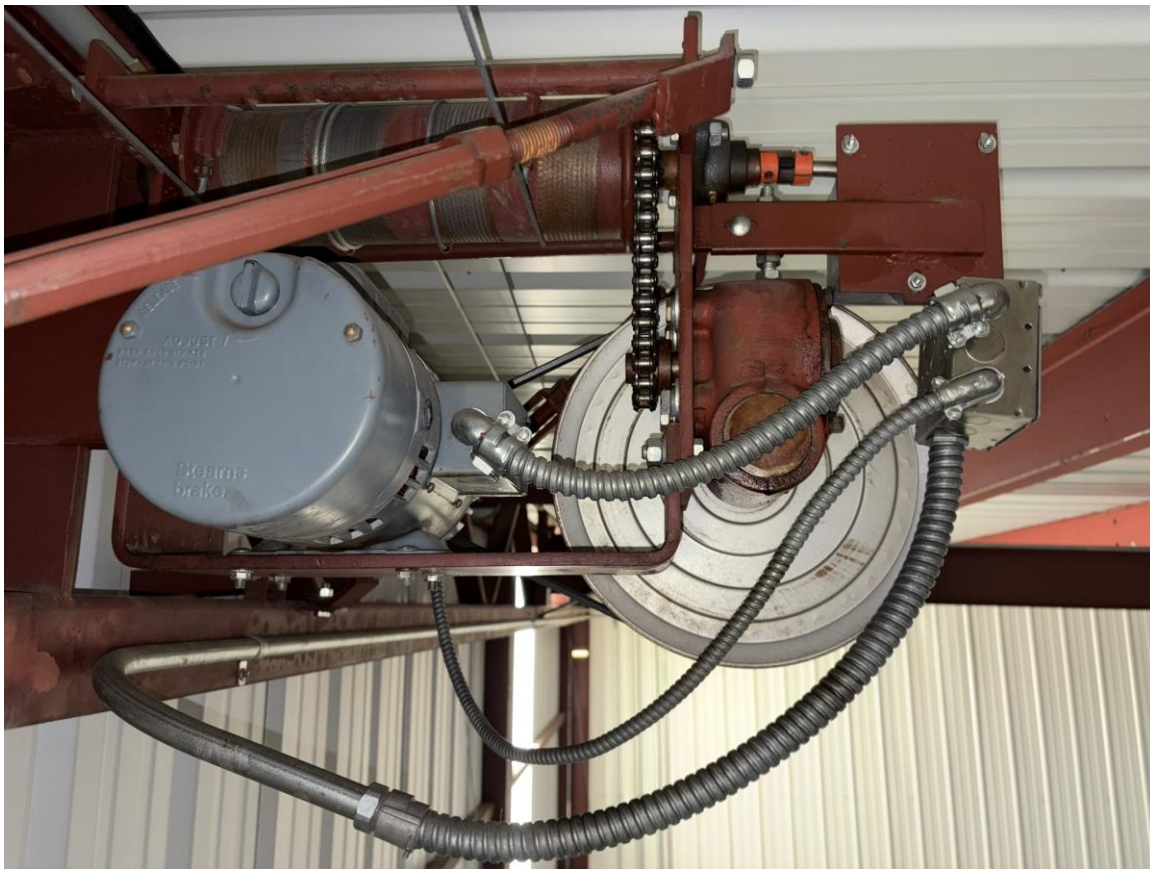
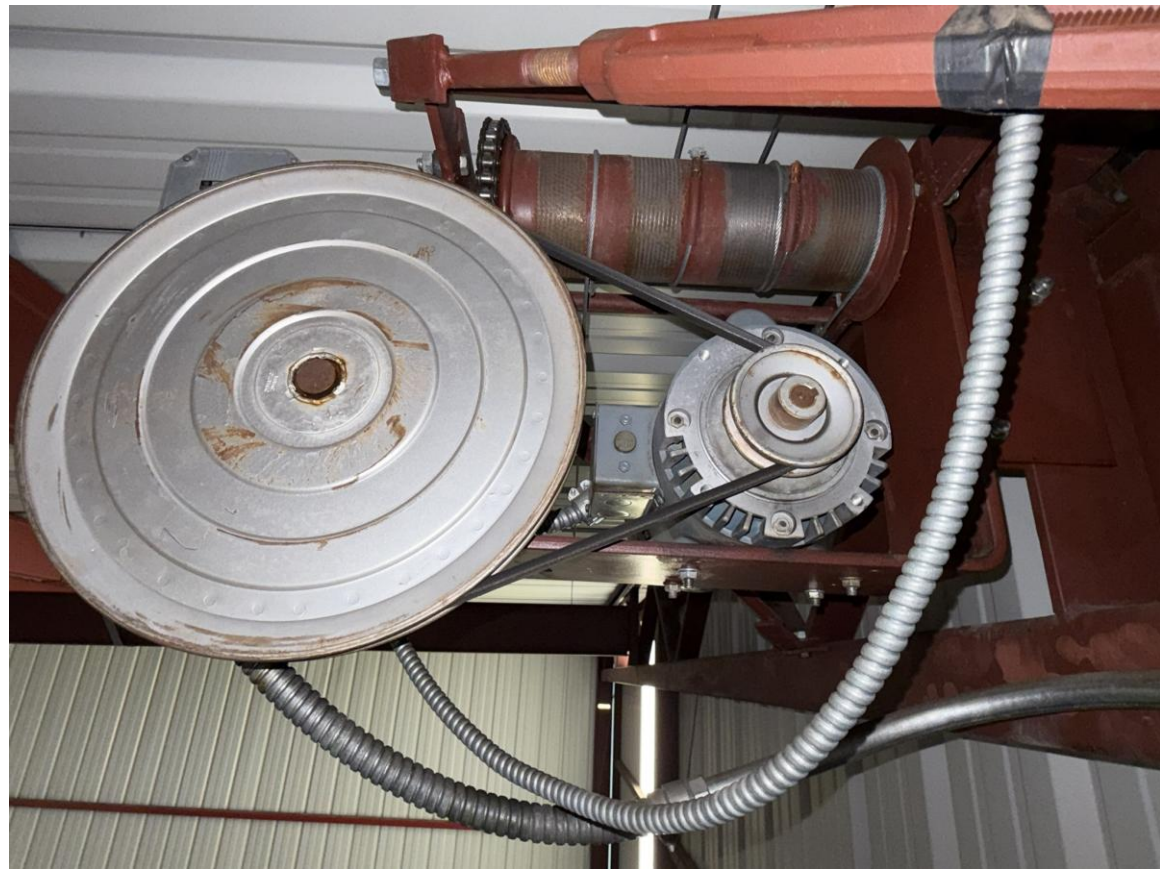
Alpha Row Single Point of Failure Chain

- 2018 Alpha row – Door Fell. Door jammed on the way down, cables unspooled, door unjammed and fell (video) **SEVERE** Mitigation: Momentary door switch

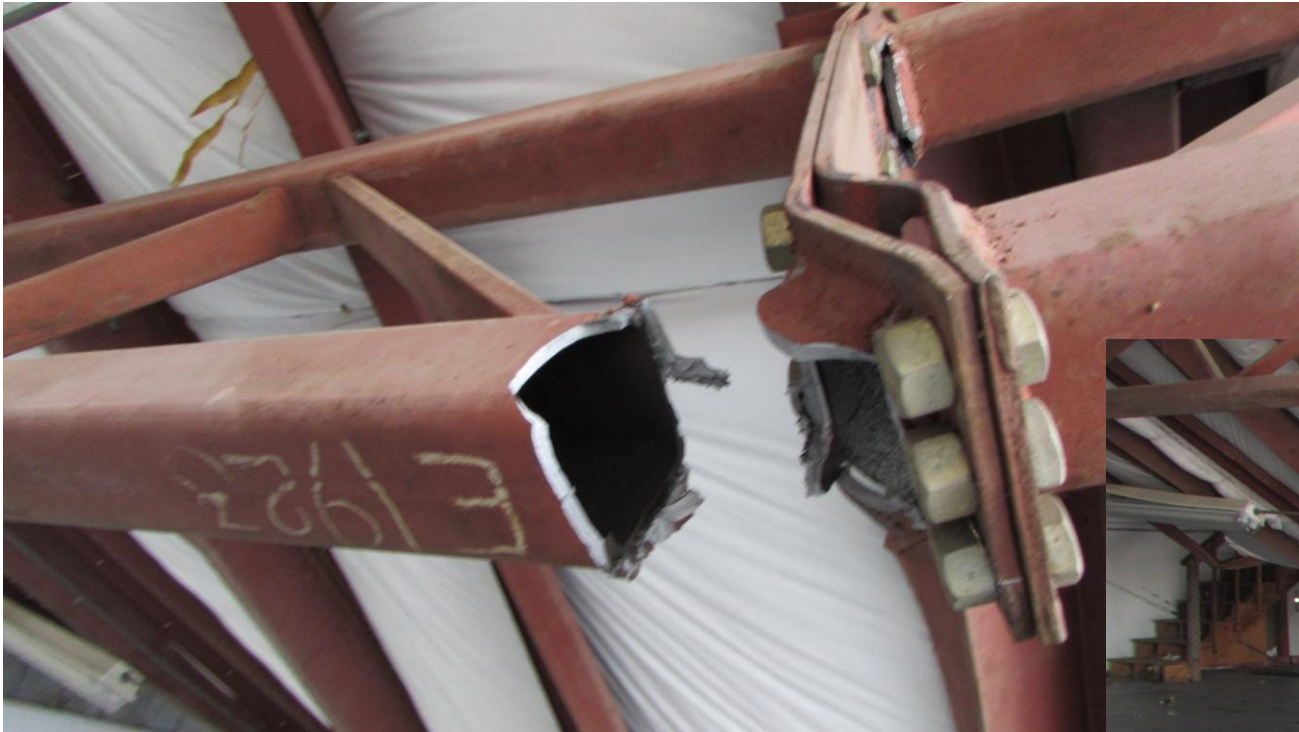
Hangar 2 Collapse

**-Hangar 2: Built 1967 collapsed 2017...50 yrs
Having survived:**

- 2017 Hangar 2 collapse **SEVERE** Mitigation: Demolition, other hangars monitored by SRS, snow load testing

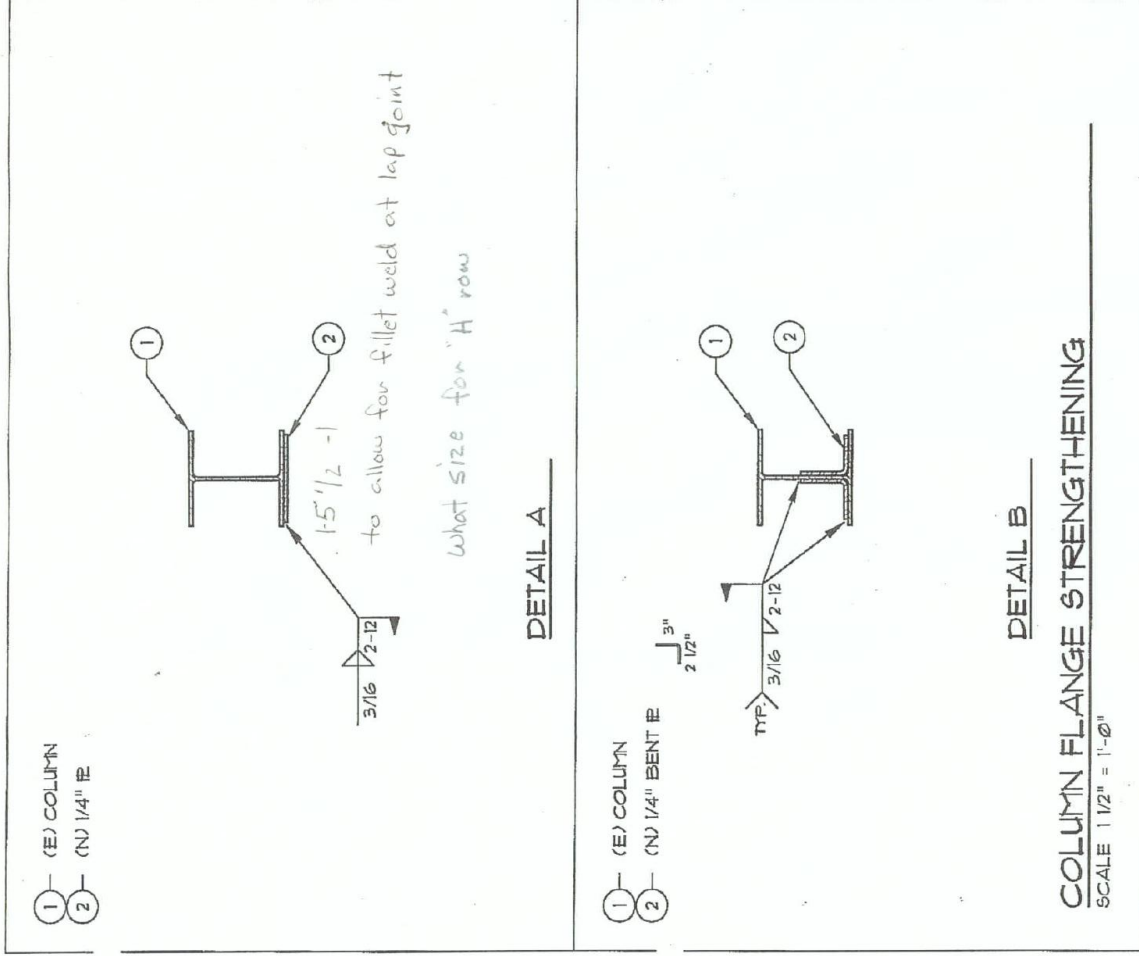
Column Distortion Mitigation

- Ongoing Various Hangars - Bent vertical I-beam structure due to weight of door – **SEVERE** Mitigation: Lowering door opening heights and reinforcing per structural engineer's guidance

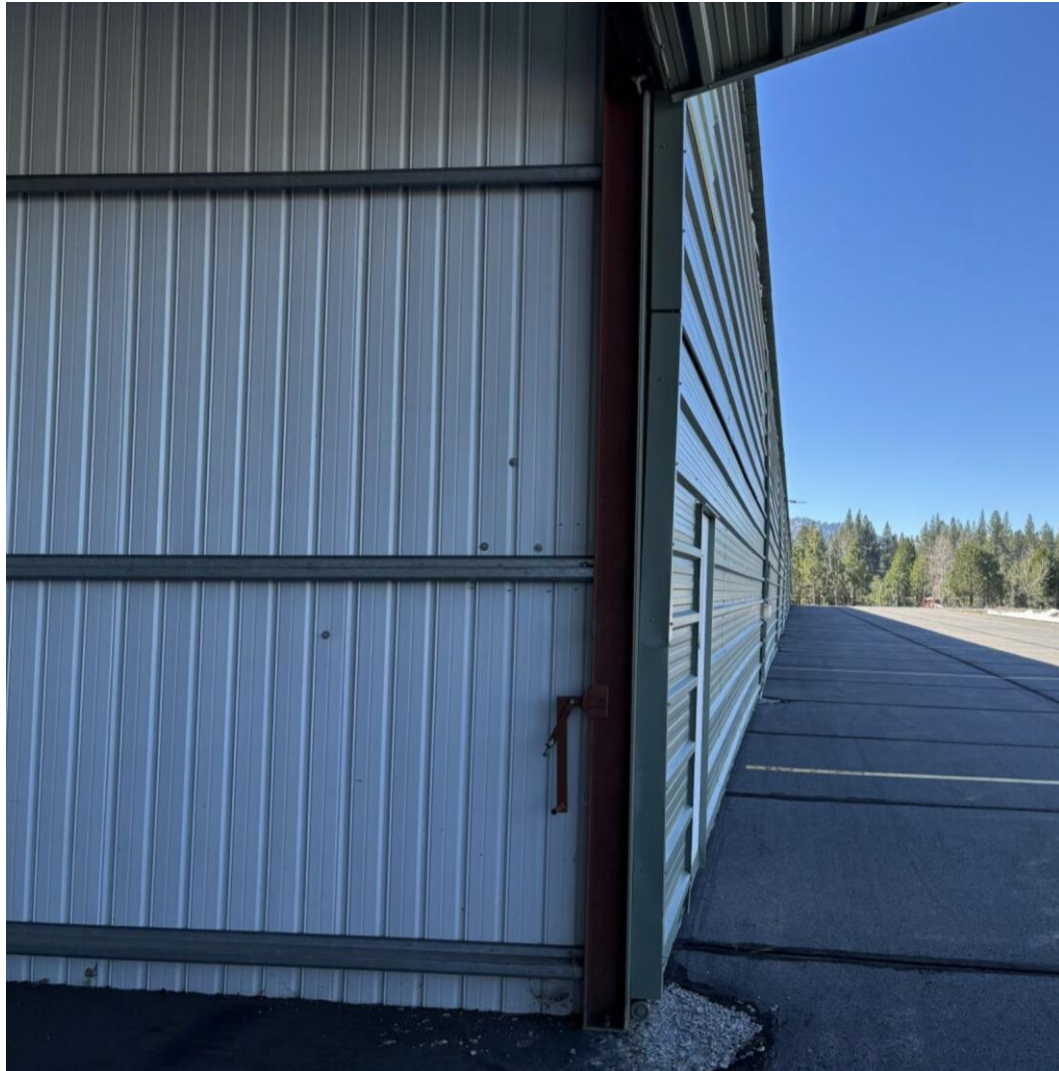
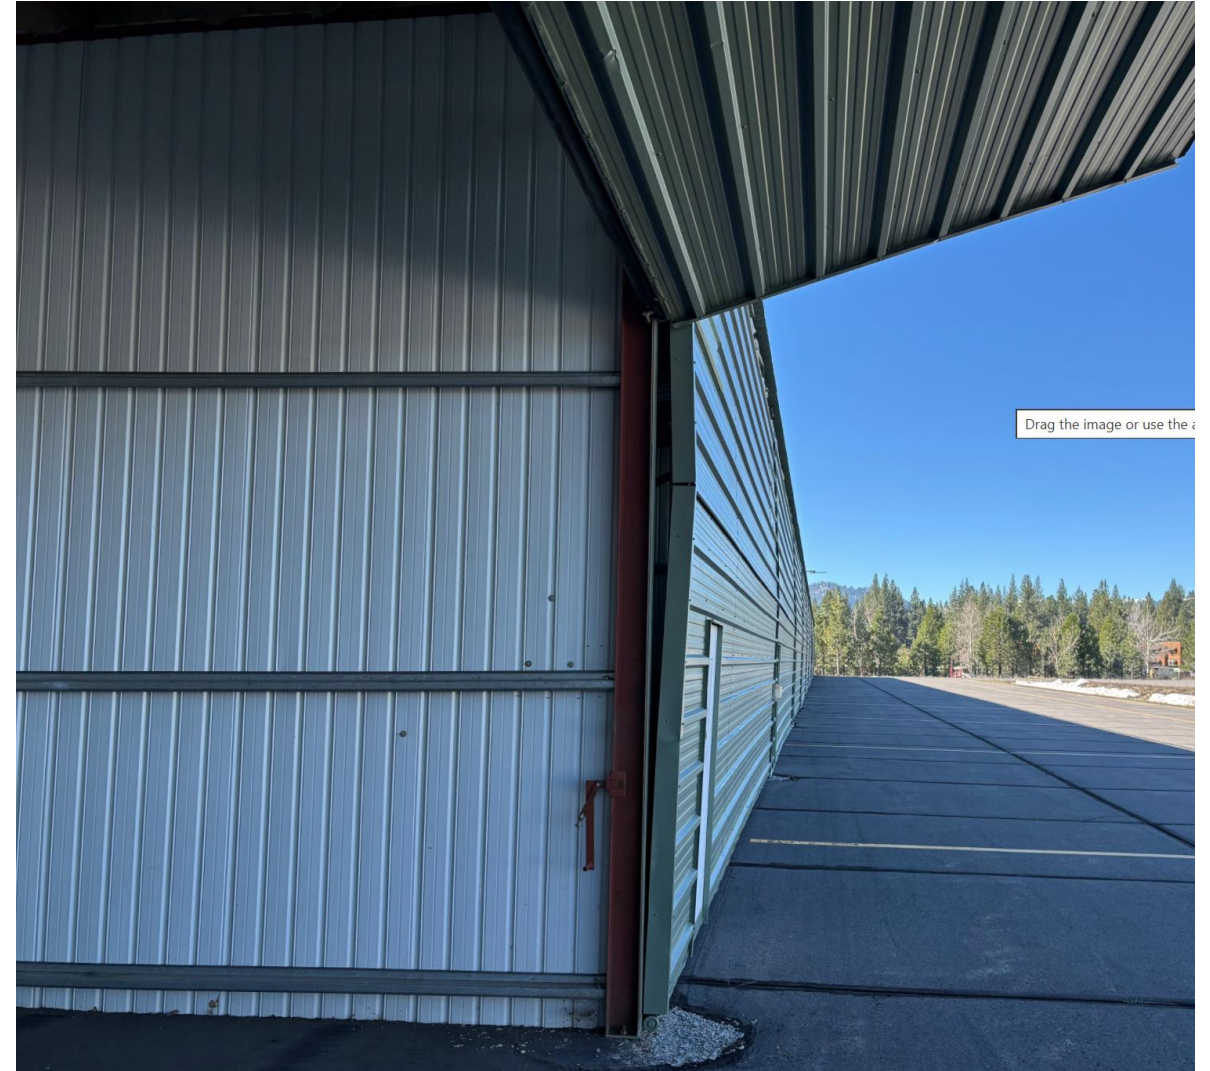
Manual Hangar Latches

- 2026 Delta row – Door Fell (SPF). Chain failure resulting in free fall - **SEVERE** Mitigation underway, decisions pending
- 2026 Bravo and 2023 Charlie row – Manual Latch Injury. Doors lifted without unlatching manual latches. At least two injuries to persons after tenants tried to unlatch tensioned doors. **MAJOR** Mitigation: Momentary switch, Policy, Retrofit with 'Auto-latches?'

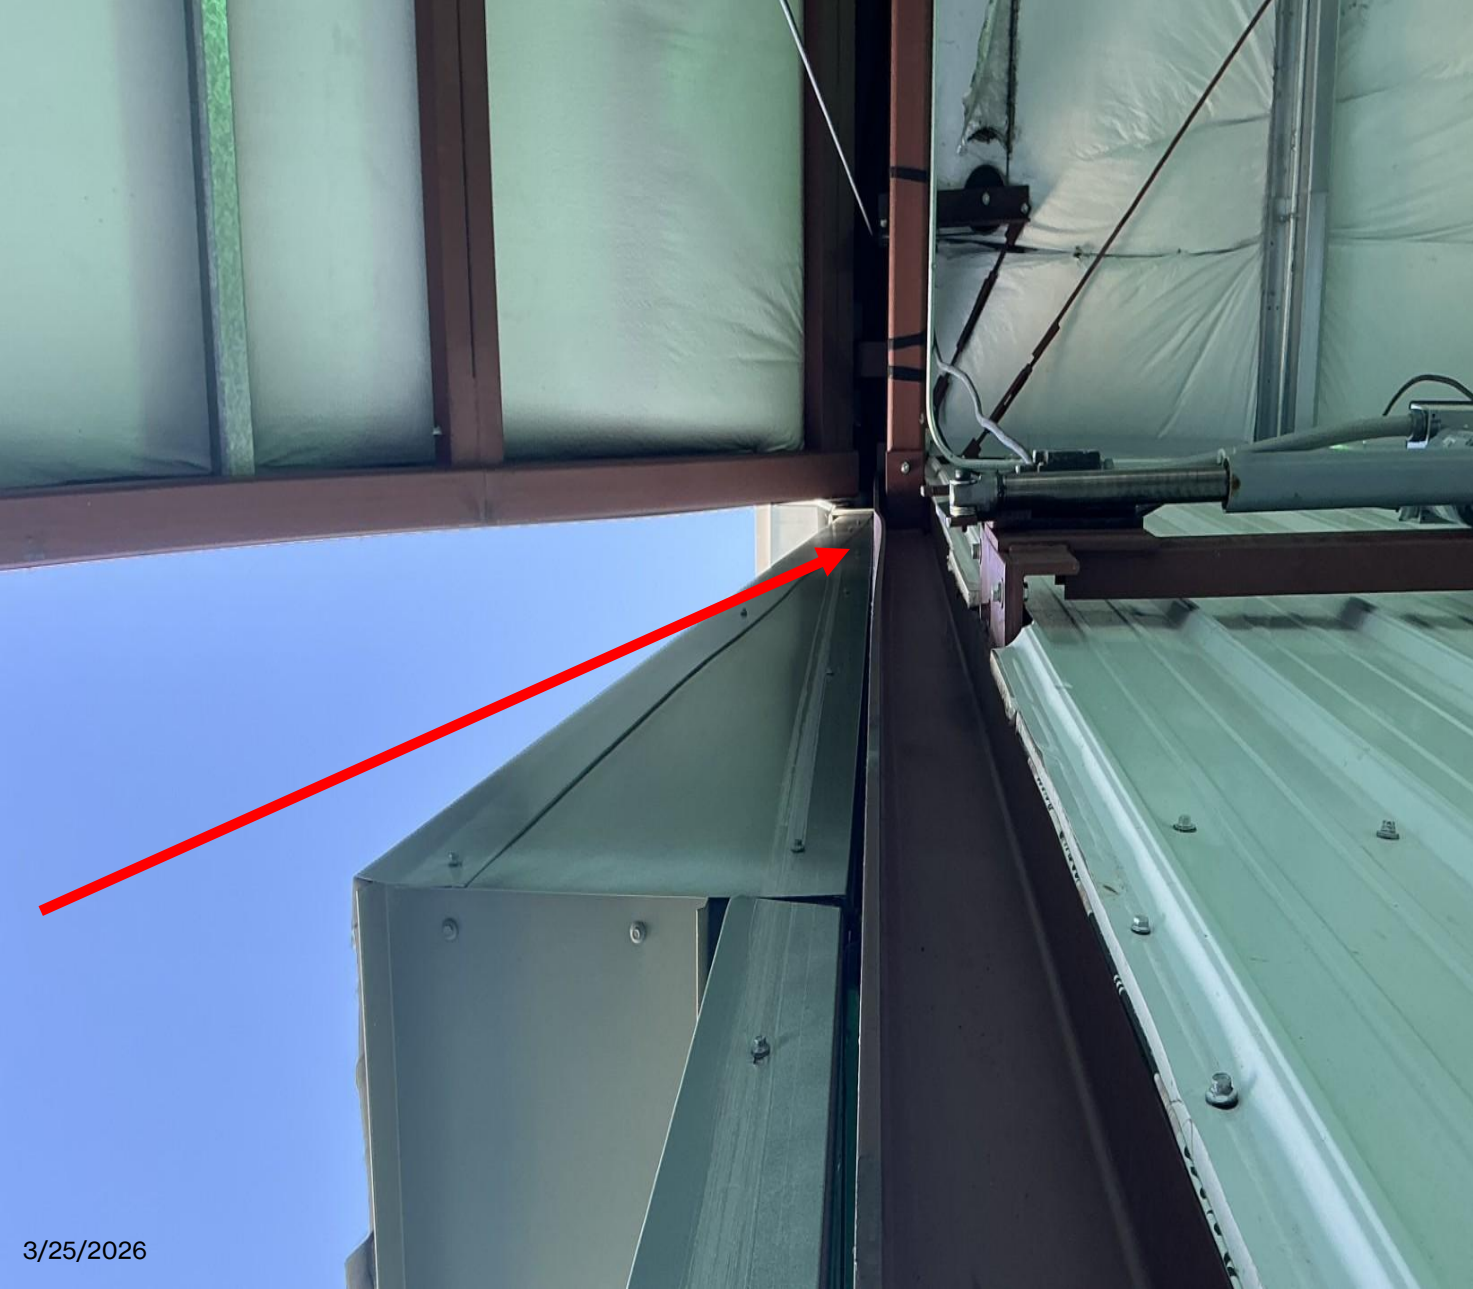
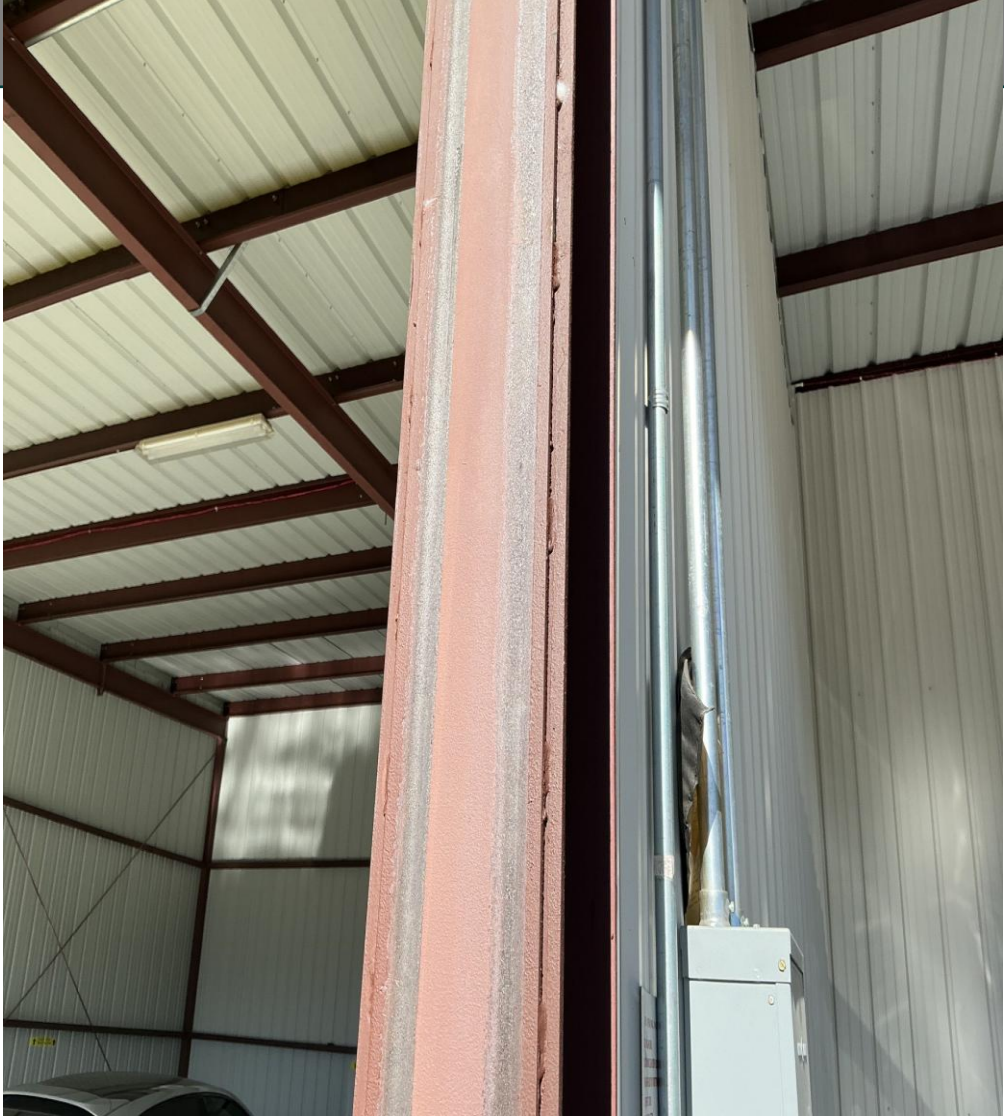
Compromised I-Beam Column

- Bent vertical I-beam structure due to weight of door – have bolstered many with addition steel structure
- 50+ incidents of tenants bypassing momentary switches. D22 failure is first major failure since momentary switch install November of 2018

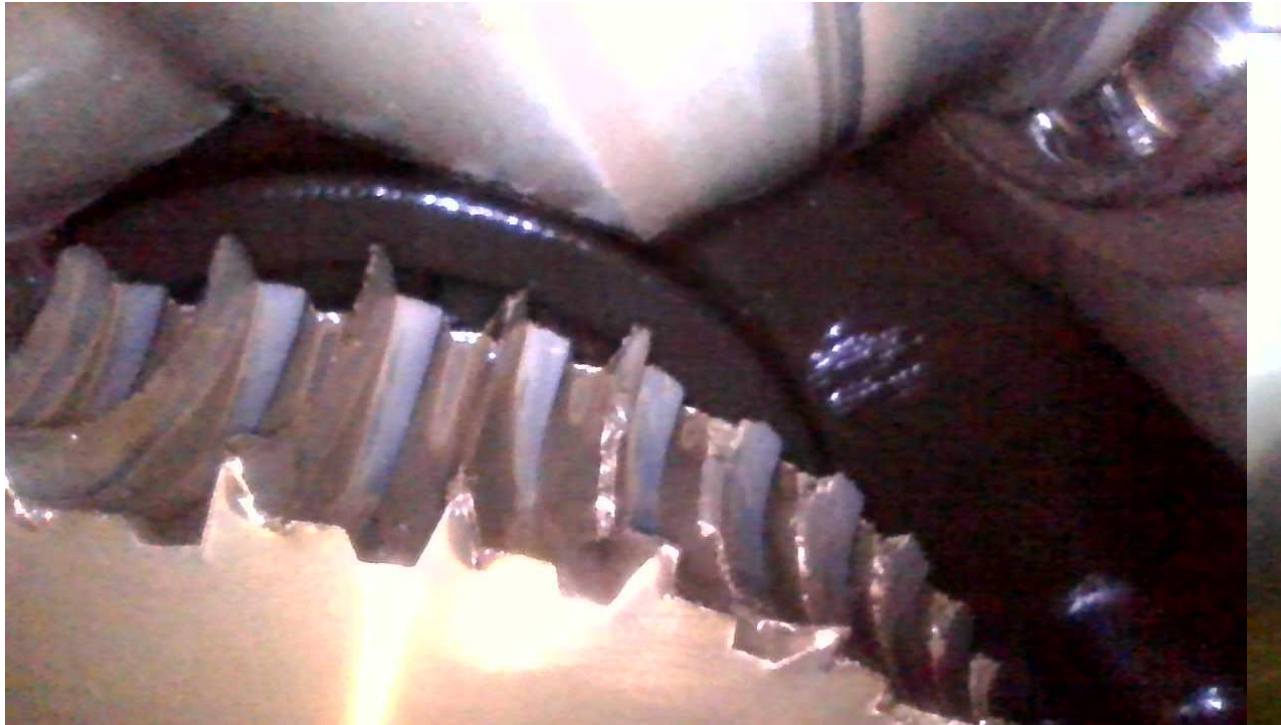
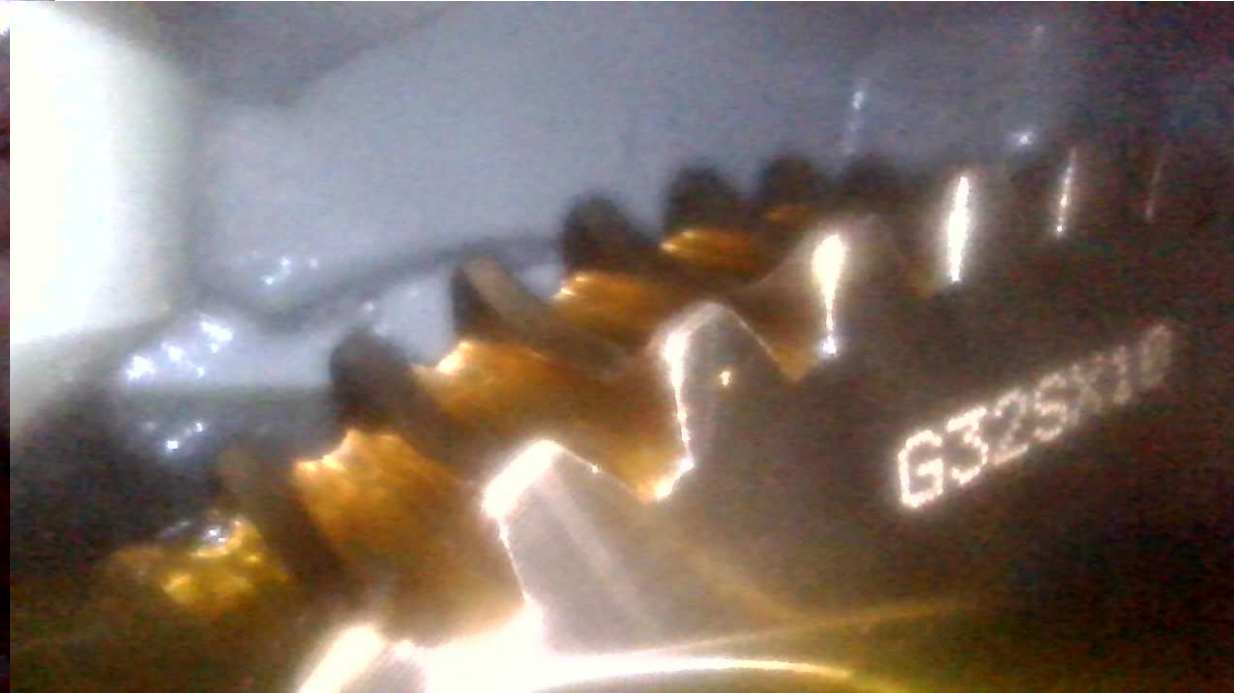
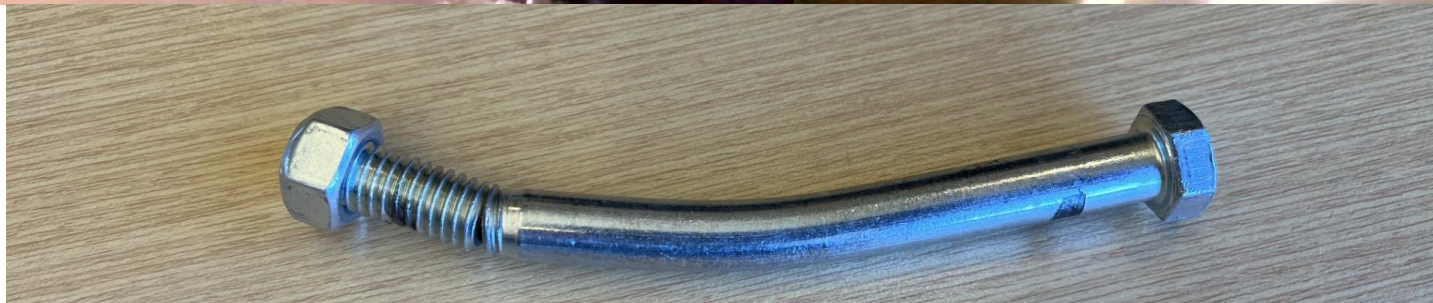
Schweiss Door Hazards

- November and Papa Row – tripping electrical contactors causes door to stop and must be reset by maintenance
- Papa Row – failed gearbox would not allow door to open – all gearboxes have been inspected and replaced if necessary

- Papa Row – Strap pins were bent which caused one to fail – door remained operational due to number of straps – all pins have been upgraded
- Before momentary switch, many doors were lowered onto objects, cable would slack and cause uneven wrapping in later cycles. This led to many premature failures of cables. Also causing damage to vehicles and planes.
