TRUCKEE-TAHOE AIRPORT Pavement Evaluation Study Pavement Maintenance/Management Plan

NOVEMBER, 2011 (UPDATED DECEMBER 2014)

**TRUCKEE TAHOE AIRPORT
PAVEMENT EVALUATION STUDY
PAVEMENT MAINTENANCE/MANAGEMENT PLAN**

*Prepared by:
Reinard W. Brandley
Consulting Airport Engineer*

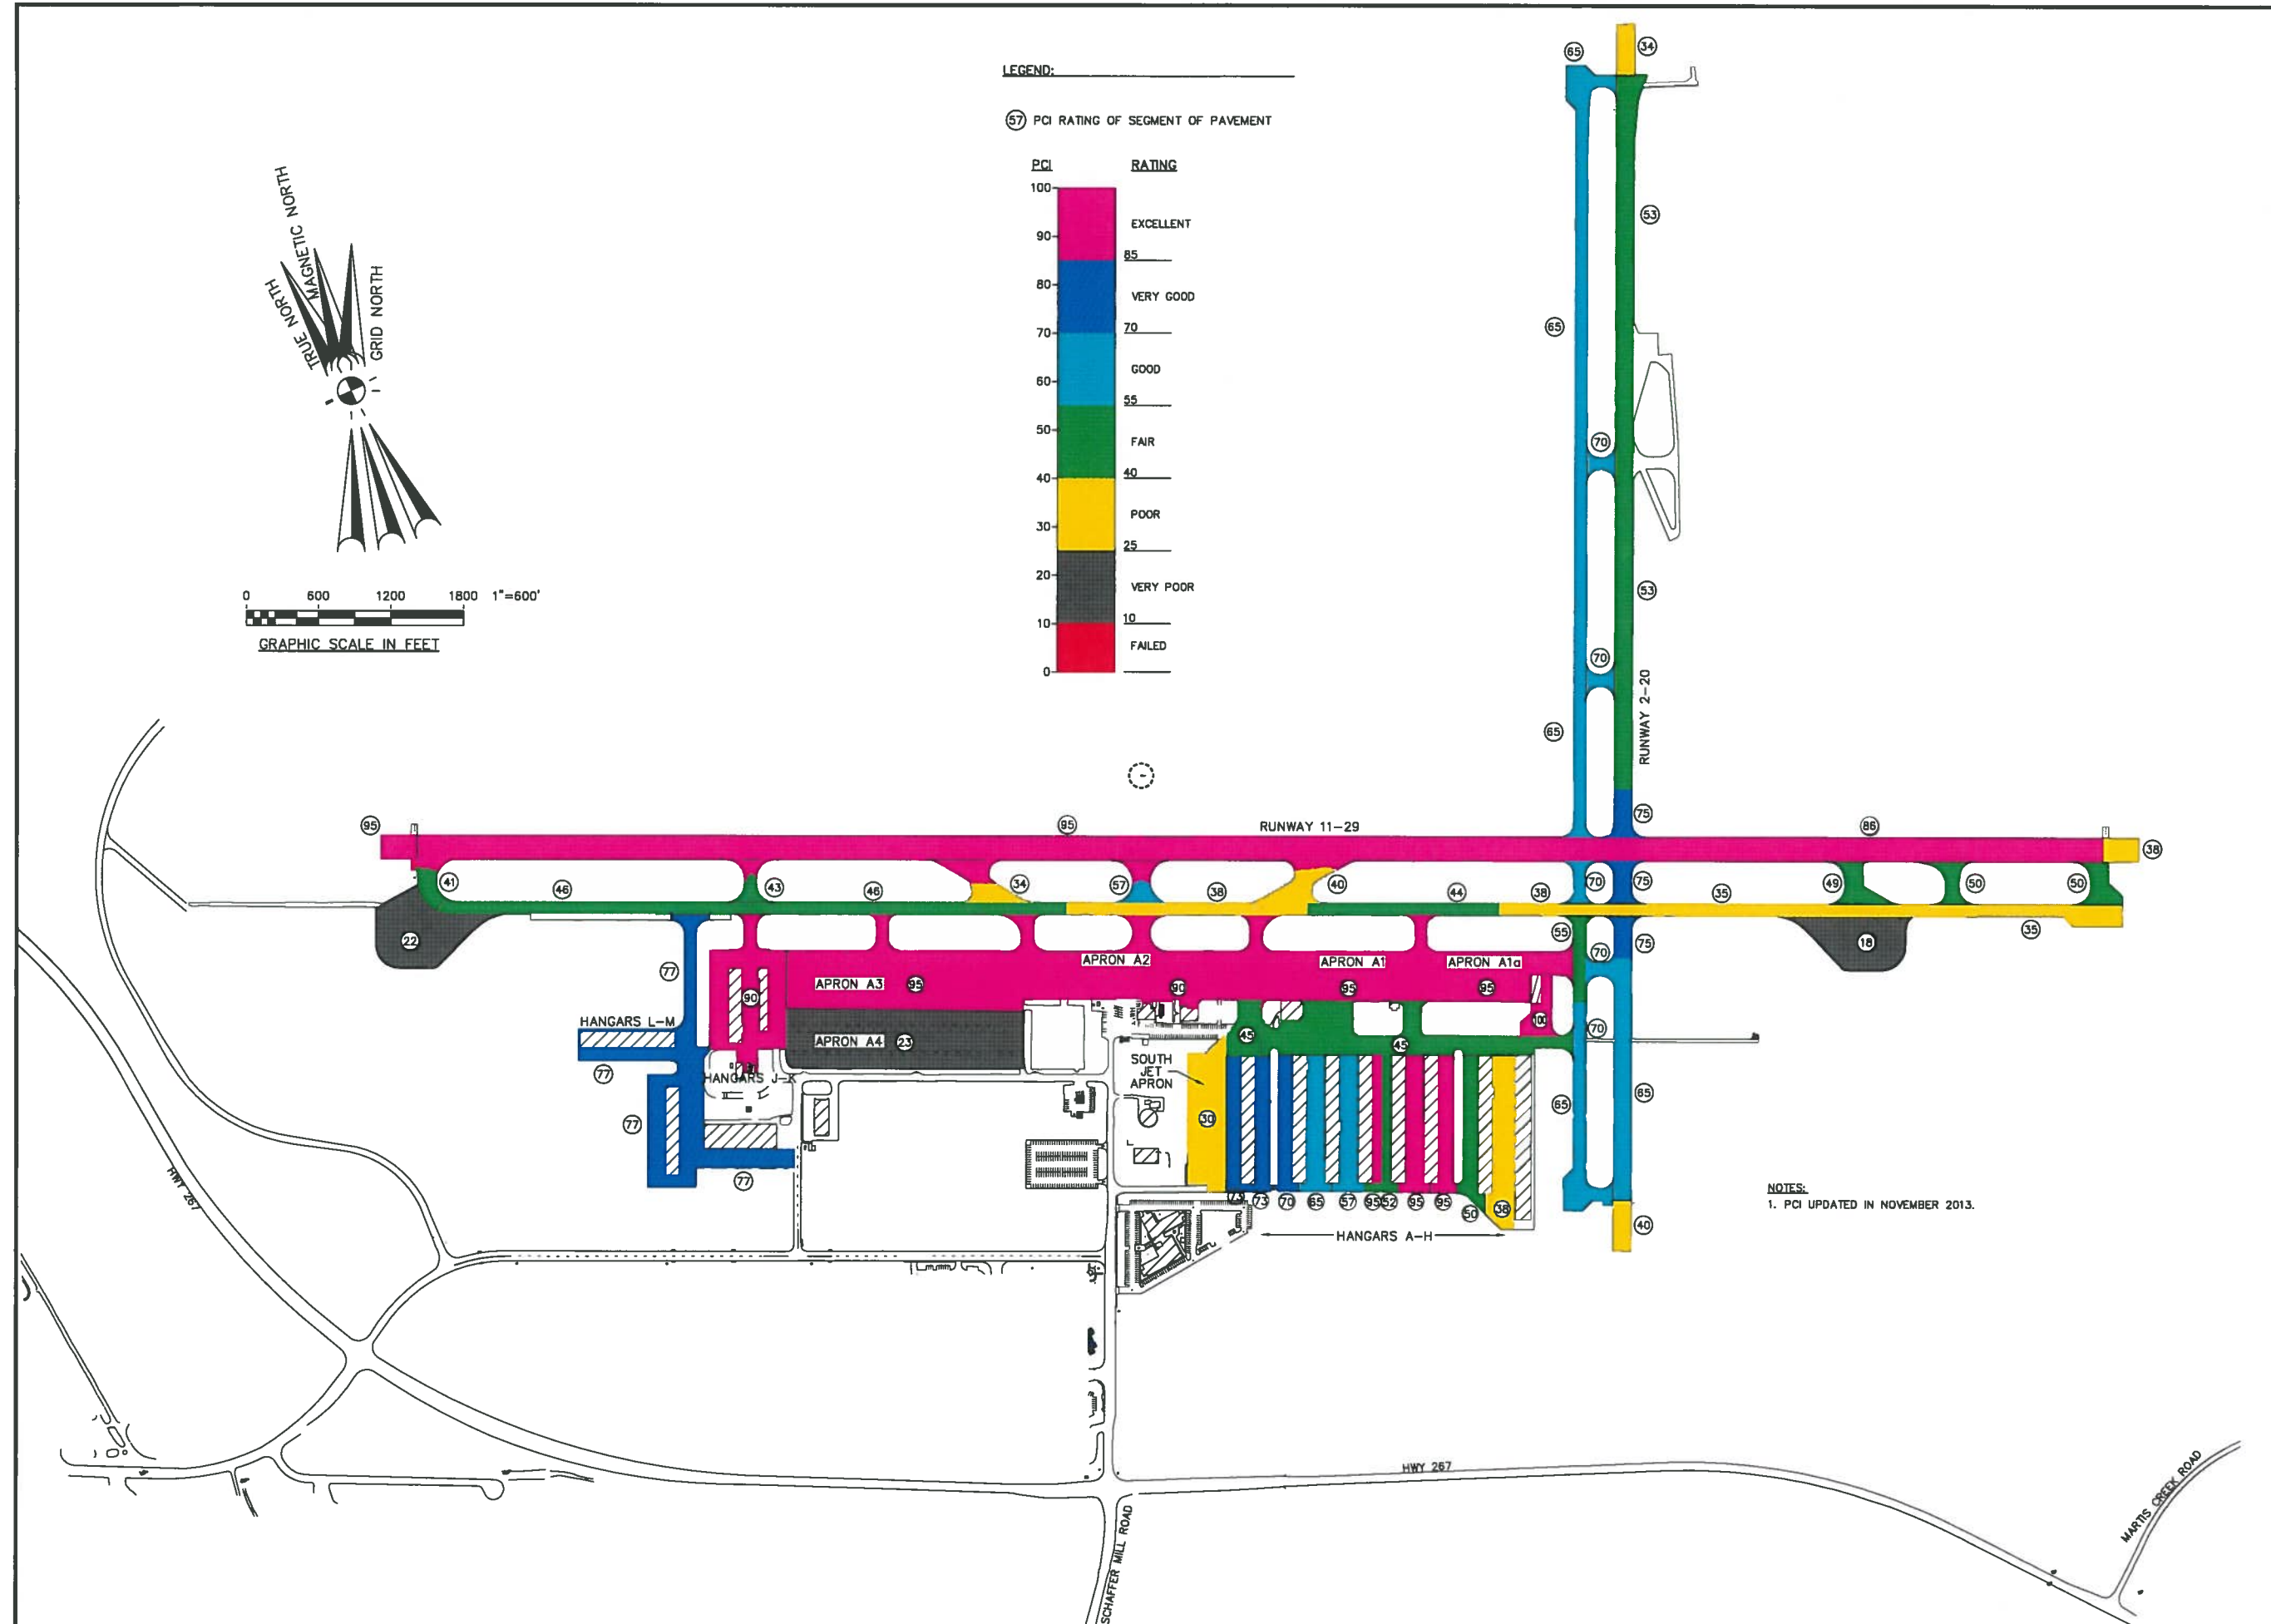
The ASTM Standard provides a relationship between Pavement Condition Index (PCI) and pavement rating. On Plates No. 2-1a and 2-1b the rating system is indicated as a color legend and the rating of each segment of pavement is indicated by color. The PCI of each segment is also indicated adjacent to each segment of the pavement. It will be noted that in 2013 most pavements at the airport range from the “fair” to “excellent” condition. The South Jet Apron and Portions of Taxiway A are rated as “poor”, and Apron A4 and run-up areas at Taxiways B and H are rated “very poor”.

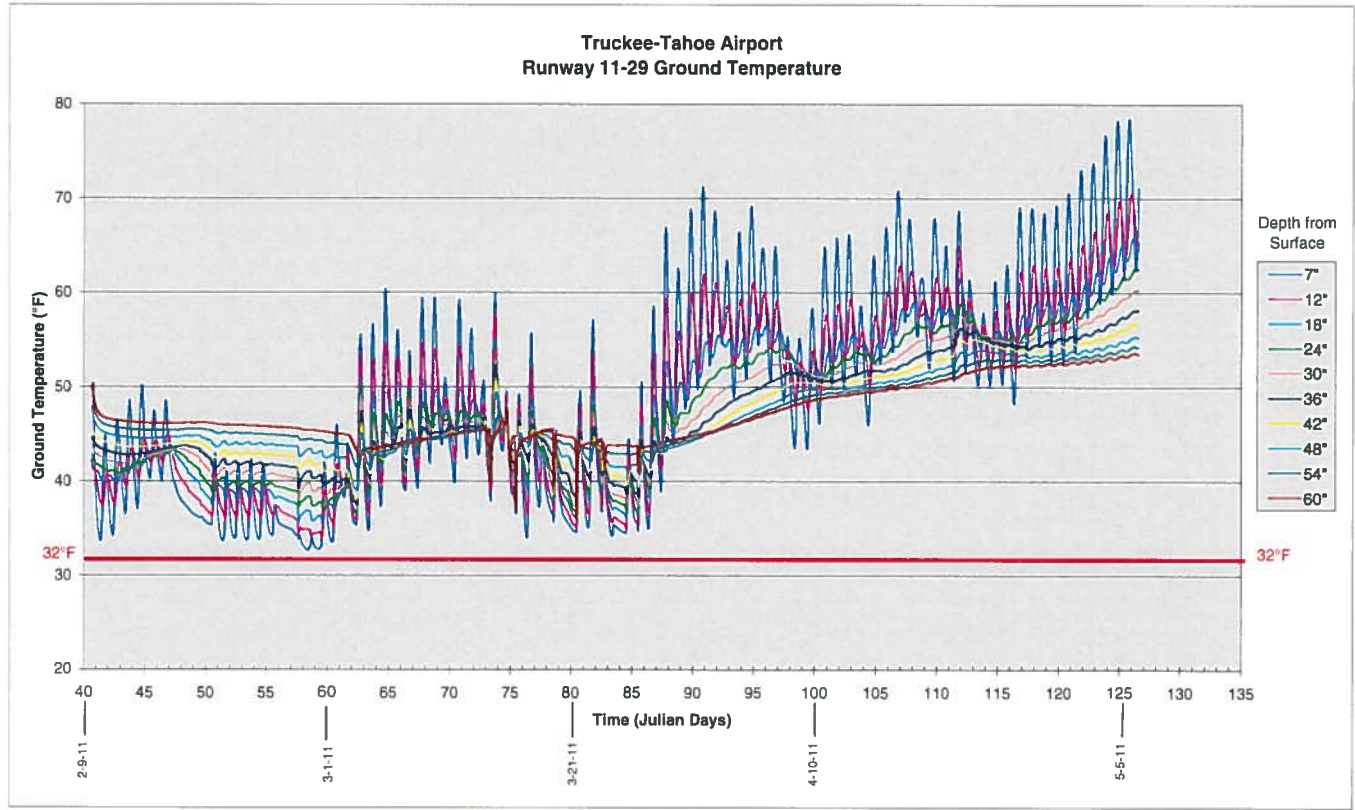
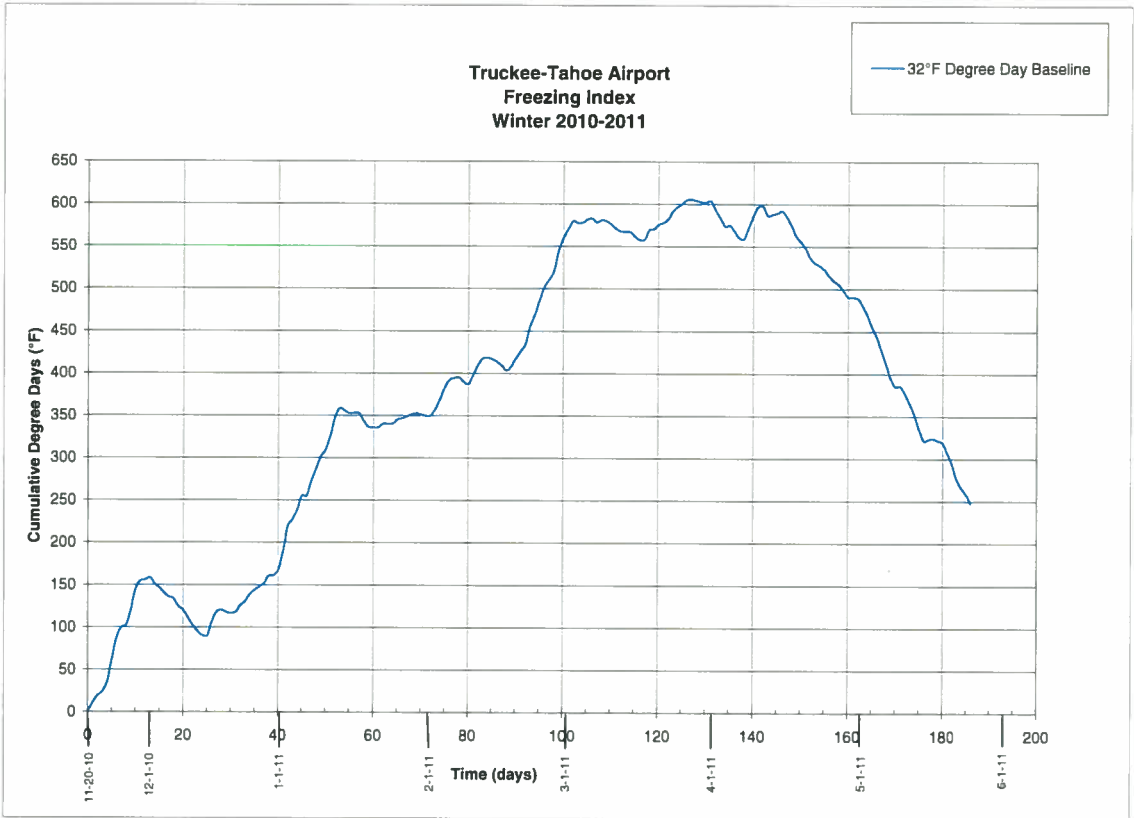
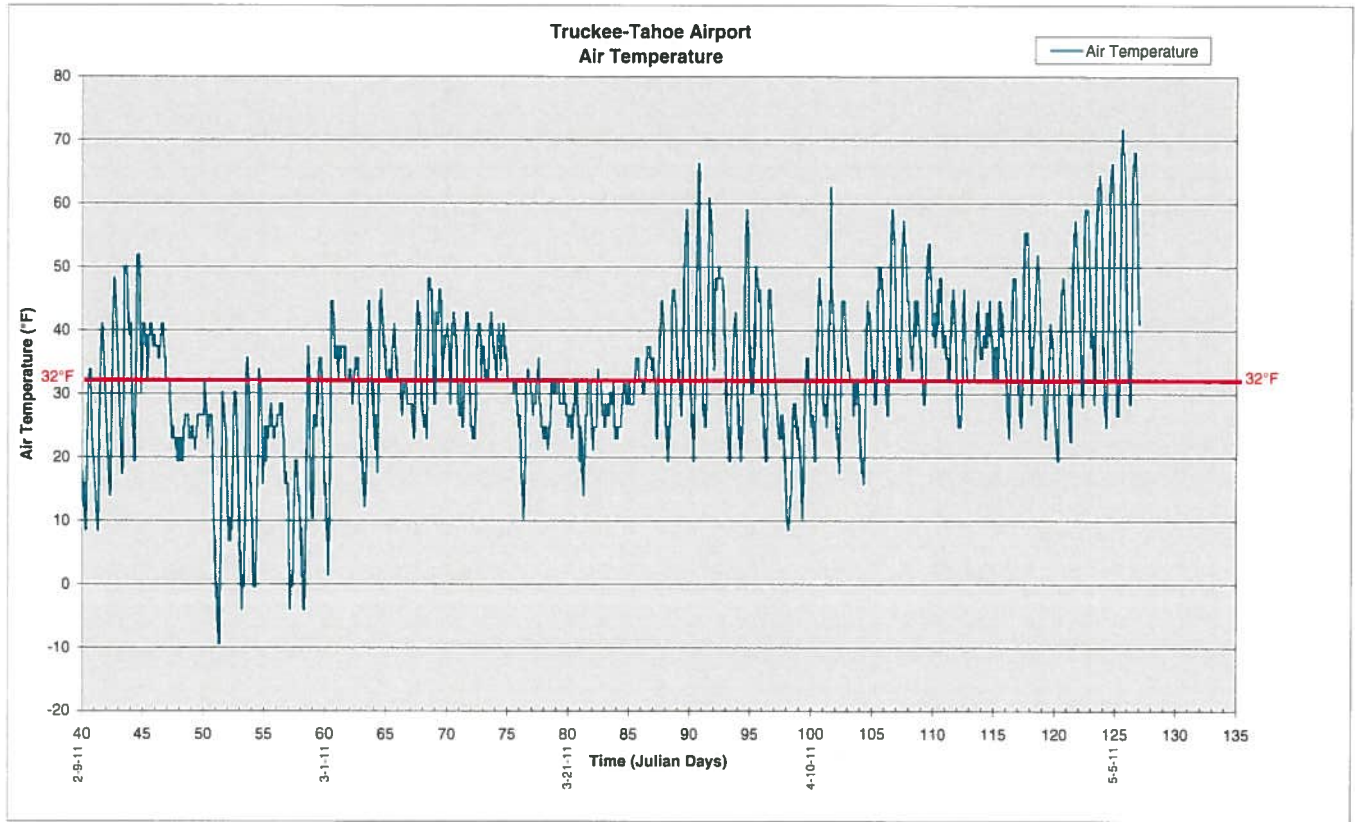
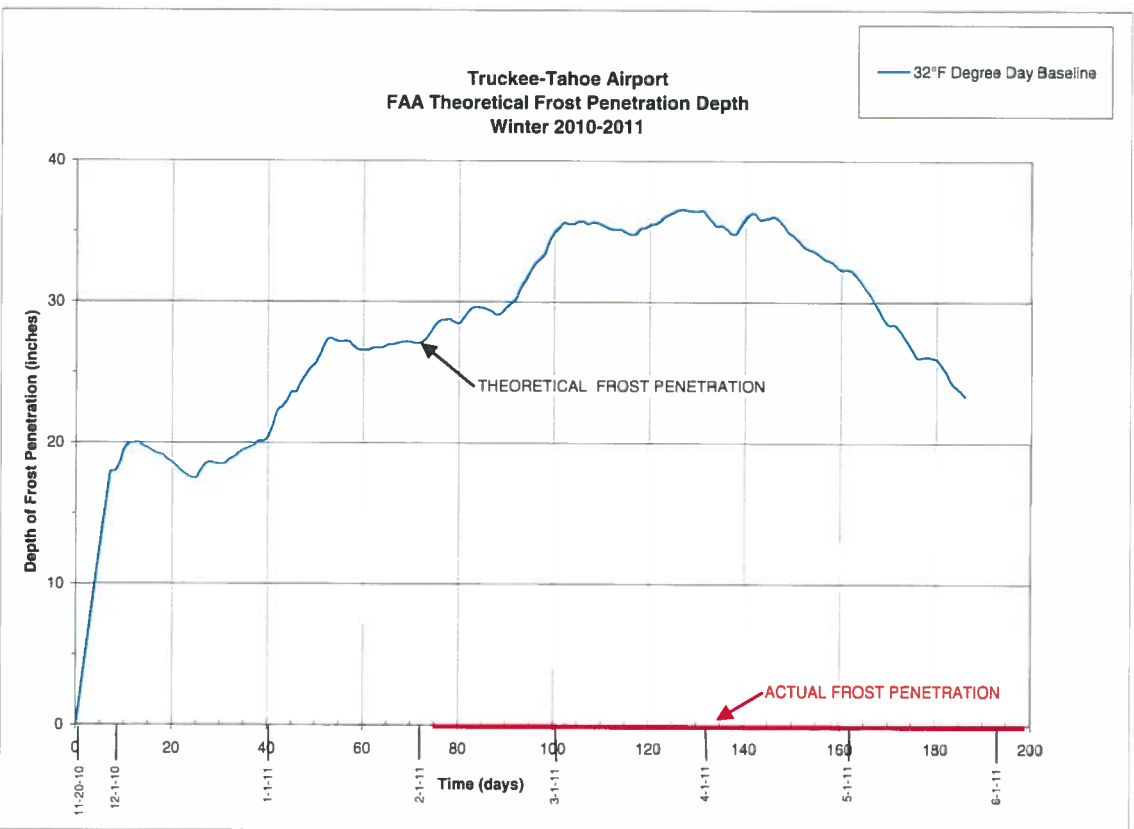
PLATE NO. 2-3 - FROST PENETRATION STUDY
Data Collection: February 9 - May 5, 2011

Experience at other airports in the Sierra Nevada Mountains indicates that frost penetration under a dark colored pavement is significantly less than that indicated by the freezing index; whereas, the frost penetration under a white reflective painted surface can be greater than that indicated by the freezing index. In order to determine the depth of frost penetration at Truckee Tahoe Airport a series of thermocouples were installed at various depths below the pavement surface on a section of Runway 11-29 located west of Taxiway G. Gauges were installed at depths of every 6 inches beginning at the depth of 6 inches and extending to 5 feet below the pavement surface. These gauges were installed on February 9, 2011. When the hole was drilled through the pavement for installation of the gauges, it was noted that there was no frost in any of the subgrade or subsoil materials that existed below a depth of 11 inches from the surface. The existing temperature data at each gauge were recorded hourly starting after installation. The results of these readings are shown on the Runway 11-29 Ground Temperature chart on Plate No. 2-3. Air temperature during that same period was also recorded and is also shown on Plate No. 2-3.

The frost penetration data observed during the winters of 2011-2012 and 2012-2013 showed little change from the data included in the original report. During the month of January 2013 there were approximately 20 days that there were freezing temperatures in the base rock 6" below the surface, but the frost never penetrated to the temperature gauge located 12" below the surface. There are no additional updates to the Frost Action section of the report.

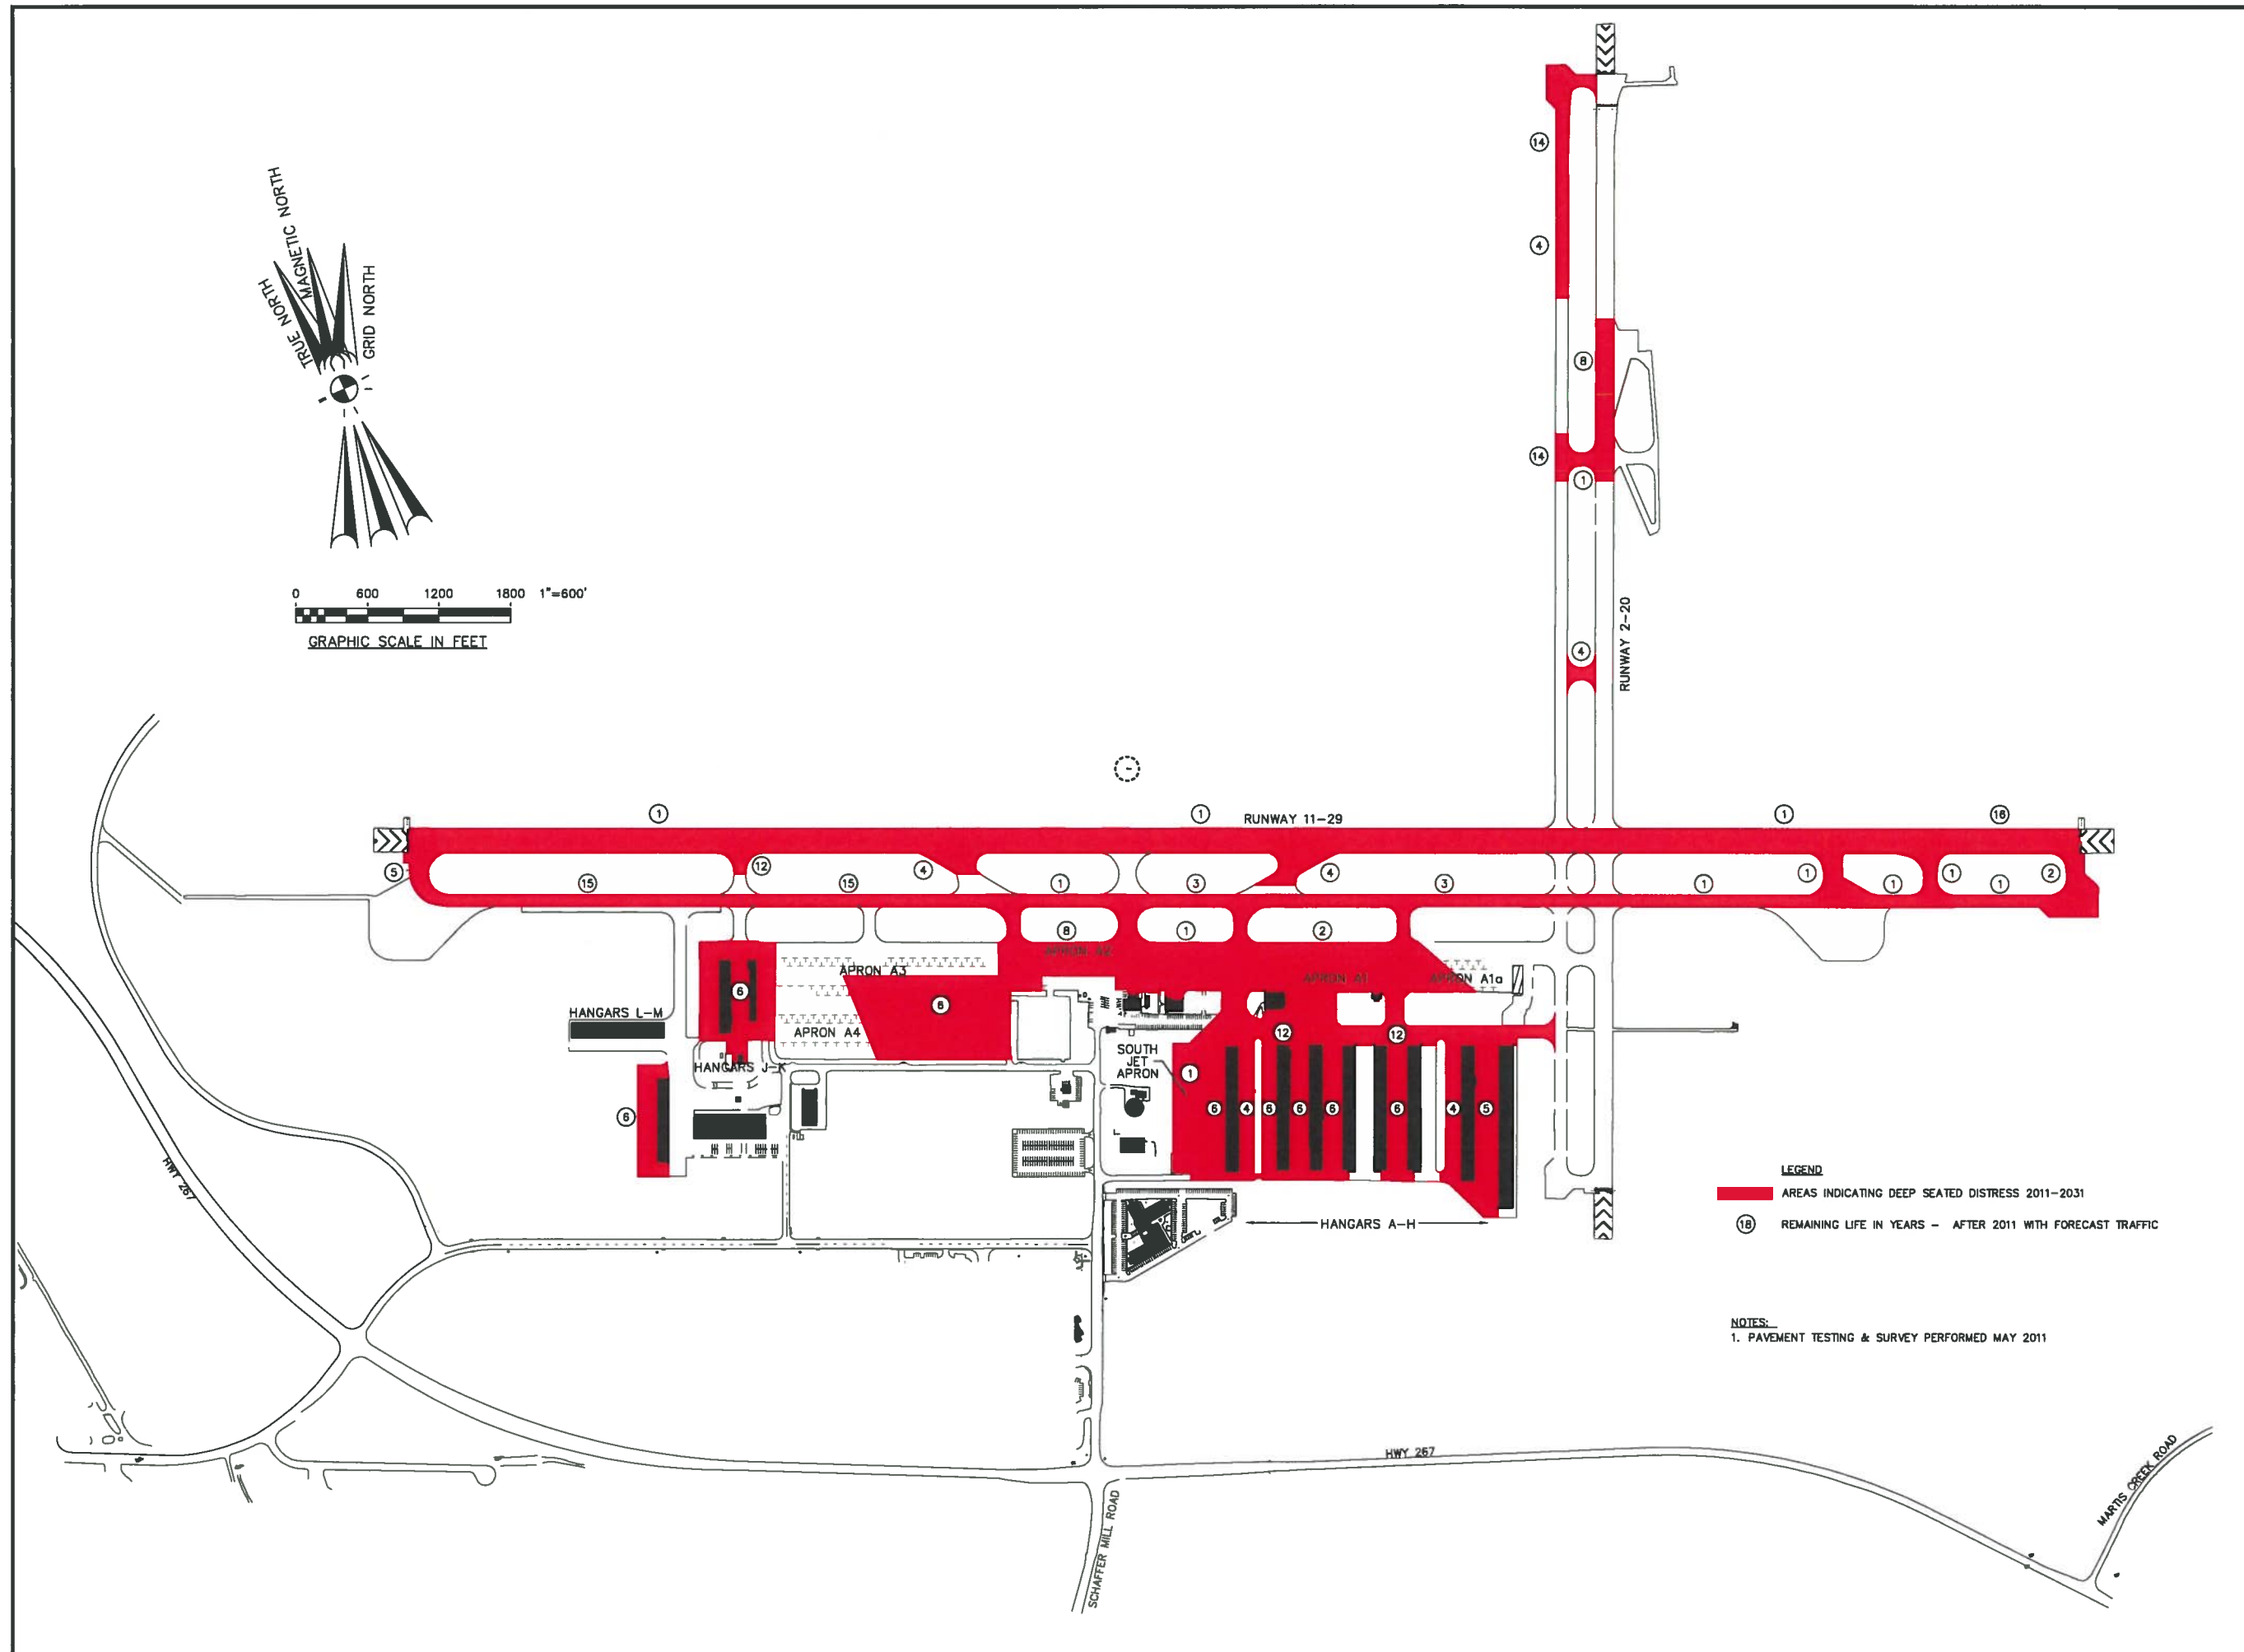
It will be noted that there are extreme differences in forecast pavement life between the Brandley Fatigue Analysis and FAARFIELD design. In most cases FAARFIELD’s forecast pavement life is much less than the Brandley Fatigue Analysis forecast pavement life, but in many instances the FAARFIELD forecast pavement life is significantly greater than the Brandley forecast pavement life. Noting these differences, a comparative study of the two systems was made on some airport pavements
