Project No. 41377A-01

July 9, 2013

Reference: *Truckee Tahoe Airport District Facilities Maintenance Master Plan*
10356 Truckee Airport Road
Truckee, California

Subject: *Geotechnical Engineering and Building Foundation Review Report*

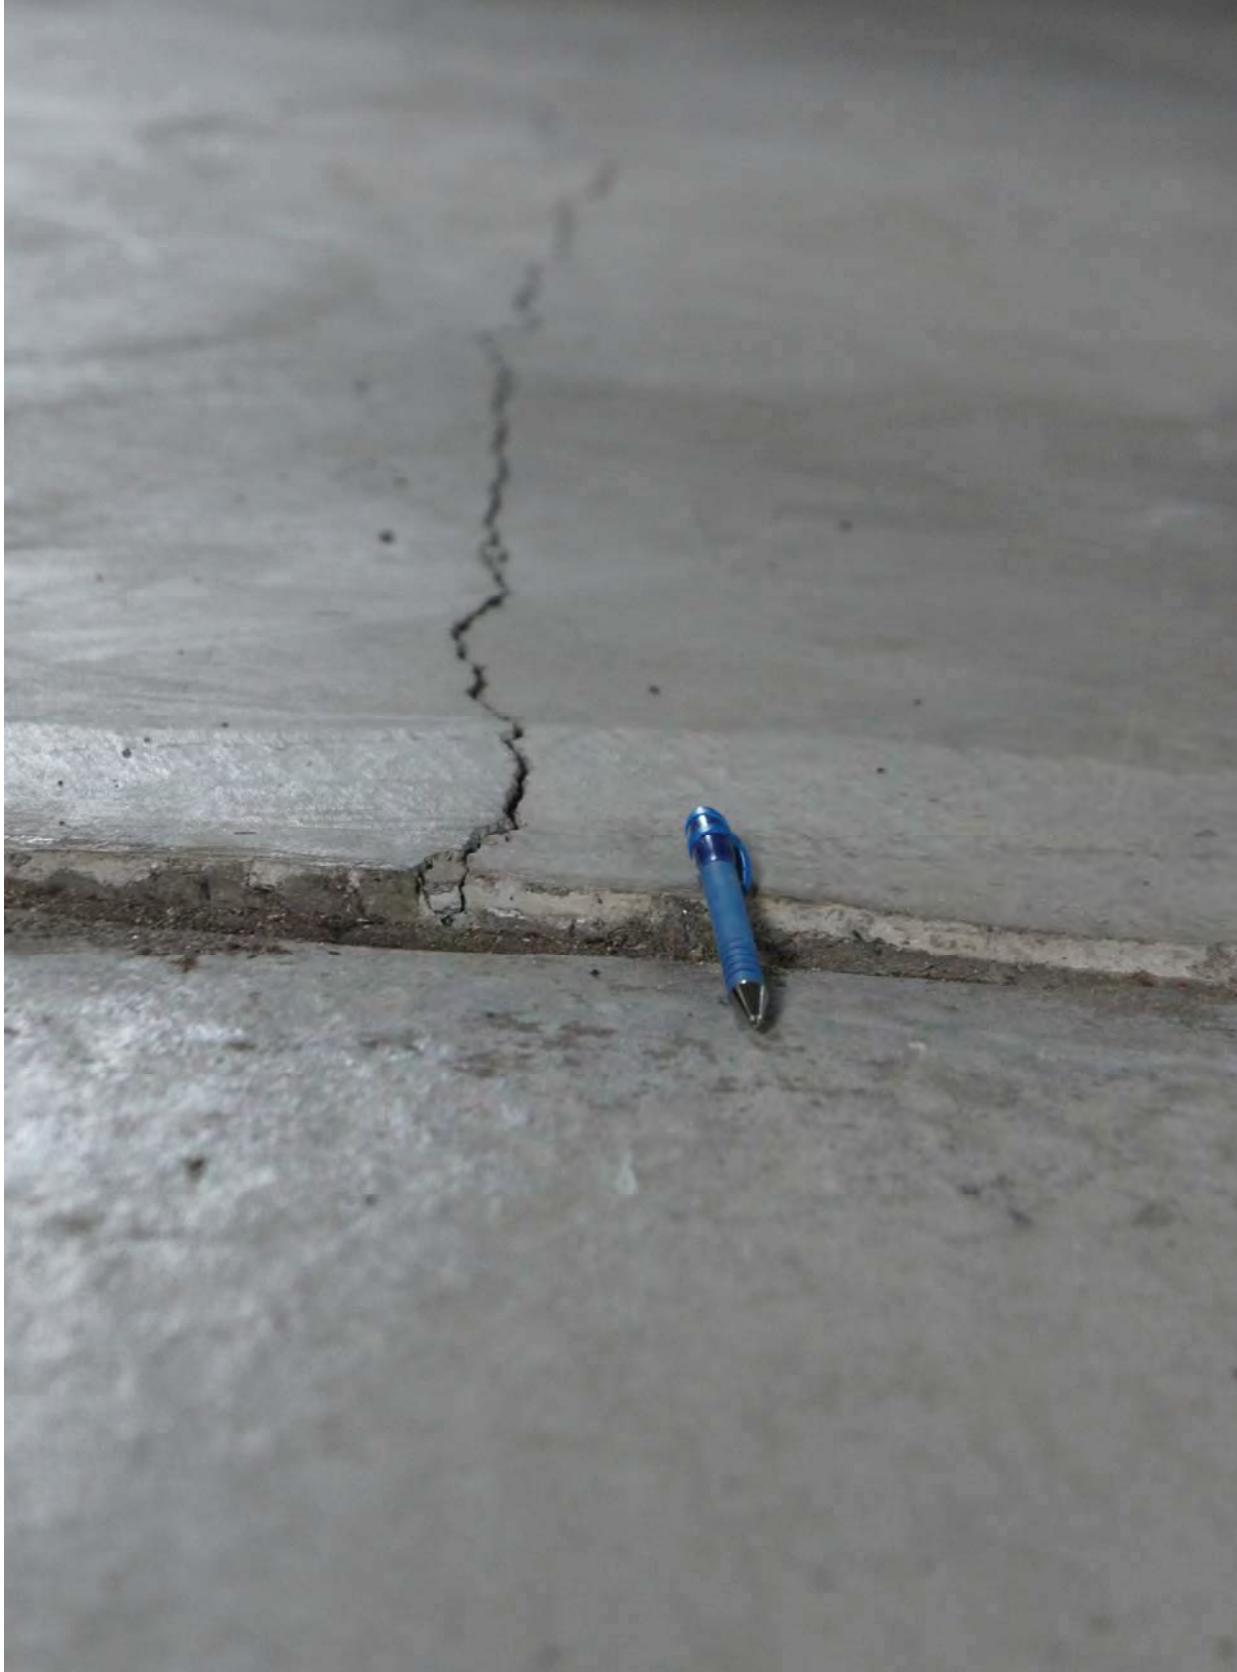
Photo #1: Heaving along expansion joint inside Hangar F (Building 13).

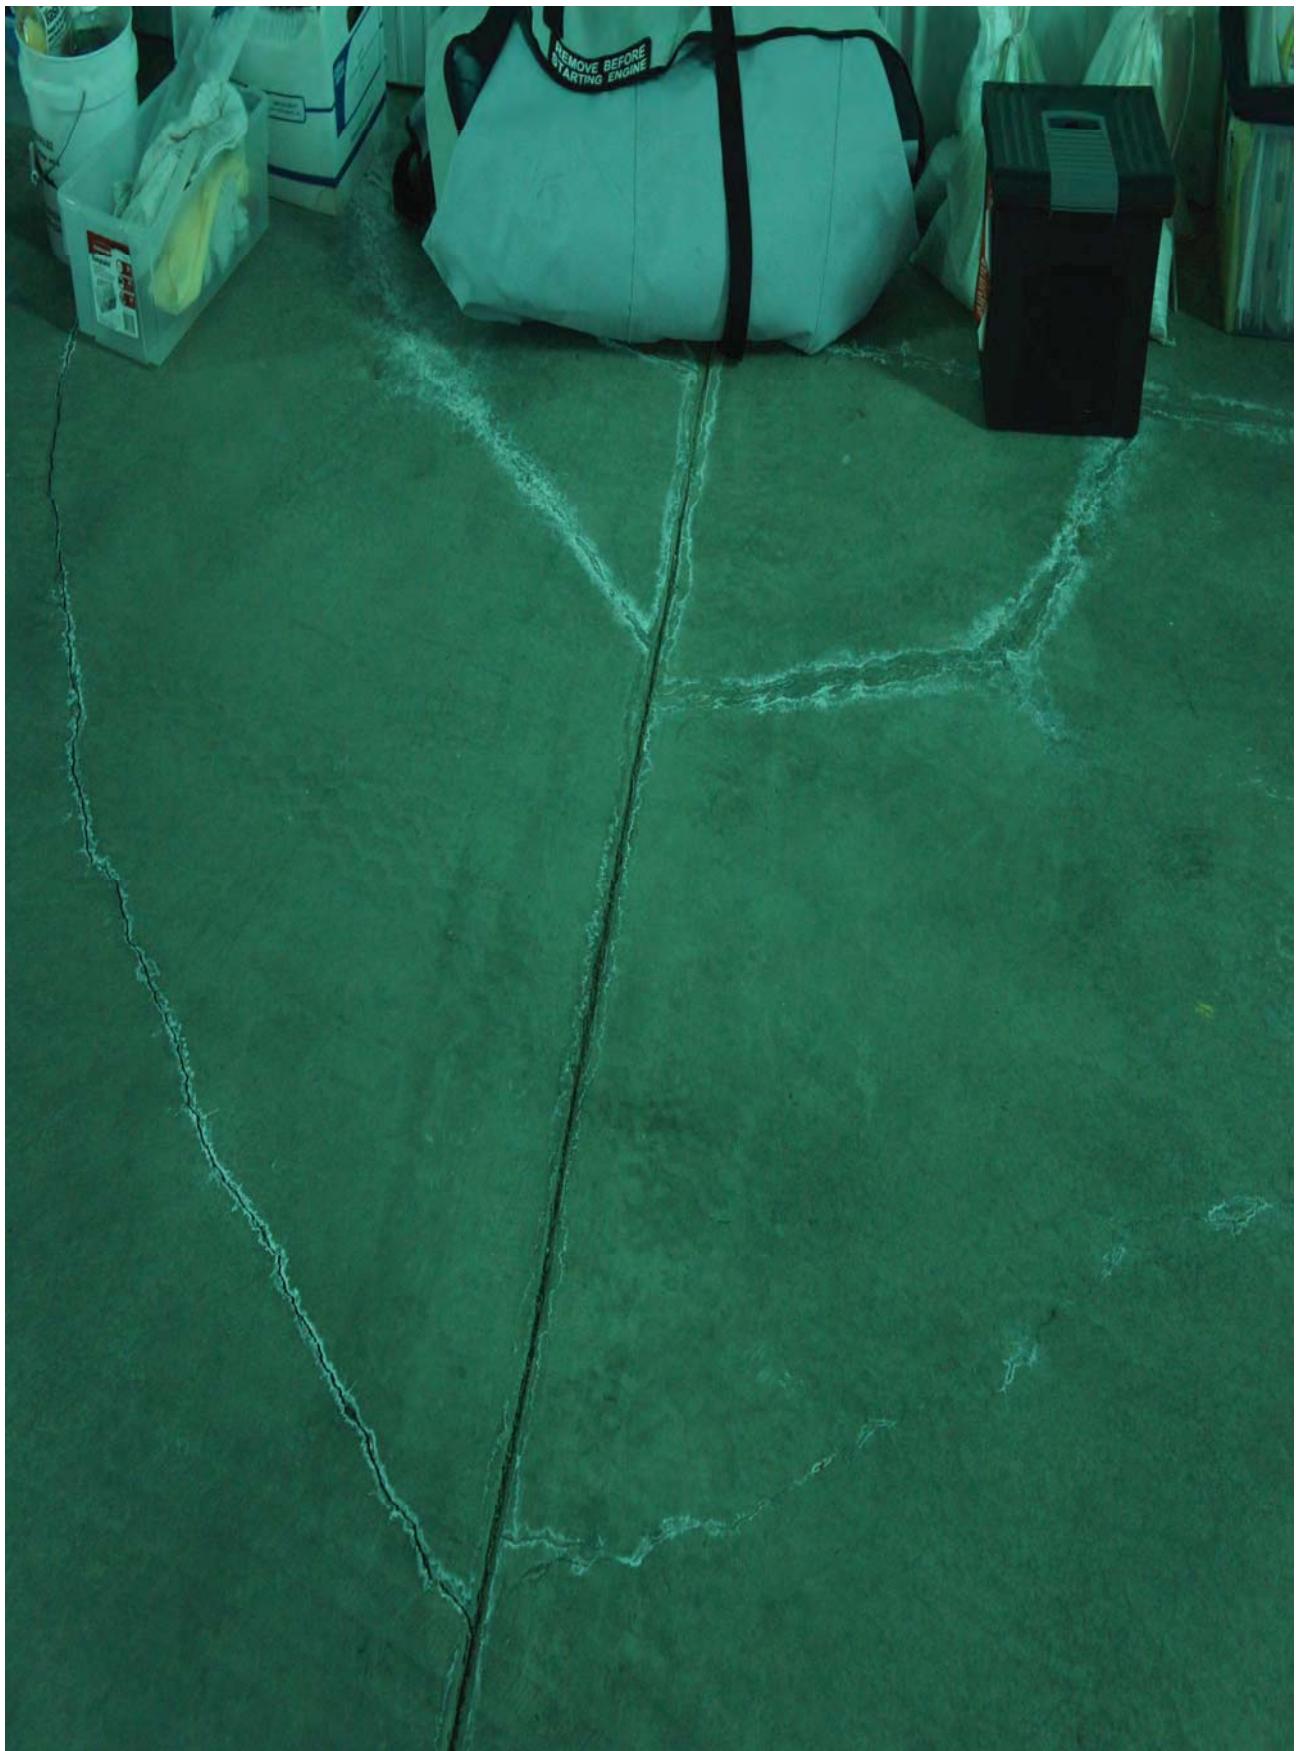
Photo #2: Cracking and moisture staining in slab in Hangar H (Building 15).

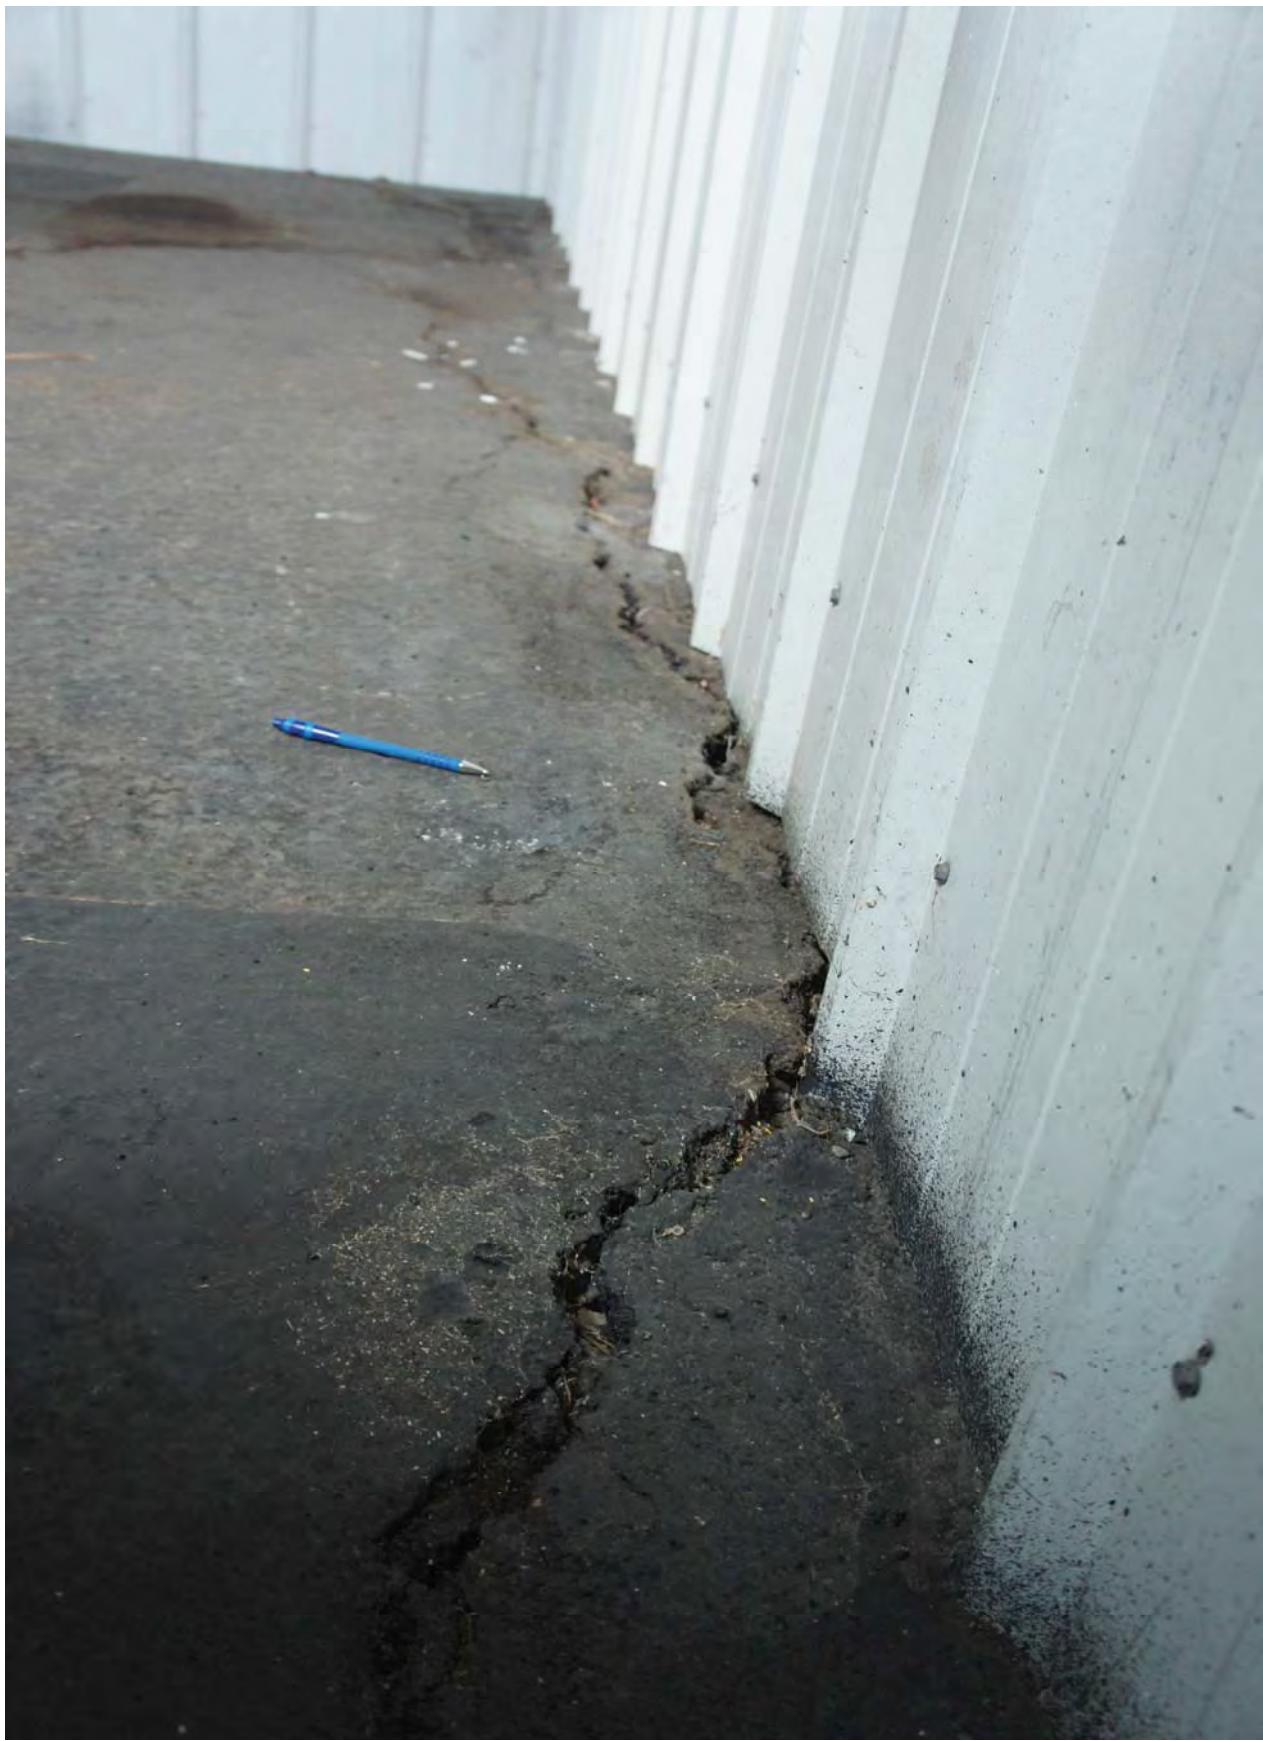
17	Hangar Row K	1981	Metal	IP (circular) with AC floor (o)	B-15 and B-16 (Stantec 2007)	Medium dense SM with gravel to 4 feet	NA	Low plasticity Cracking and settlement at pier. AC patching. Minor to mod. Slab cracking.

Photo #3: Cracks in asphalt concrete floor inside Hangar K (Building 17). AC is at or above the metal siding level.

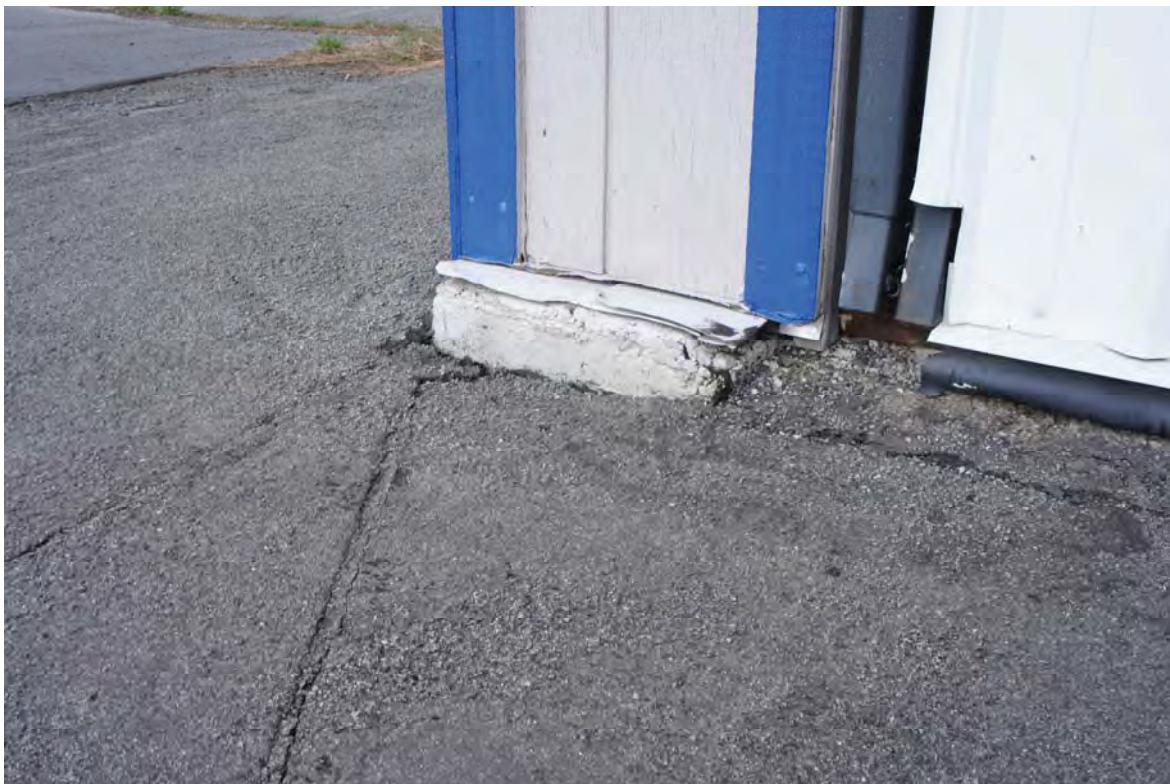
Photo #4: Perimeter footing at the EAA structure (Building 21).

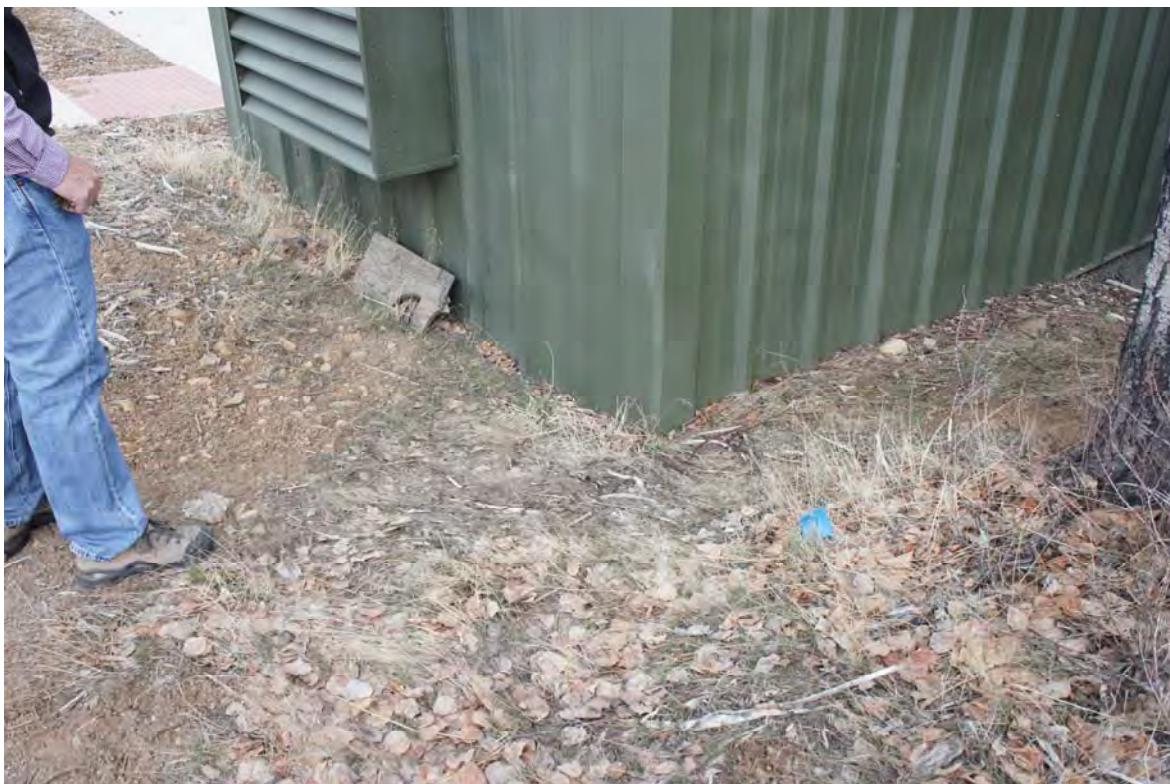
Photo #5: Subgrade soil higher than foundation at generator (Building 22).
