Re: Truckee Tahoe Regional Airport
Facilities Maintenance Plan

The following is our preliminary report concerning the review of the 25 existing structures and recommendations for a short term (1-5 years) maintenance plan. A long term (5-20 years) maintenance plan was requested, but in this case, if the 5 year plan is followed, there will be minimal maintenance required for the following 15 years, thus we have not provided long term maintenance plan. We have numbered the buildings according to site map provided by your office.

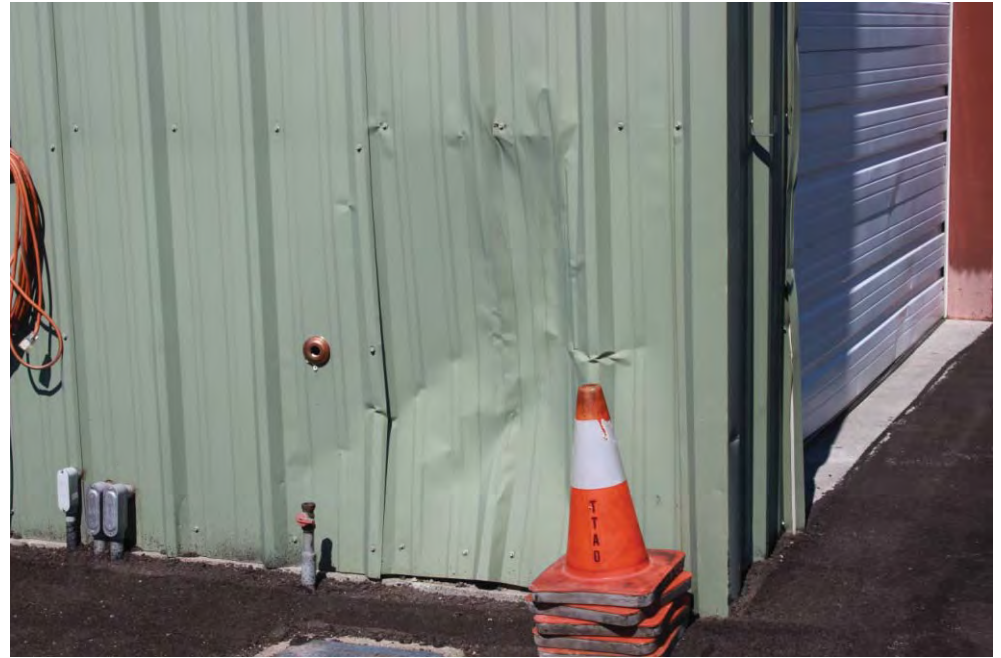
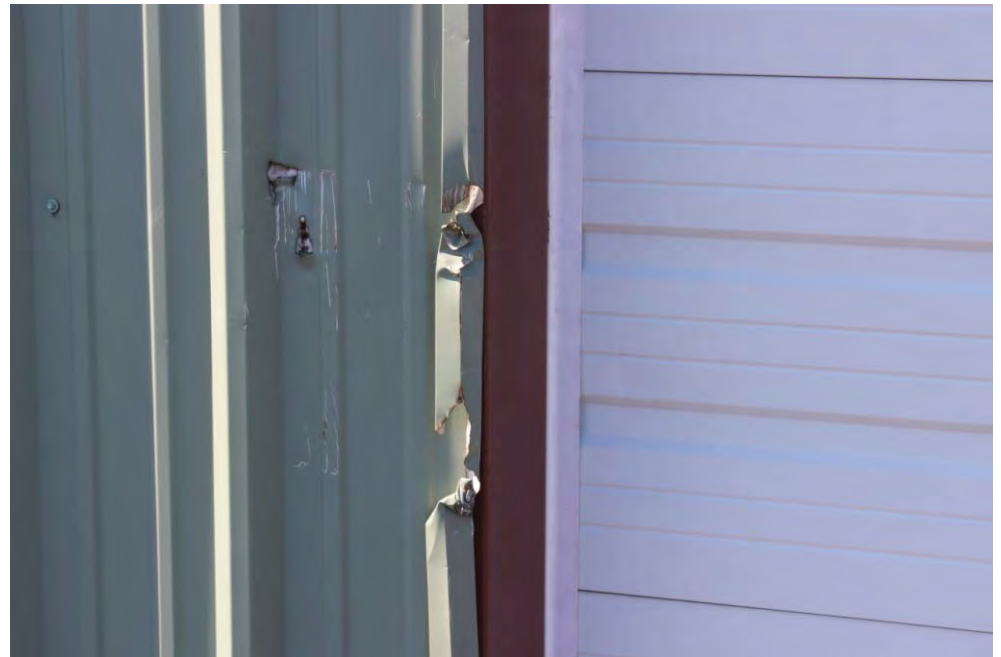
Building 6 – (Garage) - 1991. There is a gash in the rear southwest corner of the building corner trim. There is a big dented panel in the front northeast corner from some kind of impact. The roof screws are an old style of screw with neoprene washers. They will probably leak within 5 years.

5 Year maintenance: Replace all screws with shielded screws. Repair the southwest rear corner trim and replace the northeast lower section of wall panel that has been severely dented.

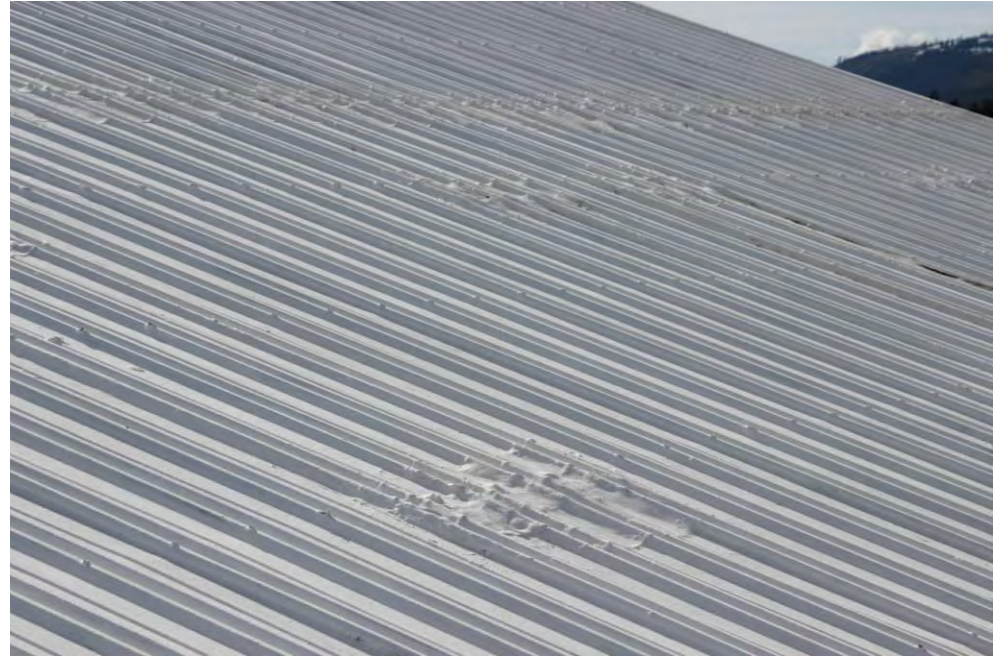
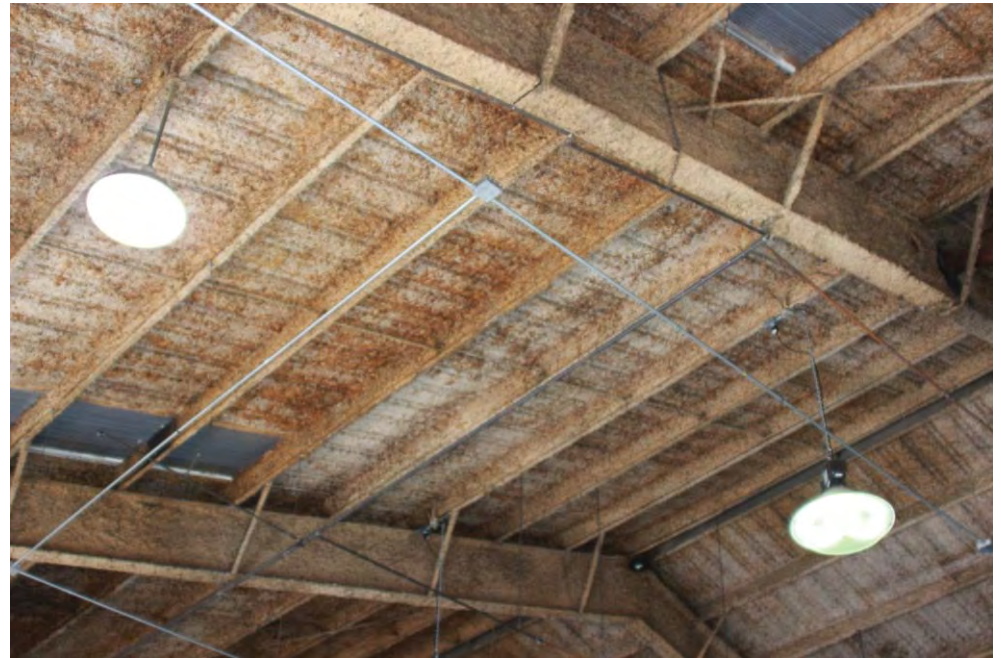
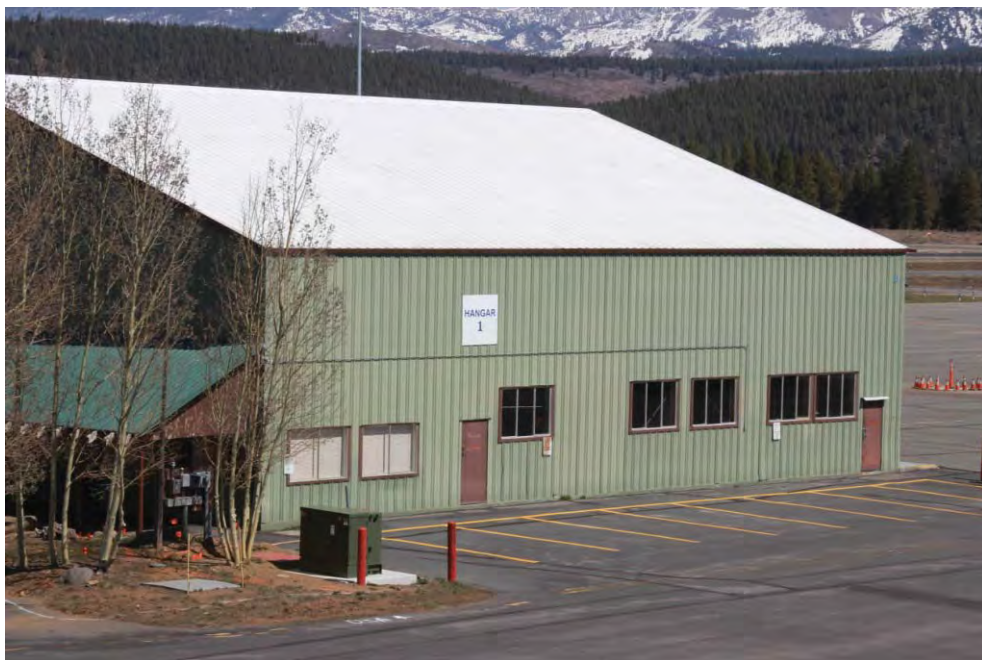
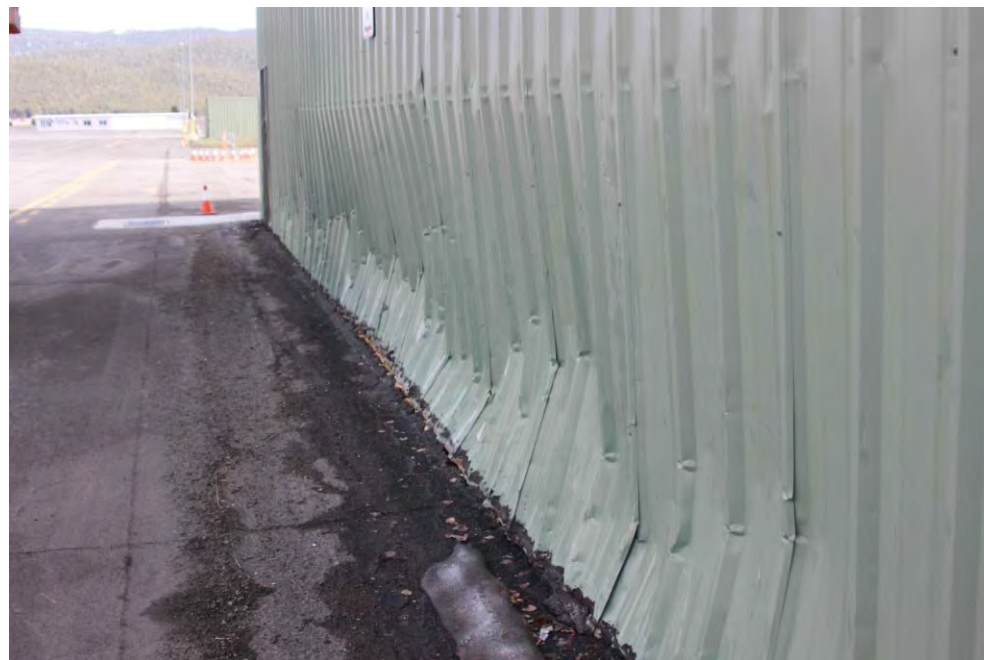
Building 5 – (Hangar 1) - 1963. This is the oldest metal building at the airport. There is a lower section of metal panels on a wood roof on the west side of the building. The interior of the building is coated with a fibrous material probably for insulation purposes. It should be tested for asbestos or other deleterious substances as it is exposed to the interior finish space. The roof panels on this

building are near the end of their useful life. There are numerous patches. It has already been coated and the screws topped.

5 Year Maintenance: Remove and replace existing roof panels as soon as possible.

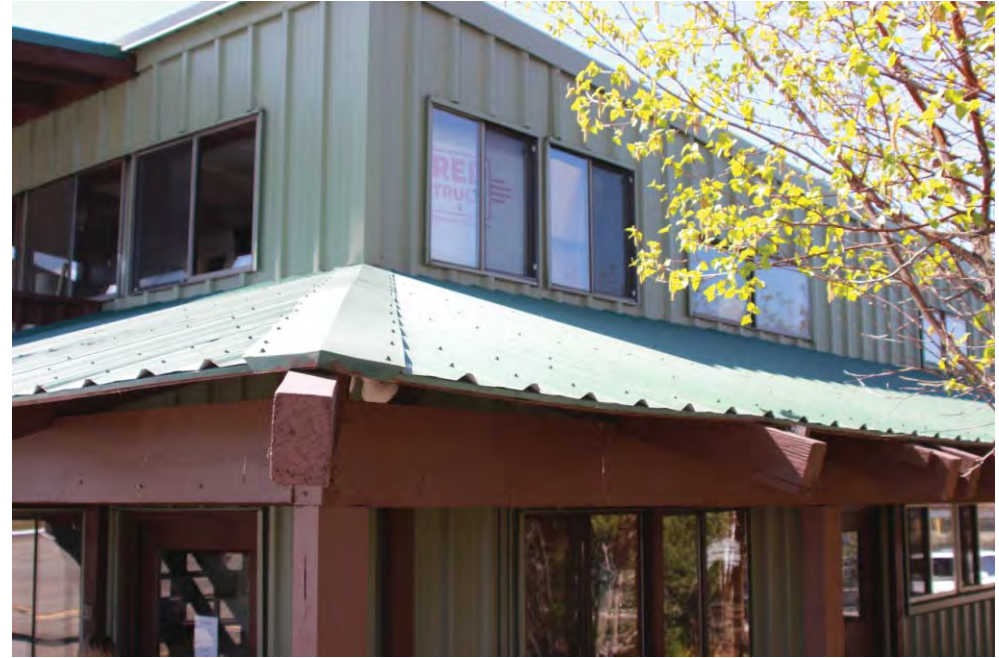
Building 4 – (Hangar 2) - 1966. This is a metal building with a lower section on the south side of wood framing. The condition of the main and low roof looks good.

5 Year Maintenance: Replace screws on lower roof.

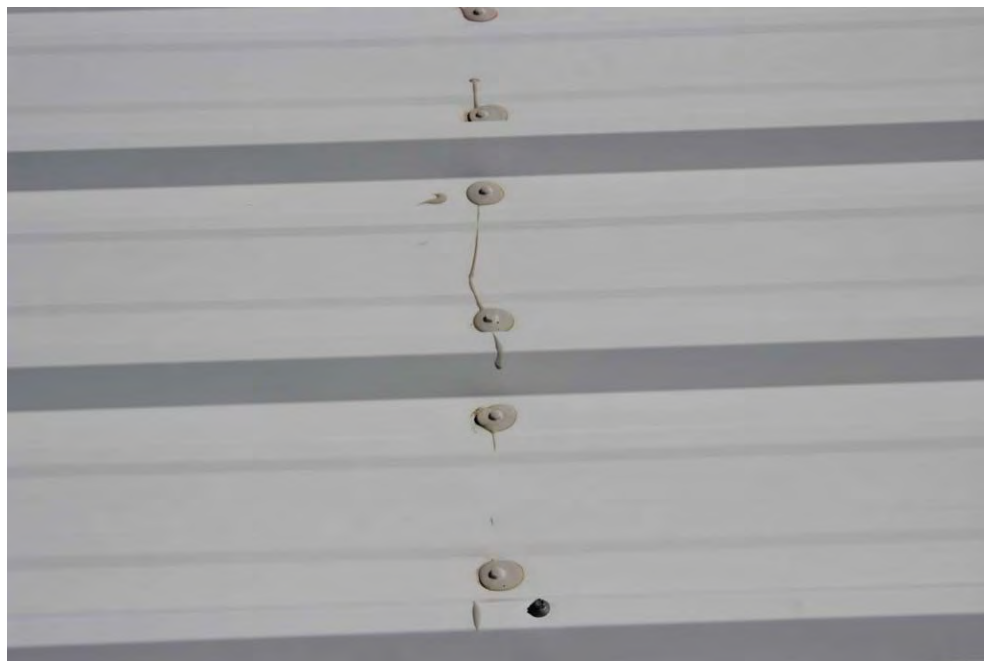
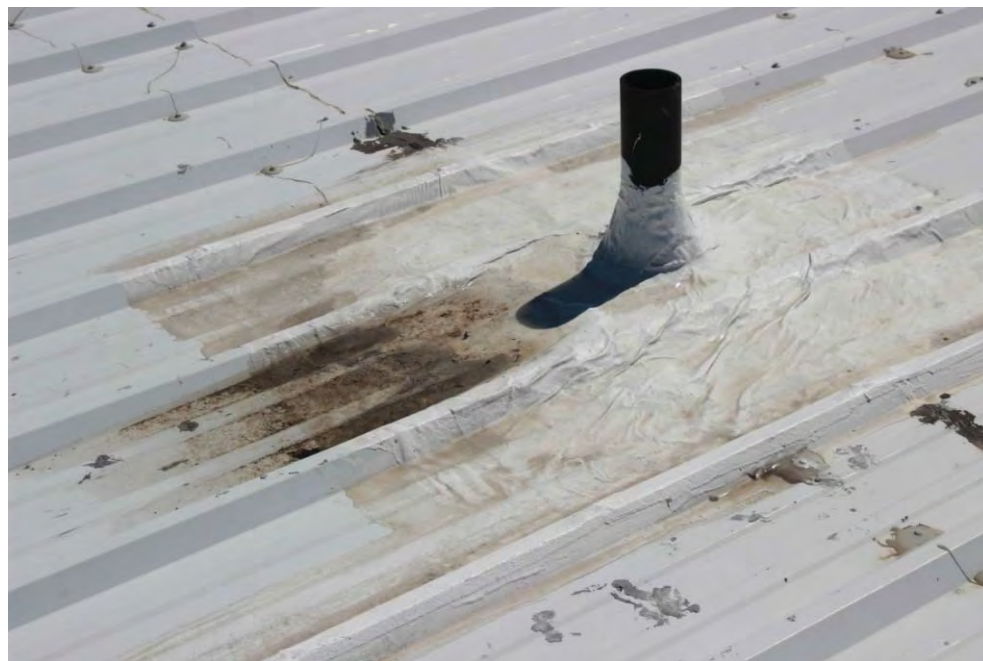
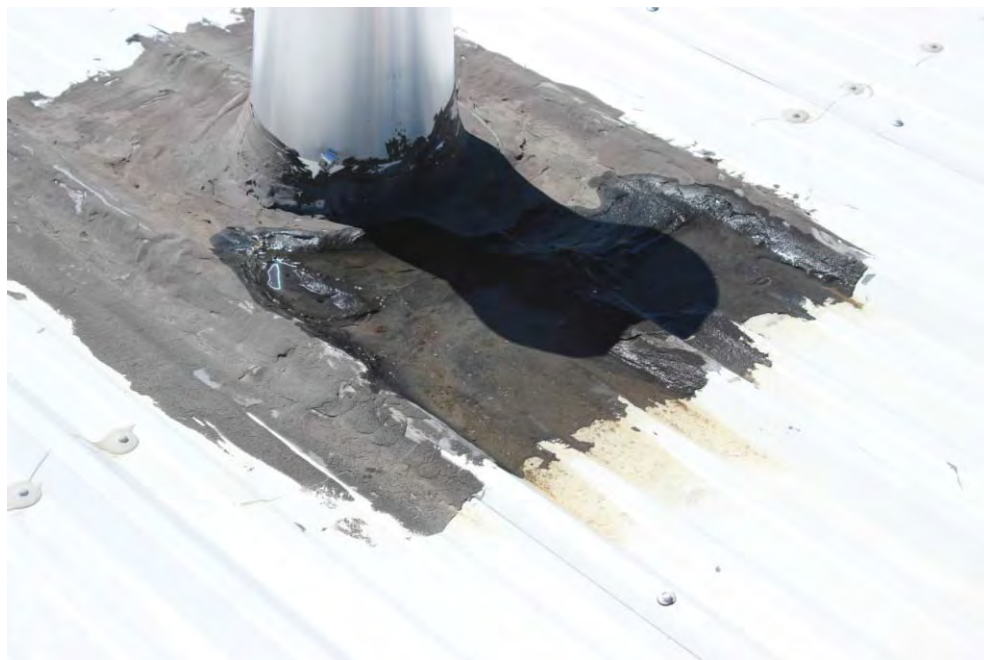
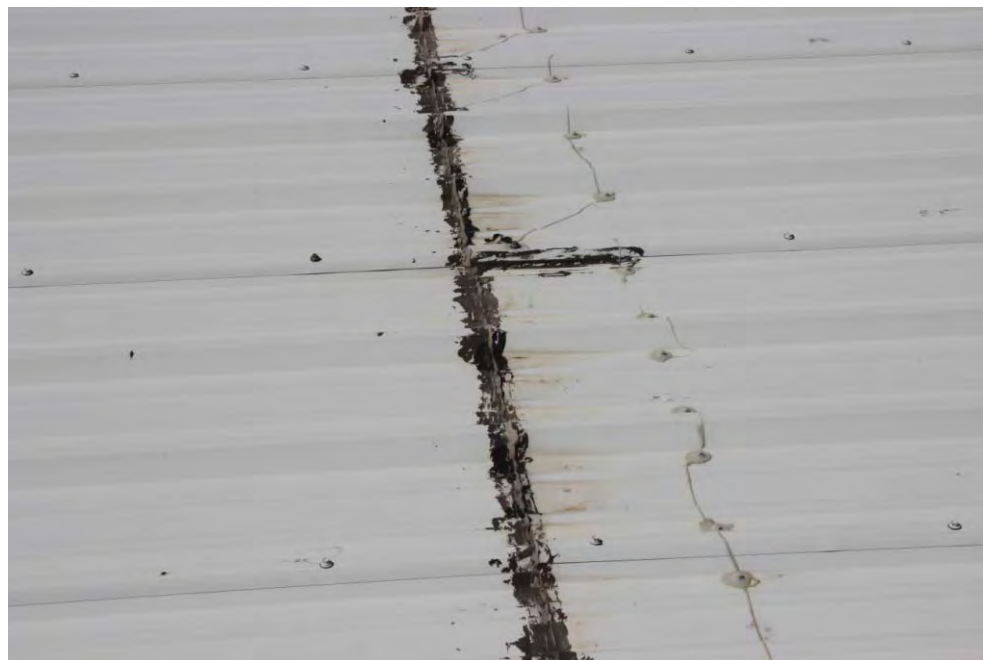
Building 3 – (Maintenance Building) - 1998. The screws on this building have already been topped. Ridge screws appear to be over tightened and are not topped. The flashing on the roof penetrations dam water on the high side such that it does not drain. An ineffective sealant (black jack) has been used and its use should be discontinued.

5 Year Maintenance: Top ridge screws, extend roof penetrations flashing coatings up two purins so that water ponds on coating and not flashing. Redo all black jack sealants with an effective coating system.

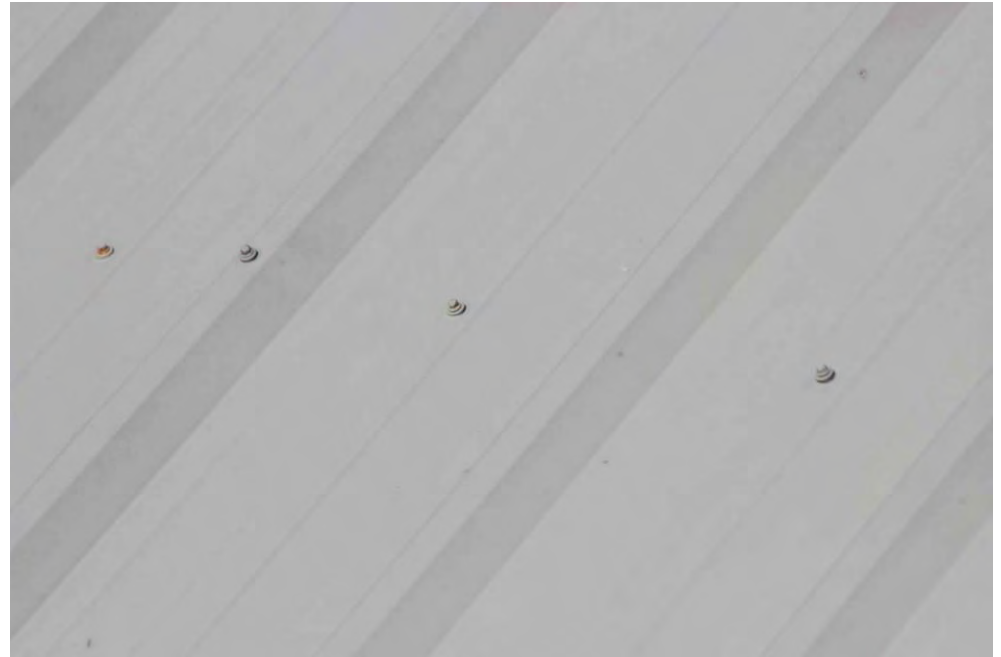
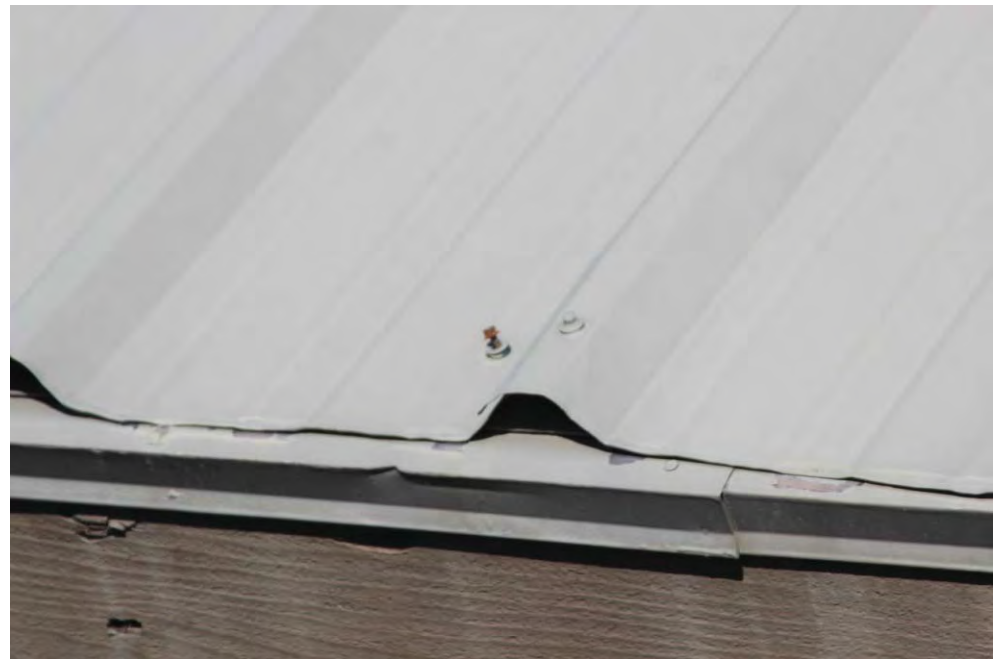
Building 1 – (West Side Modular) - 1991. This is a wood framed building with metal roof panels screwed to the wood framing. Many of the screws are backing out.

5 Year Maintenance: Replace all wood screws with shielded wood grip screws. Maintain the wood exterior siding with timely application of a quality exterior paint.

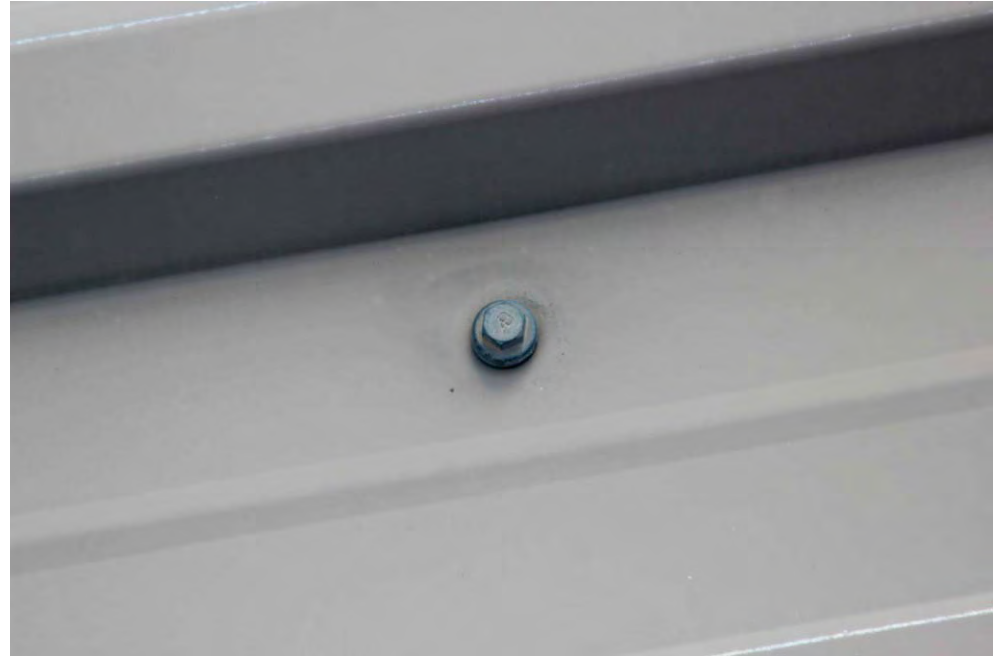
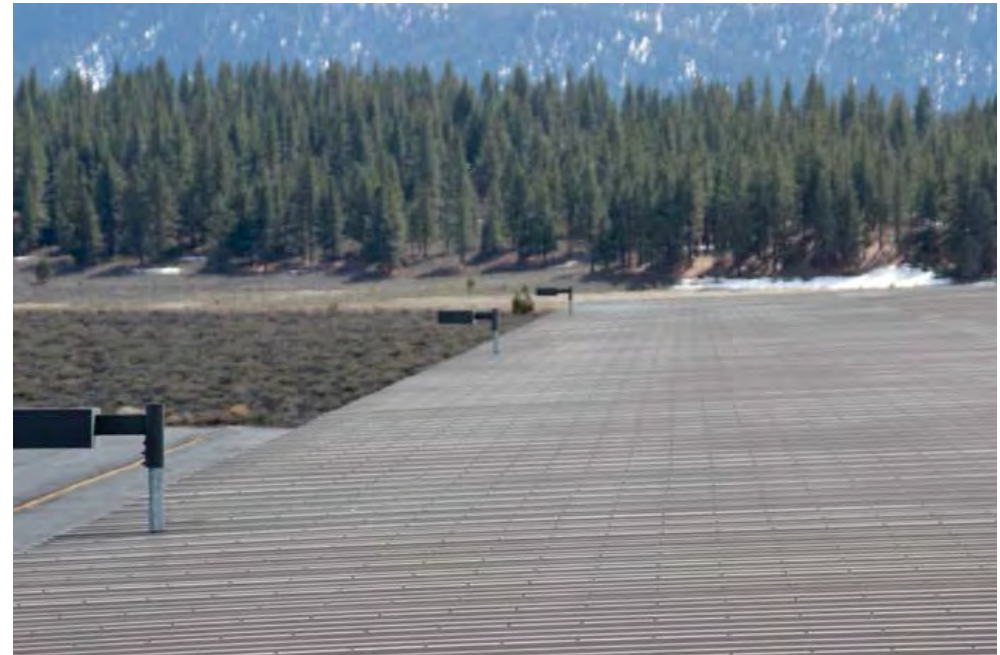
Building 14 – (Hangar G) - 1988. This roof appears to be in good condition and has been installed with newer type shielded screws.

5 Year maintenance: Replace selected screws as they fix leaks.

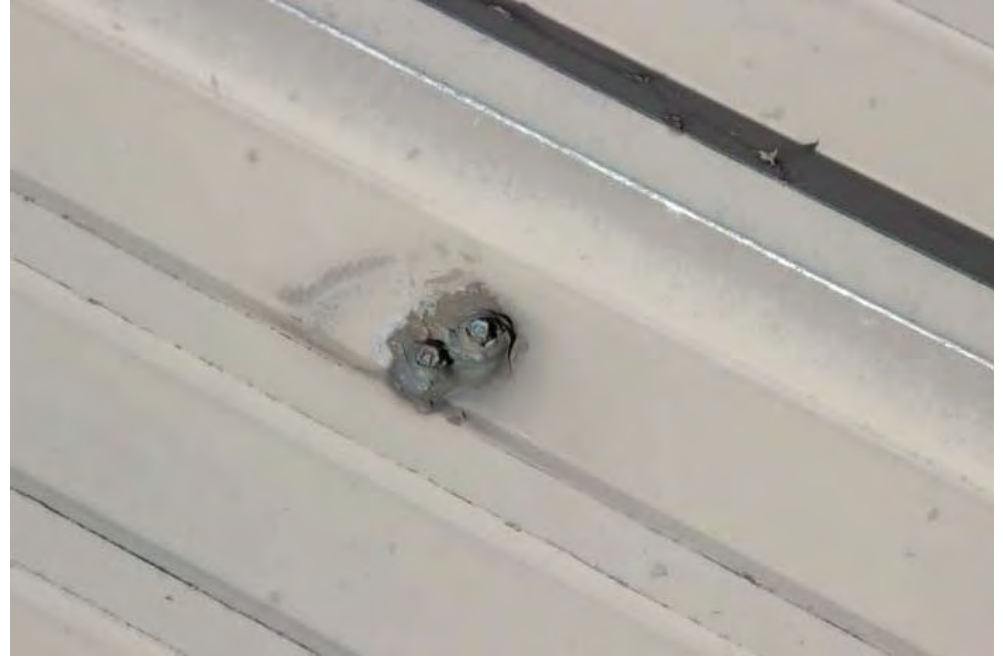
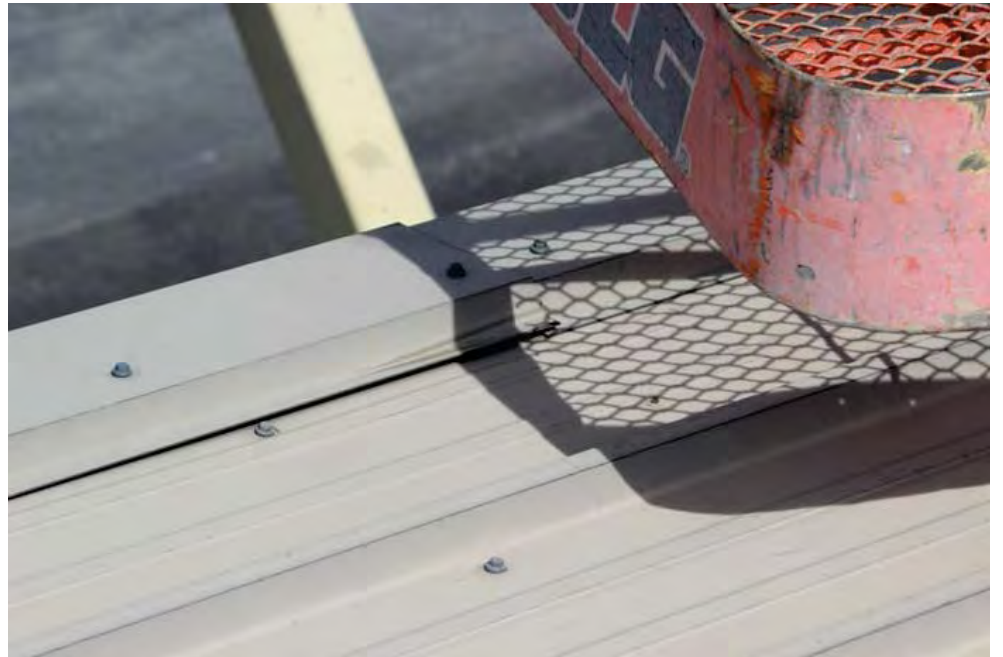
Building 13 – (Hangar F) - 1987. This roof is in much better condition that Building C and D with regards to the enamel finish. There is some evidence of rusting at the screw heads and some screws have been caulked. The edge trim at the north end of the building is loose in one small area.

5 Year Maintenance: Replace selected screws as they fix leaks.

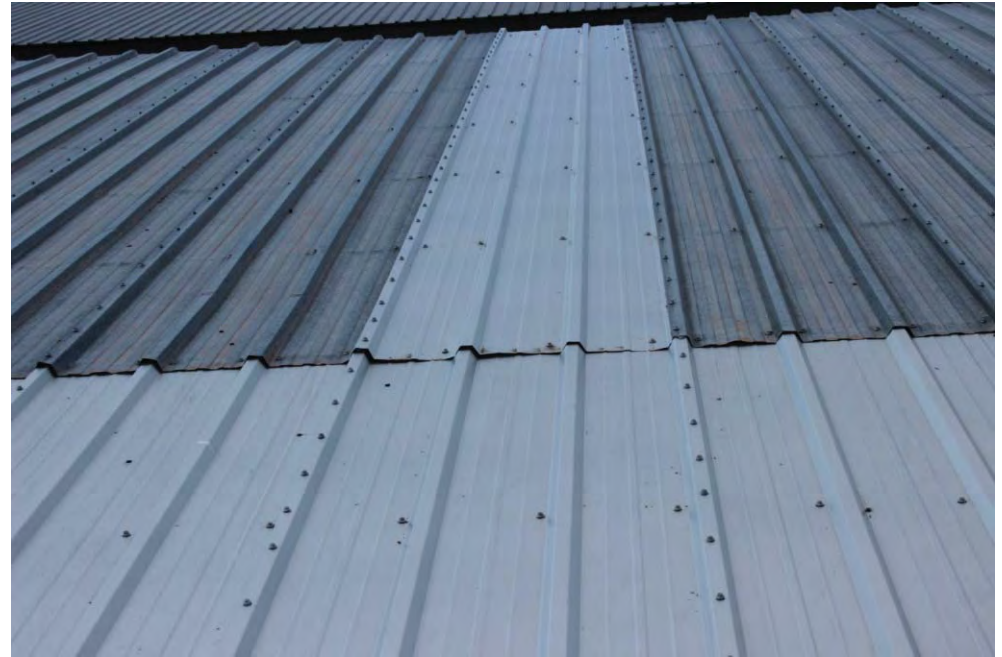
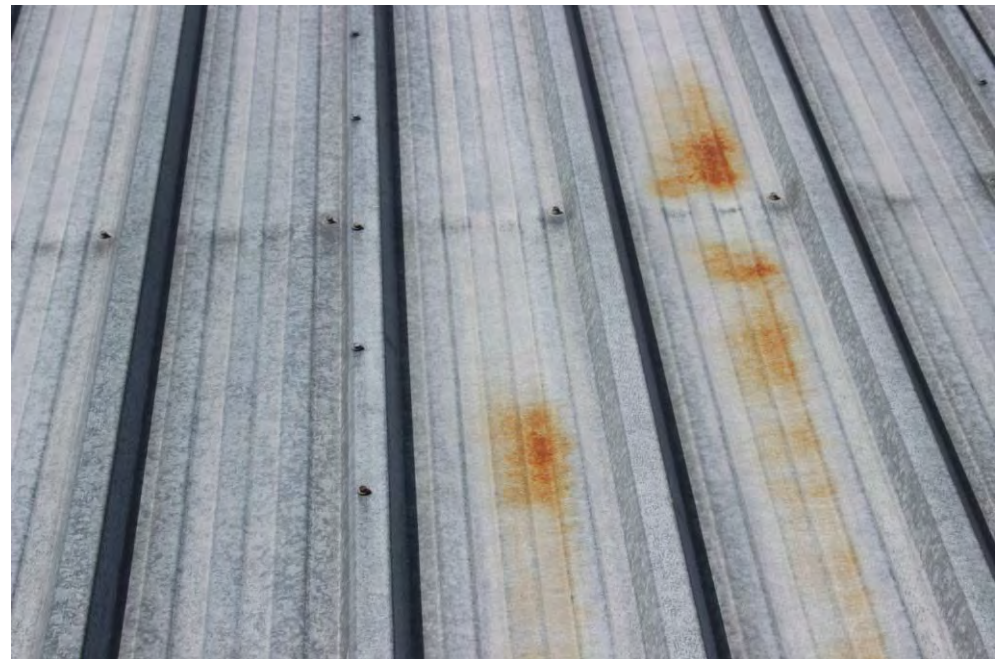
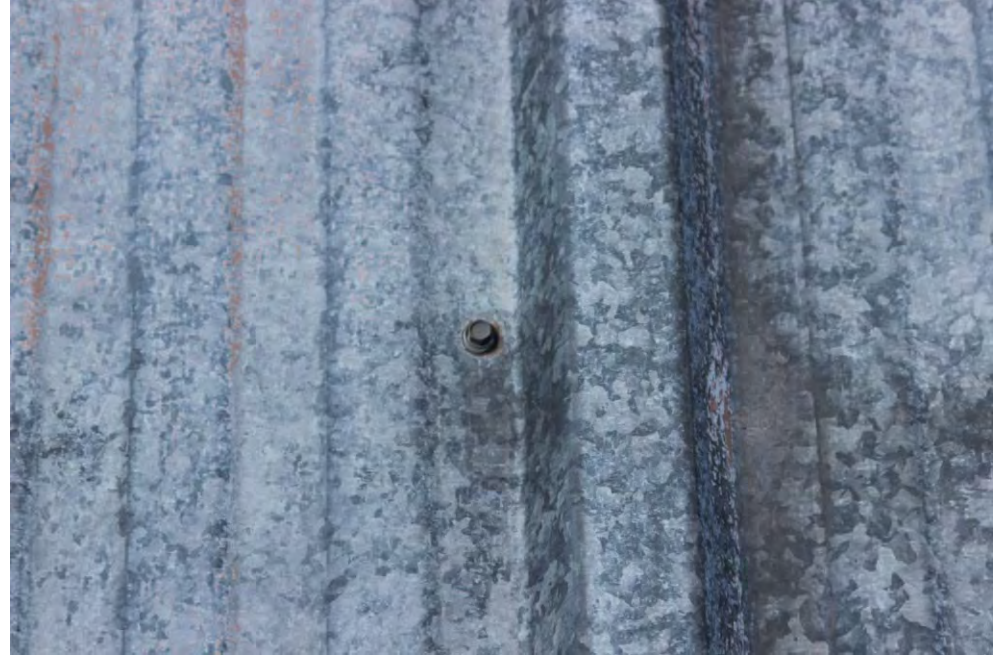
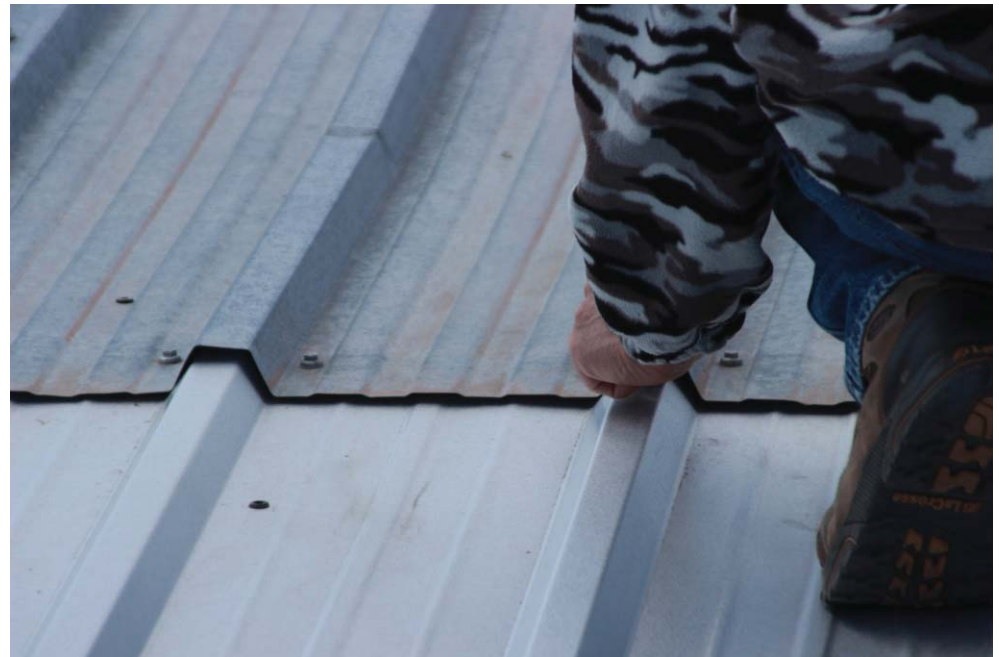
Building 12 – (Hangar E) - 1981. The building is the same age as Building 11 and the roof panels are essentially in the same condition. The enamel coating is completely gone. The washers below the screws show numerous signs of disintegration. Rust spots are visible on the surface of the panels. See comments for Building 9 and 11. These panels are rapidly reaching a point where replacement may be the only long term option.

Additionally, the roof was struck by a small plane last summer and a large repair was installed at the damaged area. The repair was poorly done. New panels were only installed on the lower half of the building instead of from eave to ridge. There is a large gap showing at the seam between the new and existing panels.

5 Year Maintenance: Replace all screws. Consider applying a coating system to extend the life of the panels. Flash all light pole penetrations with Deck Tight rubber boots. Rework the large patch to eliminate the gap between the existing and new panels.

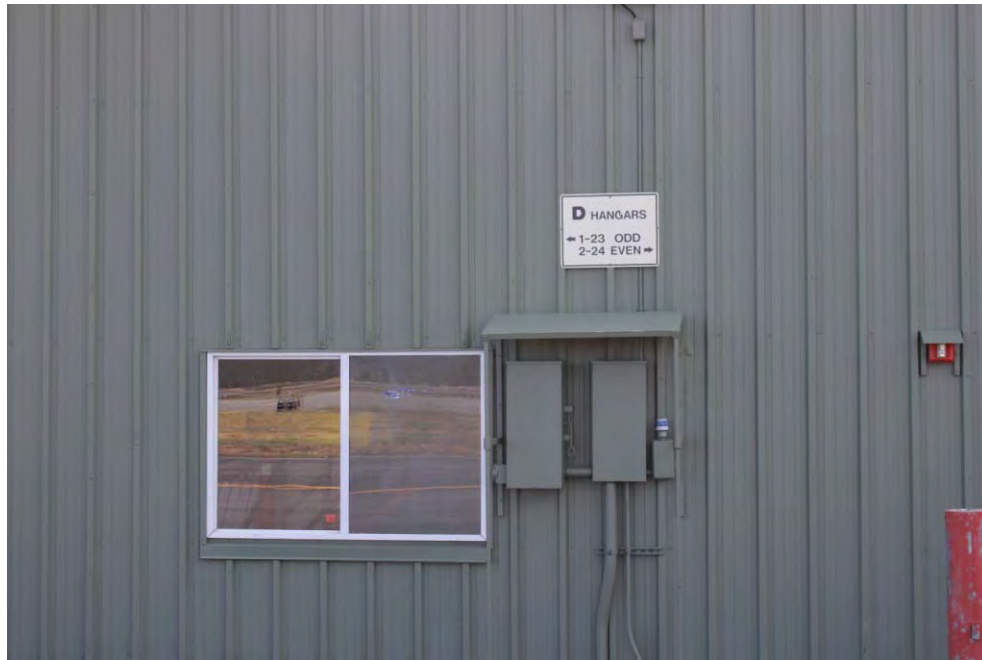
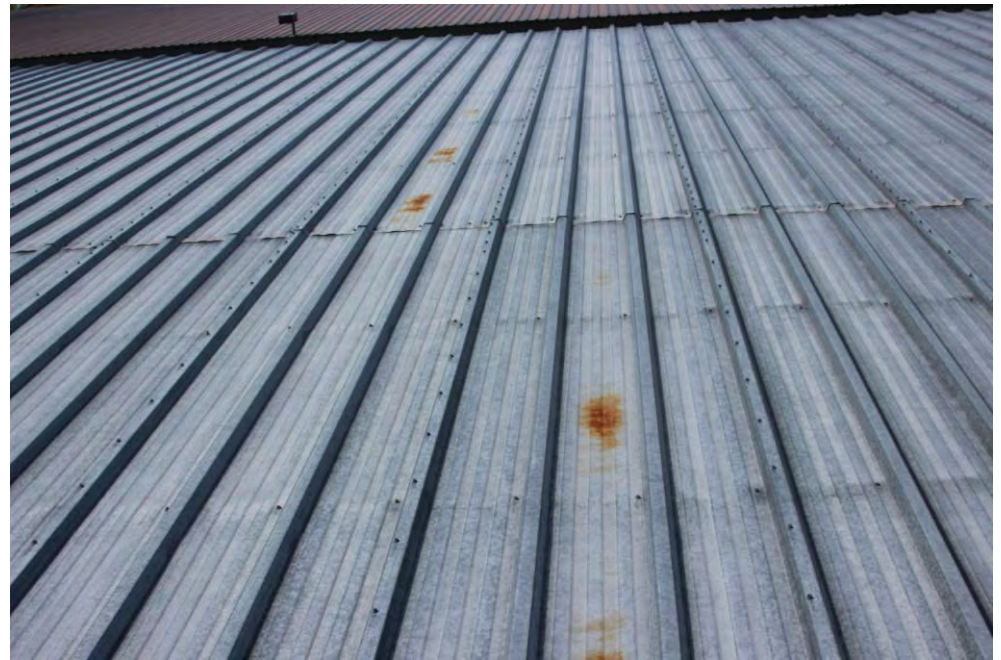
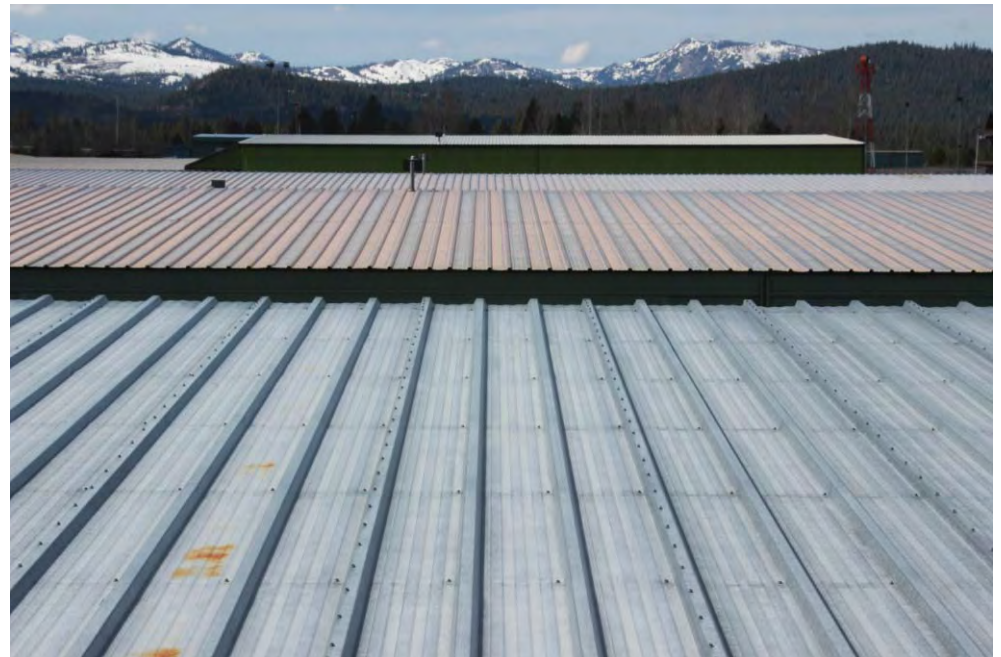
Building 11 – (Hangar D) - 1981. – This building is noted on the site map as constructed in 1981 and thus is five years younger than Hangar C, however, the roof panels appear to be the oldest in the east side row of hangars. There is no enamel coating visible except at the eaves. Rust areas are quite visible on some of the panels. See comments for building 9. This roof is rapidly reaching a point where replacement may be the only long term option.

5 Year Maintenance: Replace all screws. Consider applying a coating system to extend the life of the panels. Flash all light pole penetrations with Deck Tight rubber boots.

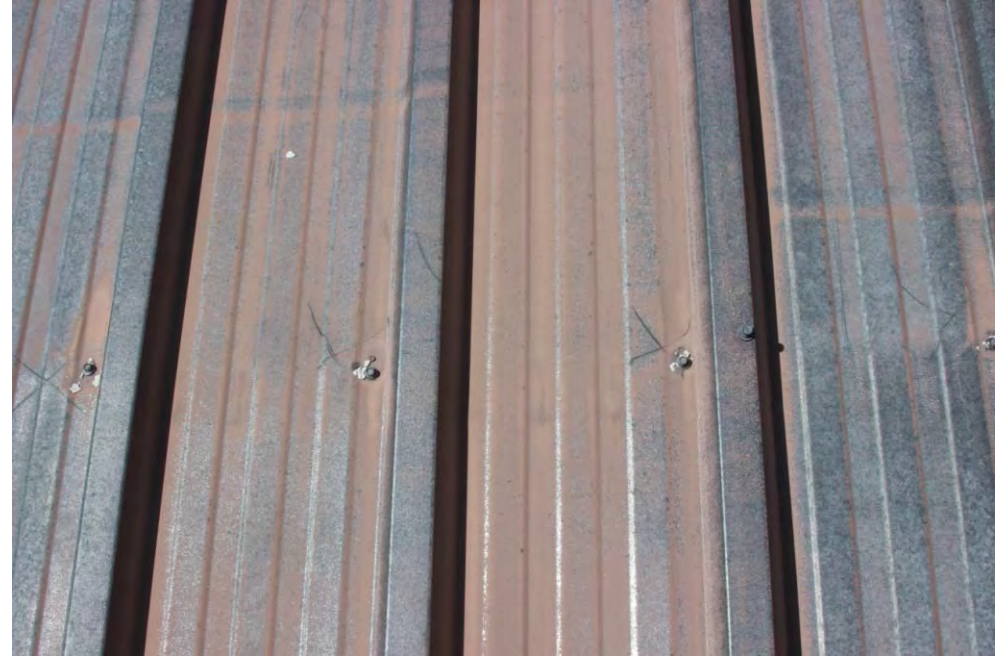
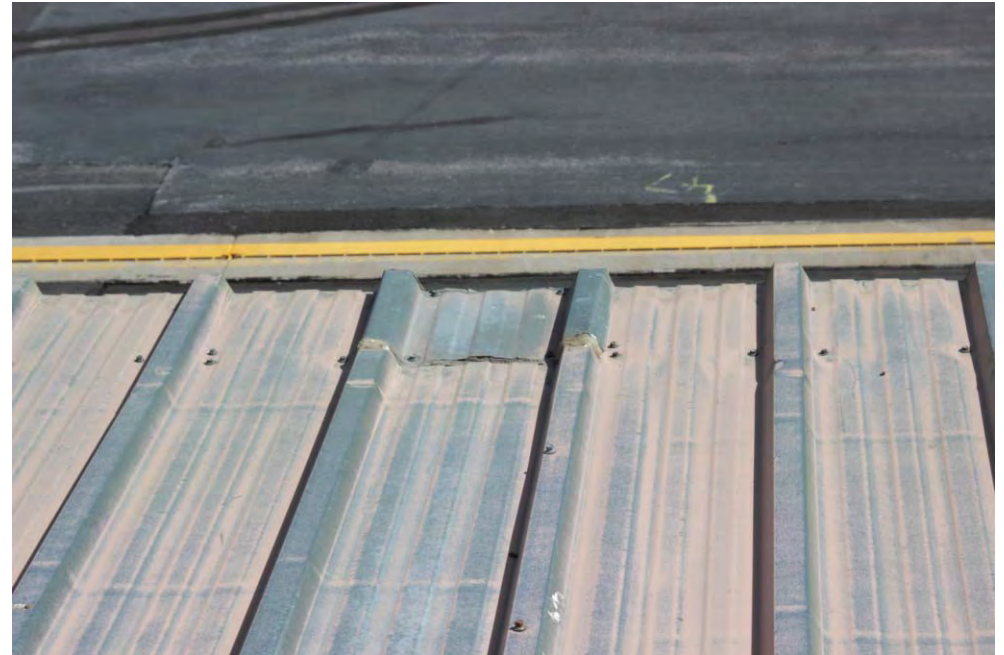
Building 10 – (Hangar C) - 1976. This is the oldest building in the east side row of hangars. The enamel coating has disintegrated. See comments for building 9. This building has reported numerous leaks so many of the screws are no longer functioning.

5 year maintenance: Replace all screws. Consider applying a coating system to extend the life of the panels. Flash all light pole penetrations with Deck Tight rubber boots. There is a roof panel small patch at the north side of the building that needs to be redone.

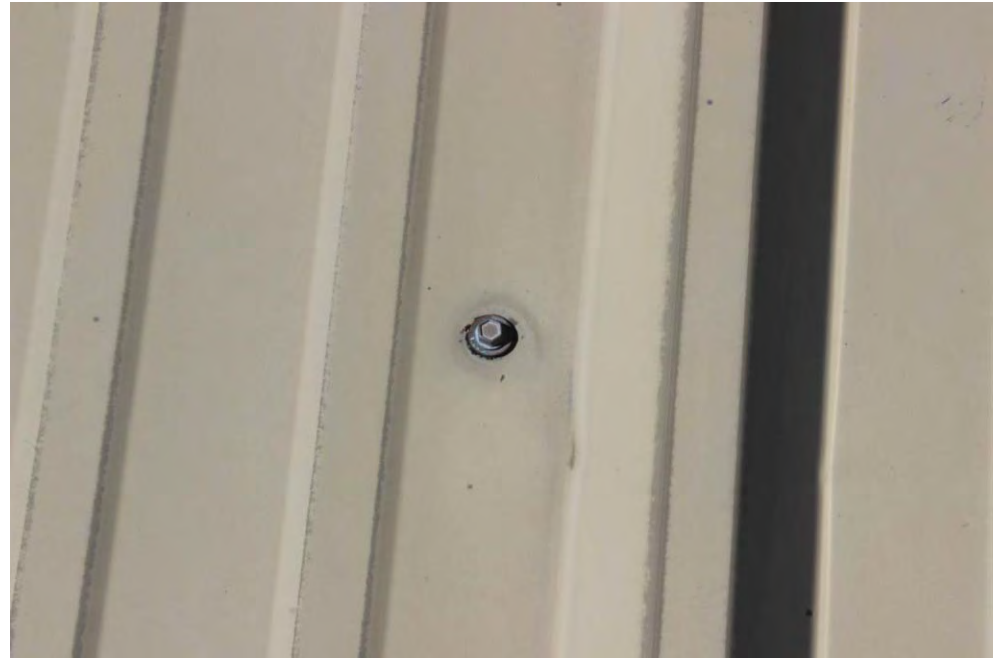
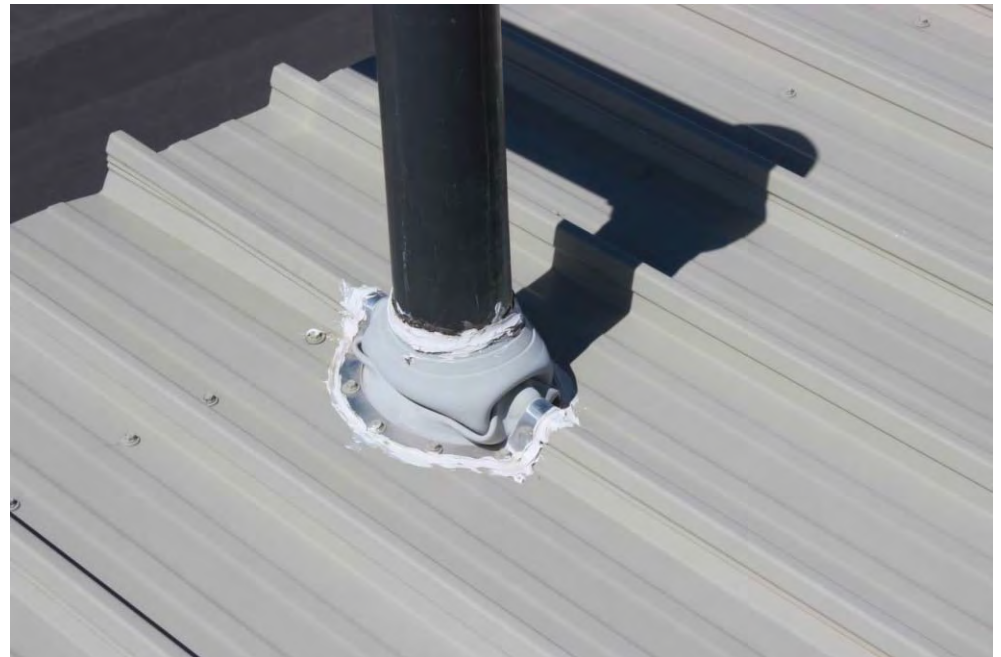
Building 8 – (Hangar A) - 1984. This building has a high and low roof section. The enamel coating on the roof panels is still in reasonable condition. Old style screws were used with this roof and some appear to be over tightened with washer disintegration. The light pole roof penetrations were caulked with black jack mastic which is ineffective for the long term. This situation occurs at all east side hangars A thru H.

5 Year Maintenance: Replace all screws with shielded screws. Flash light pole penetrations with Deck Tight rubber boots.
