Re: Truckee Tahoe Regional Airport
Facilities Maintenance Plan

The following is our preliminary report concerning the review of the 25 existing structures and recommendations for a short term (1-5 years) maintenance plan. A long term (5-20 years) maintenance plan was requested, but in this case, if the 5 year plan is followed, there will be minimal maintenance required for the following 15 years, thus we have not provided long term maintenance plan. We have numbered the buildings according to site map provided by your office.

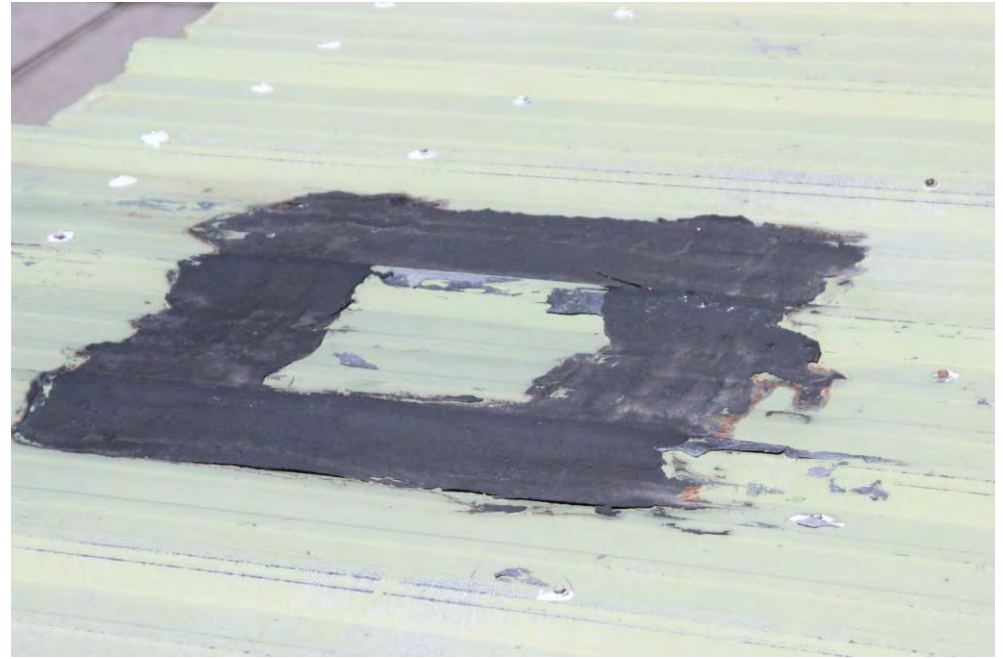
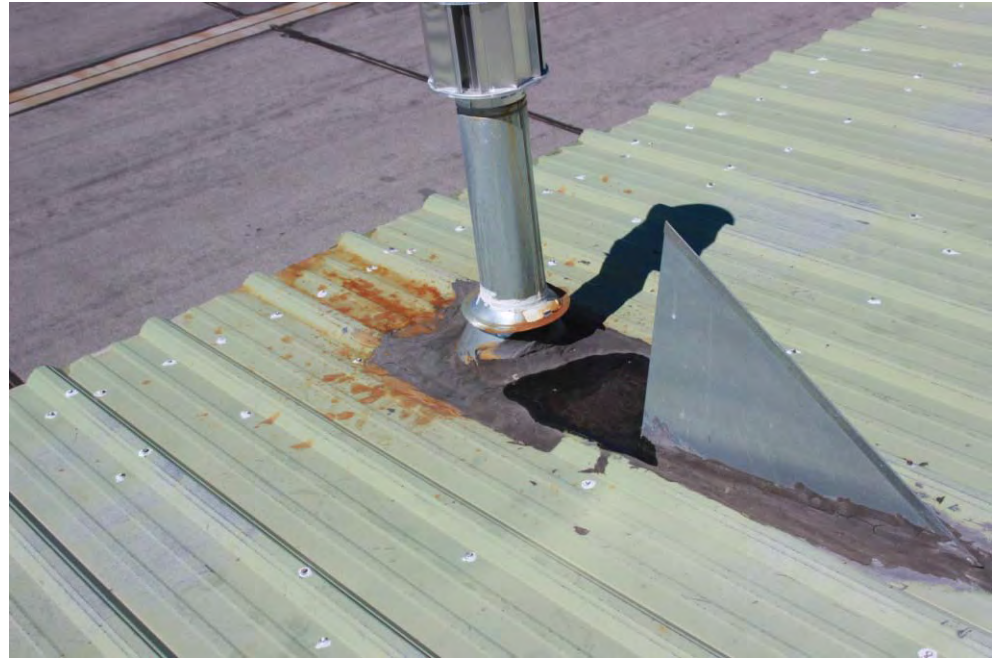
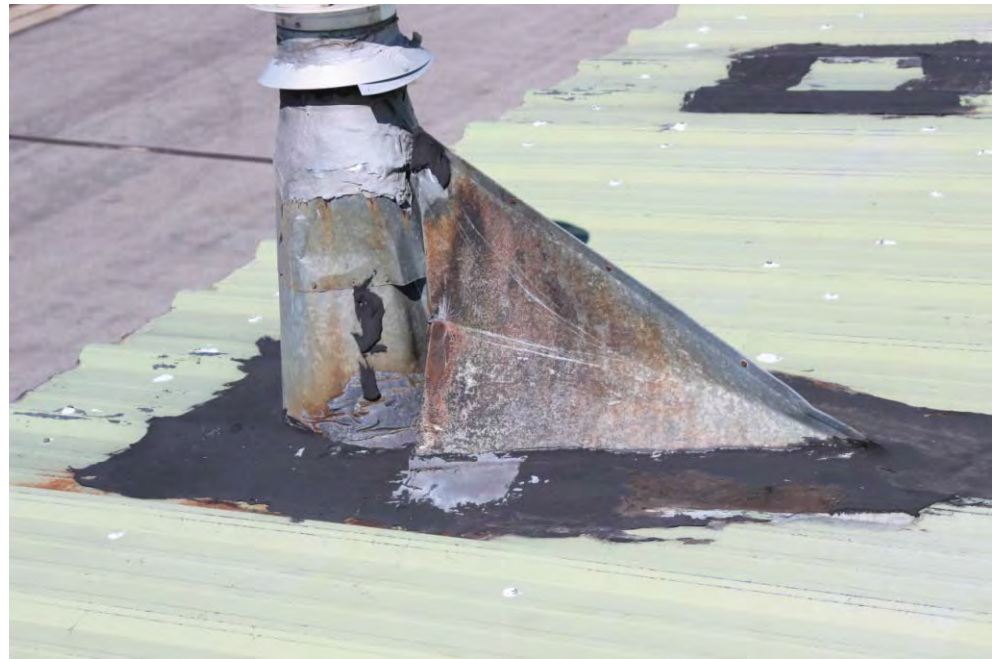
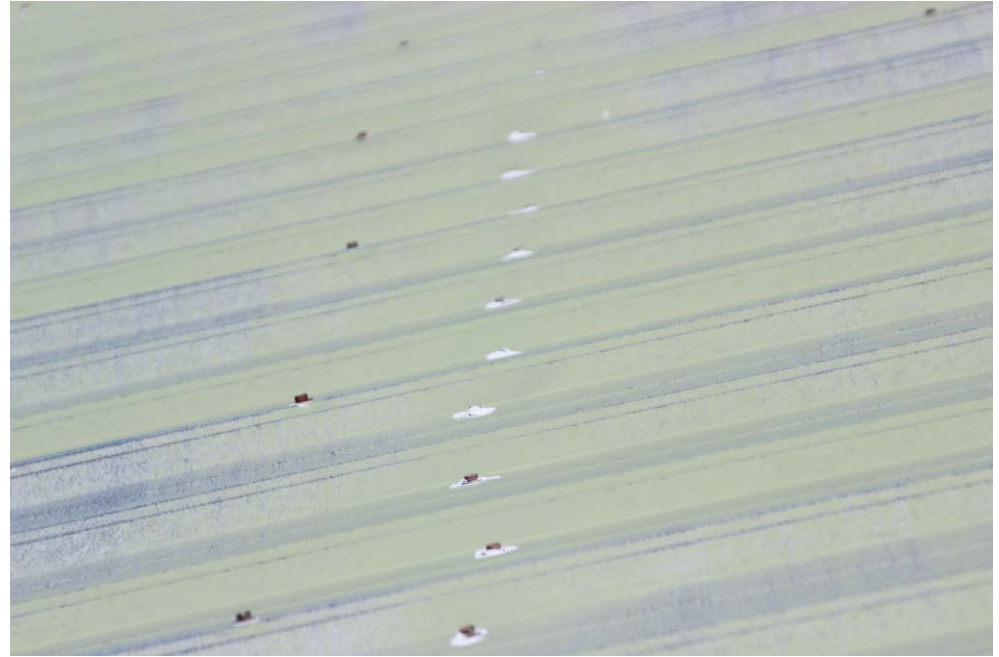
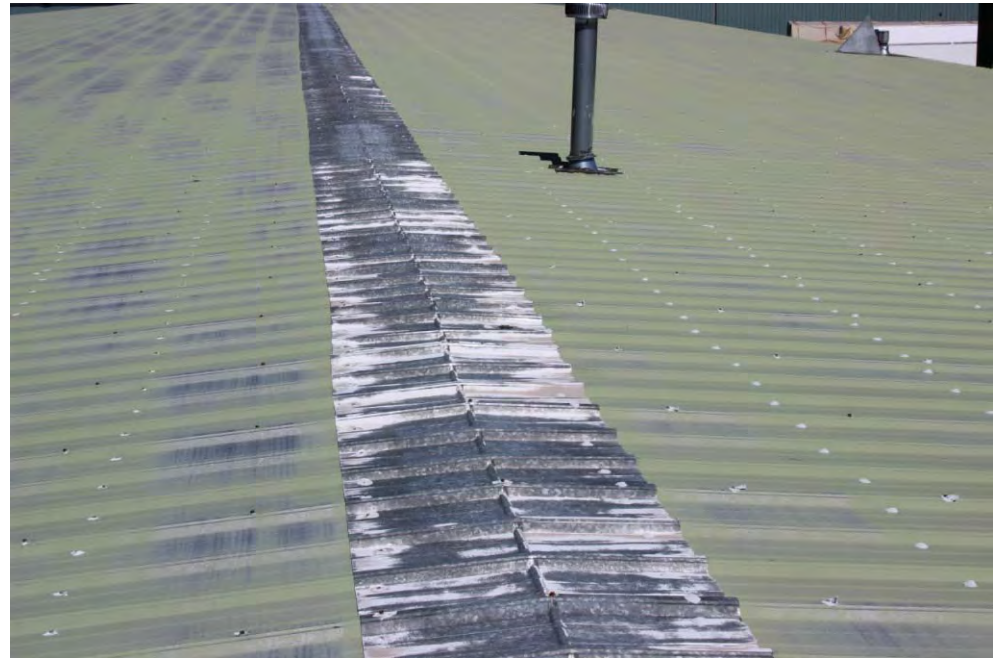
Building 7 – (Warehouse) - 1974. – This building is full of unbraced ceiling high shelving full of materials. There is a modular trailer supported on jacks as well. Current codes require all shelving above 4 ft. in height to be braced for seismic forces. The modular trailers need seismic restraint as well. The roof panels are in reasonable condition but the screws are an old style screw that has already been caulked. The caulking is ineffective for the long term. The screws not caulked show evidence of being over tightened or the washer has disintegrated.

5 Year Maintenance: Replace all existing screws with shielded screws. An alternative longer term repair would be to coat the entire roof with a coating system.

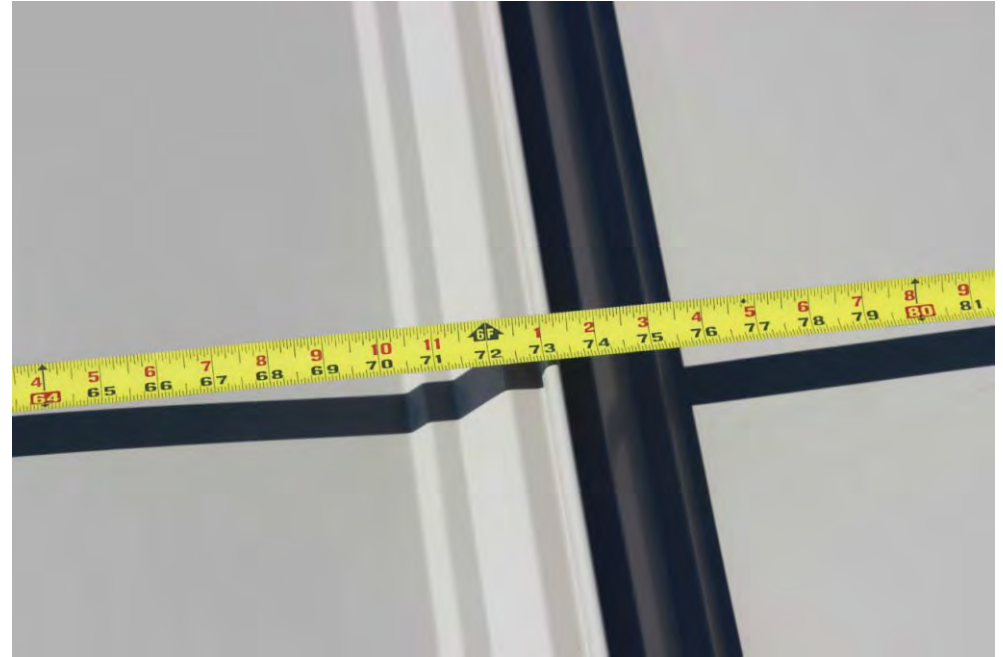
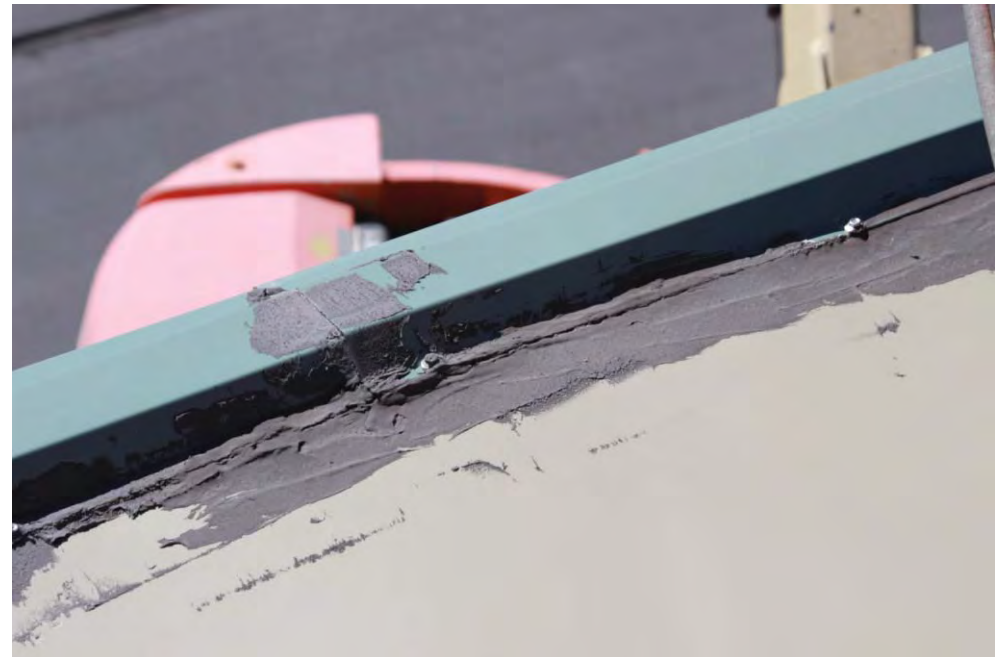
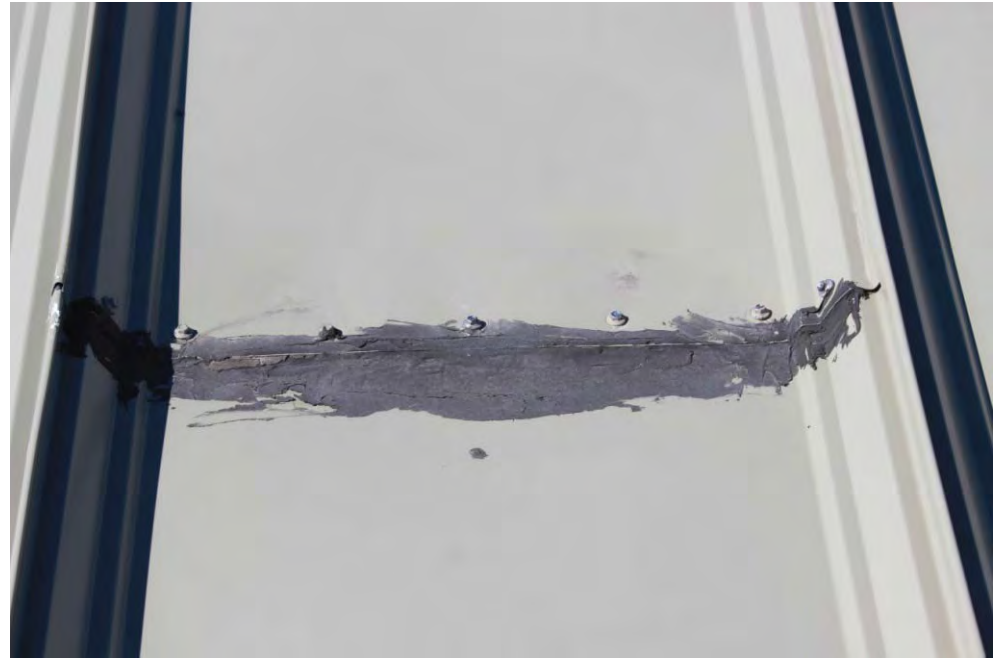
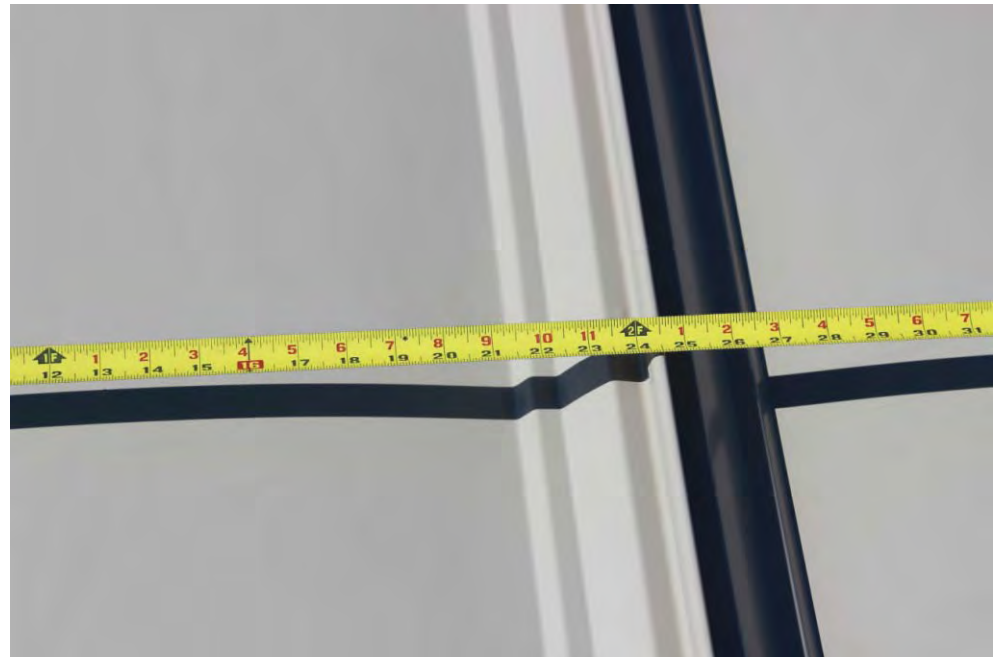
Building 19 – (Hangar M) – 2005. This building has serious leak problems due to the manner in which the roof was sloped in the long axis of the building. Snow and ice accumulate at the eave and then back up for more than 100 ft. This is a design flaw. Also the roof panels have been stretched during erection in the short direction and measure +/- 2'-1 ½" instead of the normal 2'-0". This is causing the standing seams to leak when ice dams and standing water occur. Ineffective mastic has been used to try and seal some of the leaks.

5 Year Maintenance: Recover roof with a PVC membrane material.

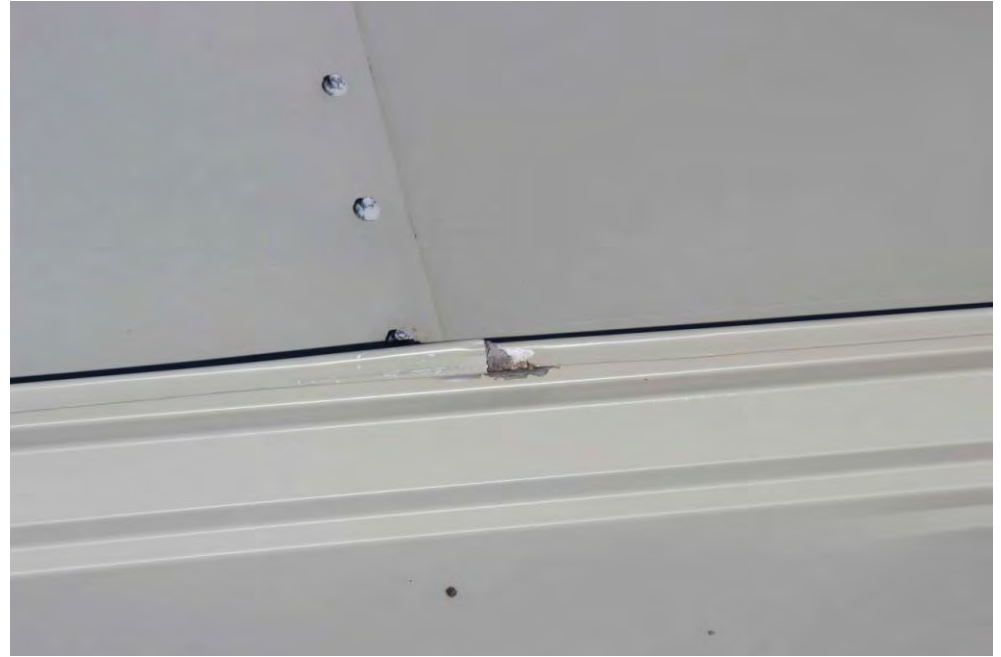
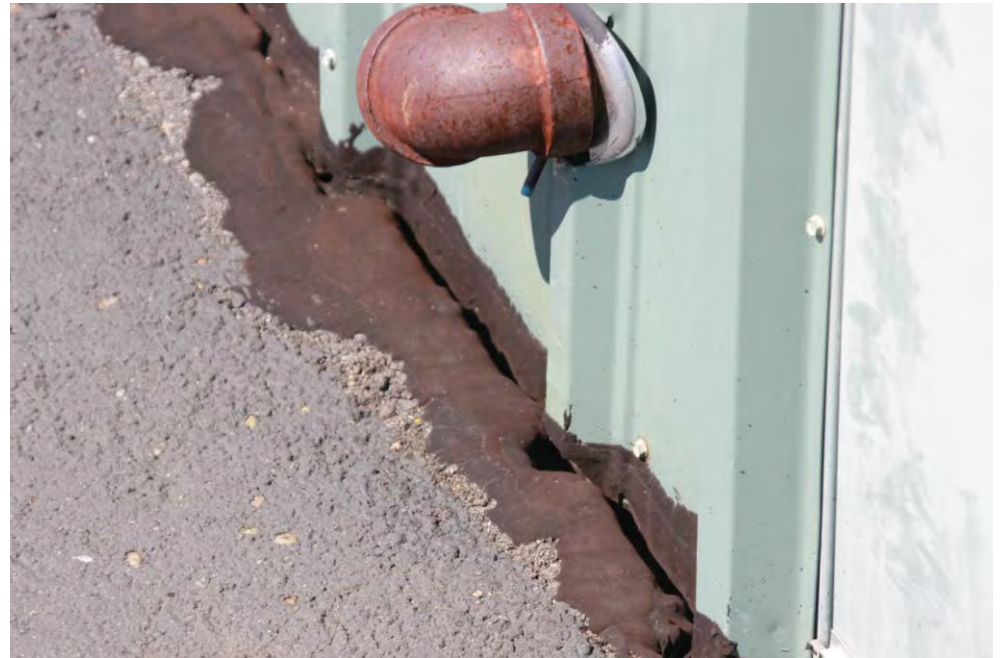
Building 18 – (Hangar L) – 2005. This roof is in good condition.

5 Year Maintenance: Check fasteners within 5 years.

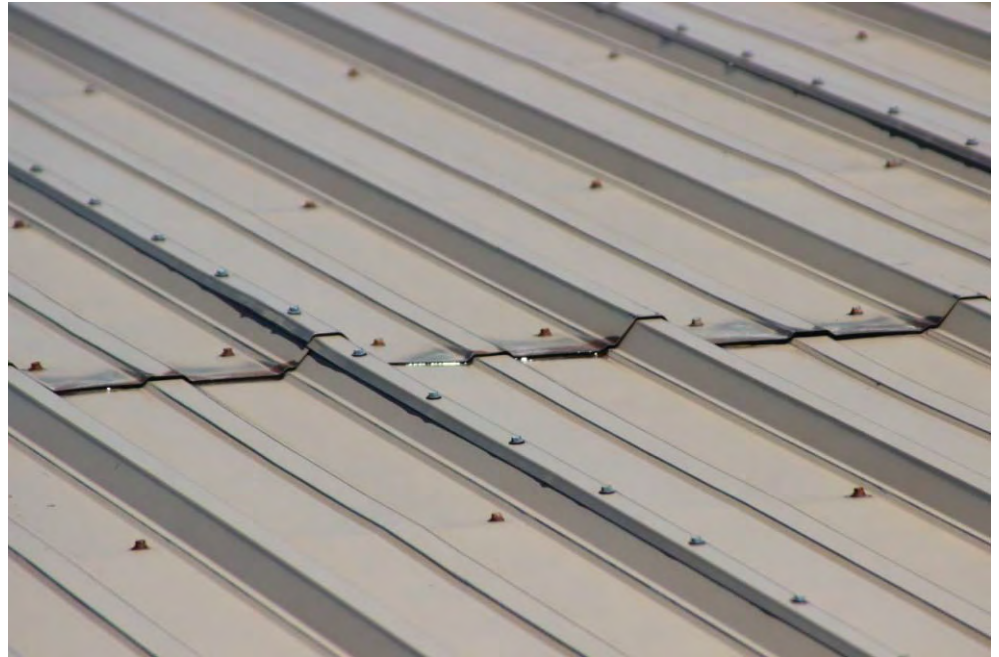
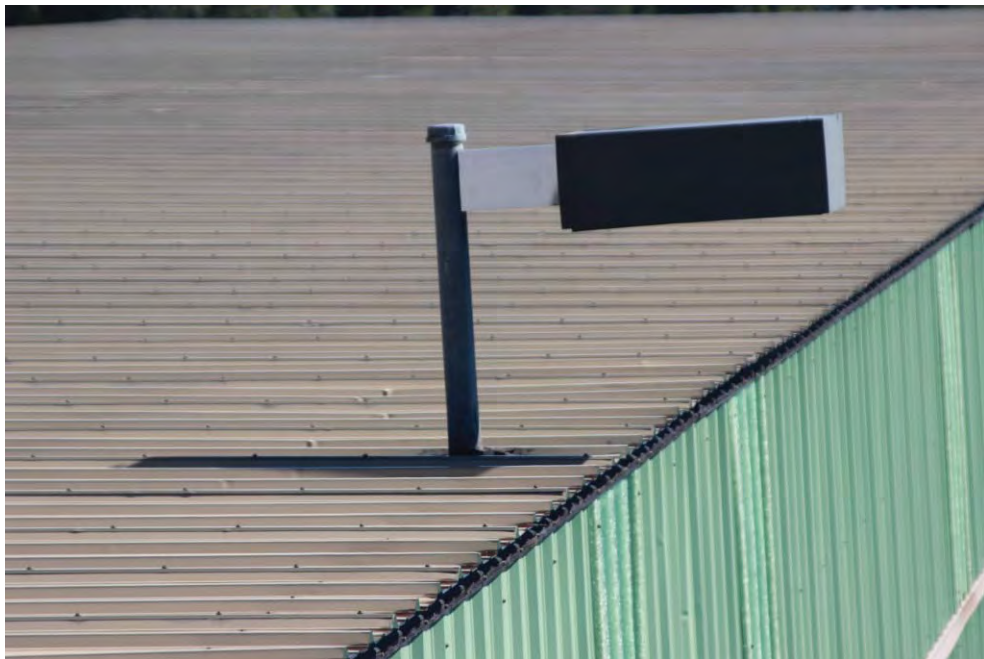
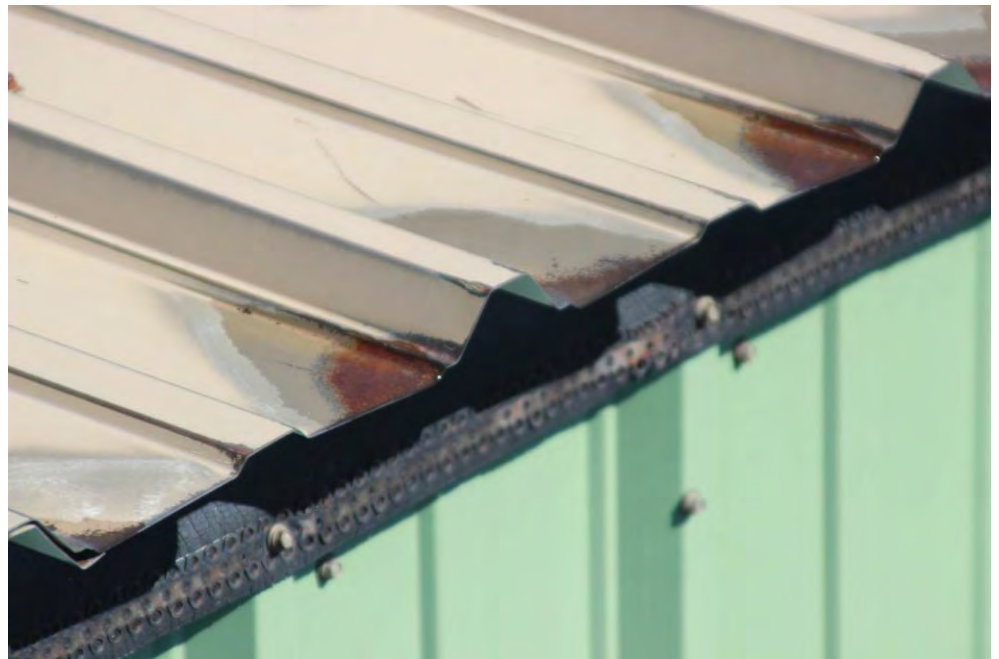
Building 17 – (Hangar K) – 1981. This roof is in poor condition with visible rust areas in the panels and at nearly all screw locations. Most of neoprene washers have disintegrated. A coating manufacturer should evaluate this roof to determine if coating is a possibility. It appears questionable.

5 Year Maintenance: Apply coating within two years if manufacturer will guarantee. If not, replace roof within 5 years.

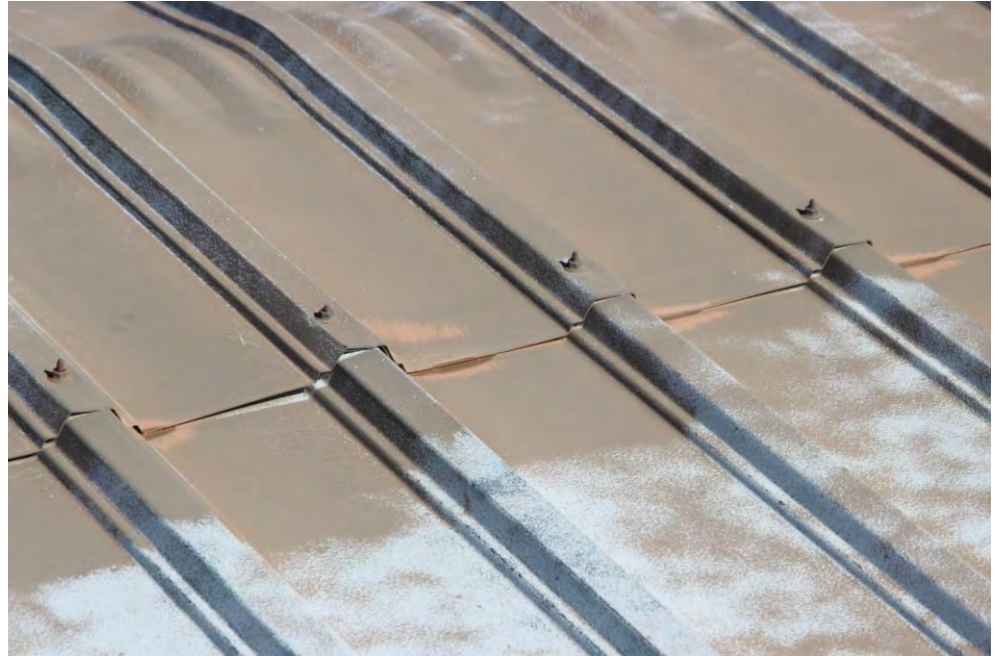
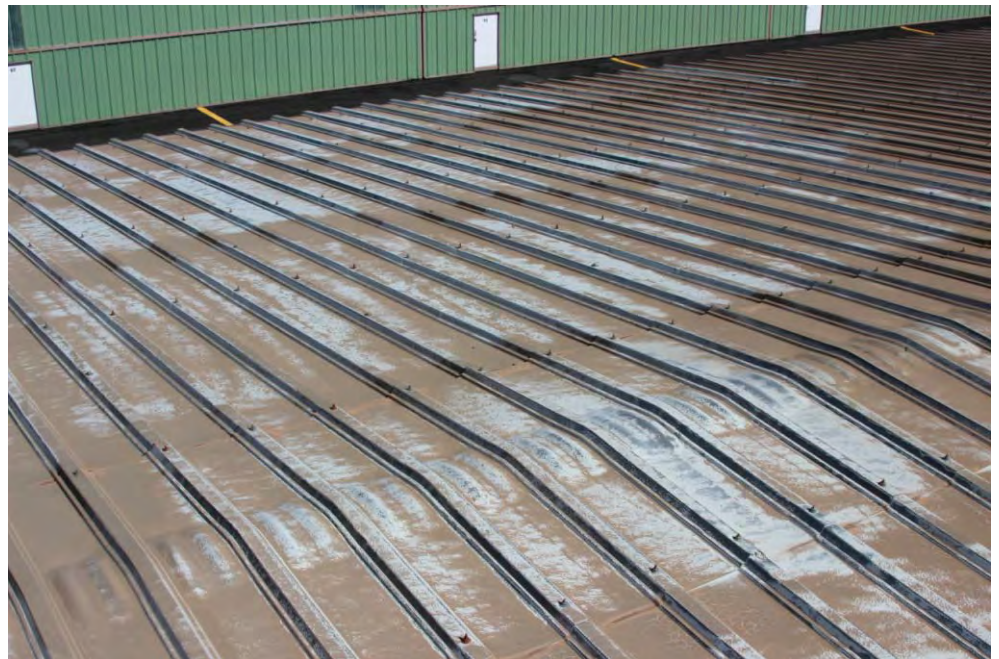
Building 16 – (Hangar J) – 1970. The roof panel construction is atypical for metal buildings. The roof panels have been coated with some type of unrecognizable coating. The roof screws have a pointed end protruding above the head and have been placed the high section of the panel ridge in lieu of the lower flat section of the panel. However, no roof leaks have been reported in this building. Despite its unusual construction we recommend leaving this roof alone until it starts to develop problems as its performance has been satisfactory. A coating manufacturer should evaluate whether an additional coating could be applied over the existing coating.

5 Year Maintenance: If problems develop, consider coating the existing roof if a manufacturer thinks it would adhere to the existing panels. If not, replace roof.

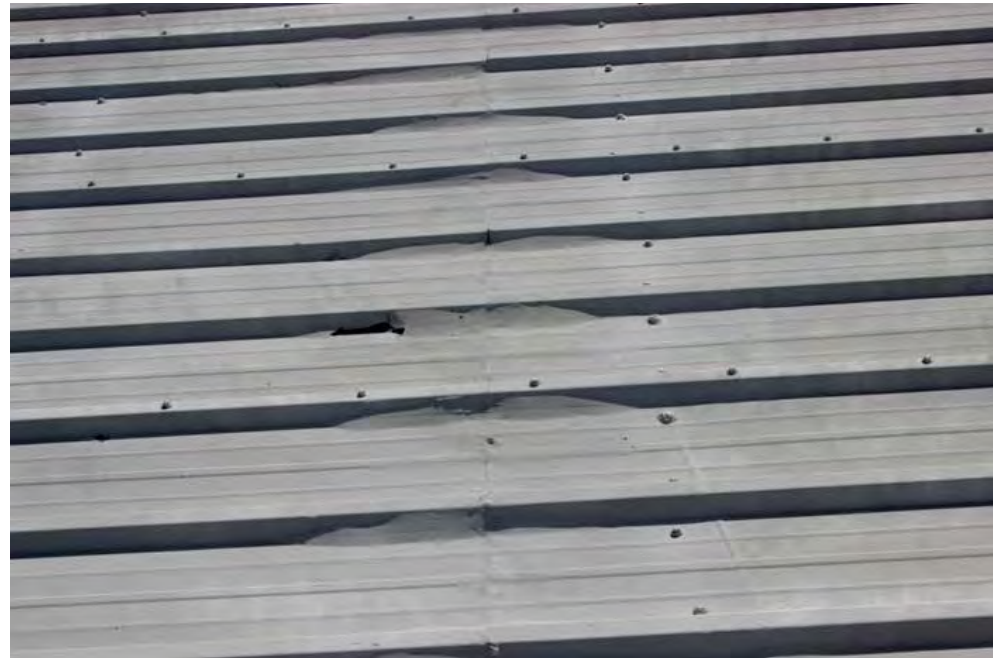
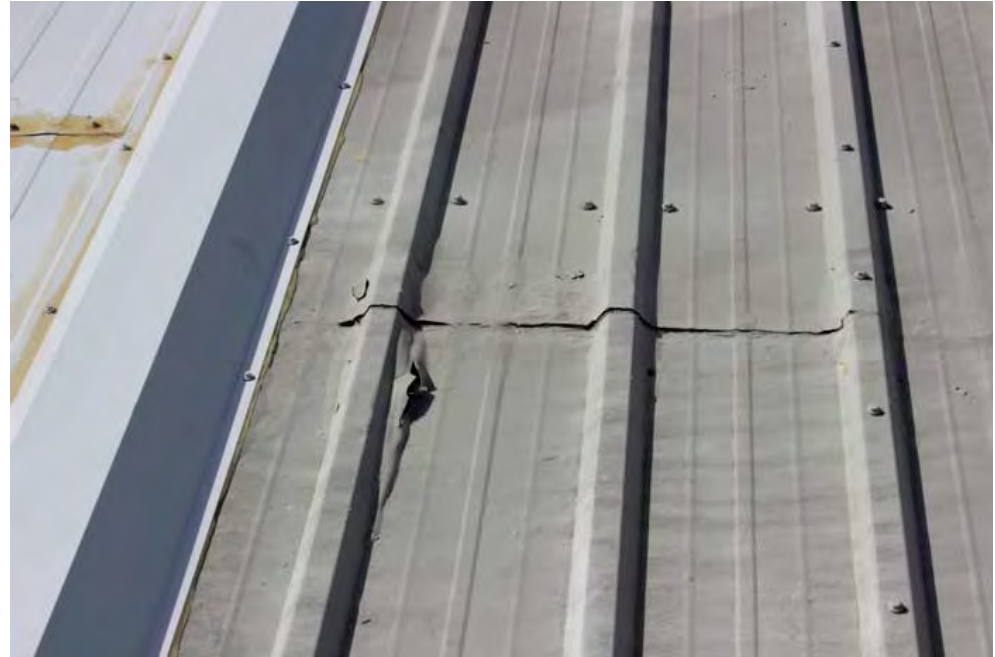
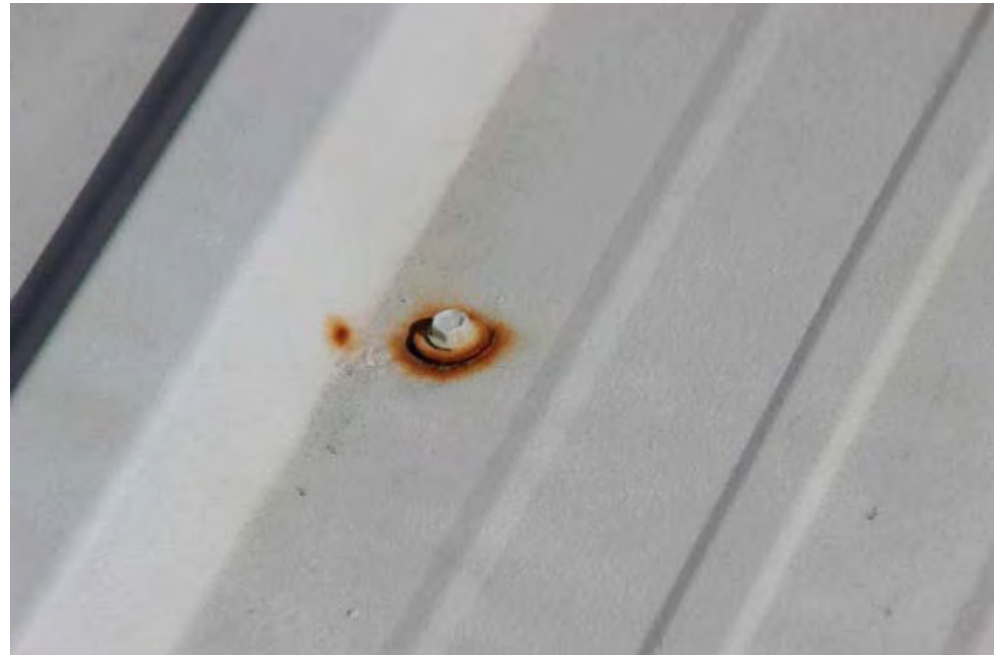
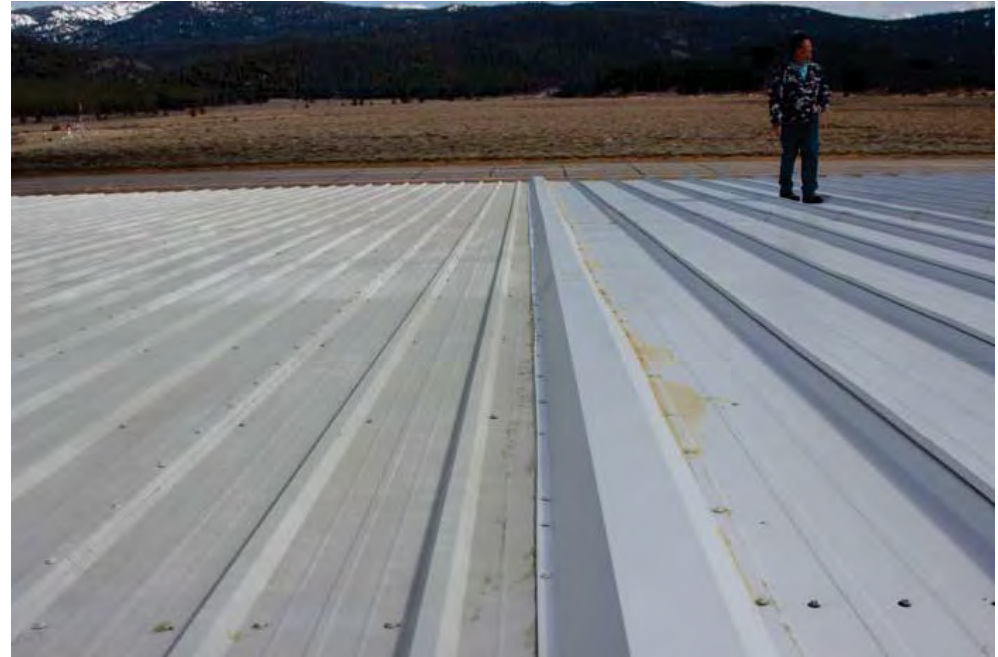
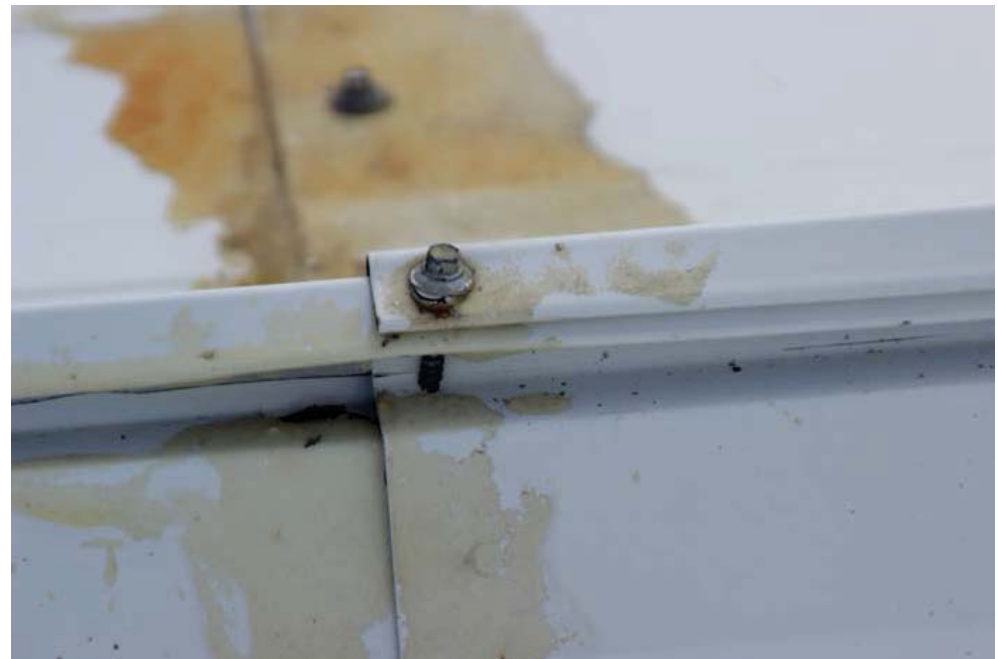
Building 15 – (Hangar H) - 1991. This building was constructed in two sections. The older roof has been coated however; the coating has failed due to improper installation. It is questionable whether a coating manufacturer would guarantee a new coating over the top of this existing coating.

The newer roof appears to be installed with two upper ridge panels as opposed to a lower eave panel and upper ridge panel. The lap where the two panels meet is improperly installed. This building has had leak problems and it's not hard to see why based on the way the panels were originally installed.

5 Year Maintenance: Rework all laps between the upper and lower panels of the newer roof. Consider adding a new roof above the older section.

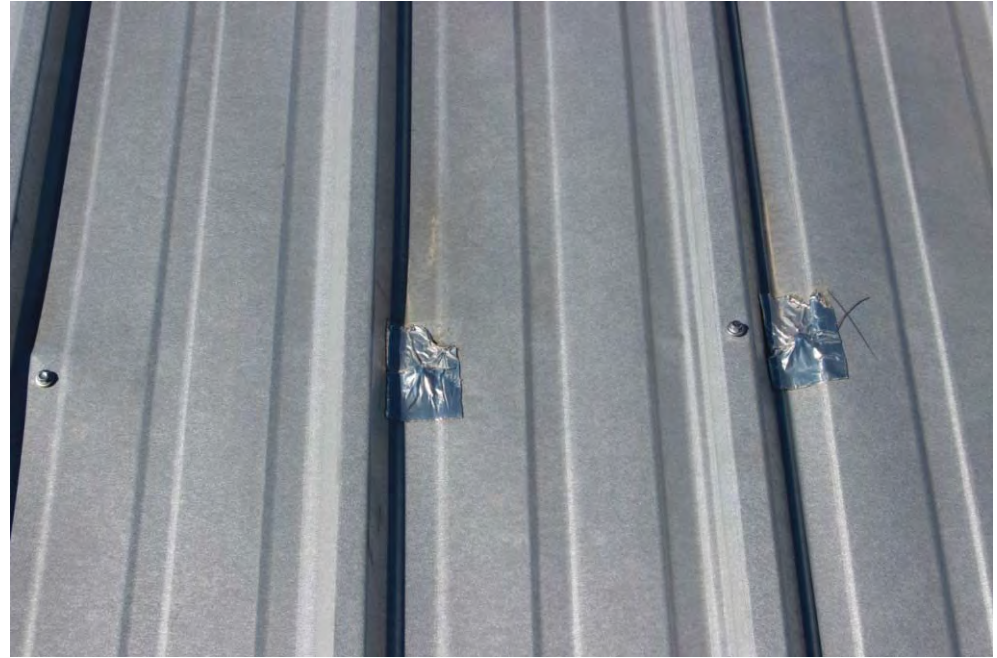
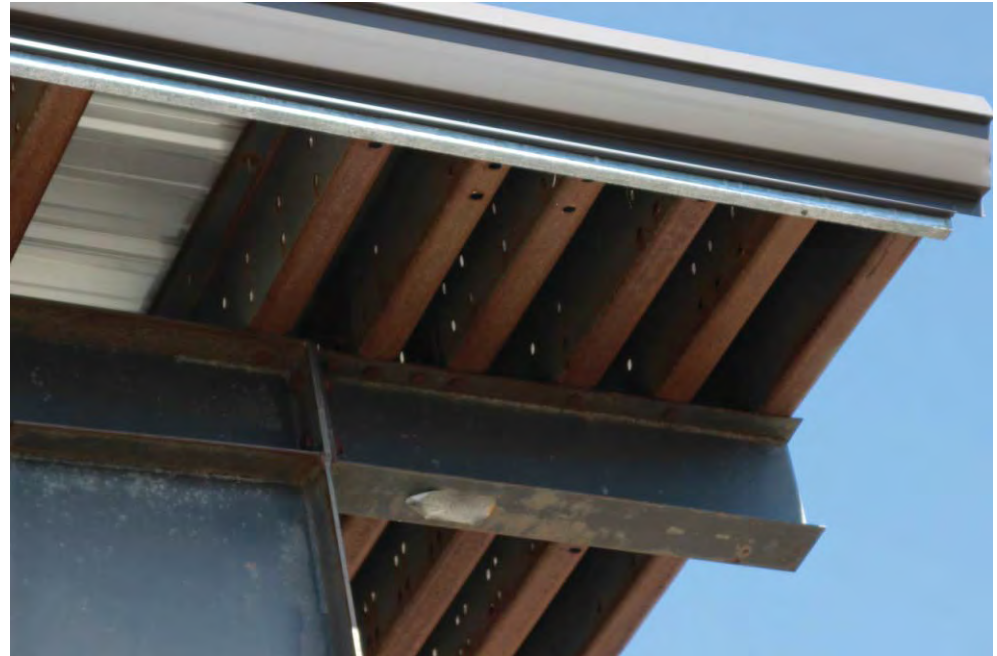
Building 25 – (Fuel Farm Cover) – 1996. This is an open building with just a roof above the fuel tanks. The roof appears to be in good condition. Some type of foil faced adhesive patch has been applied in numerous locations. The longevity of this patch is questionable. There is evidence of rusting in the leading edge purlins at both the upper and lower eaves. This is simply due to moisture collecting on these purlins as they are exposed to weather.

5 Year Maintenance: Sand blast and repaint purlins as necessary. Review efficacy of metallic patches.

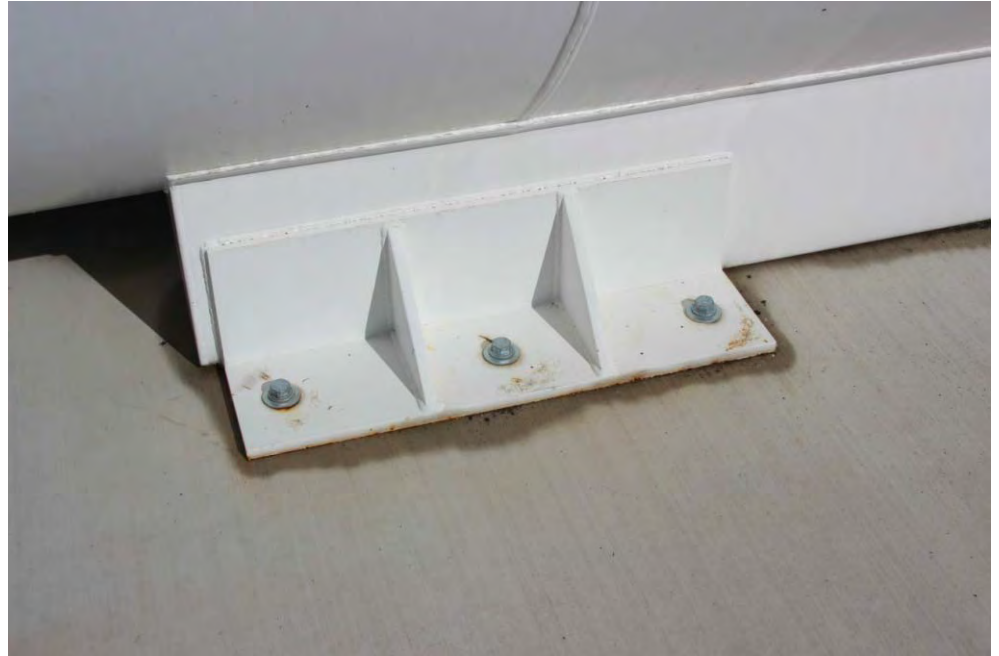
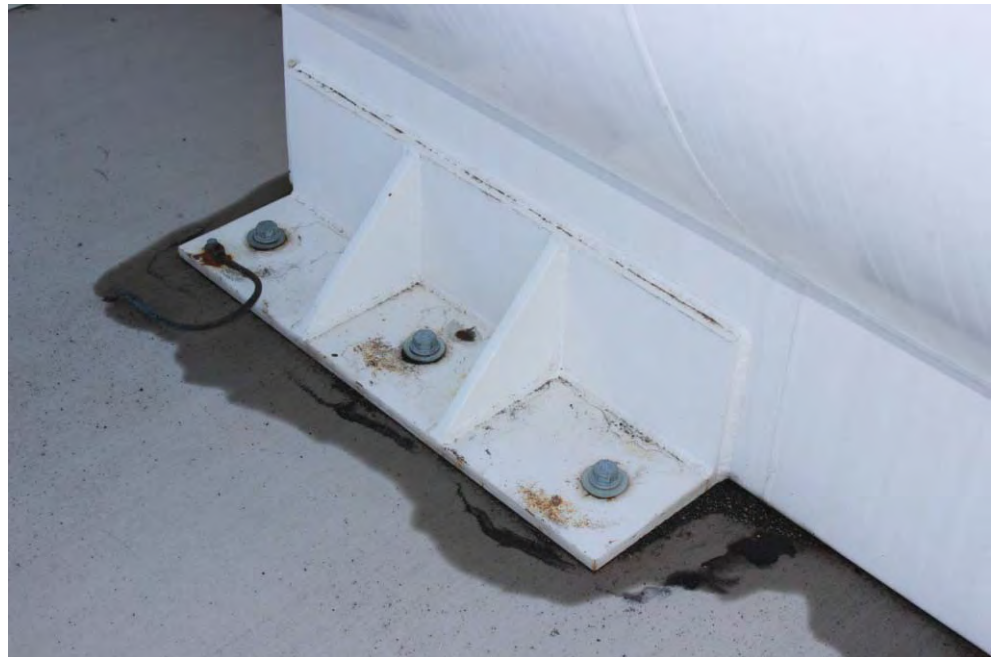
Building 24 – (Self-Serve Tank) – 1999. This is a large fuel tank. The tank appears to be in good condition except for some minor rusting at the feet attached to a concrete pad.

5 Year Maintenance: Sandblast and paint the feet with an appropriate rust inhibitor coating as required.

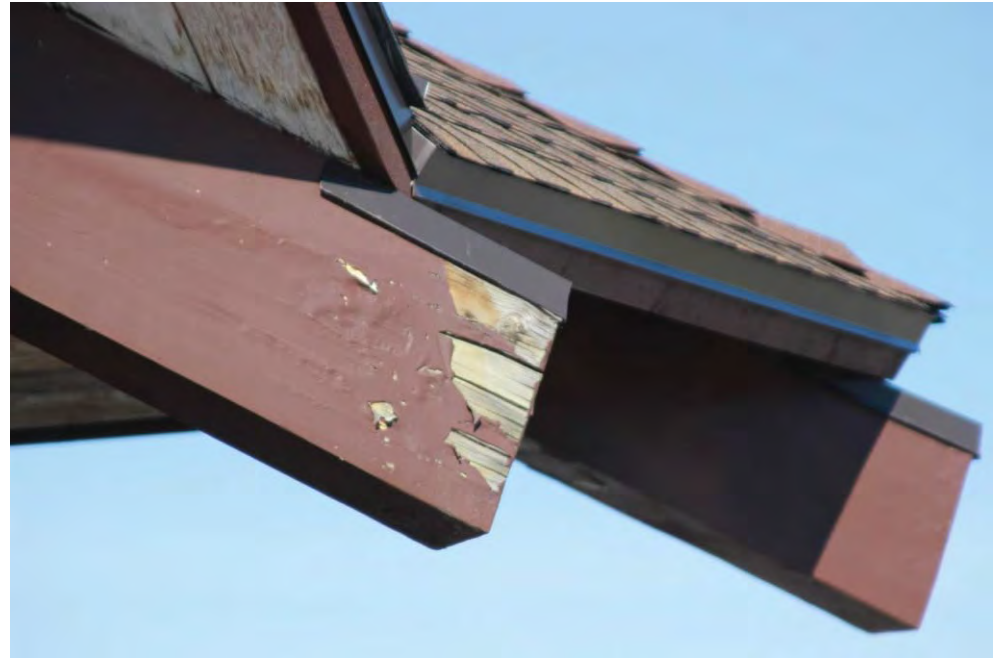
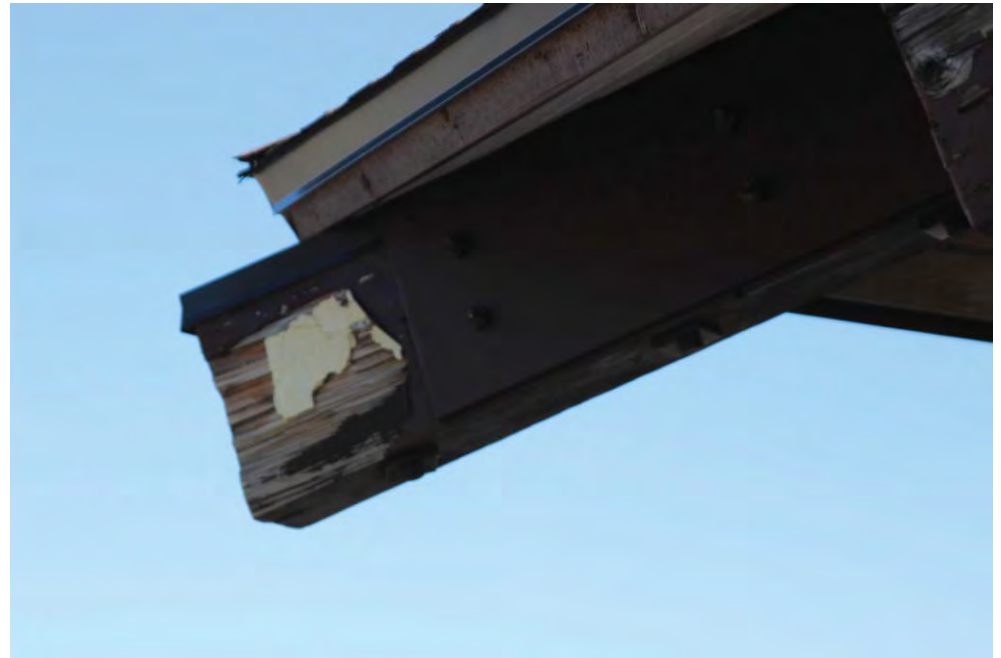
Building 23 – (Auto Rental Building) – 1978. This is a wood framed building with composition roofing. The hip rafters extend past the building and are exposed to the weather with a metal cap on the top edge. The paint on the exposed eaves is failing and the wood is deteriorating.

5 Year Maintenance: Coat exposed hip beam eaves with an appropriate weather coating.

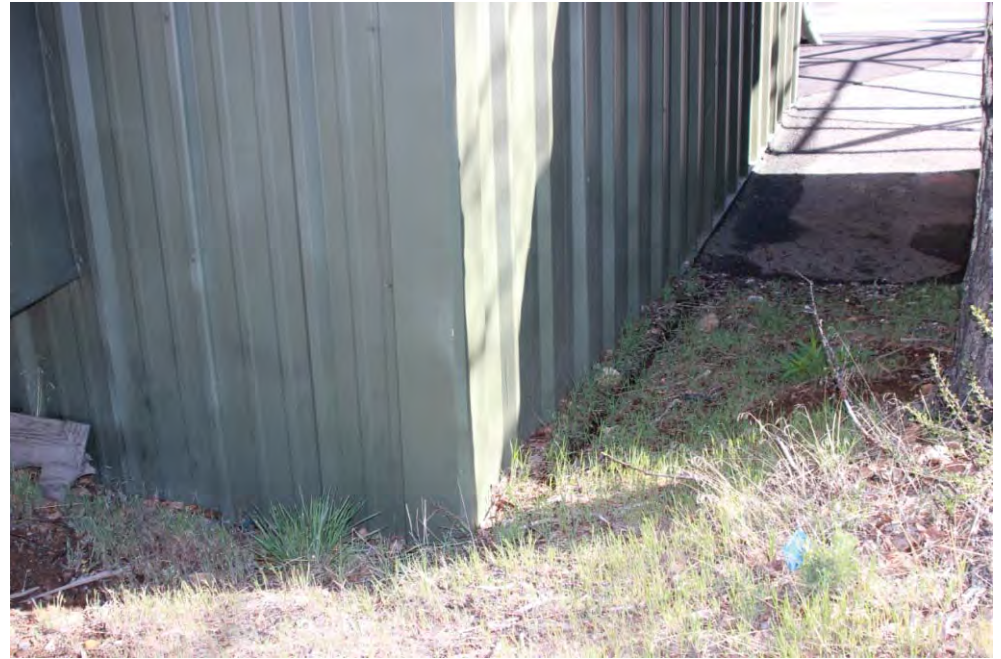
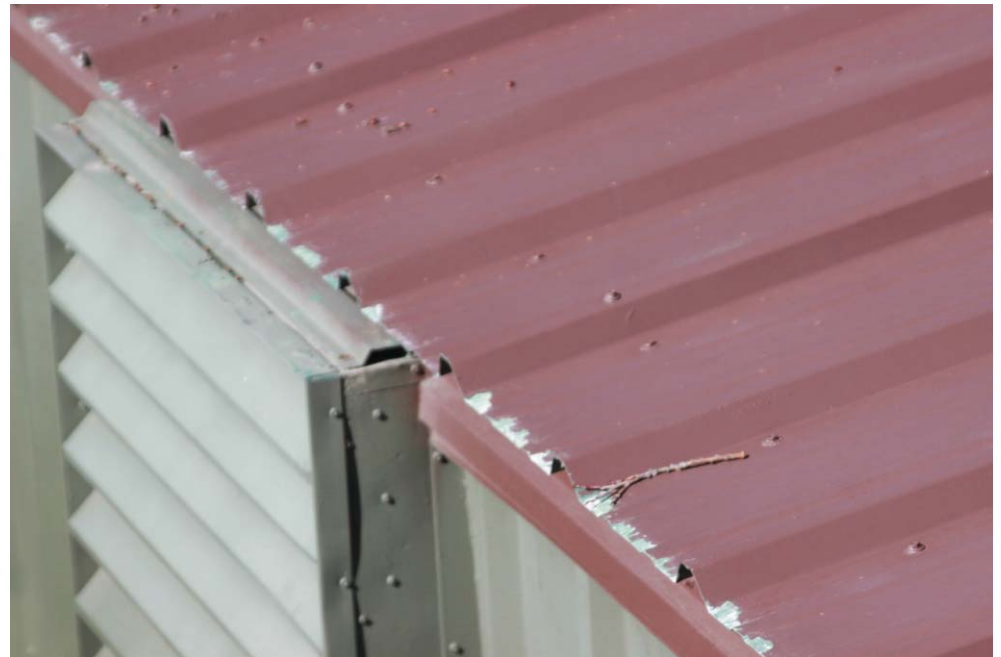
Building 22 – (Generator Building) -1990. This building has an upper and lower roof. The lower roof is a standing seam metal roof and the upper roof a typical roof panel. Both appear to be in good condition. The exterior grade at the south and east side of the building has gradually been raised where it is above the finished floor and directly against the metal panels.

5 Year maintenance: Check for loose screws. Remove soil against the metal wall panels.
