Re: Truckee Tahoe Regional Airport
Facilities Maintenance Plan

The following is our preliminary report concerning the review of the 25 existing structures and recommendations for a short term (1-5 years) maintenance plan. A long term (5-20 years) maintenance plan was requested, but in this case, if the 5 year plan is followed, there will be minimal maintenance required for the following 15 years, thus we have not provided long term maintenance plan. We have numbered the buildings according to site map provided by your office.

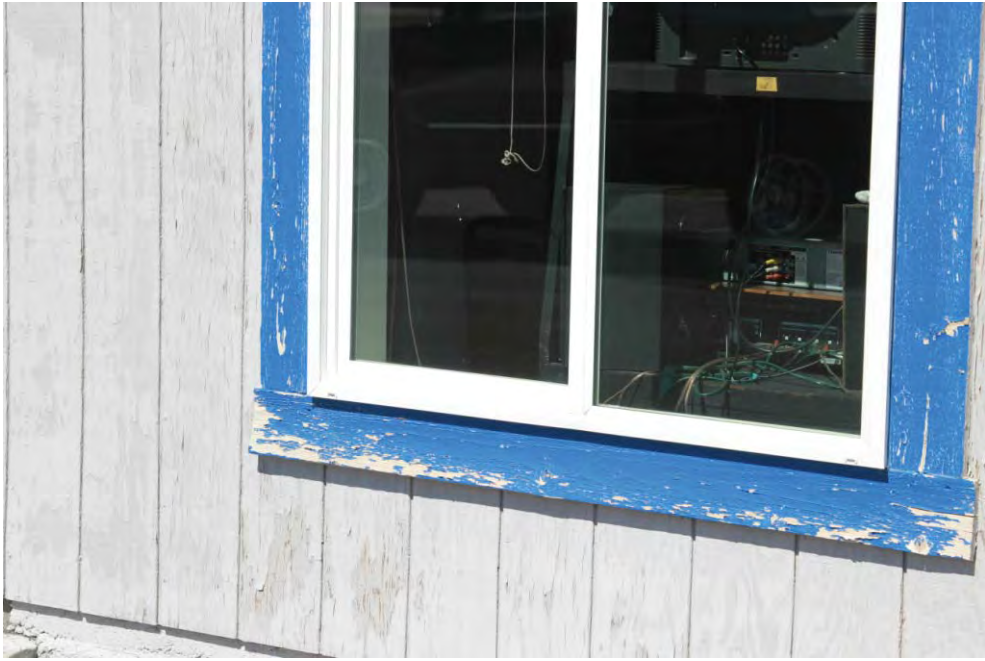
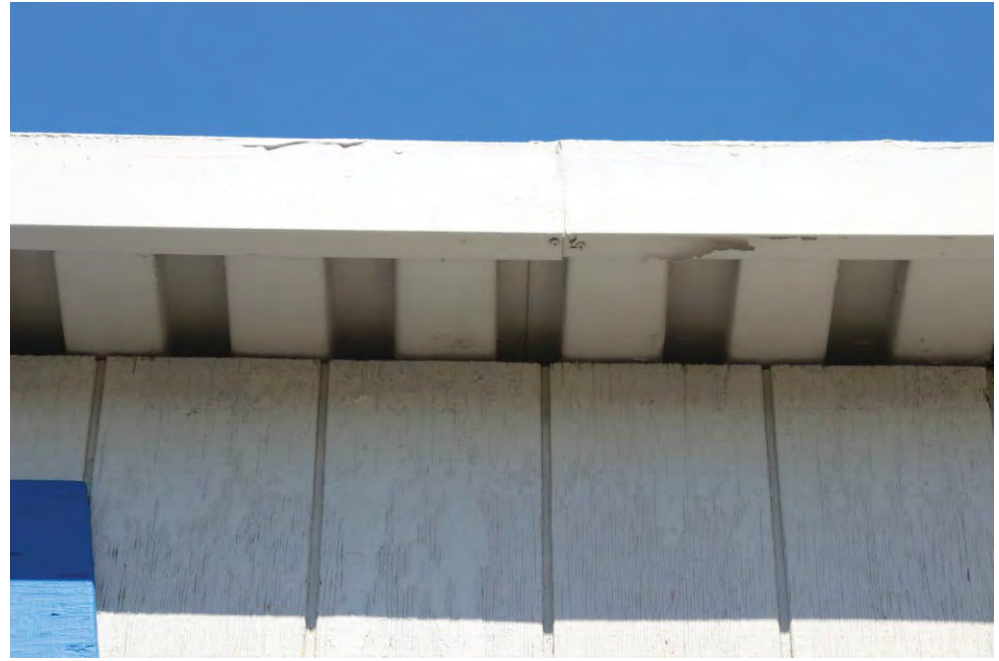
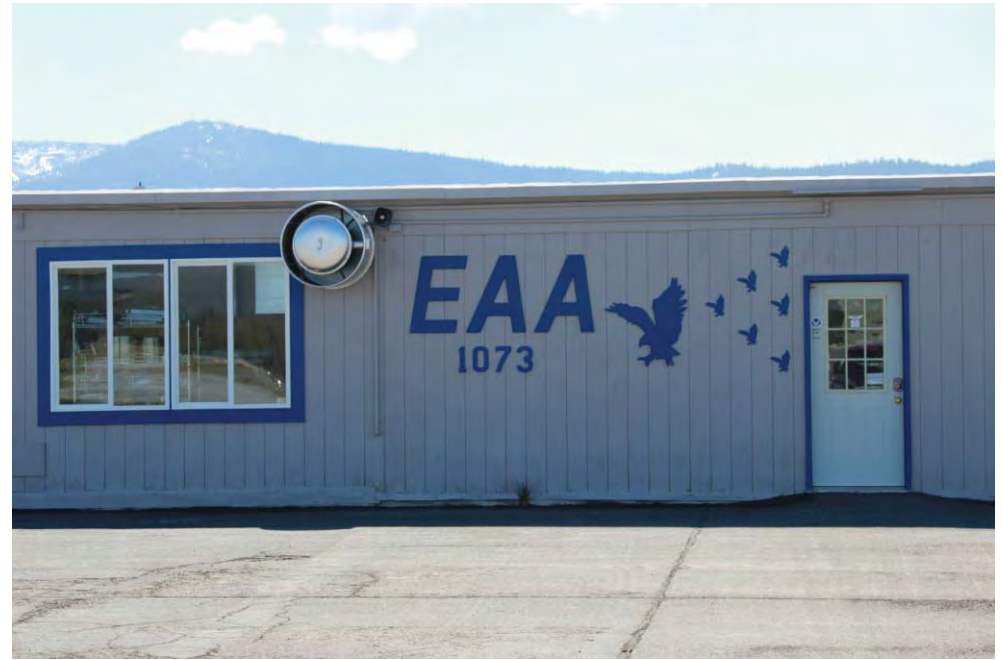
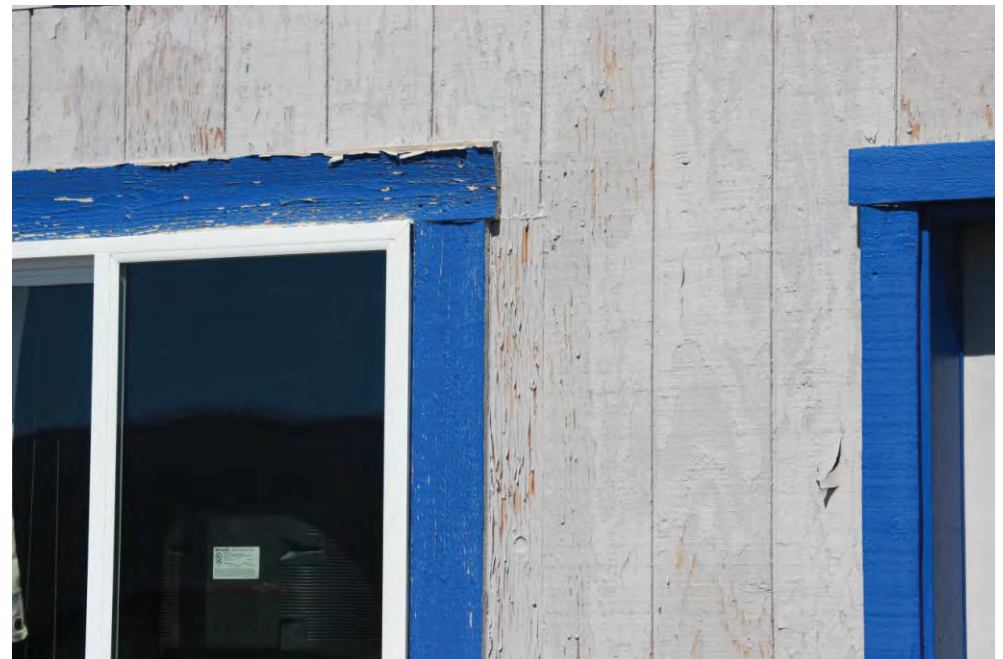
Building 21 - (EAA Building) – 1963. This is a wood framed building with a structural metal deck. Some type of foam roof coating has been applied to the roof surface. There is probably rigid insulation on top of the roof deck. A coating manufacturer should evaluate this roof to determine if a new coating could be applied. The exterior wood siding on this building has not been maintained and needs an immediate application of a good quality exterior paint.

5 Year Maintenance: Recoat roof if possible. Paint exterior walls as needed.

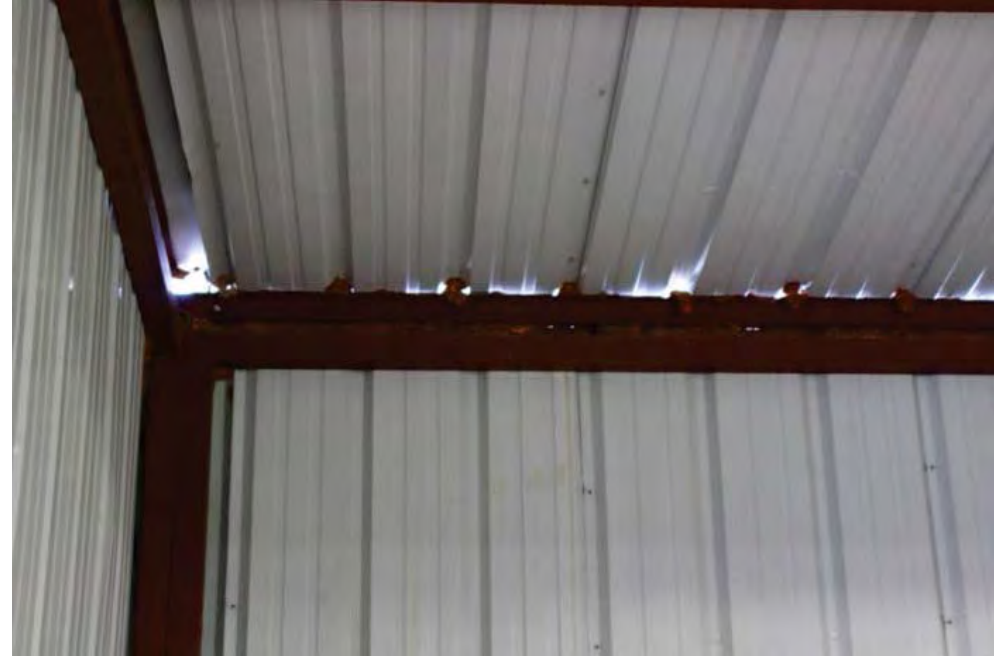
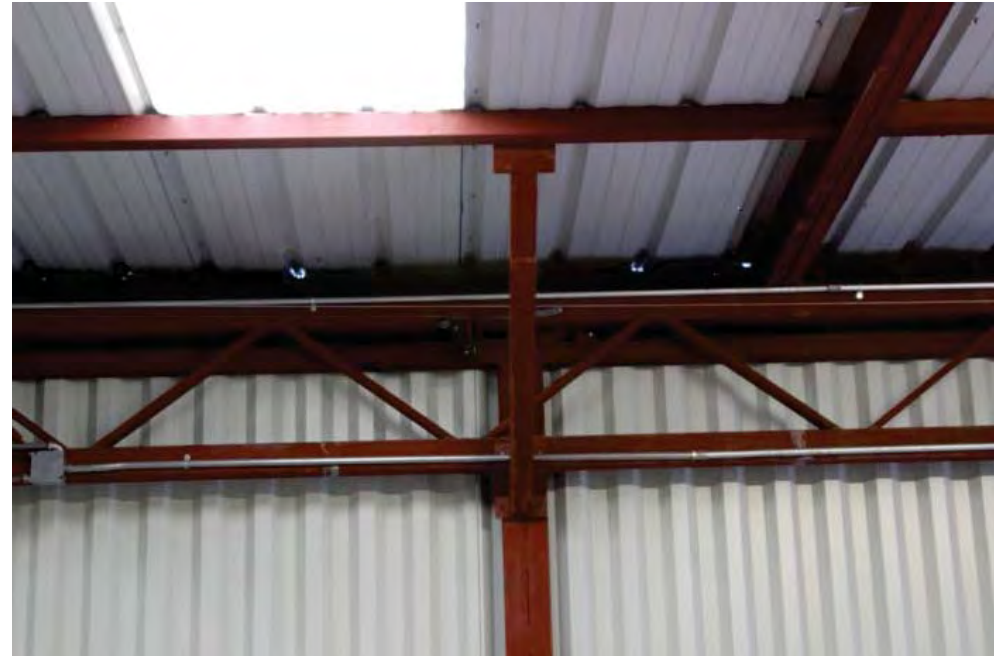
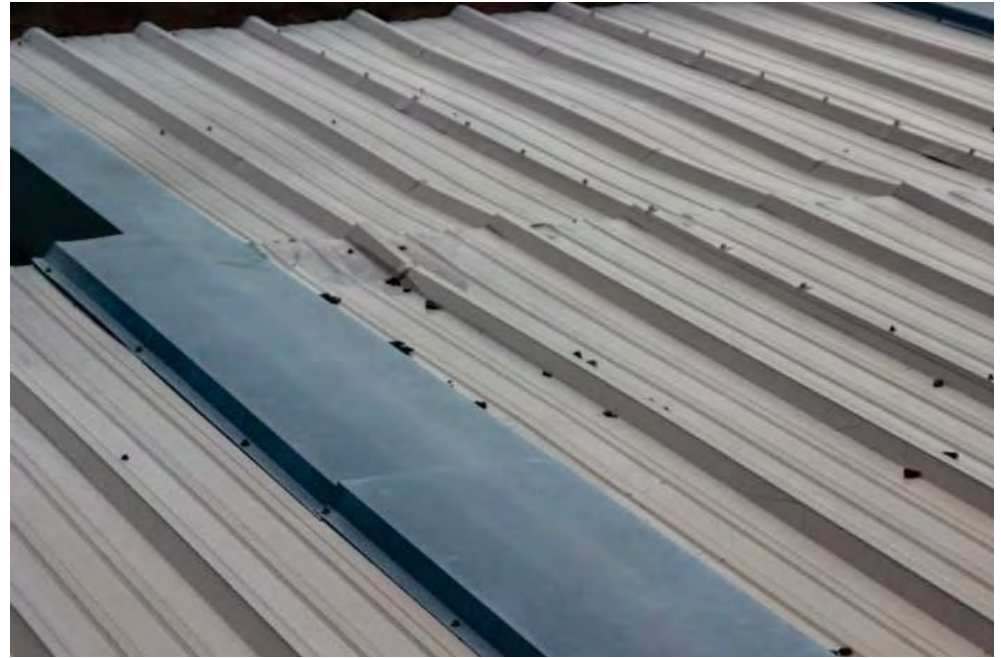
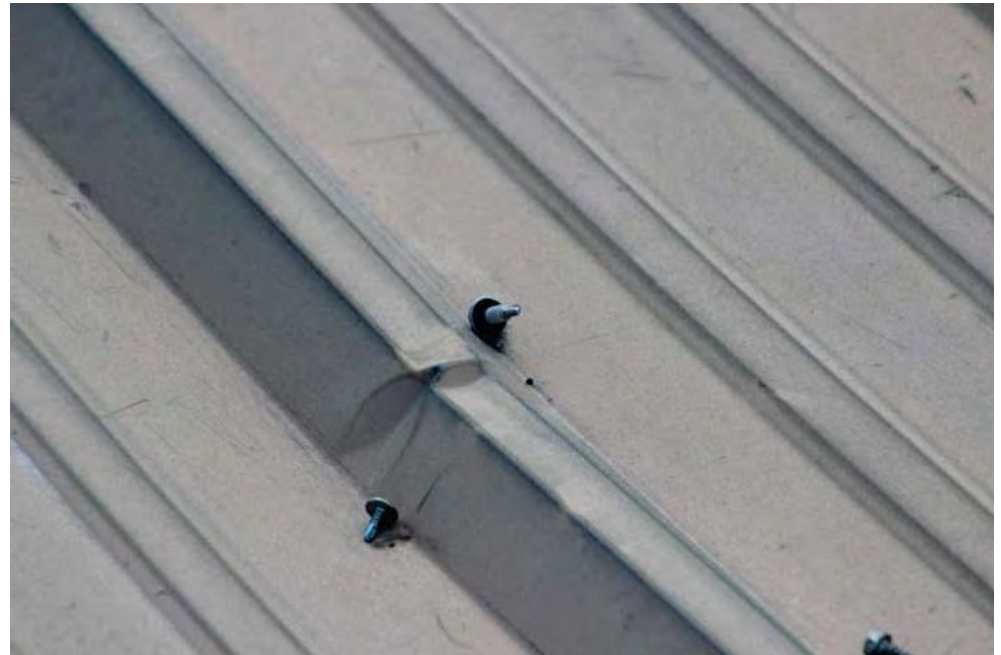
Building 20 – (Phoenix Hangar) – 1985. The roof panels appear worn and dented. Either skylights or metal panels have been replaced with a fiberglass translucent panel. Daylight is visible all along the inside perimeter of the roof/wall junction. Screws appear to be loose in several locations.

5 Year Maintenance: Replace roof and provide weather tight seal between roof/wall junctions.

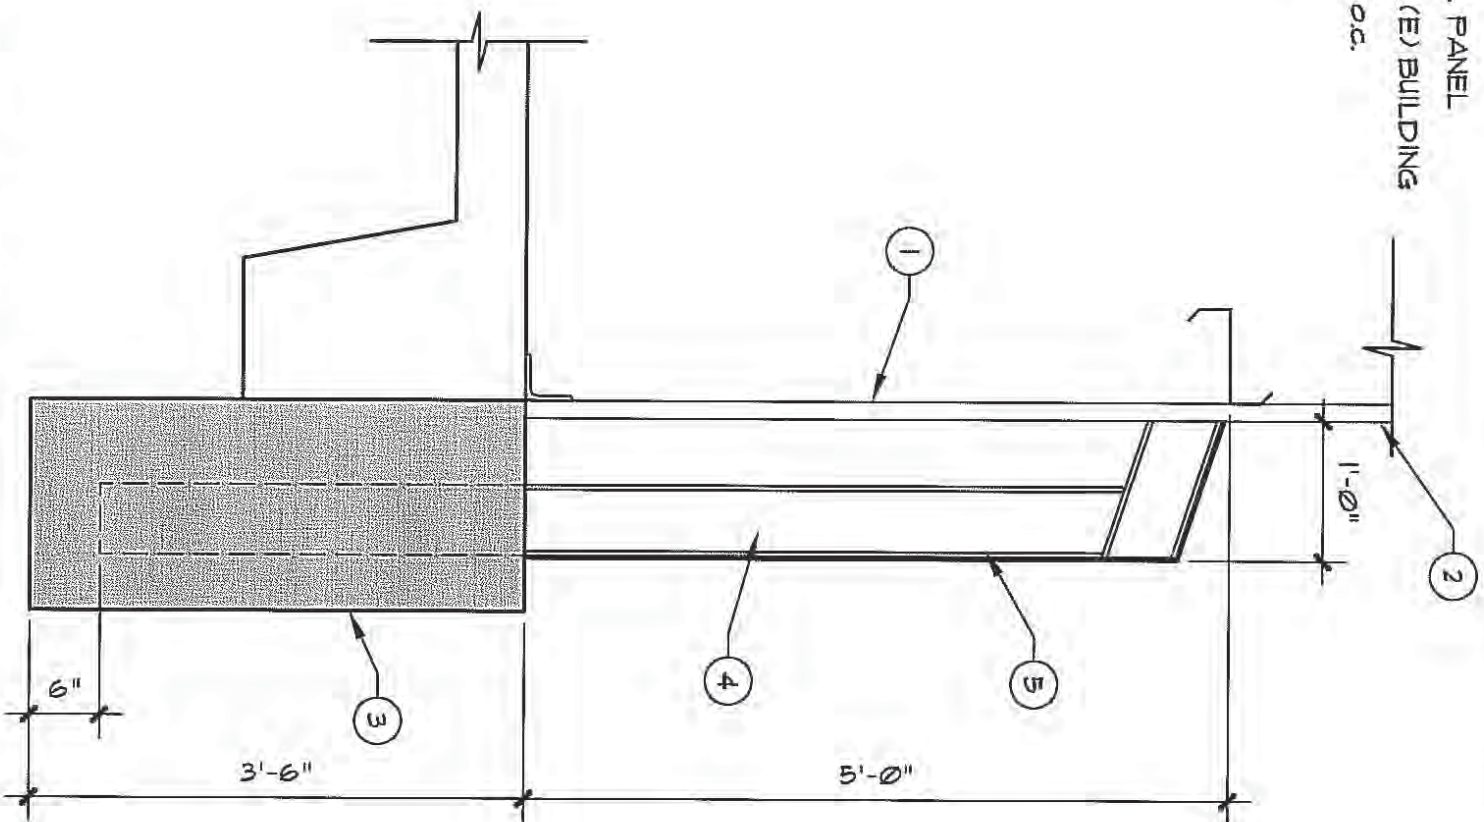
SK-1

The wall panels on the north side of some of the buildings suffer damage as the snow sheds off the roof and falls to the ground. The snow rebounds against the wall panels or lateral pressure is exerted on the wall panels due the snow build up and causes considerable deformation of the panels. Buildings 5, 15, 18 and 19 have the most noticeable damage. Additional horizontal girts have been added to Buildings 18 and 19. The damage to the wall panels at building 5 is quite severe and needs to be replaced at the lower sections. Adding girts help the wall panels to resist deformation but it still allows them to be crimped. A more positive long term solution would be to provide a protective barrier of plate steel for the lower 5 ft. of the wall. This plate steel could be supported by the existing girts or an independent support system could be installed just behind the plate steel. Attached is a concept drawing, SK-1, showing an independently supported plate system.
