WEST COAST COATING CONSULTANTS

Subject: Budgetary Cost Estimates for Painting Work at Truckee Airport

Acumen Engineering contracted with West Coast Coating Consultants (WCCC) to conduct coating/corrosion assessments on numerous structures at the Truckee Airport in Truckee, CA. The assessments were deemed necessary since the airport is in the process of preparing a twenty year maintenance plan. A detailed plan for maintenance painting was desired to be part of the overall plan. Mr. Ray Tombaugh, Senior Consultant for WCCC was assigned to perform the investigation and prepare this report.

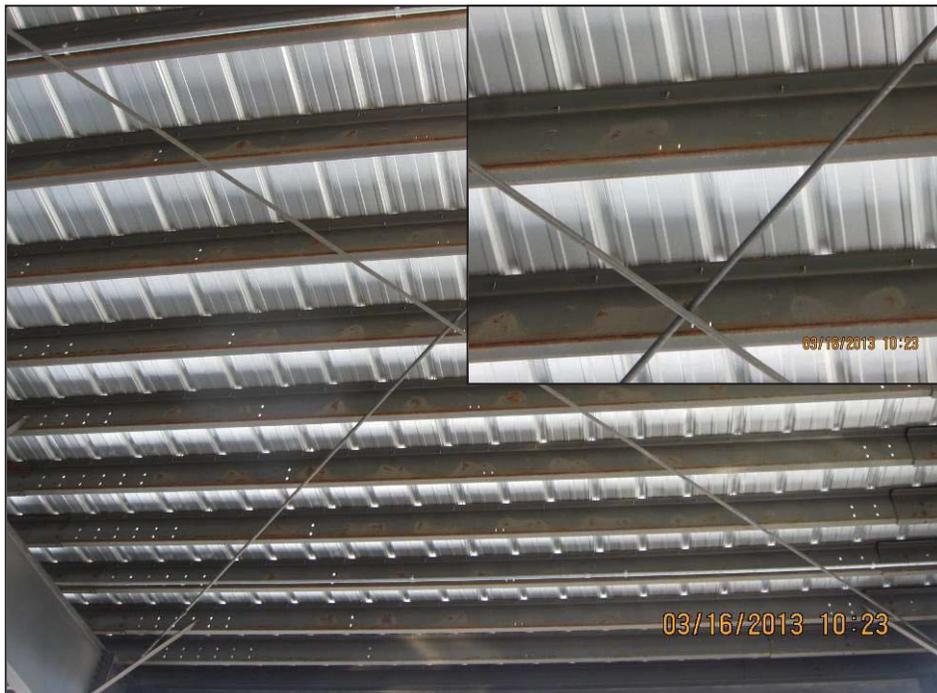
There is significant edge rusting on the roof rafters and diagonals that support the roof (Photo 2).

Photo 2 shows a general view of the roof rafters and the diagonals that support the roof structure. Note the edge rusting on the rafters. The diagonal rods are also rusted. The inset photo shows a closer view.

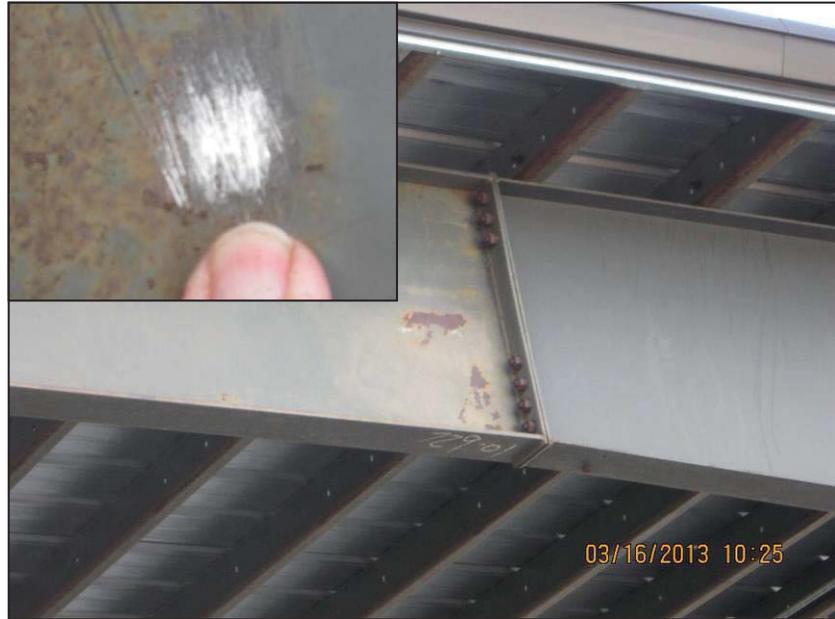
In addition there are few isolated areas of spot rust and pinpoint rust on the columns and main structural members. When evaluated in accordance with SSPC VIS-2 rust grades of 9-S and 9-P were observed. These grades represent less than 0.03% of the surface that is rusted. When the coating is forcibly disbonded the underlying surface appears free of rust and mill scale but there is little evidence of surface abrasion (abrasive blasting) (Photo 3).

Photo 3 shows an example of the spot rust that is observed on the structural members. The inset photo shows an example of the pinpoint rust that is present and the underlying substrate when the coating is forcibly disbonded.

The applied coatings are very thin (between 0.8 and 2.5 mils) and are tightly bonded to the substrate.

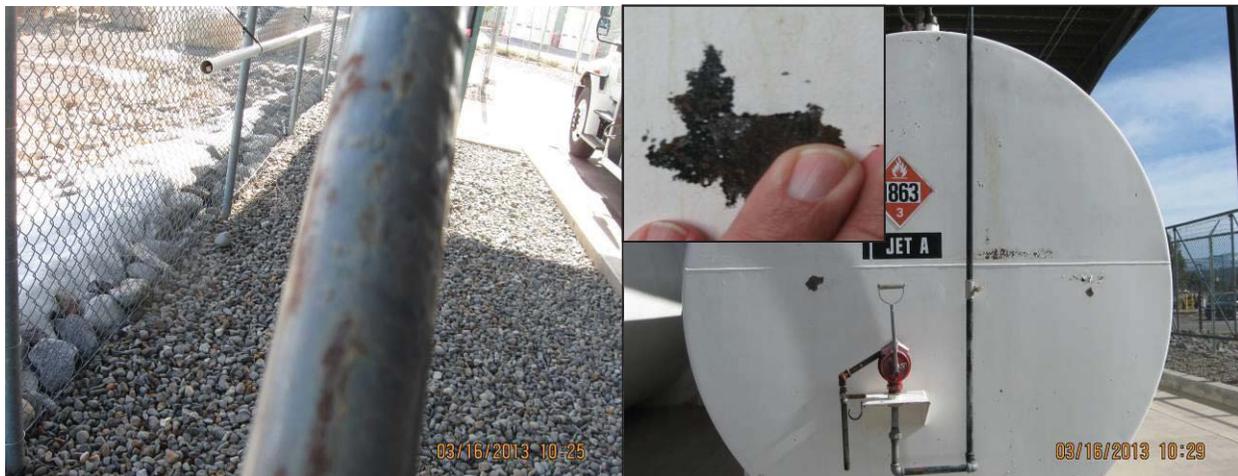
The seismic rods that run between the columns have rust (SSPC VIS-2: 5G) and mill scale that is lifting the coating off of the surface (Photo 4). Approximately 3% of the surface is rusted. Coating adhesion is poor.

Tanks 1 through 3 and the Diesel Fuel Tank have coating delaminations that are primarily found on the back end of the tank. Overall less than 10% of the surface is affected (Photo 5). When the coating is forcibly disbonded the substrate is covered in mill scale. The coating is poorly bonded to the substrate and is heavily chalked. The coatings applied to the tanks are thin (primarily between 3 and 7 mils).

Photo 4 (left) shows a general view of the seismic rods that run between the columns. Note the significant amount of rust on the surface. Photo 5 (right) shows a general view of the tanks. The inset photo shows a close-up of a delaminated area. Mill scale is present on the surface of the steel.

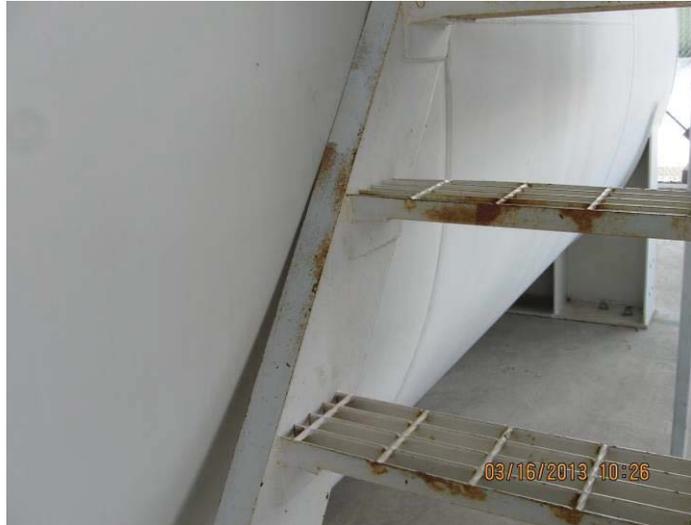
The stairways and grating have patches of pinpoint rust, primarily found on the grating but also on the hand rails, stringers and support structure (Photo 6).

Photo 6 shows the general condition of the stairways.

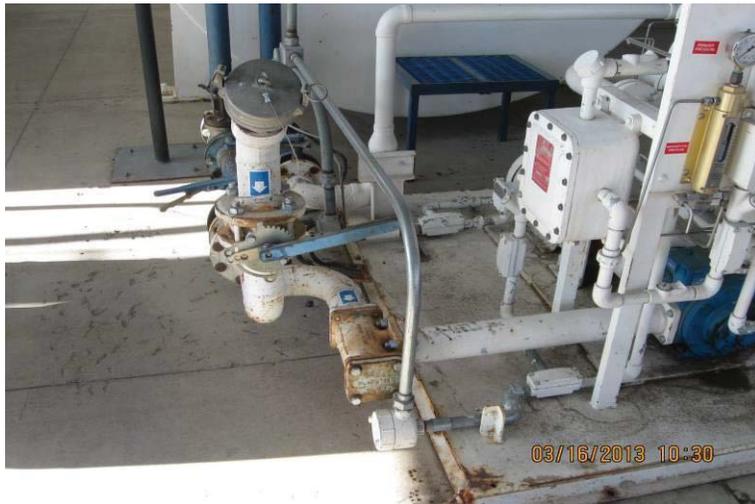
Photo 7 shows the general condition of the pumping station.

The main pumping station has coating delaminations and areas of worn coating (Photo 7). Rust is present where the substrate is exposed. Oil and grease is present on the painted surfaces.

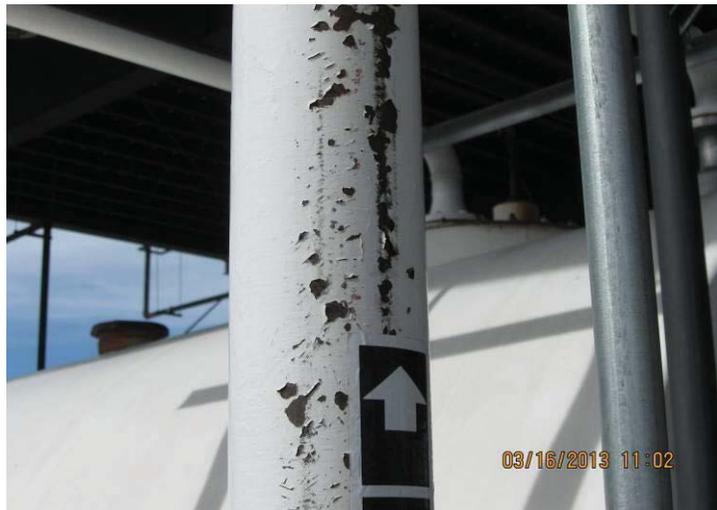
The piping associated with the tanks and pumping station has a significant amount of coating delaminations (Photo 8). In addition there is also unpainted black iron pipe included in the piping system.

Photo 8 shows the general condition of some of the painted surfaces on the piping associated with the pumping station.

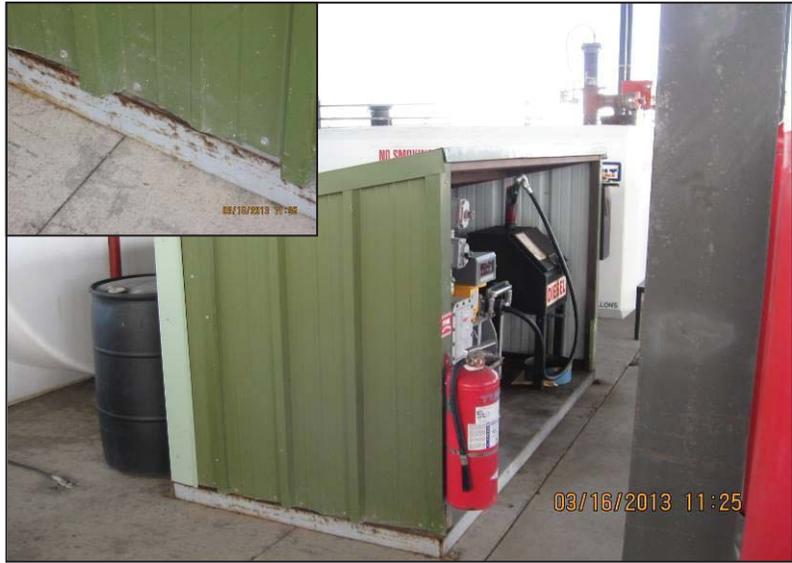
The diesel tank pumping station consists of factory painted equipment and instruments and is enclosed in a corrugated panel shed (Photo 9). The corrugated panels are shop coated and the coating is in excellent condition. It is tightly adhered to the substrate and free of rust. The pump skid sits on a steel platform that is rusted and oily.

Photo 9 shows a general view of the Diesel Tank Pumping Station.

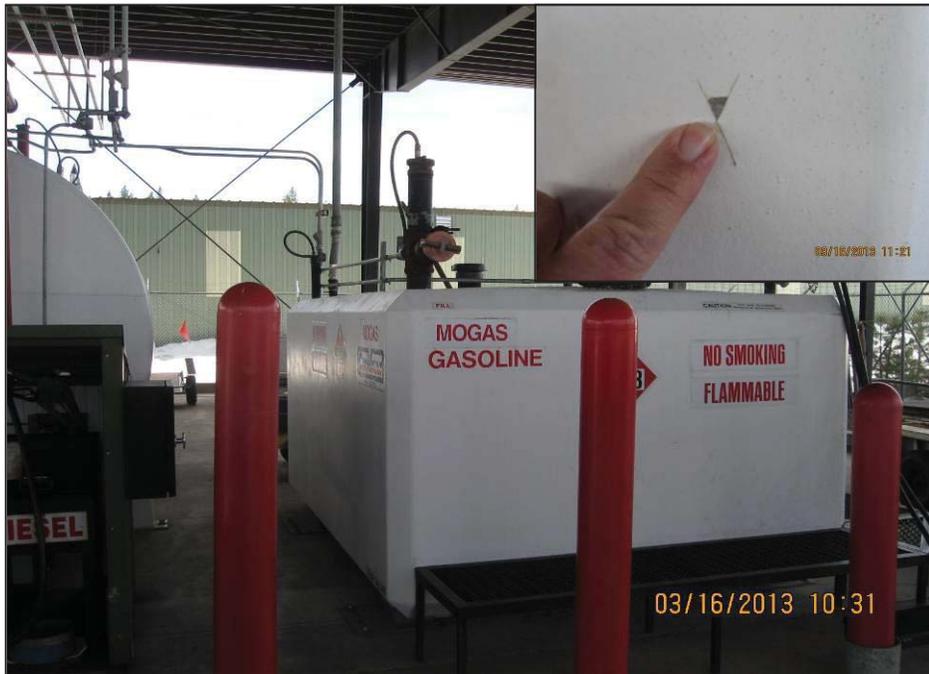
The coating applied to the concrete tanks is in reasonably good condition with only minor wear (Photo 10). Adhesion tests indicated moderate adhesion (ASTM D6677: 6).

Photo 10 shows a general view of the concrete tanks. The inset photo shows the results of an adhesion test performed on the tank surface.

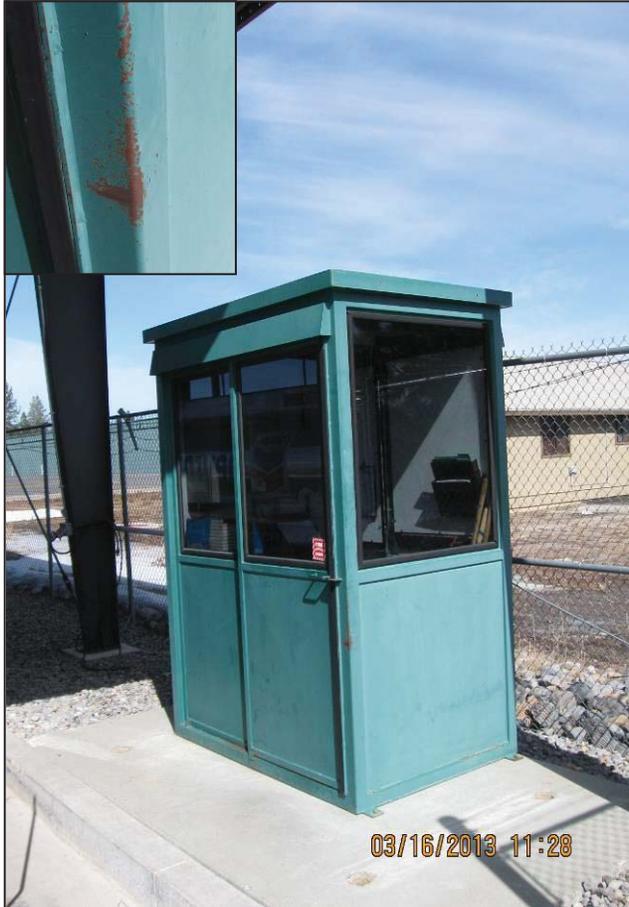
The guard shack is constructed of a painted steel frame and composite panels. There is some coating delamination and rust on the steel frame, most of which is located in areas of wear (Photo 11). The coating ranges between 2.2 and 2.5 mils thick on the steel surfaces and is tightly adhered to the substrate.

Photo 11 shows a general view of the pumping station. The inset photo shows a close-up of some of the rust that was found on the structure.

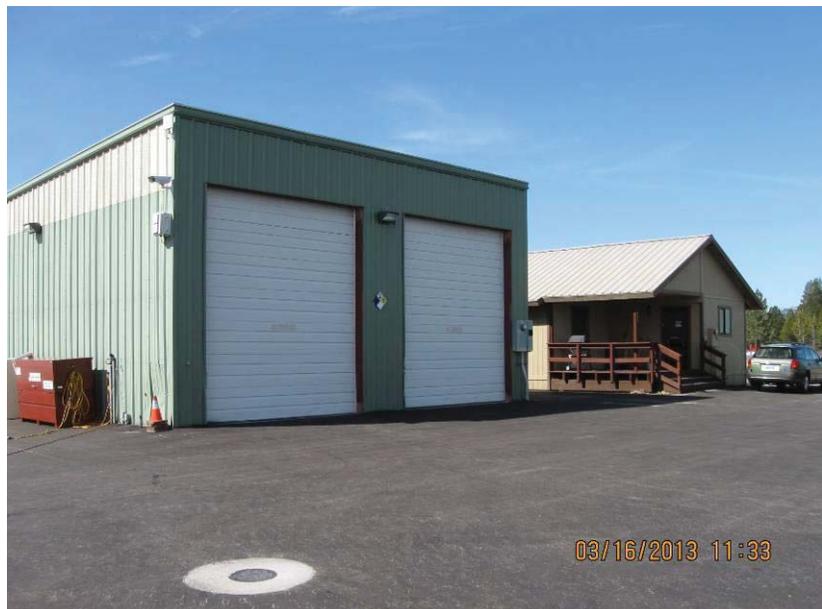
The garage is constructed of factory coated corrugated metal siding and roll-up doors. The coating is in good condition with no delaminations and only minor rust (Photo 12). The rust is primarily restricted to areas of wear or damage to the siding.

The coating on both the siding and roll-up doors is tightly adhered to the substrate and free of chalk.

Photo 12 shows a general view of the garage.

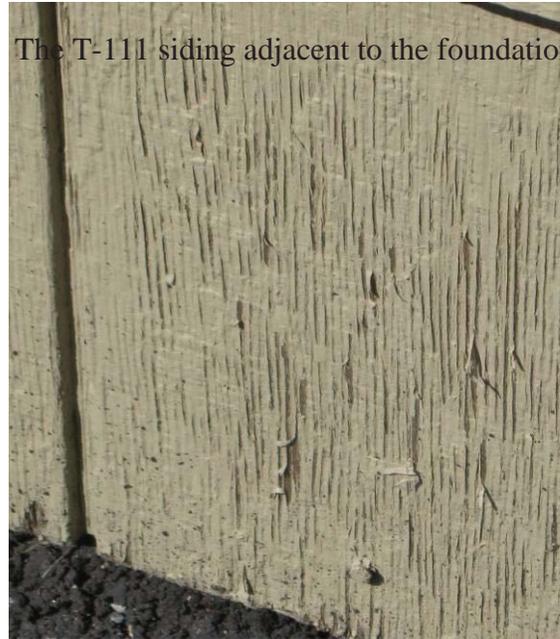
The T-111 siding is generally good condition. Only a minor amount of degradation (splintering as a result of exposure to water) was observed along base of the building.

Photo 14 shows the typical condition of the T-111 siding at the base of the building.

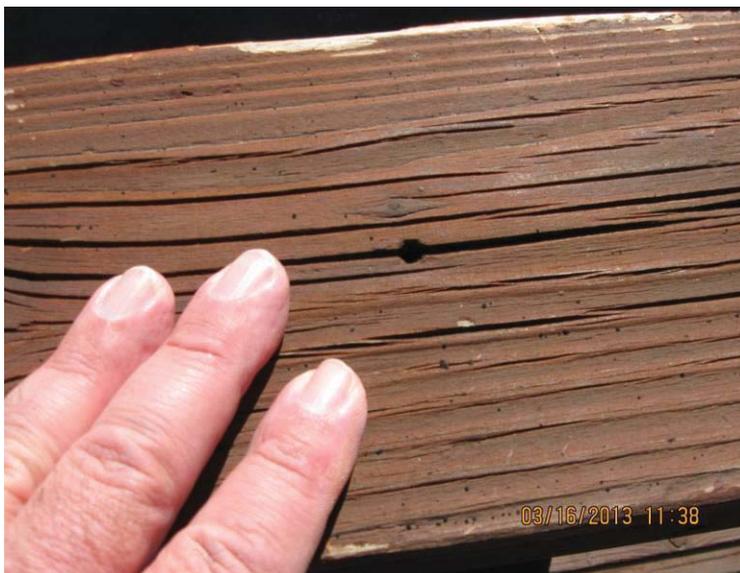
Photo 15 shows the general condition of the handrails.

The top surfaces of the wood handrails, however, are heavily cracked (Photo 15).

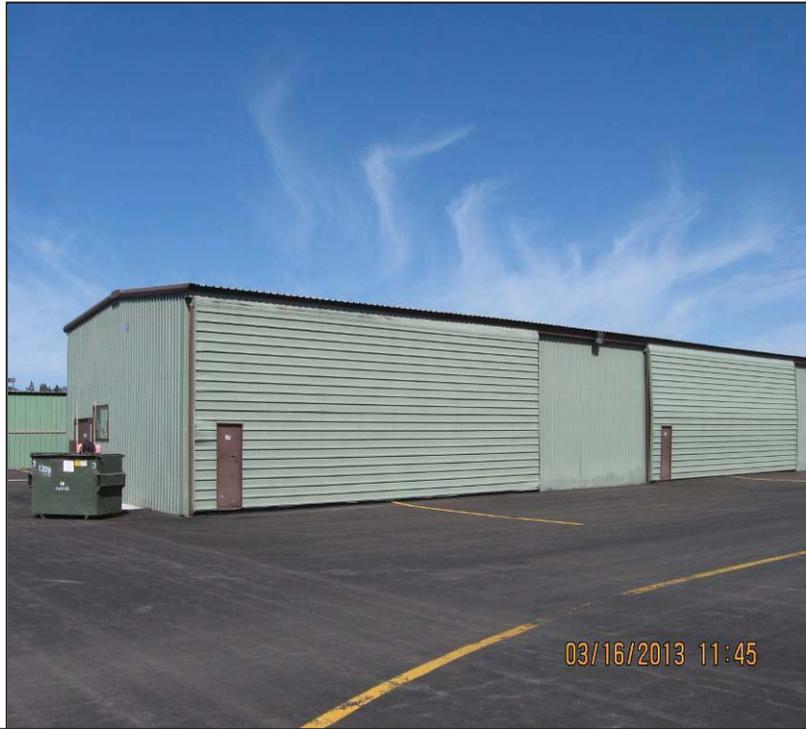
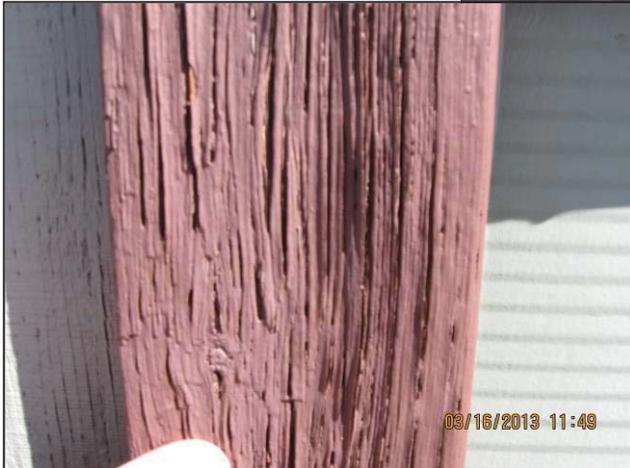
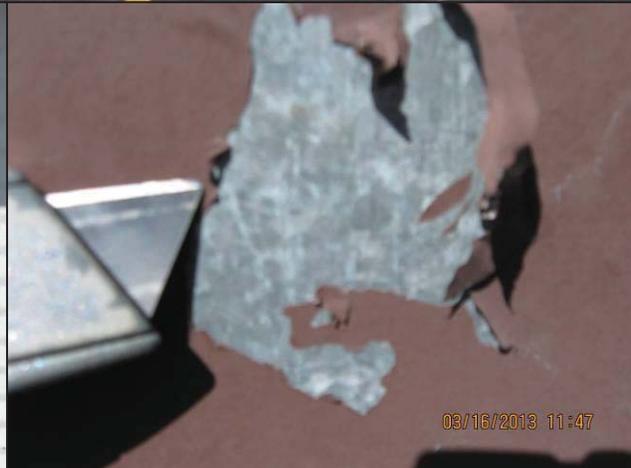
Hangar J was repainted several years ago and is constructed of corrugated metal panels. Adhesion tests indicated that the coating is tightly adhered to the substrate. The coating is in good condition with only mild chalk (ASTM D4214: 6).

The hangar has painted galvanized steel doors some of which have wood frames. The coating on the doors has faded and is poorly bonded to the substrate. It is also heavily chalked (ASTM D42451: 2). The wood trim is heavily cracked.

Photo 16 (top) shows a general view of Hangar J. Photo 17 (bottom, left) shows the condition of the wood frames around the doors. Photo 18 (bottom, right) shows the condition of the coatings applied to the galvanized steel doors.

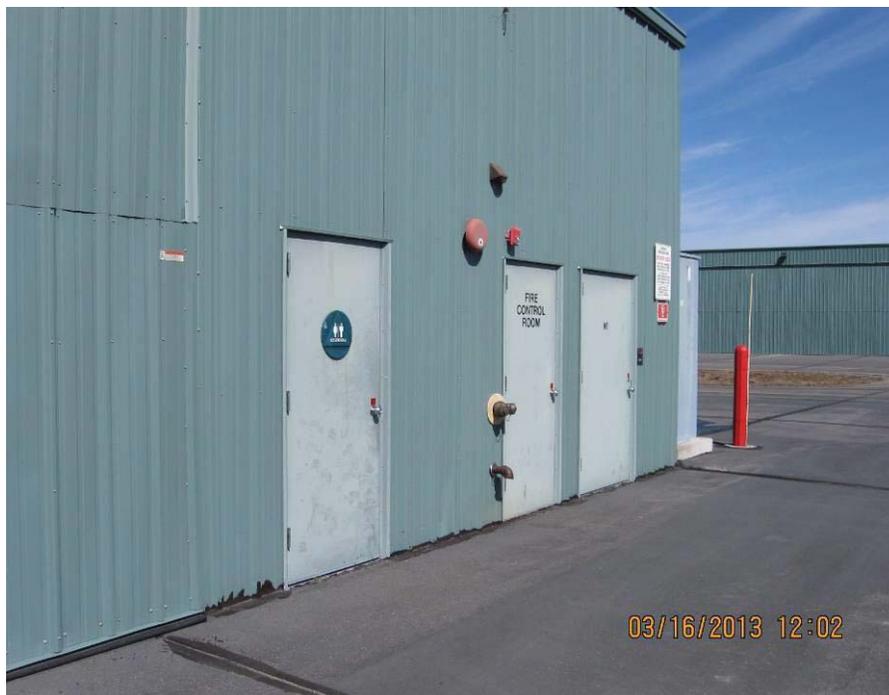
Photo 22 shows the door coatings that have faded.

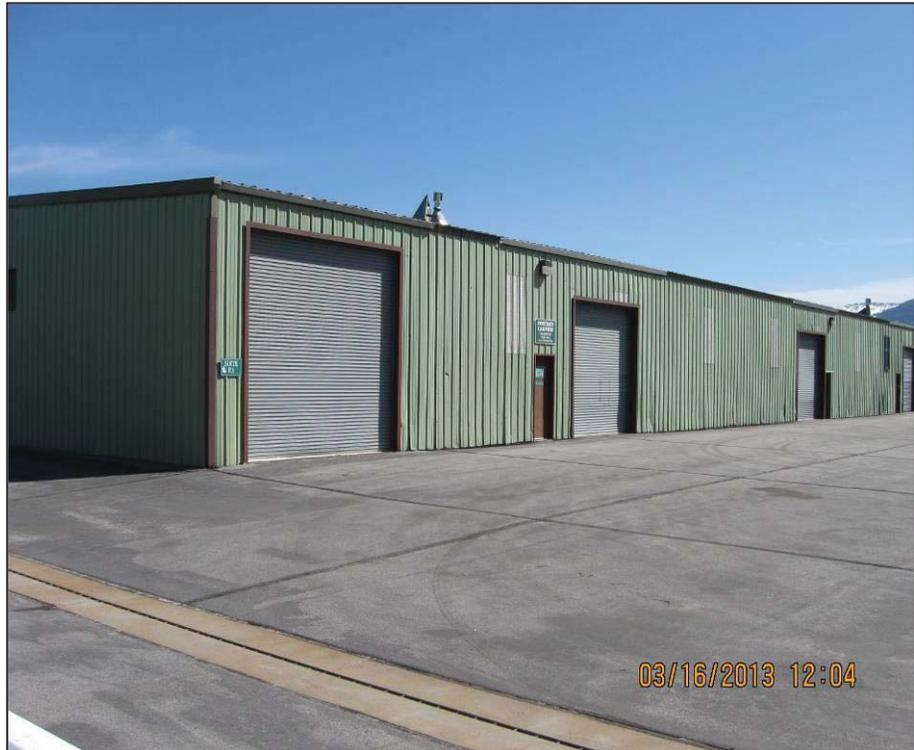
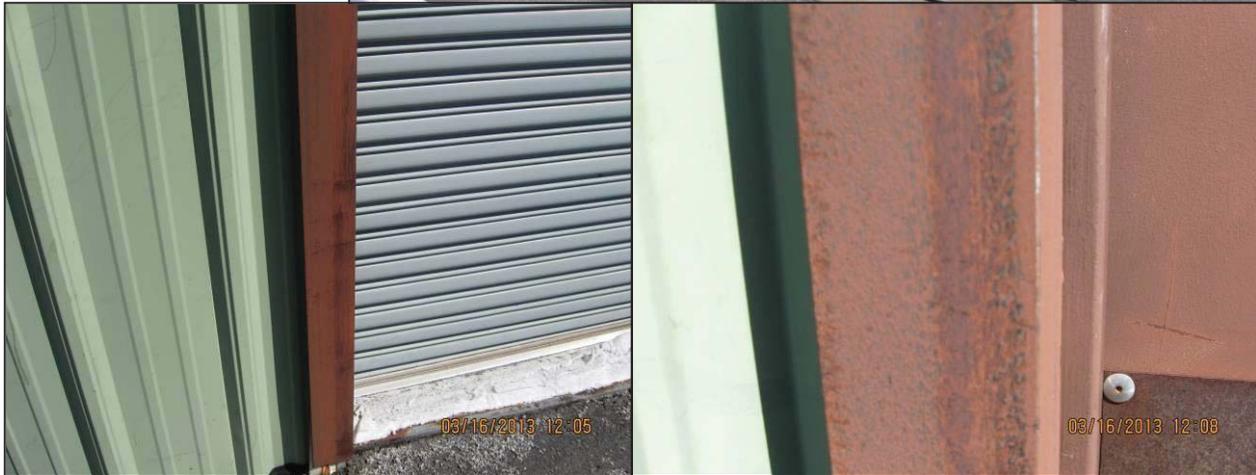
Most of the warehouse siding has the original factory finish (Photo 23). This coating is free of rust and chalk and tightly adhered to the substrate. The end of the warehouse has been repainted and is also free from rust, chalk and other failures.

The door frames are unpainted and covered in tightly adherent pinpoint rust (Photo 24). The doors, while painted are rusty as well (Photo 25).

Photo 23 (top) shows a general view of the warehouse. Photos 24 and 25 (bottom, left and right) shows the rusted steel frames and doors (right).

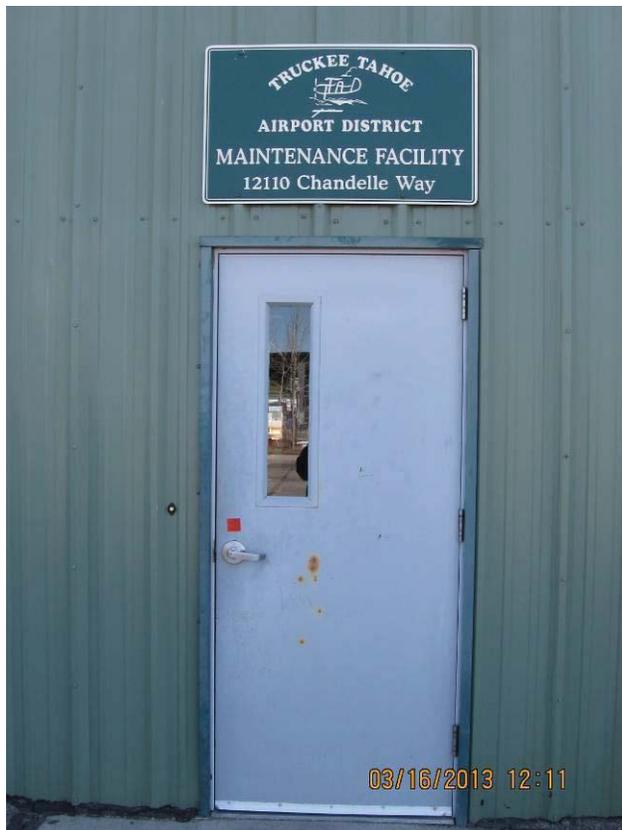
The coating on the personnel door is heavily chalked and pinpoint rust is poking through at a number of locations (Photo 26).

Photo 26 shows the general condition of the personnel door on the Maintenance Facility.

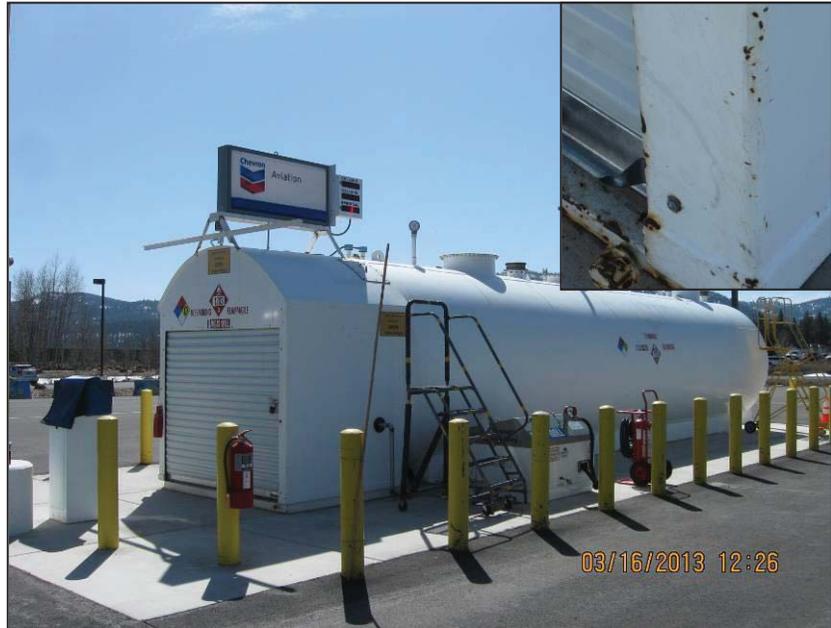
The self serve facility consists of a horizontal tank with a shed attached to the front of the tank. The coating is glossy and has only a few areas of rust that were likely caused by impact damage (Photo 27).

The applied coating is tightly adherent to the substrate and ranges between 8 and 11.4 mils in thickness.

Photo 27 shows a general view of the Self Serve Facility.

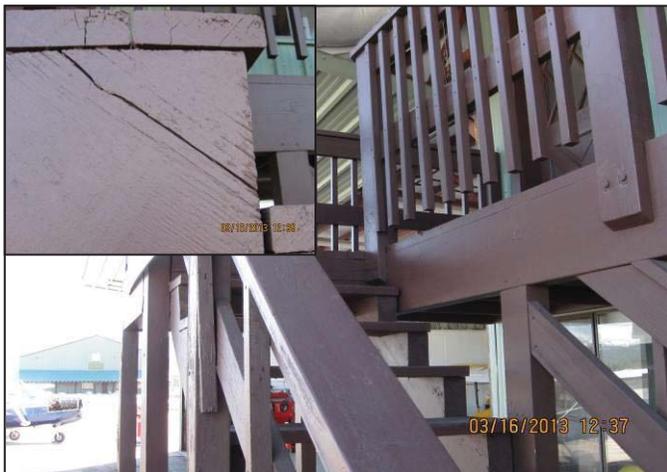
substrate in most locations. The only areas of damage were found on the stair stringers which were moderately cracked (Photo 29).

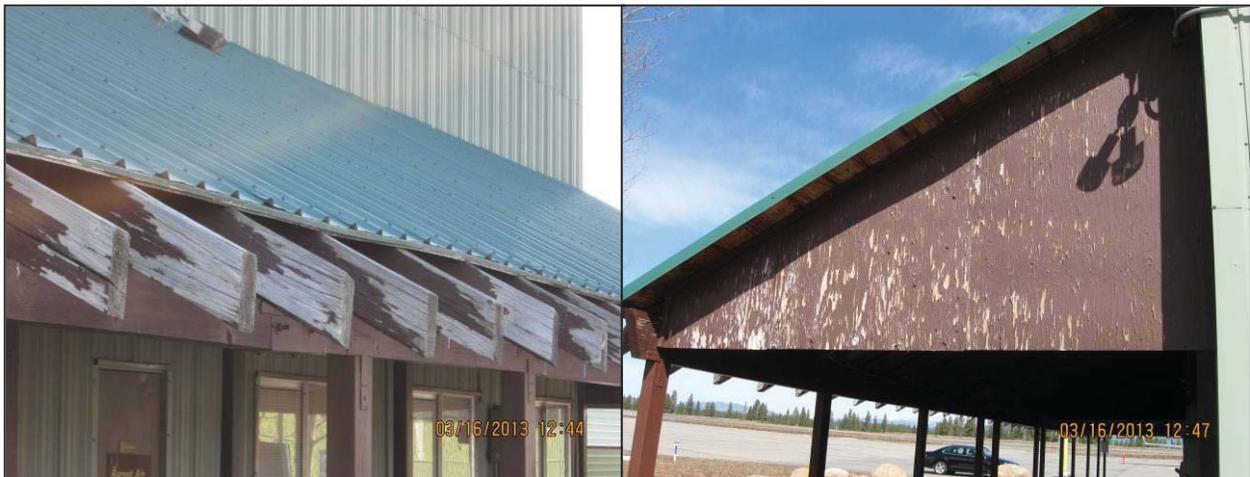
The coating has delaminated from the wood rafter tails on the first floor porch and the substrate is heavily cracked and is severely oxidized (Photo 35). Similar conditions were observed on plywood fascia pieces at the end of the porch. The eaves are unpainted (Photo 36). Coating adhesion varies on the wood surfaces from good to poor.

Photo 35 (left) shows the condition of the rafter tails. Note that most of the paint is gone and the substrate is heavily cracked. Photo 36 (right) shows the condition of the plywood on the southwest side of the building. The coating is delaminating and the substrate is degraded. Note that the eaves are unpainted.

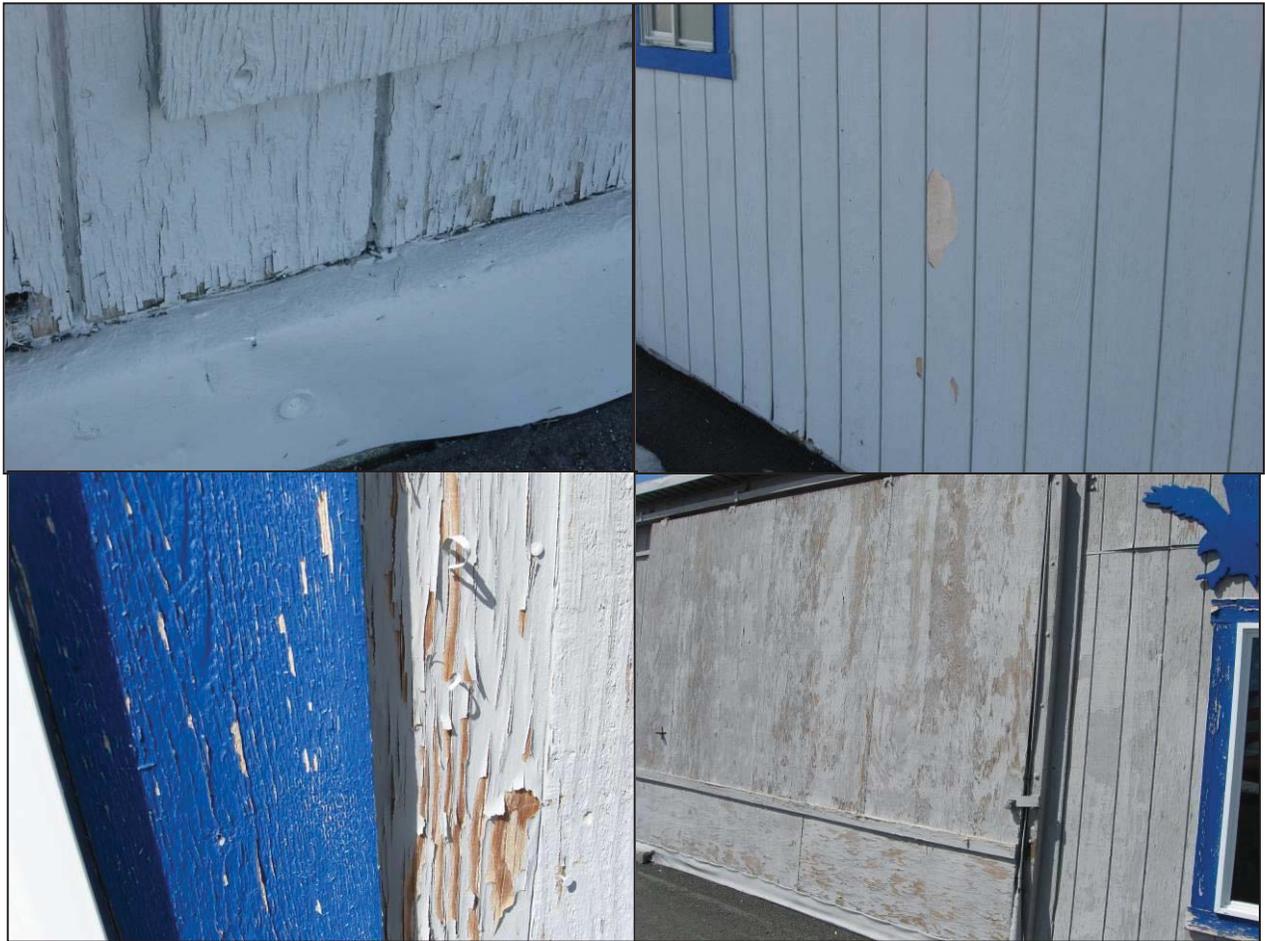
The front of the building is in good condition. There is no evidence of any coating delamination or damaged wood. The only evidence of damage is along the base of the building where the wood grain is lifting (Photo 38). The joint between the siding and the flashing is uncaulked and is allowing moisture to penetrate into the wood, subsequently resulting in coating delaminations and wood rot. The other sides of the building have many coating delaminations on the siding (Photo 39), the window trim (Photo 40) and the plywood (Photo 41). The plywood is degraded. Adhesion test conducted on the wood surfaces indicated poor coating adhesion in the heavily failed areas.

Photo 38 (upper, left) shows the condition of the siding where it meets the flashing. Photo 39 (upper, right) shows a delamination on the siding. Photo 40 (lower, left) shows delaminating wood trim. Photo 41 (lower, right) shows delaminations on the plywood.

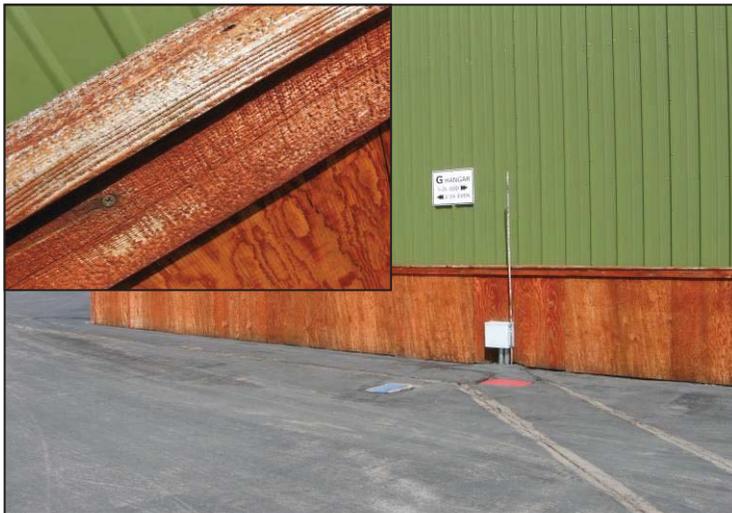
Hangars F and G have stained wood and plywood wainscot at the south end of the building (Photo 43). The wood is oxidized and mildly cracked in some areas.

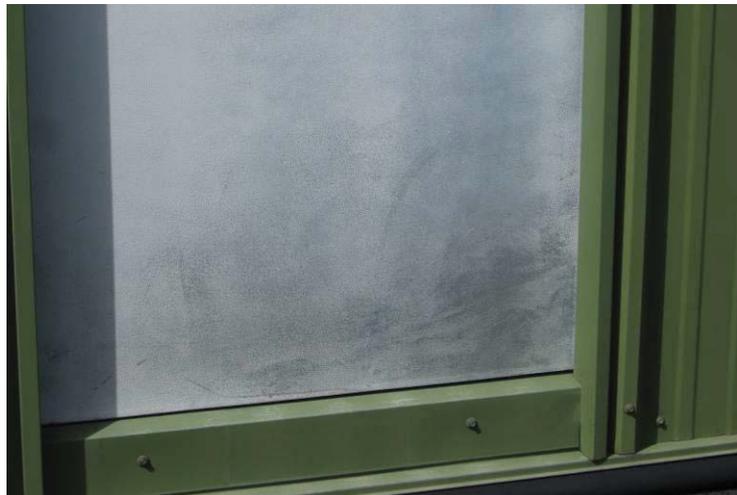
There are textured aluminum doors with the original factory finish. The coating is in good condition in most areas, but is worn away on some doors (Photo 44).

Photo 44 shows a door with worn factory finish.

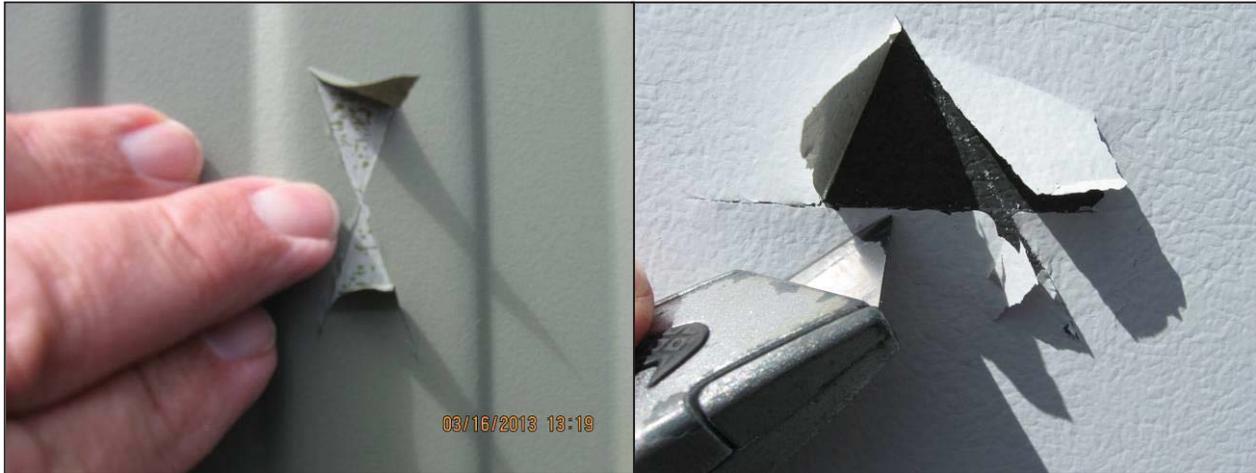
Hangars C, D and E, while similar in construction to Hangars F, G and H, have been recently repainted. Maintenance painting work was completed on both the siding and the textured aluminum doors. The applied coatings appear to be in good condition with no evidence of rust or delaminations. However, the coatings applied to the siding and doors on Hangar D are poorly adhered to the substrate (Photos 45 and 46)). Adhesion tests conducted on representative areas of the siding and doors on Hangars C and E showed good coating adhesion in all areas tested. The only difference between the two conditions was that the coatings applied to Hangar D was several mils thicker than on Hangars C and E.

Photo 45 (left) shows the results of an adhesion test conducted on the siding on Hangar D. Photo 46 (right) shows a test conducted on an aluminum door.

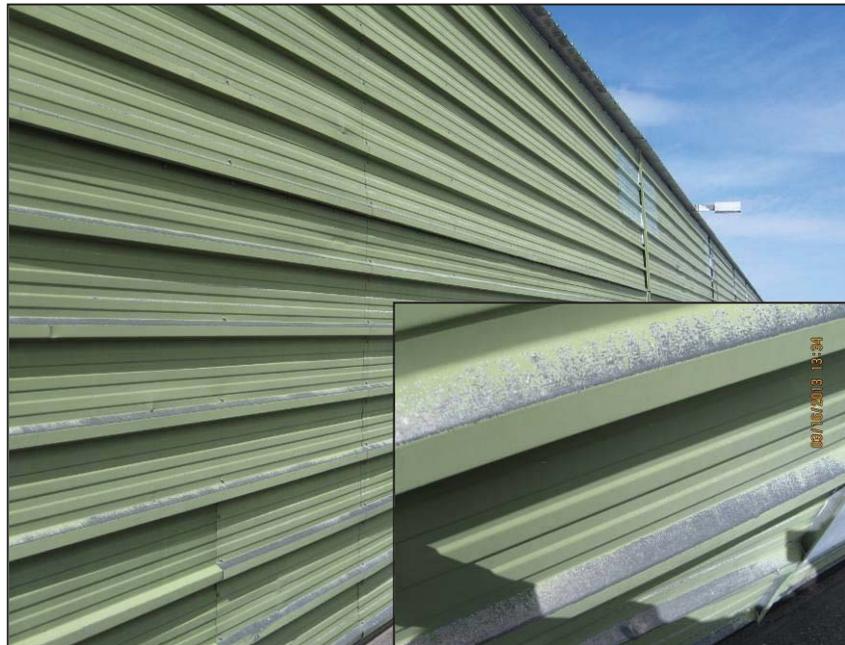
Hangars A and B are sided with corrugated panels. The panels have the original factory finish. The coating is worn away in many areas on the southeast side of the hangars (Photo 47). The condition is worse on Hangar B. Galvanized steel is exposed where the coating has worn away.

Photo 47 shows the condition of the siding on the southeast façade of Hangars A and B. Note the exposed galvanized steel.

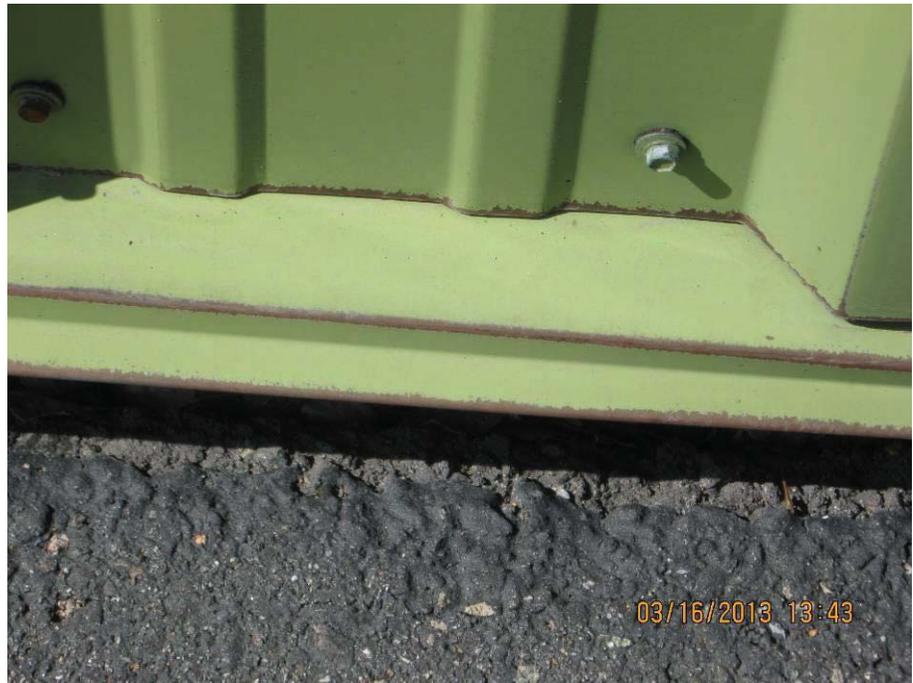
Photo 48 shows the rust that has formed on the edges of the galvanized steel.

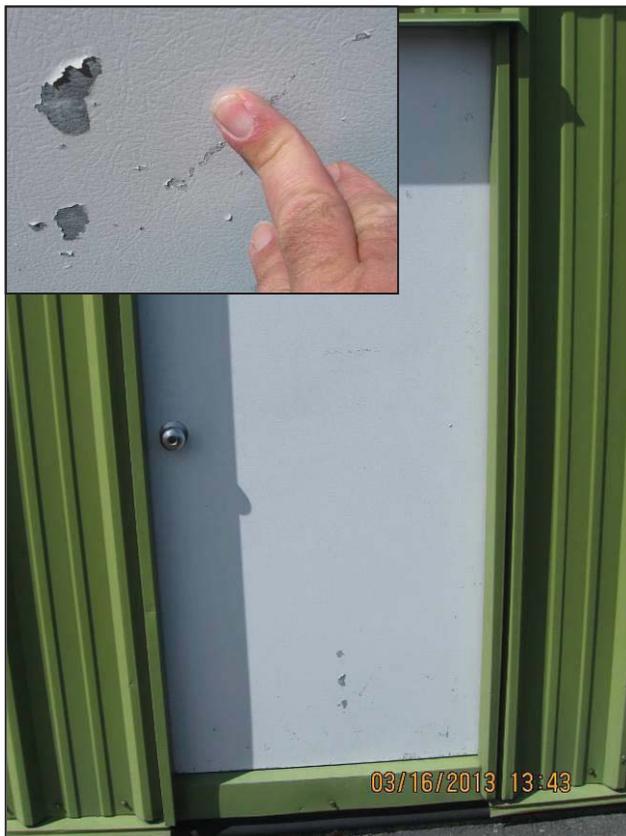
The doors on the hangars have the original factory finish. The doors are glossy and free of chalk. However, the doors on Hangar A have a number of coating delaminations (Photo 49).

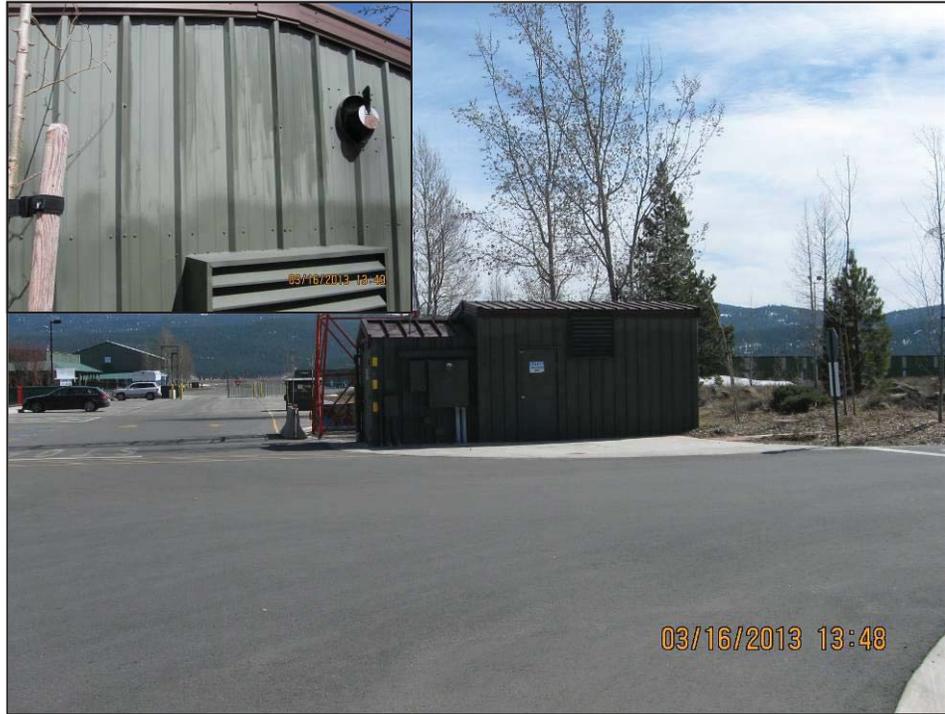
The Generator Building, another corrugated metal sided building appears to have been partially repainted at some time. There are two different colors on the panels (Photo 50). There is no evidence of rust. Adhesion tests indicated that the coating is tightly adhered to the substrate.

Photo 50 shows the condition of the corrugated siding on the Generator Building. Note the two different color paints.

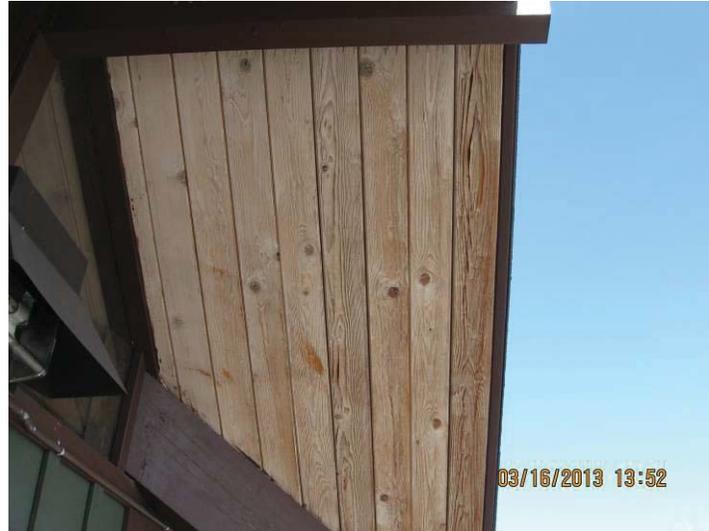
The exposed underside of the eaves is not coated (Photo 52). The wood is heavily oxidized (gray in color).

Photo 52 shows the unpainted wood under the eaves.

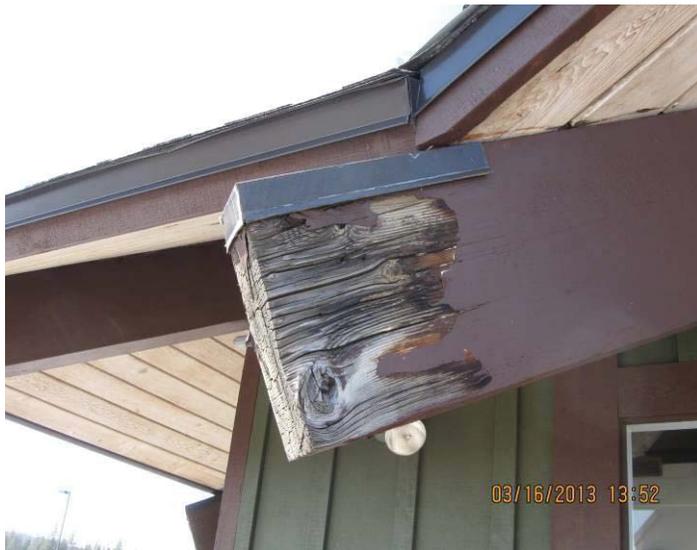
The rafter tails, while protected from rain with an aluminum collar, have significant coating delamination on the ends where they are exposed to weather. In addition the substrate is heavily cracked (Photo 53).

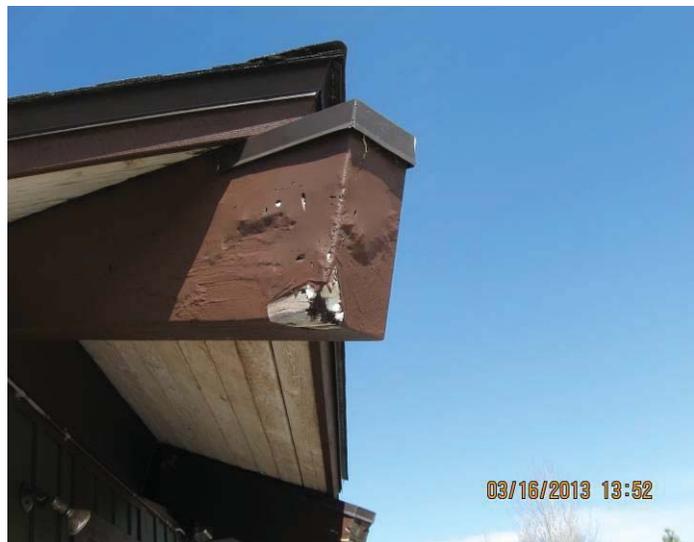
While attempts were made to fill in the cracks with what appears to be a trowel grade caulk, moisture still penetrates the coating film and continues to cause degradation of the wood substrate (Photo 54).

Photo 54 shows the results of spackling the rafter tails with a knife grade caulk.

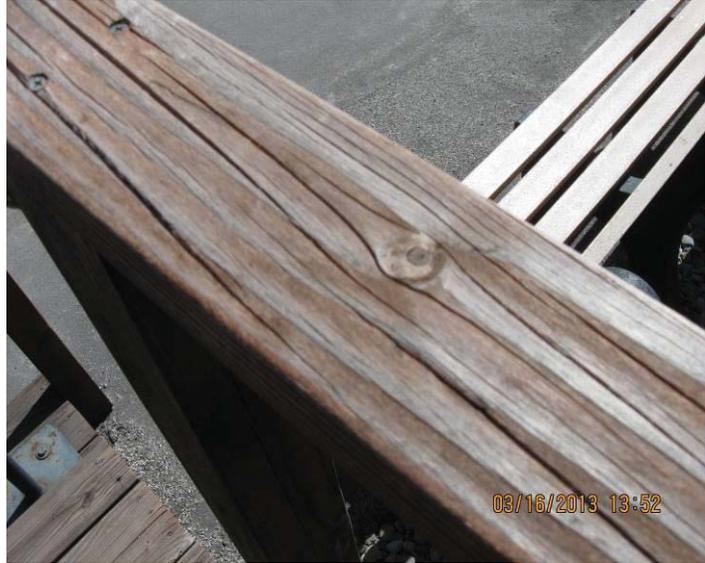
The front porch surfaces are stained. Except for the handrails the wood is in good condition. The handrails, however, are heavily cracked (Photo 55).

Photo 55 shows the condition of the handrails on the porch.
