National Transportation Safety Board Aviation Accident Preliminary Report

Location:	Truckee, CA	Accident Number:	WPR21FA286
Date & Time:	July 26, 2021, 13:18 Local	Registration:	N605TR
Aircraft:	BOMBARDIER INC CL-600-2B16	Injuries:	6 Fatal
Flight Conducted Under:	Part 91: General aviation - Personal

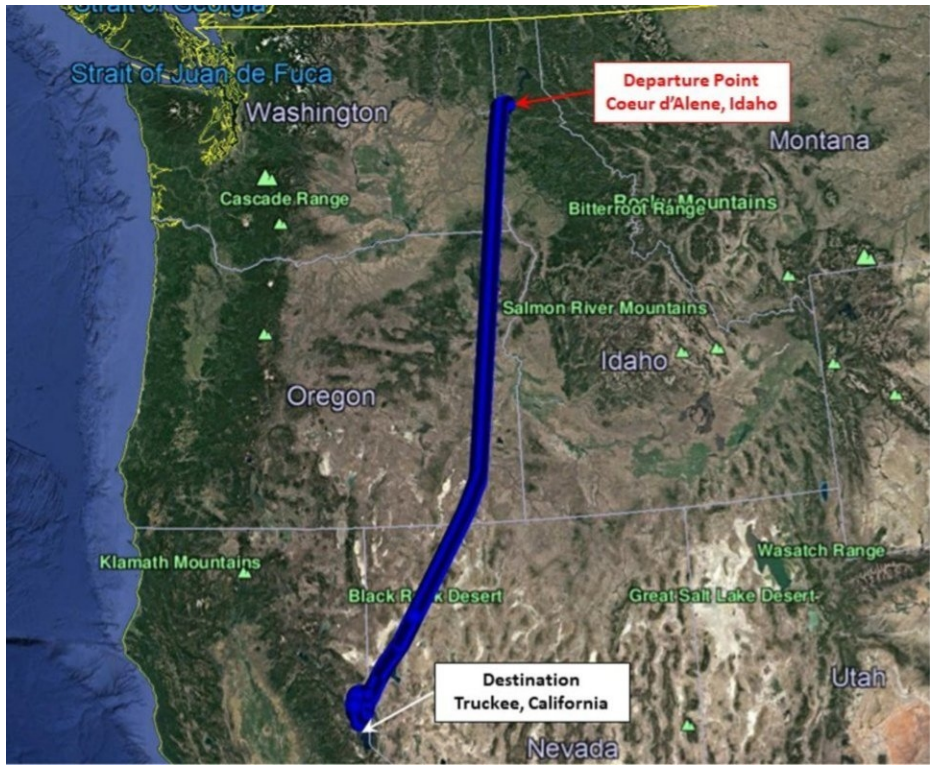
According to automatic dependent surveillance-broadcast (ADS-B) data and preliminary air traffic control (ATC) audio from the Federal Aviation Administration, the airplane departed Coeur d'Alene, Idaho, about 1145 (see Figure 1) and made a left turn to the south. The flight crew was in contact with ATC throughout the duration of the flight. As the airplane was passing over northwestern Nevada, ATC began issuing descent instructions for the airplane's approach into Truckee-Tahoe Airport (TRK). Once the airplane descended below 26,000 ft, ATC advised the flight crew to expect the RNAV (GPS) Runway 20 approach at TRK. The flight crew accepted the approach but requested to circle to runway 11 for the longer runway and the controller told them to expect the circling approach. After coordinating with the TRK tower, the controller informed the flight crew that they would be number two for TRK and could expect some delays. ATC then cleared the airplane to hold north of the ALVAA waypoint, the initial approach fix to the RNAV runway 20 approach. After one turn in holding (see Figure 2), ATC cleared the airplane for the RNAV runway 20 approach, cancelled radar services, and instructed the pilot to contact the TRK tower. The flight crew established communication with the TRK tower controller when they were near the LUMMO waypoint, located about 9.6 nm north of the approach end of runway 20. The tower controller offered the flight crew the option of crossing over the field and enter the left downwind leg for runway 29 or to enter downwind leg for runway 11. Once the flight crew announced they were making a right turn (see Figure 3) and reported runway 11 in sight, the controller then cleared them to land on runway 11 and informed them that the airplane was not in sight. The flight crew acknowledged the clearance, which was their final radio communication.

Figure 1: N605TR flight path

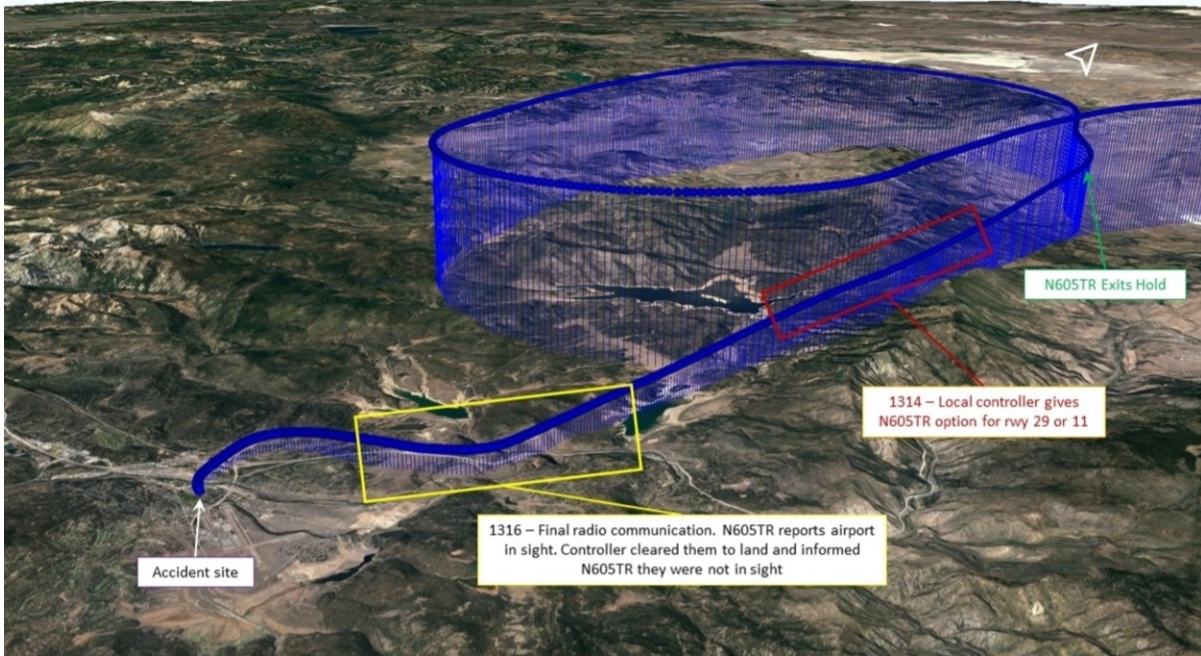
Figure 2: N605TR Holding pattern and approach to Truckee-Tahoe airport

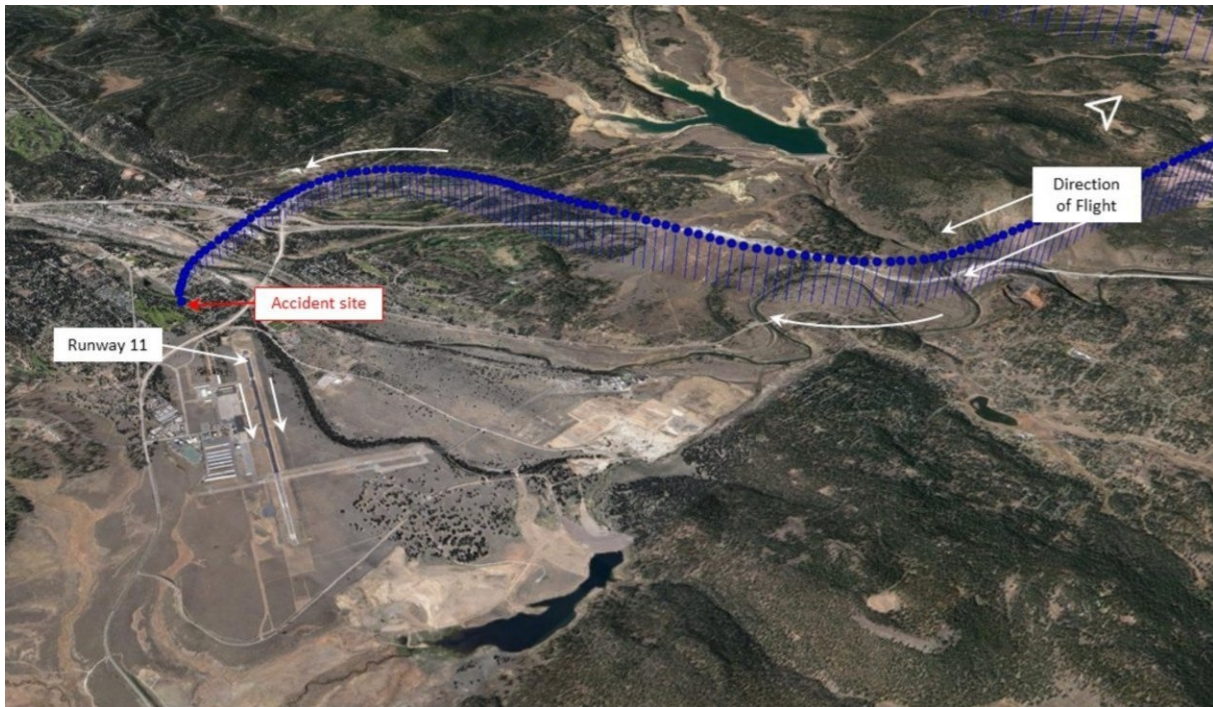
Figure 3: Truckee-Tahoe airport and N605TR flight path

Multiple eyewitnesses observed the airplane before the crash. Some reported that the airplane caught their attention because of its low altitude and abnormal flight path into runway 11. According to witnesses, the airplane was in a nose down attitude and steep left turn during its last few seconds of flight. A witness located about 50 ft from the accident site reported that he observed the airplane come from the northwest about 20 ft above the trees. The airplane then entered a steep left turn and banked erratically just before it impacted trees and then the ground. The witnesses close to the accident site stated that the airplane appeared intact when they first observed it.

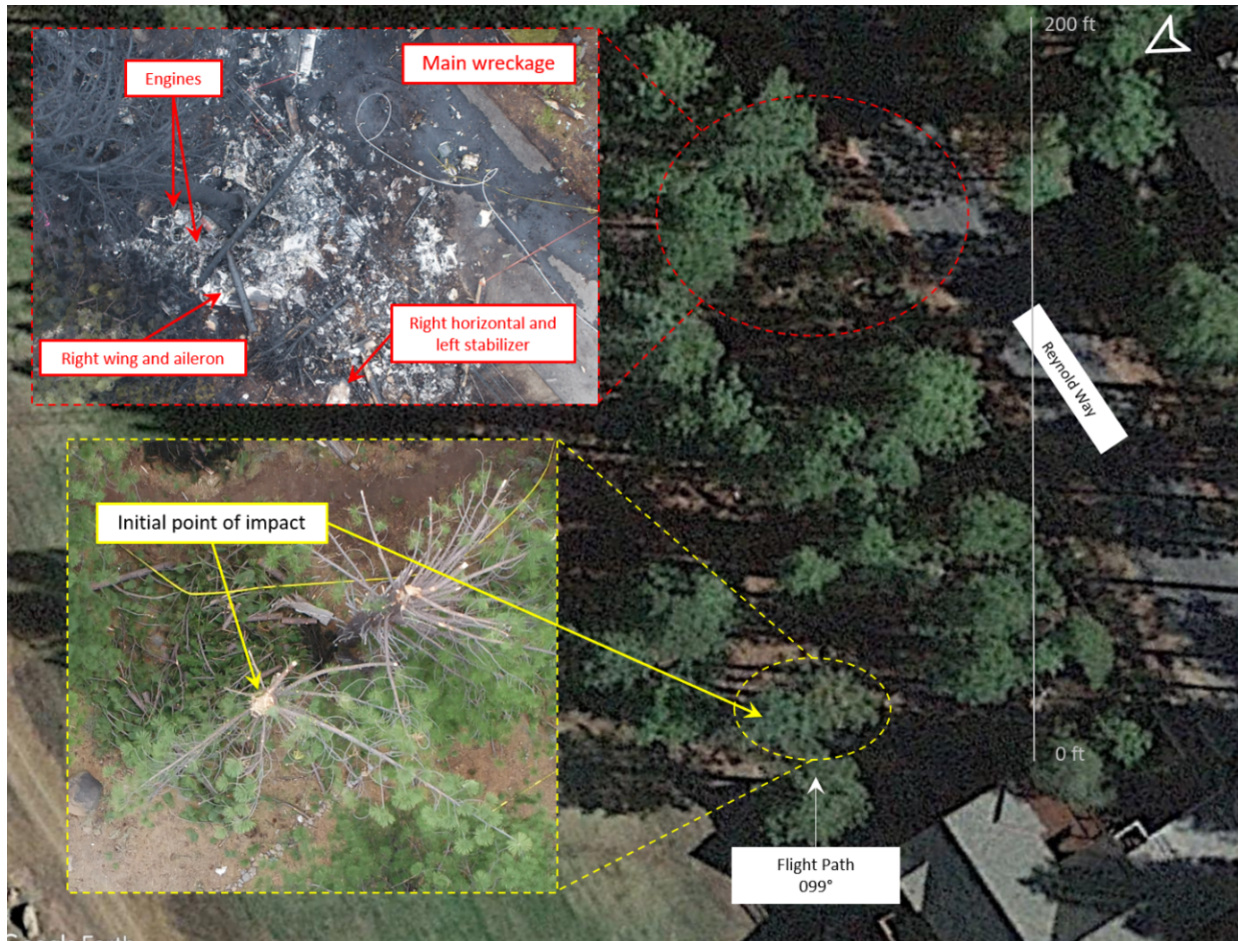
The accident site was located on a hillside between a golf course fairway and a residential street. The airplane was consumed by postcrash fire. A debris path, which measured about 225 ft long and 85 ft wide was marked by several broken trees and was oriented on an easterly heading. (see Figure 4). The initial point of impact was identified by a severed tree that stood about 70 ft tall, located about 120 ft west of the main wreckage. Portions of the right and left wings and control surfaces were found fragmented along the debris path. Additional airframe fragments were collocated with the main wreckage, which was comprised of both engines, the empennage, and fuselage remnants.

Figure 4: Wreckage path and diagram
