# Aviation Investigation Final Report

<b>Location:</b>	Truckee, California	<b>Accident Number:</b>	WPR21FA228
<b>Date &amp; Time:</b>	June 15, 2021, 10:45 Local	<b>Registration:</b>	N89423
<b>Aircraft:</b>	CIRRUS DESIGN CORP SR20	<b>Aircraft Damage:</b>	Substantial
<b>Defining Event:</b>	Loss of control in flight	<b>Injuries:</b>	1 Fatal, 1 Serious
<b>Flight Conducted Under:</b>	Part 91: General aviation - Instructional

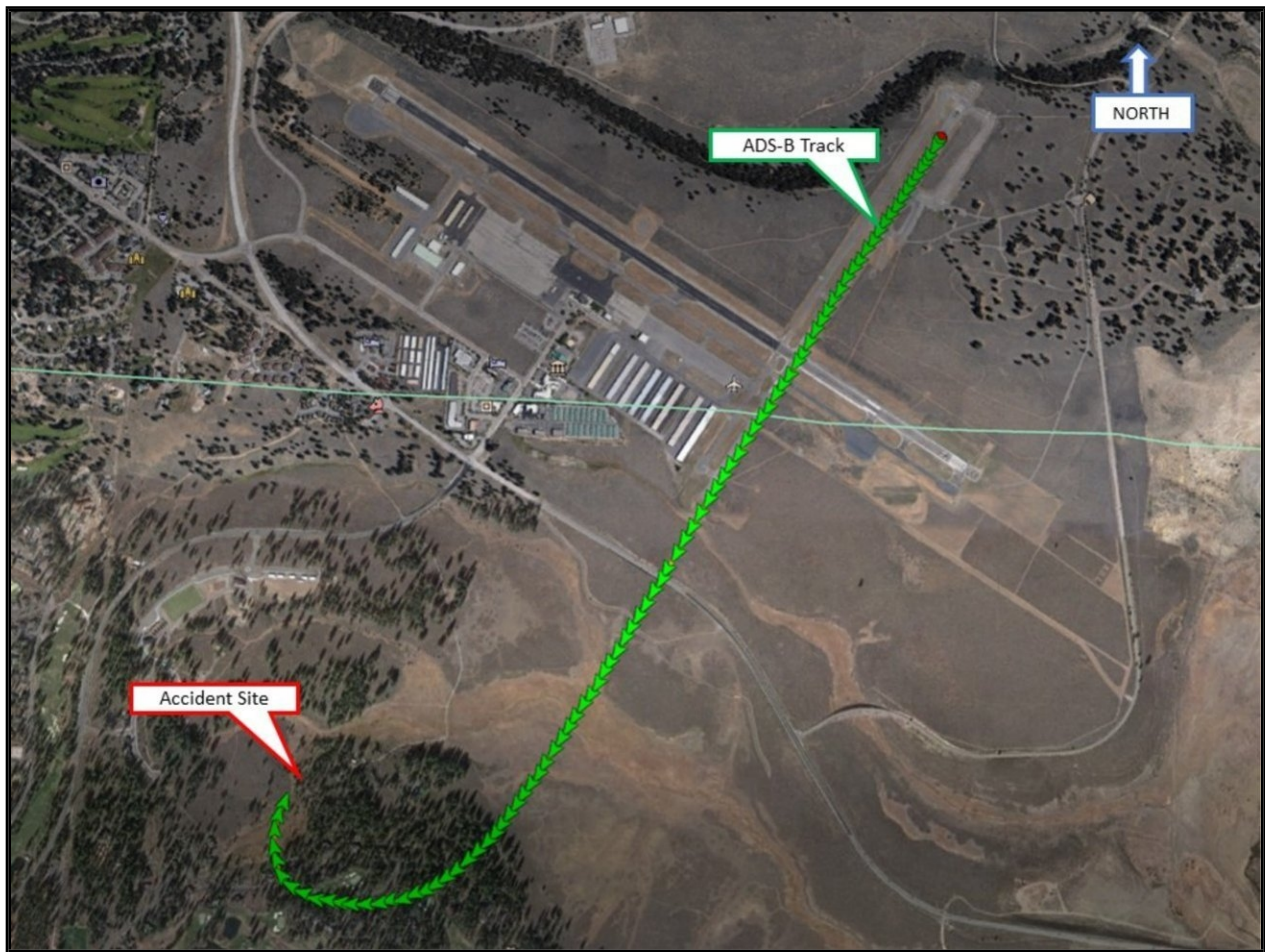
Recorded automatic dependent surveillance-broadcast (ADS-B) data provided by the Federal Aviation Administration (FAA) showed that the airplane departed at 1042:49 and that, at 1044:05, it had climbed to an altitude of 6,325 ft and was flying along a southwesterly heading. At 1044:14, the airplane was at an altitude of 6,300 ft and on a northerly heading. The airplane remained on a northerly heading and continued to descend. The last ADS-B data point, at 1044:21, indicated that the airplane was at an altitude of 6,050 ft and was about 116 ft south of the accident site. Figure 1 shows the airplane's flight track.

**Figure 1.** Airplane flight track based on ADS-B data.

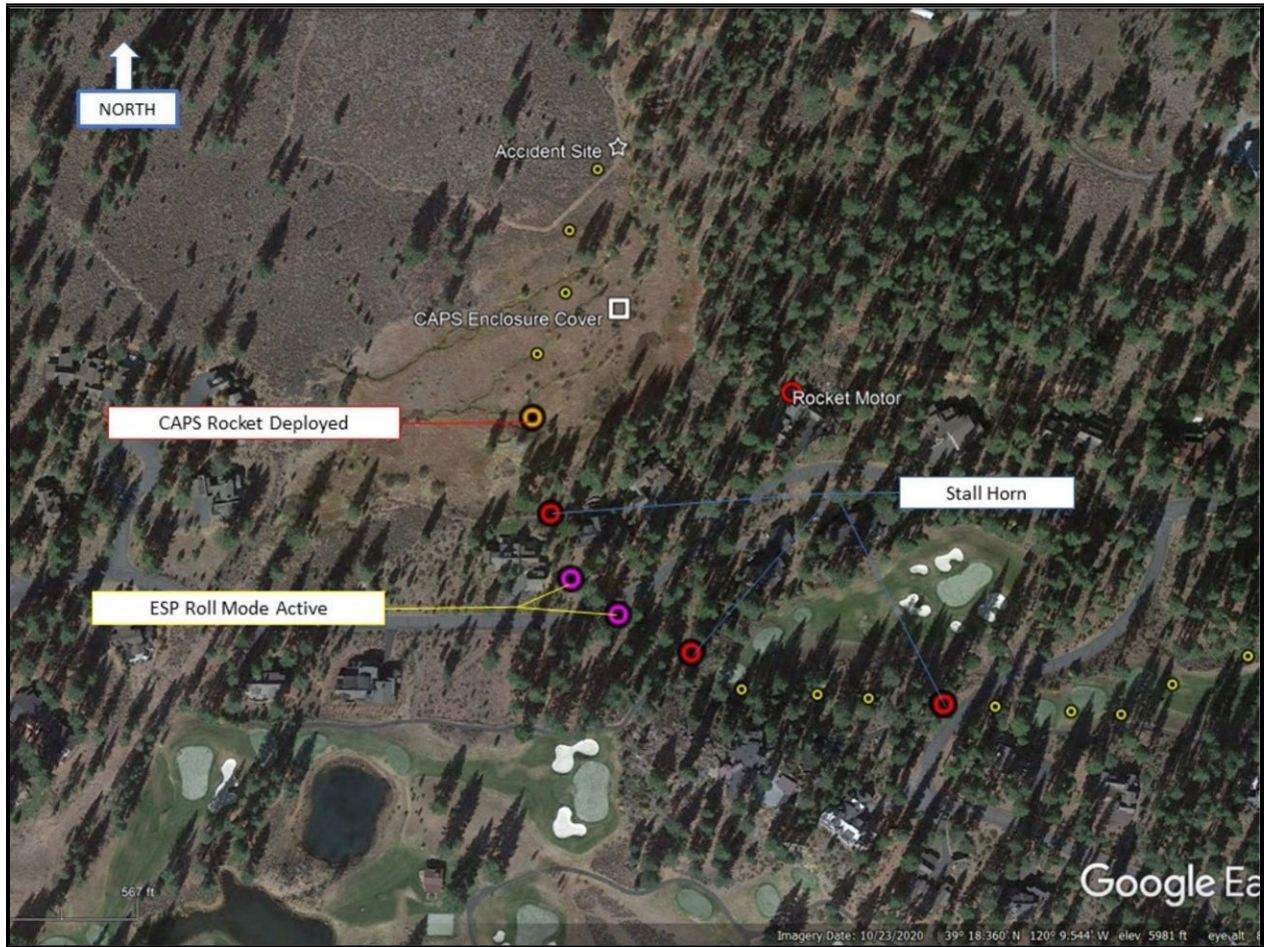
The airplane's RDM showed that, throughout the flight, the flap switch was at the 50% position. The RDM also showed that the stall warning activated three times: at 1044:09 with an indicated airspeed of 69 knots, a 12° pitch attitude, and an 11° bank; at 1044:13 with an indicated airspeed of 78 knots, a 4° pitch attitude, and a 36° bank; and at 1044:16 with an indicated airspeed of 71 knots, a -16° pitch attitude, and an 81° bank. The ESP system activated in roll mode at 1044:14 and 1044:15 as the airplane entered a steep right roll. The CAPS activated shortly thereafter, and the recording ended at 1044:21. Figure 2 shows the RDM data overlaid on an image of the area surrounding the accident site.

**Figure 2.** Airplane’s flightpath along with RDM-recorded events.
