Utilities Maintenance Plan

Truckee Tahoe Airport District

Approved October 29, 2014

Acumen Engineering

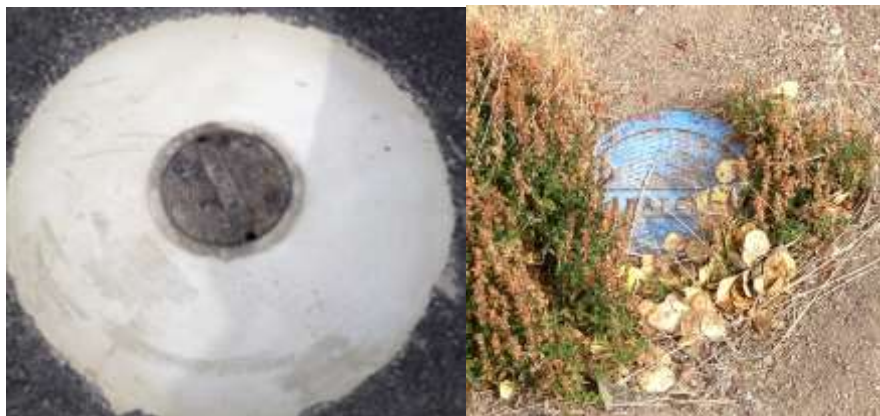
Water System Valves

2. All mainline, fire hydrant and building service valve boxes should be cleaned and the valves exercised at least bi-annually. This preventative maintenance effort will ensure the valves are accessible and functional when circumstances require. If a building's shutoff valve cannot be located, a new valve should be installed.

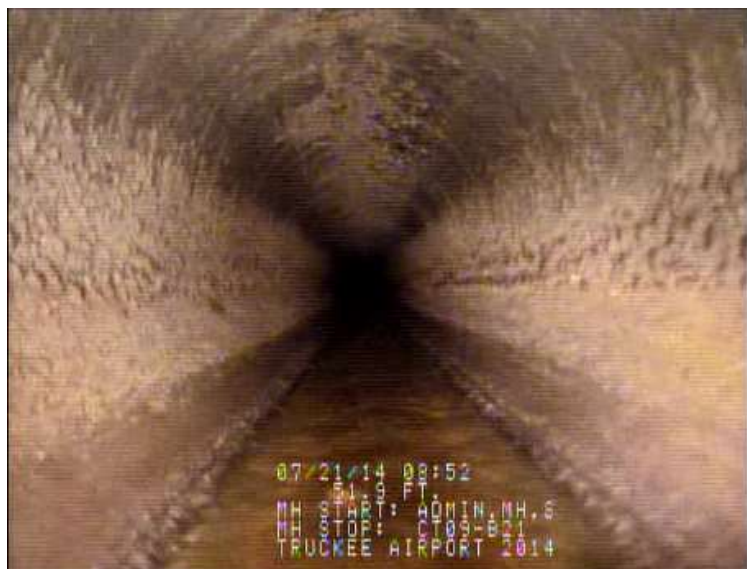
Interior of sanitary sewer pipe serving Administration Building

1. No sanitary sewer infrastructure replacement is proposed, the condition of the pipelines and manholes is considered good to very good.
2. All building cleanouts should be located, repaired as necessary and a box installed to provide protection from damage and ease in locating.

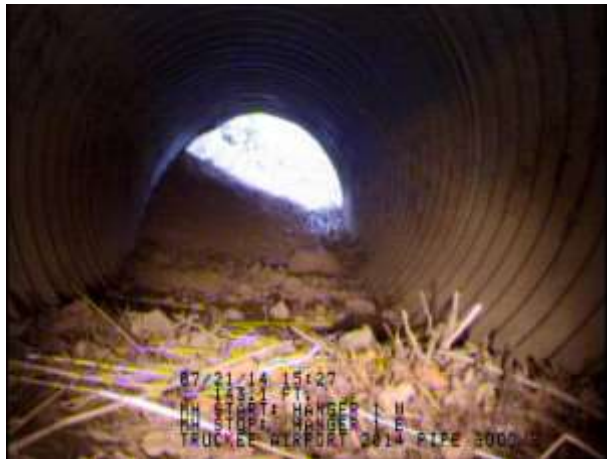
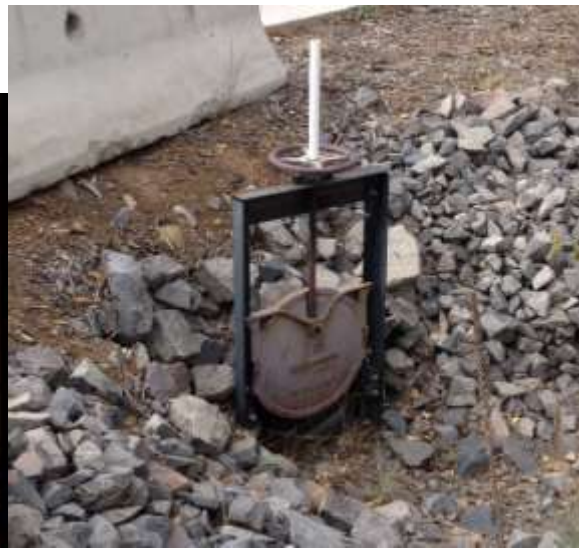
Storm Drain Pipe and Slide Gate

1. No storm drain infrastructure replacement is proposed. The condition of the pipelines and drainage inlets is considered good to very good with the exception of the slotted drain between Hangar Buildings G and H which is planned for replacement in 2015 when that taxilane is reconstructed. The condition of the remaining infrastructure should be assessed whenever repairs to the overlying pavement are planned.
2. The pipe and drainage swale network should be inspected annually and cleaned of rocks and sediment when necessary to maximize flow capacity. Accumulated sediment and
