#### **SUMMARY**

Ref: Electrical Inspections of TTAD Facilities

We have inspected many of the TTAD facilities for National Electric Code compliance. The summary of that effort is attached, a written executive report and a set of annotated pictures.

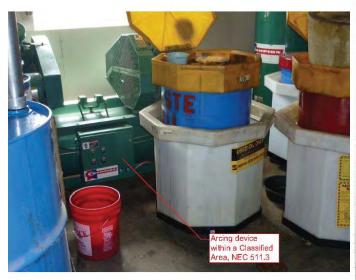
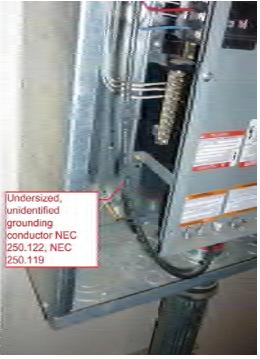
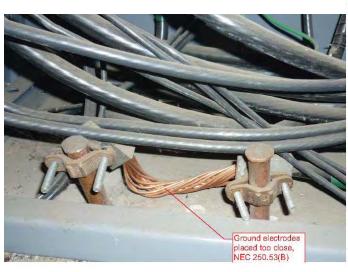
### Maintenance Building

**Permanent Buildings**: Snow and ice damage to electrical enclosures, improper grounding of system and equipment, open wiring enclosures accessible to non-qualified persons, moisture in panels from improper application of conduit fittings.

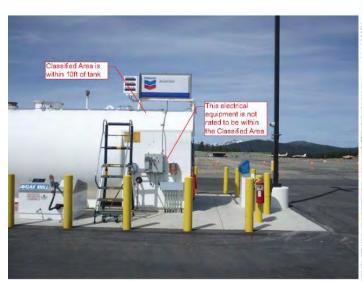
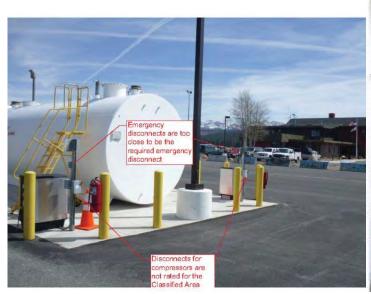
#### Fuel Island

**Airport Fuel Island**: Vapors and liquid from fueling systems are particularly dangerous when mixed with arcing electrical contacts. The NEC deals with this by defining boundaries for hazardous (Classified) areas such as in the vicinity of fuel storage and transfer systems and requiring certain methods and materials within these boundaries. One of the requirements is to have an emergency disconnect farther than 20ft but not greater than 100ft from the dispensing point. This requirement is not met. Also, electrical

equipment not rated for installation in a Classified area is installed within those areas. If fuel vapor were to be present, arcing in the unsealed contacts in ordinary electrical equipment could ignite it.
