TRUCKEE-TAHOE AIRPORT Pavement Evaluation Study Pavement Maintenance/Management Plan

NOVEMBER, 2011 (UPDATED DECEMBER 2014)

**TRUCKEE TAHOE AIRPORT
PAVEMENT EVALUATION STUDY
PAVEMENT MAINTENANCE/MANAGEMENT PLAN**

*Prepared by:
Reinard W. Brandley
Consulting Airport Engineer*

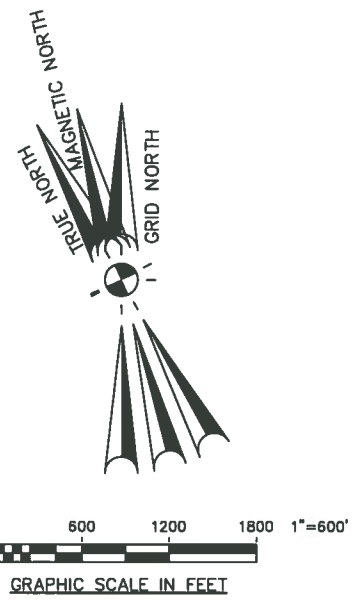
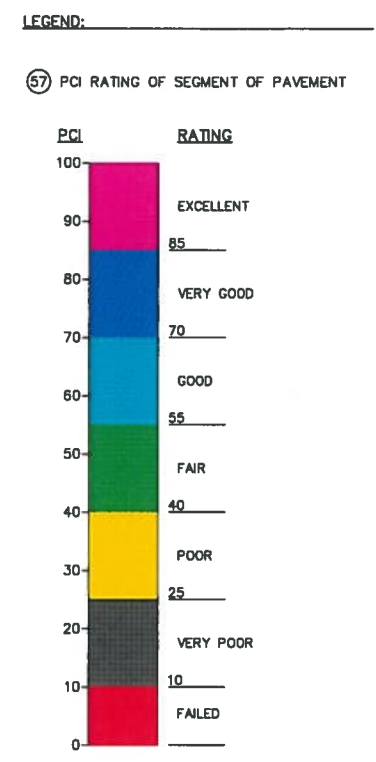
The ASTM Standard provides a relationship between Pavement Condition Index (PCI) and pavement rating. On Plates No. 2-1a and 2-1b the rating system is indicated as a color legend and the rating of each segment of pavement is indicated by color. The PCI of each segment is also indicated adjacent to each segment of the pavement. It will be noted that in 2013 most pavements at the airport range from the “fair” to “excellent” condition. The South Jet Apron and Portions of Taxiway A are rated as “poor”, and Apron A4 and run-up areas at Taxiways B and H are rated “very poor”.

Pavement Condition Index (PCI) values for each section of pavement were determined in 2011. Updated PCI values for all pavement sections were determined in the 2013 update study, including new and existing sections. The original (2011) PCI values and updated (2013) PCI values are included in this updated report to show how much they have changed as a result of two more years of use or after rehabilitation or reconstruction of the pavement sections.

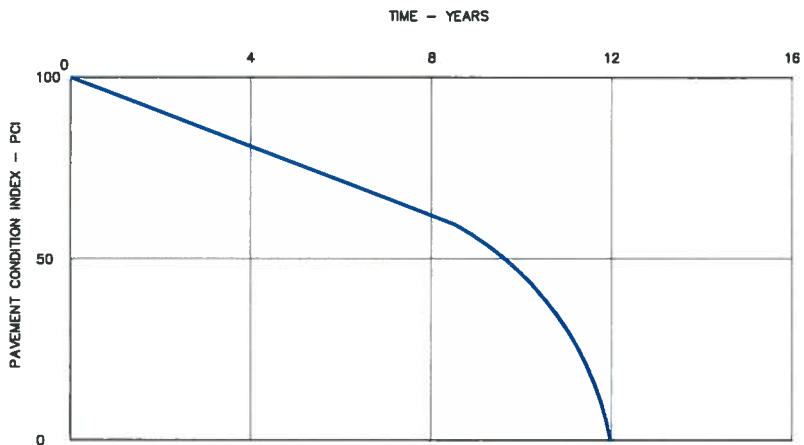
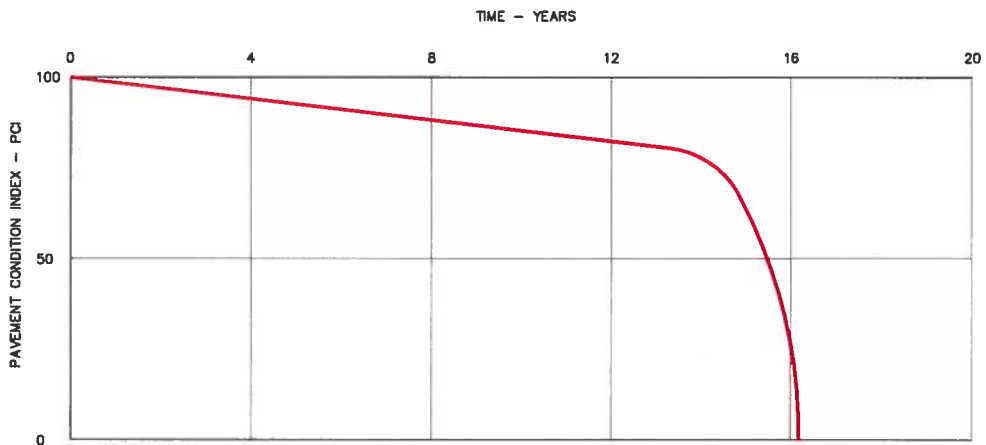
PLATE NO. 3-3 SHEET NUMBER	TRUCKEE TAHOE AIRPORT TRUCKEE, CALIFORNIA	NO. _____ REVISION _____ BY _____ DATE _____	ENGINEER OF RECORD

(PCI) can be determined for each segment to indicate the degree of distress. A typical plot of PCI vs. Time is included as Plate No. 3-3. On this plate a typical pavement index plot for asphalt concrete pavement and for Portland cement concrete pavement is shown. In both diagrams the PCI gradually decreases with time and when it reaches a certain point, it decreases at a much faster rate. The gradual decreasing portion of the curve indicates surface distress only. The sharp break off is generally caused by deep-seated distress. There is no way to predict when the deep-seated distress or failure of the section is going to occur and, therefore, it is not possible to predict when major rehabilitation or reconstruction will be required. If one waits until the PCI vs. Time curve shows deep-seated distress by the sharp break off, then failure has already occurred and it is not possible to extend the life of the section by overlays or adding to the surface of the existing pavement section. As a result, the Pavement Condition Index (PCI) cannot be successfully used to predict deep-seated distresses and failures but is effective in determining when surface rehabilitation and repairs are necessary.
