FACILITIES MAINTENANCE PLAN

AUERBACH
ENGINEERING CORP

**Facilities Maintenance Plan
Truckee Tahoe Airport District
October 2020 - FINAL**

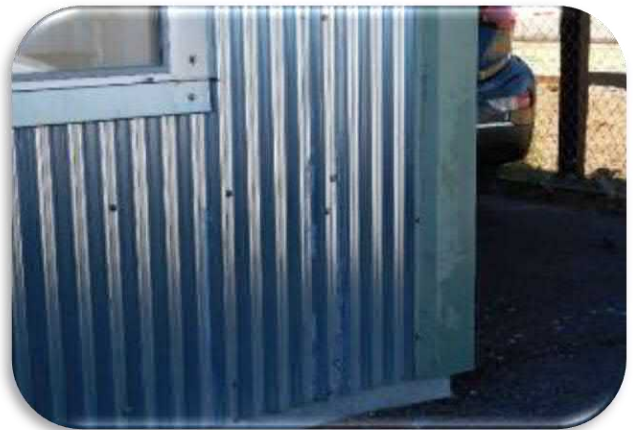
Hangar 1 is sheathed in corrugated siding that has been painted numerous times (Figure 5-1). There is also uncoated galvanized siding that has been installed on the north side of the building (Figure 5-2). The painted siding has good color retention, is glossy and it is free of chalk (ASTM D4214: 8). The coating is tightly adhered (ASTM D6677: 10) and ranges between 10 and 12 mils in thickness. The siding appears to have been painted since the last assessment in 2014. There is some impact damage at the base of the siding (Figure 5-3) and a few isolated coating delaminations.

Figure 5-2 shows the unpainted galvanized steel siding. Also note the coating delaminations on the trim at the right of the photo.

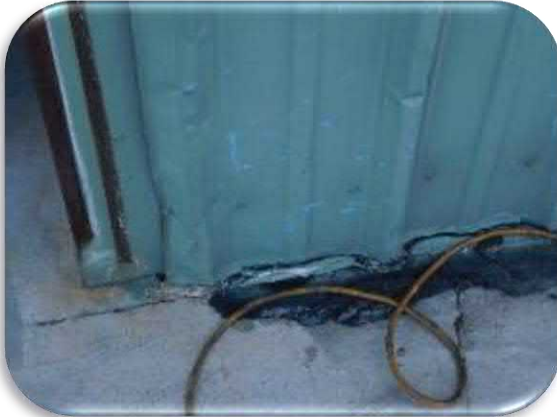
Figure 5-3 shows an example of the impact damage at the base of the siding and the associated coating delaminations

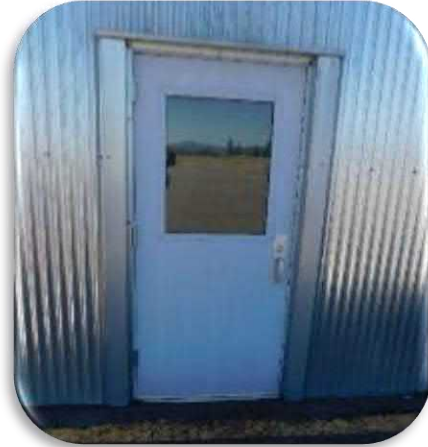
Two of the doors are finished with a factory applied coating and are free of rust. The coating is moderately chalked (ASTM D4214: 6) and has a dull finish. The other doors have been repainted. The coating is in good condition, free of chalk and tightly adhered to the substrate. The coating thickness ranges between 8 and 9 mils. The wooden carport components are heavily cracked. The coating has delaminated from the rafter tails but is in place on the other wooden components.

Figure 5-4 shows the general condition of the doors that have not been recently painted.

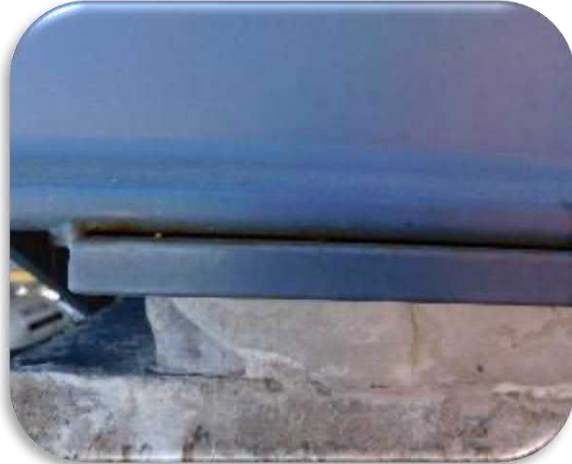
The structural steel comprising the exterior stairway is beginning to show signs of rust. There is rust staining emanating from crevices that are part of the structure (Figure 5-6). There is also edge rusting along the structural member edges. Finally, there is spot rust on the webs and other surfaces of the structural members and in areas where water puddles (Photos 7 and 8).

Figure 5-6 shows the rust and rust staining that is present on the stairway structure.

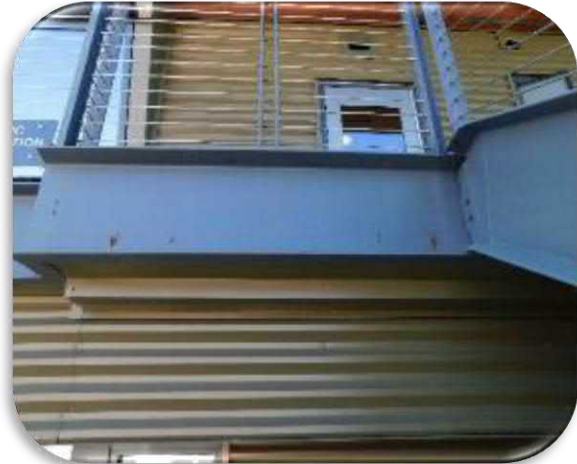
Figure 5-7 shows some minor spot rusting on the structural members.

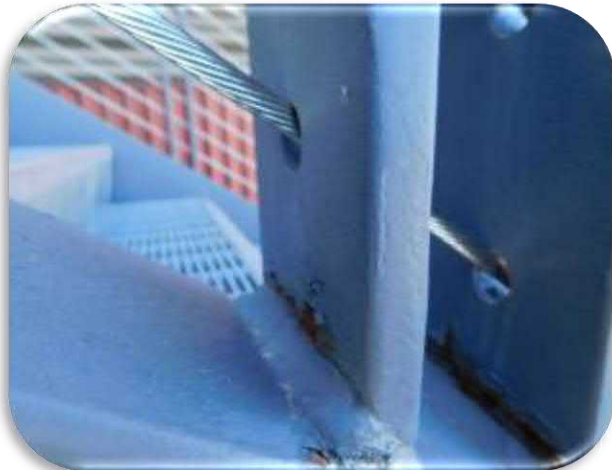
Figure 5-8 shows rusting at the base of the railing posts where water puddles.

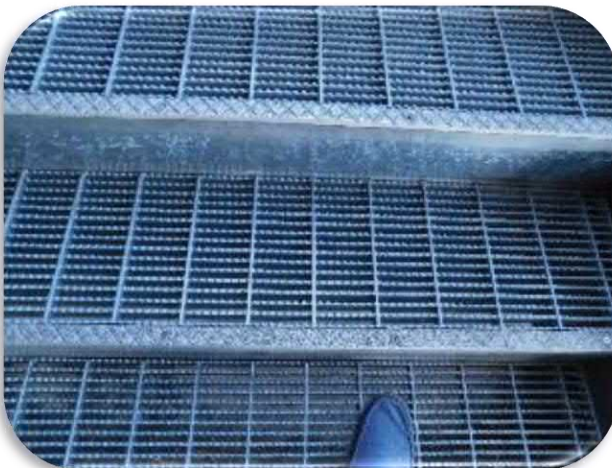
The galvanized steel decking is in good condition (Figure 5-10). The spangle is still visible in most locations.

Figure 5-10 shows a general view of the galvanized steel decking.

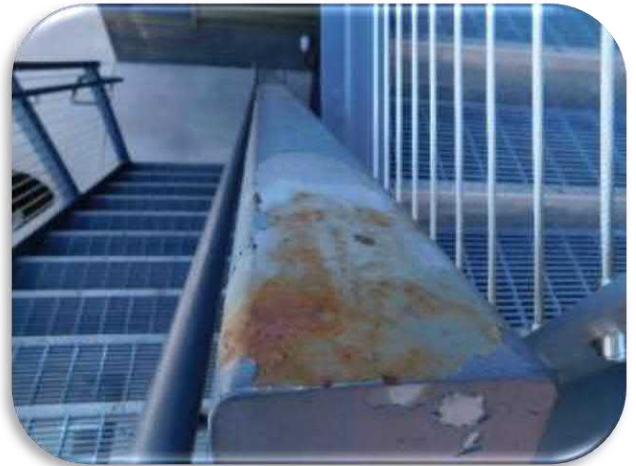
The coatings applied to the stairway railings is heavily delaminated exposing an underlying coating (Figure 5-11). Adhesion testing conducted on the full coating system that remained. The railing that runs around the second floor observation deck is constructed of painted steel posts with stainless steel wire running through the posts. The wire is in contact with the posts and corrosion staining is visible emanating from the holes in the post. There are no washers present in the holes (Figure 5-12).

Figure 5-11 shows an example of the extensive coating delaminations and rusting that is occurring on the stairway handrails.

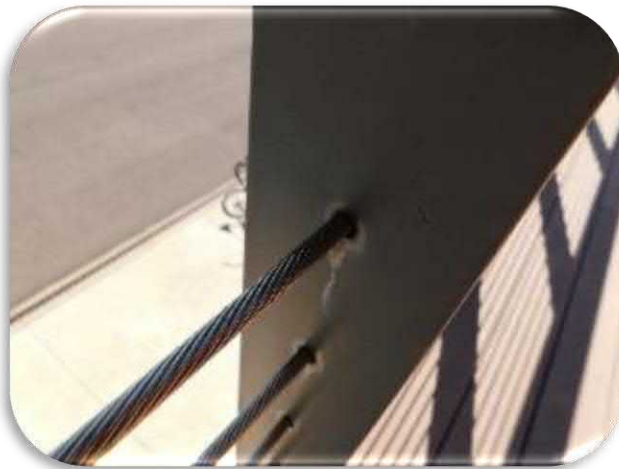
Figure 5-12 shows the mid corrosion that is occurring in the second floor railing post holes.

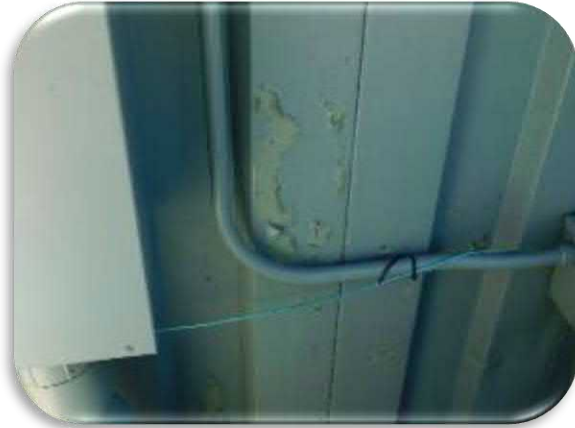
The Generator Building (Figure 5-14) is constructed of corrugated siding. The coating is glossy and free of chalk (ASTM D4214: 8). Except for a small area of delaminated coating (around the far corner from the entrance) there are no coating defects or rust (Figure 5-15). Coating adhesion is good (ASTM D6677: 8) and the thickness ranges between 7 and 11 mils.

Figure 5-15 shows the small area of coating delaminations on the south side of the building.

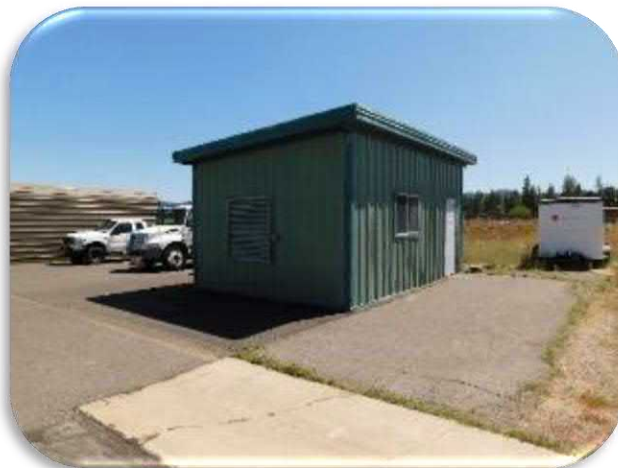
The original factory finished siding and trim is faded and moderately chalked (ASTM D4214: 6). However, there are no coating delamination or other coating defects (Figure 5-16).

Figure 5-16 shows a general view of the generator building shed.

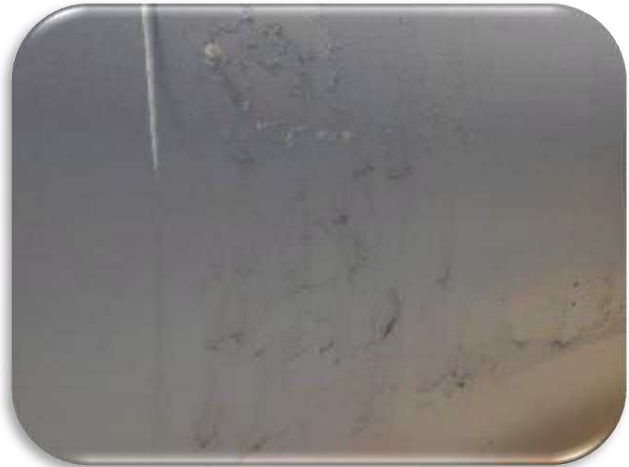
The self-serve tank (Figure 5-17) consists of a horizontal tank with a shed attached to the front of the tank. There are several large intercoat delaminations on both sides of the tank (Figure 5-18). Coating adhesion is poor in those areas (ASTM D6677: 2). However, adhesion is good on the remainder of the tank surfaces (ASTM D6677: 10). The topcoat is glossy and chalk free (ASTM D4214: 8). The coating thickness ranges between 10.5 and 11.4 mils.

Figure 5-18 shows the delaminations that are present on both sides of the tank.

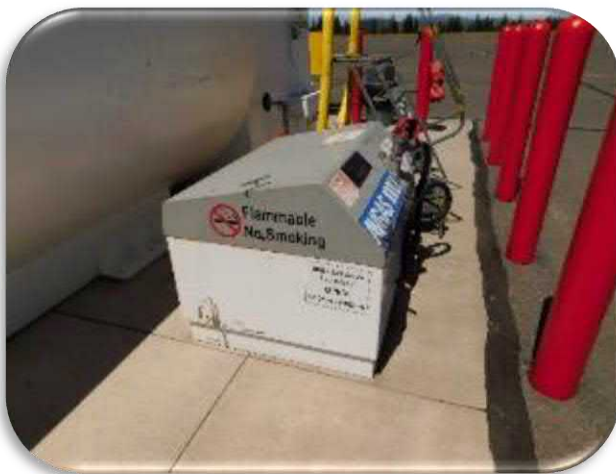
The pump enclosures (Figure 5-19) have edge rust and the coating is heavily chalked (ASTM D4214: 2). The roll-up door and electrical box (Photos 20 and 21) has numerous coating delaminations and coating adhesion is poor (ASTM D6677: 2).

Figure 5-19 shows a general view of the pump enclosure that has edge rusting.

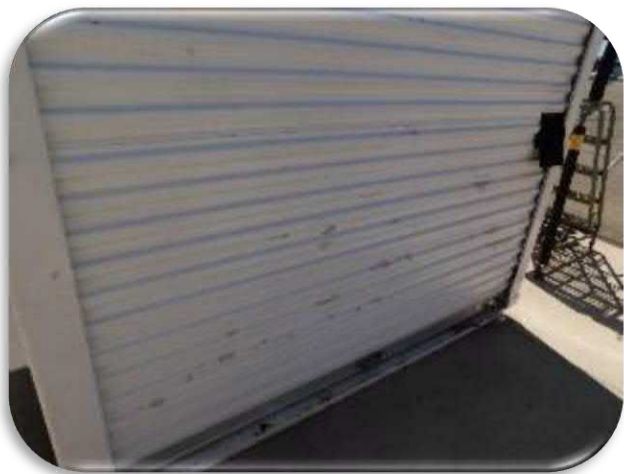
Figure 5-20 shows the delaminations that are present on the roll-up door.

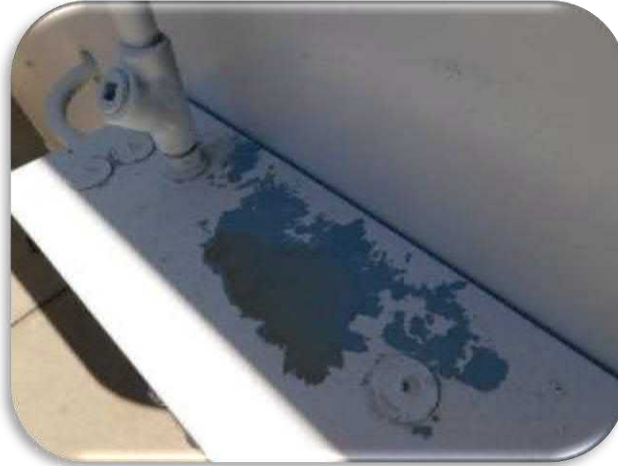
Figure 5-21 shows the delaminations on the electrical box.

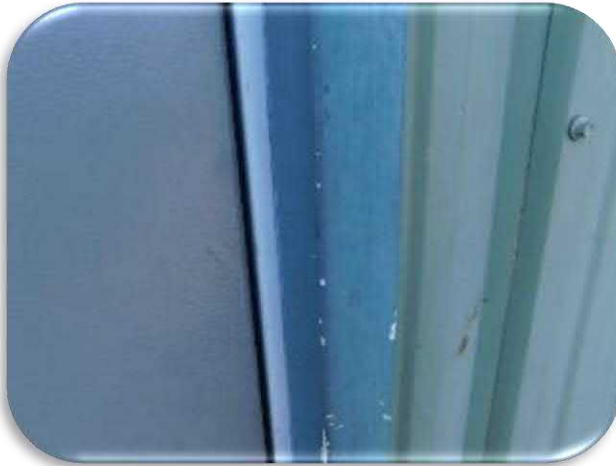
Figure 5-27 shows the faded siding and trim on the maintenance facility. Also note the impact damage on the trim.

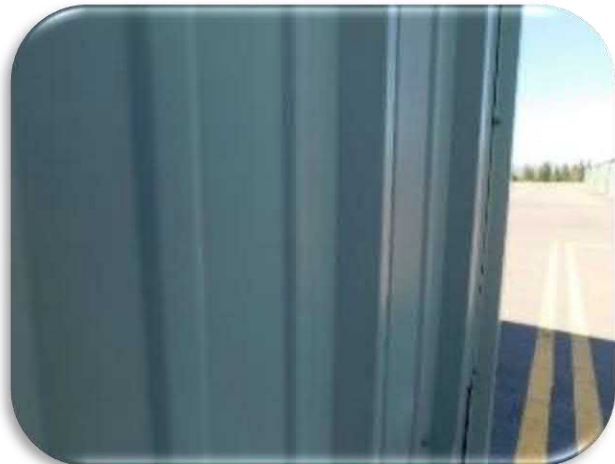
The coating on both the siding and roll-up doors is glossy (Figure 5-30), tightly adhered to the substrate (ASTM D6677: 10) and free of chalk (ASTM D4214: 8).

Figure 5-30 shows the appearance of the siding. Note that it is glossy and free of coating defects.

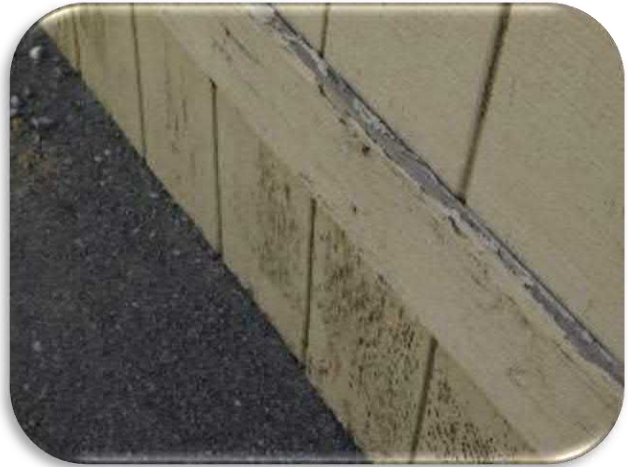
The West Side Modular is a wooden structure consisting of T-111 siding with wooden trim, decking and railings (Figure 5-31). The siding is splintered at base of the building. Coating delaminations are present on the siding and trim (Figure 5-32). The railing and porch floorboards are heavily cracked, and the stain is heavily worn (Figure 5-33). The stain or coating applied to all surfaces is not chalky (ASTM D4214: better than 8).

Figure 5-32 shows the condition of the T-111 siding. Note the coating delaminations and cracked wood.

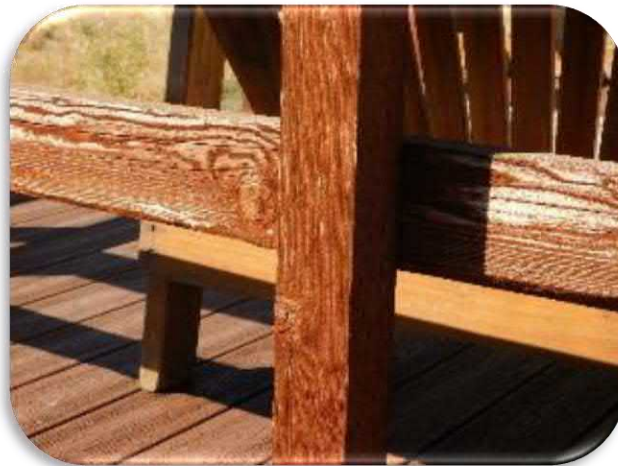
Figure 5-33 shows the general condition of the wood decking and railings.

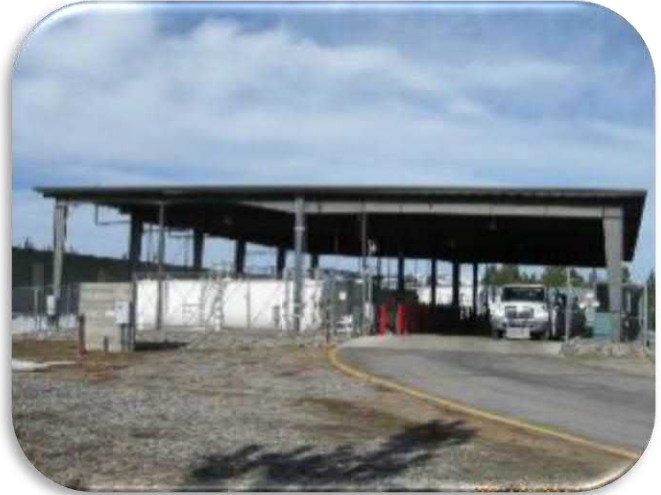
A number of different components are included in the Fuel Farm located at the northwest end of the airport property (Figure 5-34). The components include an overhead structure, four fuel tanks, associated piping and equipment, stairways and walkways leading up to and across the tops of the tanks, two concrete tanks, two pumping stations, and a guard shack.

Figure 5-34 shows a general view of the Fuel Farm.

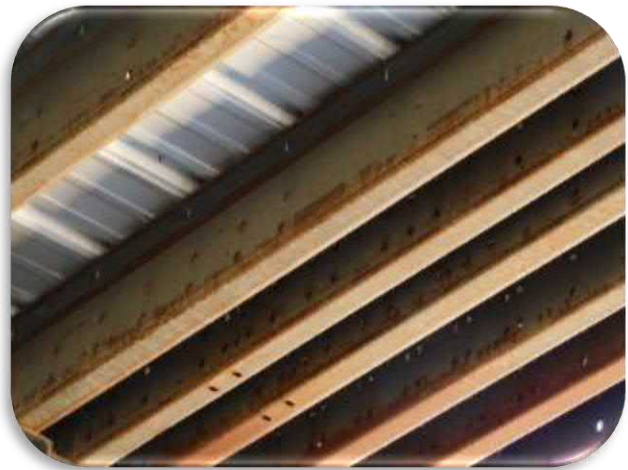
There is significant edge and pinpoint rusting on the roof rafters and diagonals that support the roof (Figure 5-35). A comparison of the current condition to what was reported in 2013 indicates a significant increase in corrosion. Nevertheless, there does not appear to be significant section loss at this time.

Figure 5-35 shows a general view of the roof rafters that support the roof structure. Note the edge and pinpoint rusting on the rafters.

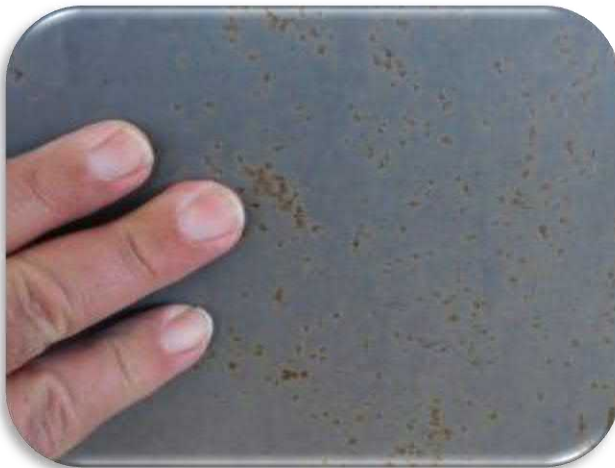
The structural steel (columns and main structural members) has pinpoint rusting penetrating the coating. In addition, there is some isolated spot rusting (Figure 5-36). When evaluated in accordance with SSPC VIS-2, rust grades of 6-S and 6-P were observed. These grades represent approximately 1% of the surface that is rusted.

Figure 5-37 shows an example of the pinpoint rusting that was present on the structural steel.

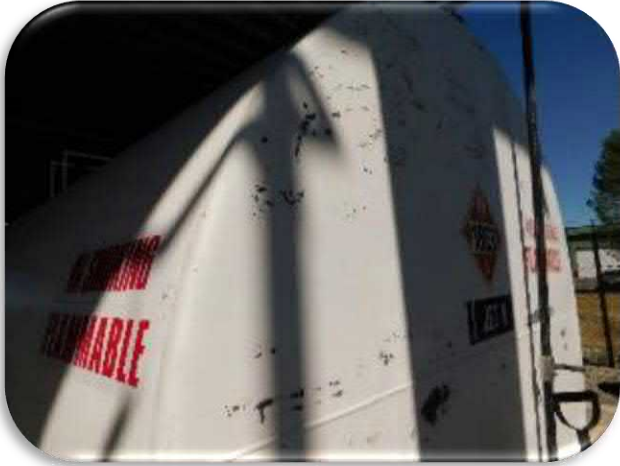
Figure 5-39 shows the condition on the back ends of the tanks. Note the numerous delaminations.

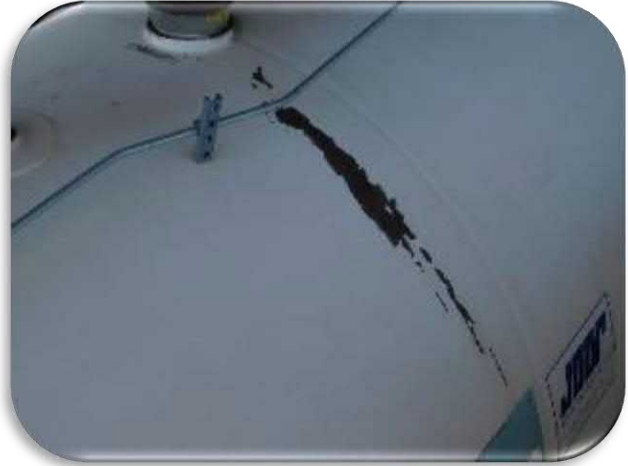
Figure 5-40 shows the coating degradation that was observed directly beneath the fill ports.

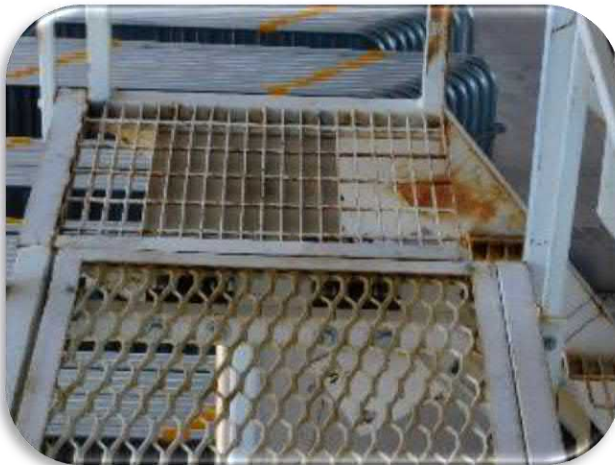
The stairways (grating, handrails, stringers and support structure) have patches of pinpoint rust and impact damage (Figures 5-41 and 5-42). The coating is heavily chalked (ASTM D4214: 2) and has moderate adhesion to the substrate (ASTM D6677: 6). The amount of rusting has increased since the 2013 assessment from approximately 1% of the surface to 10% of the surface.

Figure 5-41 shows the general condition of the stairway support structure and grating.

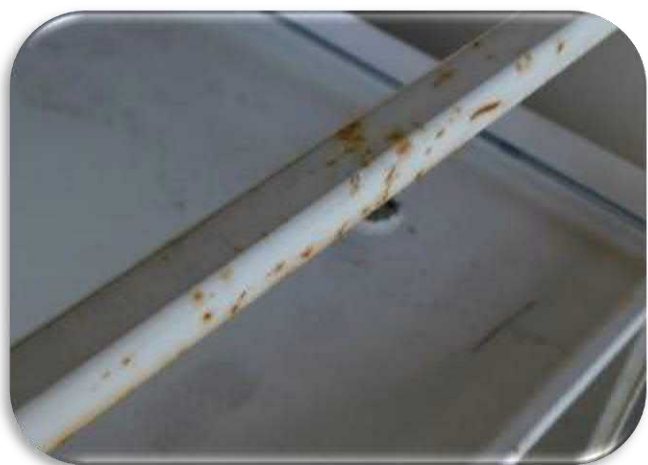
Figure 5-42 shows the typical condition of the stairway handrails.

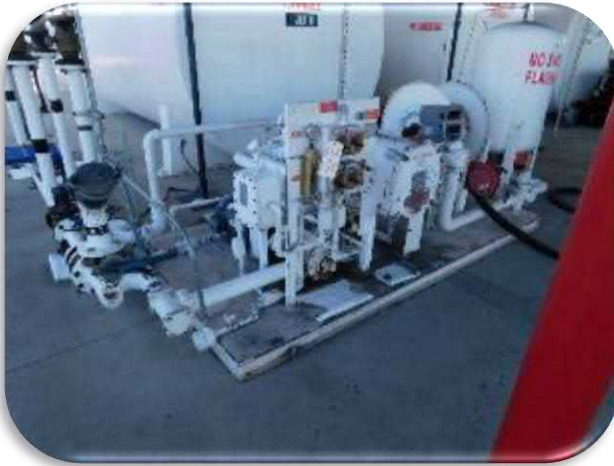
The main pumping station has coating delaminations and areas of worn coating (Figures 5-43 through 5-45). Rust is present where the substrate is exposed. When evaluated in accordance with SSPC VIS2, the condition is consistent with a rust rating of 7S (approximately 0.3% of the surface) Oil and grease are present on the painted surfaces.

Figure 5-43 shows a general view of some of the painted surfaces on the pumping station.

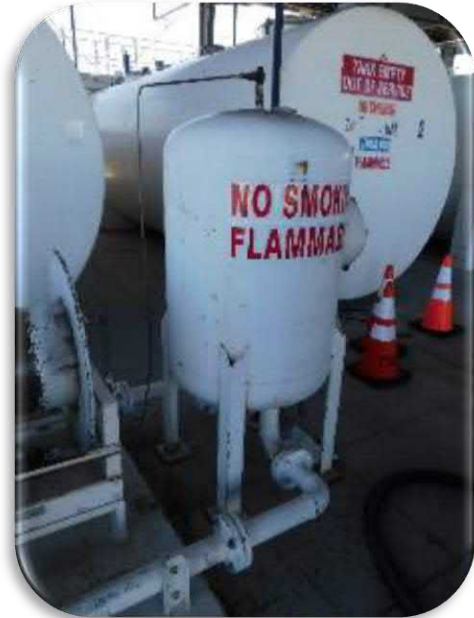
Figure 5-44 shows a view of the far end of the equipment skid with rust and impact damage.

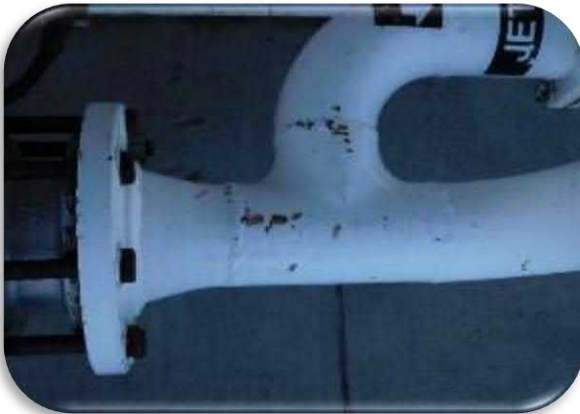
Figure 5-45 shows the typical degree of impact damage and rust on the pumping station surfaces.

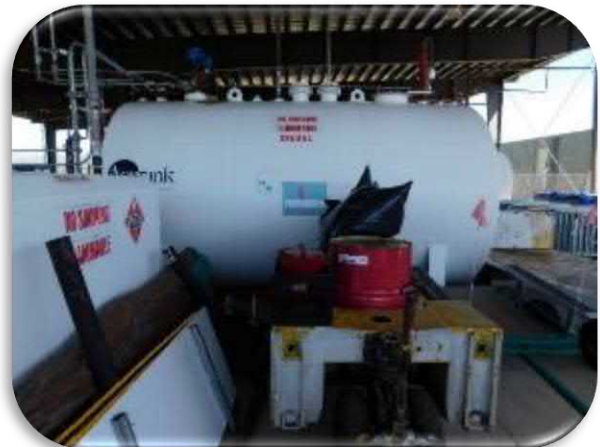
Figure 5-46 shows a general view of the diesel fuel storage tank. The coatings applied to this tank are in good condition.

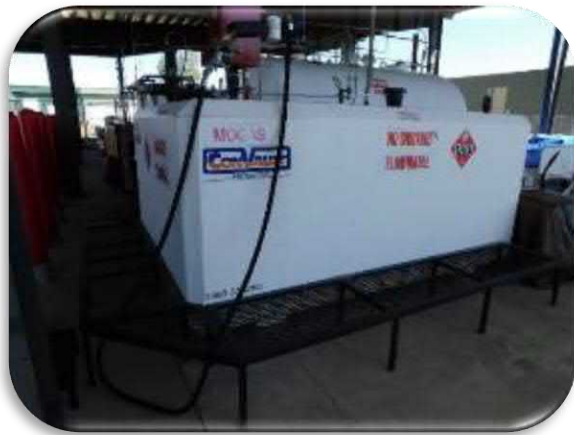
The coating applied to the Mogas concrete tank is in good condition with no visible coating defects (Figure 5-47). The coating is heavily chalked (ASTM D4214: 2) and poorly adhered to the substrate (ASTM D6677: 4).

Figure 5-47 shows a general view of the Mogas concrete tank. The coating applied to this tank is free of coating defects.

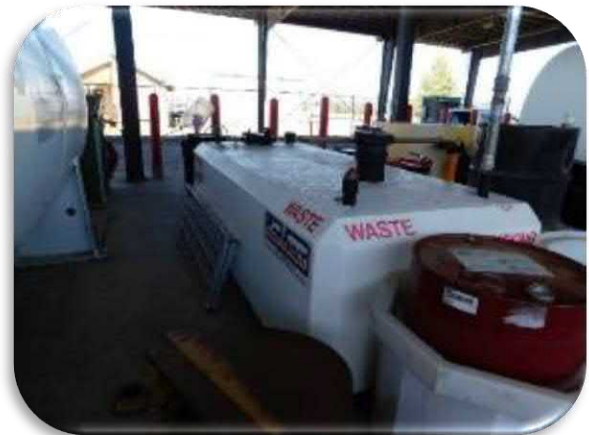
The coating applied to the concrete waste tank is in good condition with no visible coating defects (Figure 5-48). The coating is only mildly chalked (ASTM D4214: 6) and is tightly adhered to the substrate (ASTM D6677: 10).

Figure 5-48 shows a general view of the concrete waste tank

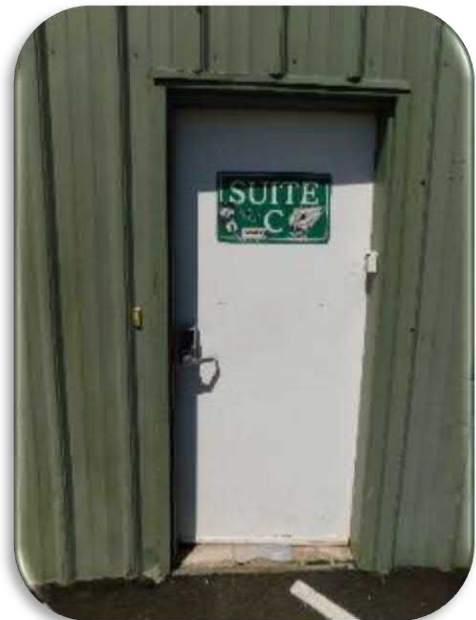
The building is sheathed in corrugated metal siding and has a few delaminations, usually at impact points at base of building (mostly on the north side). The siding coating has faded and is blotchy in some areas but glossy in others (Figures 5-49 through 5-51). The doors have impact damage and minor spot rust. The coating on the doors is glossy (Figures 5-52 and 5-53). All of the coating is tightly adhered to the substrate (ASTM D6677: 10) and free of chalk (ASTM D4214: 8). The dry film thickness ranges between 6 and 8 mils. The gray entranceways have edge rust. The coating is flat and faded (Figure 5-53).

Figure 5-49 shows an example of the condition of the coating on the doors (bright and glossy). Note, however, that the adjacent siding is faded and flat.

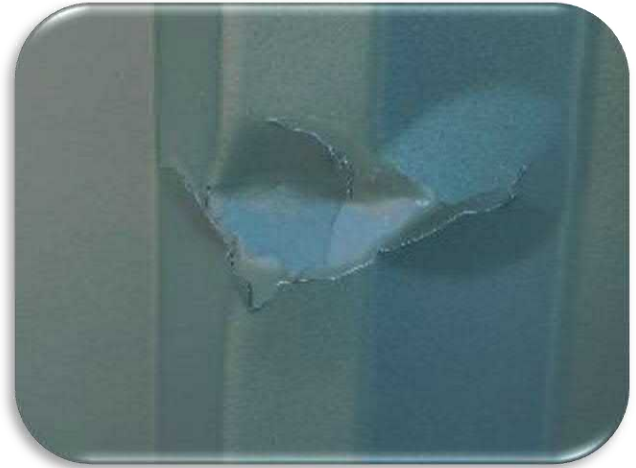
Figure 5-51 shows an example of the impact damage that was observed with the associated coating delaminations

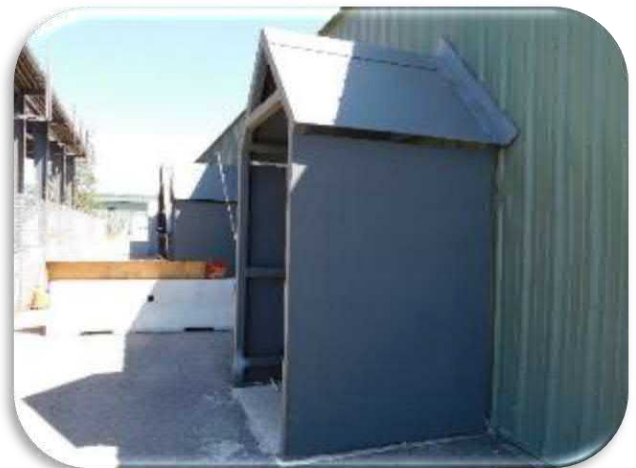
Figure 5-53 shows a general view of the steel entrance ways. The edges of these structures are rusted.

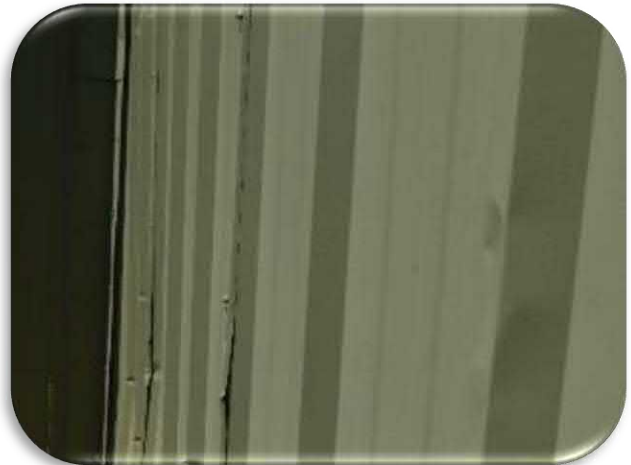
Figure 5-55 shows an example of the impact damage that was present on the hangar surfaces.

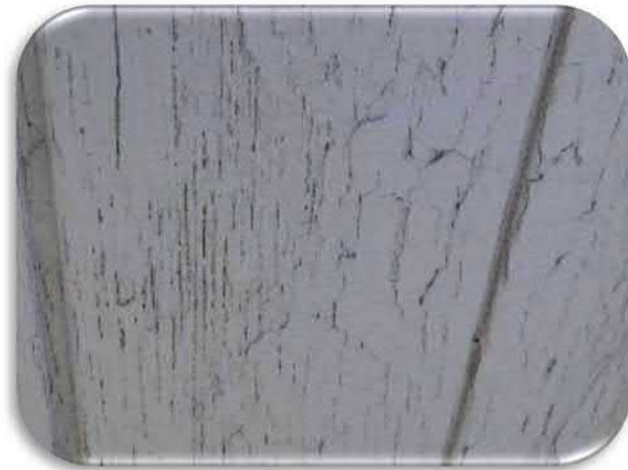
The wood siding and trim has been scraped and over coated at some time in the past. There are islands of thick paint that are lifting and delaminating. The wood substrate is cracked (Figures 5-57 and 5-58). The aluminum siding is heavily damaged. All of the wood substrates are cracked and degraded. Adhesion tests (Figure 5-59) conducted on the wood surfaces indicated poor coating adhesion (ASTM D6677: 0).

Figure 5-57 shows the typical condition of the wood siding. Note the cracked and lifting paint.

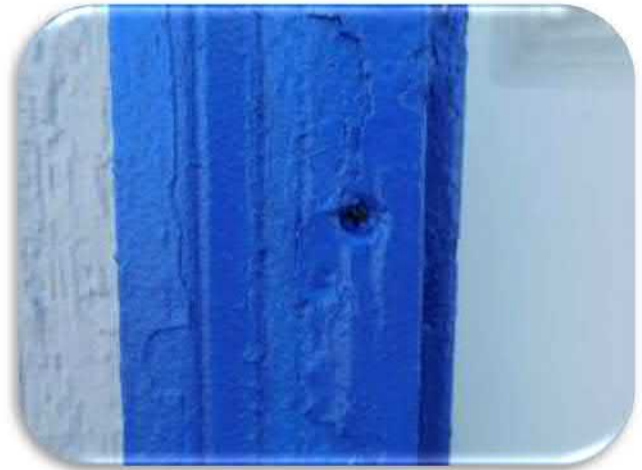
Figure 5-58 shows the typical condition of the siding with lifting paint.

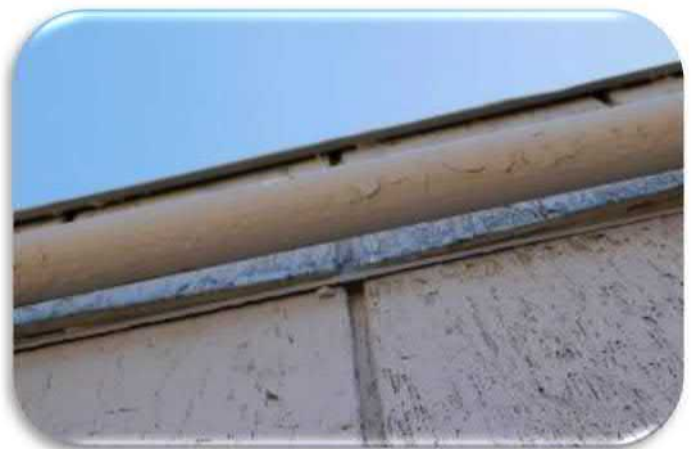
The piping has coating delaminations and rust on the surface (Figure 5-60).

Figure 5-60 shows the condition of the piping associated with the EAA Building.

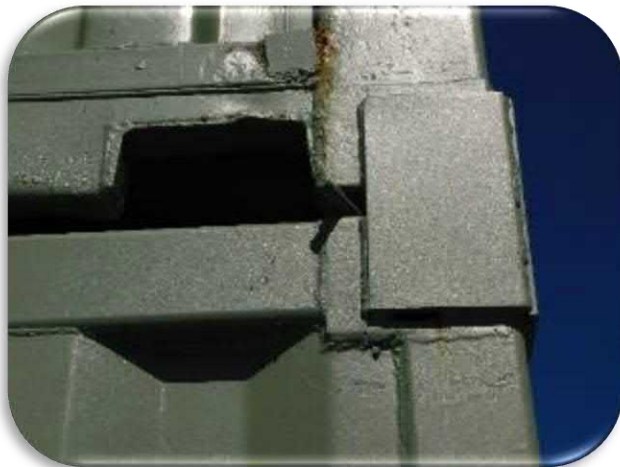
Pinpoint rusting is present in a few locations on the container structure and the stairway. The rusting is found on rough welds on the containers (Figure 5-62) and at spots of thin coating and coating holidays on the stairway (Figure 5-63).

Figure 5-62 shows an example of the rusting that was observed on the Air Traffic Control Tower stairway.

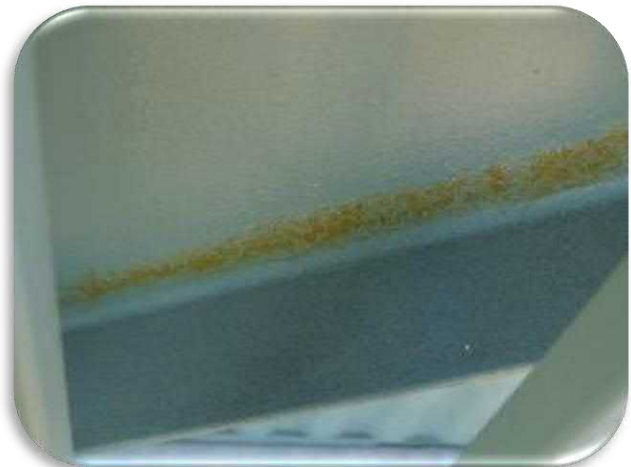
Figure 5-63 shows the typical corrosion on the Air Traffic Control Tower.

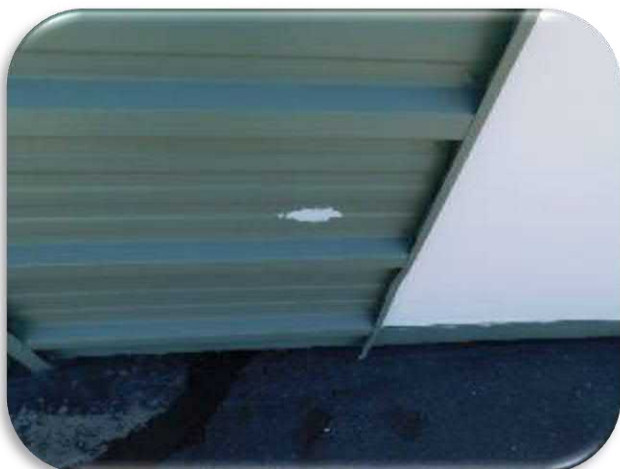
The coating applied to the siding on these hangars is in good condition (Figure 5-64). The coating is glossy, tightly adhered to the substrate (ASTM D6677: 10) and free of chalk (ASTM D4214: 8). The coating thickness ranges between 4 and 10 mils with most of the readings between 4 and 7 mils. There are a few small coating delaminations on Hangar B (Figure 5-65).

Figure 5-65 shows an example of the infrequent coating delaminations on Hangar B.

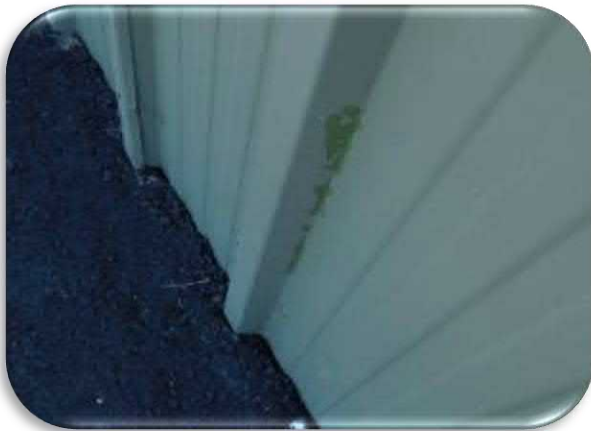
The coating applied to the siding on Hangar C is aged and has lost its gloss. There are a few small delaminations scattered across the building (Figure 5-67). There are also areas where the coating has worn off and the aluminum substrate is clearly visible (Figure 5-68). The coating is tightly adhered to the substrate (ASTM D6677: 10) and moderately chalked (ASTM D4214: 4). The coating thickness ranges between 2 and 4 mils. The doors are in similar condition to the siding and are free of coating defects and rust.

Figure 5-67 shows an example of one of the infrequent delaminations on Hangar C.

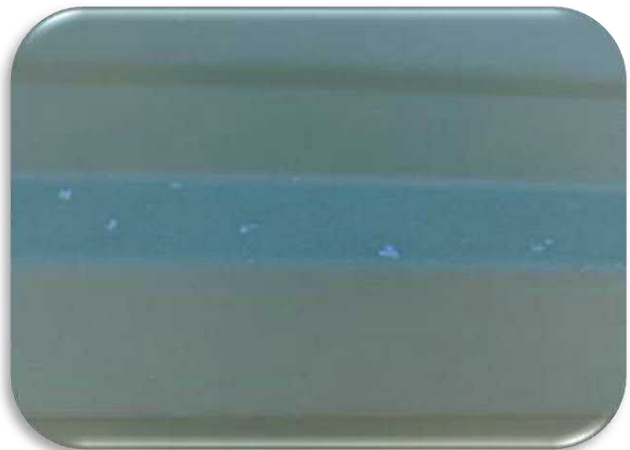
Figure 5-68 shows an example of an areas where the coating has worn away exposing the galvanized substrate.

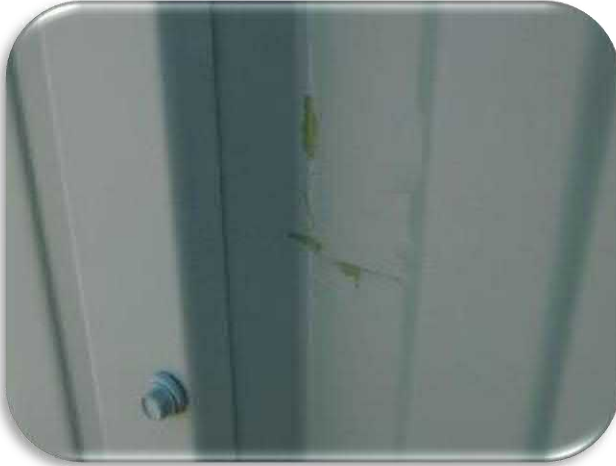
The coating applied to the siding on Hangar D is also aged and has lost its gloss. There are a few small delaminations scattered across the building many of which are associated with impact damage (Figures 5-69 and 5-70). Others are associated with deflated blisters. There are also areas where the coating has delaminated from the galvanized steel windowsills (Figure 5-71). Coating adhesion varies with some tests indicating excellent adhesion (ASTM D6677: 10) and equal number indicating poor (Figure 5-72) coating adhesion (ASTM D6677: 2). The coating is moderately chalked (ASTM D4214: 4). The coating thickness ranges between 3 and 5 mils. The doors are in similar condition to the siding and are free of coating defects and rust.

Figure 5-69 shows one example of the blistered that were observed on the siding.

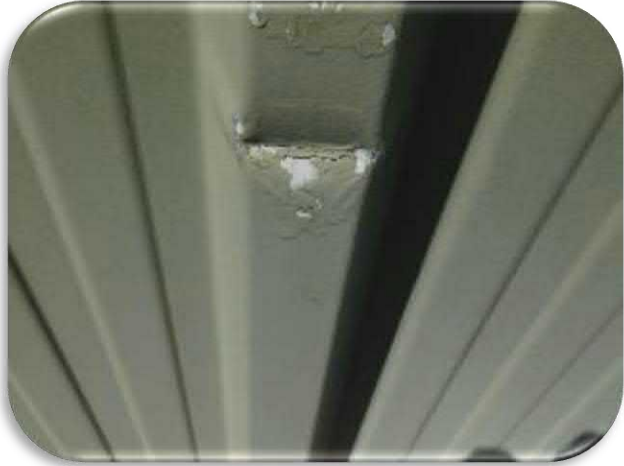
Figure 5-70 shows a delamination at an impact point.

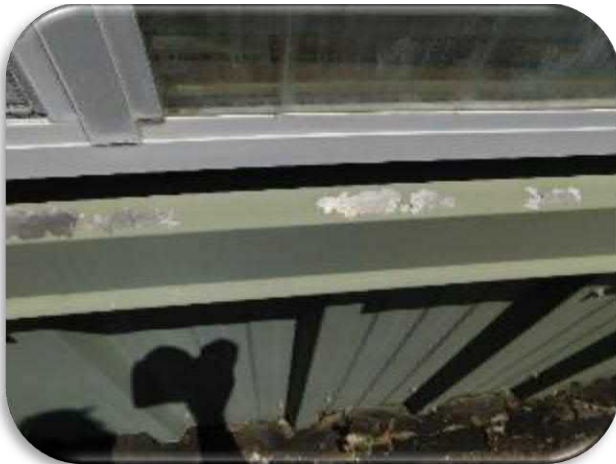
Figure 5-71 shows the delamination on the galvanized windowsill.

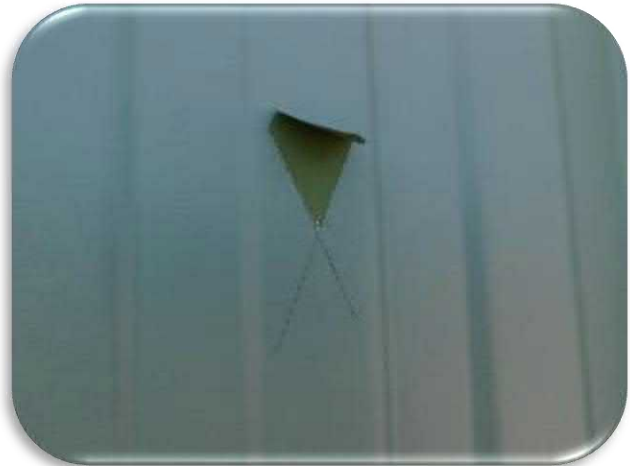
Figure 5-72 shows an example of an adhesion test indicating poor coating adhesion.

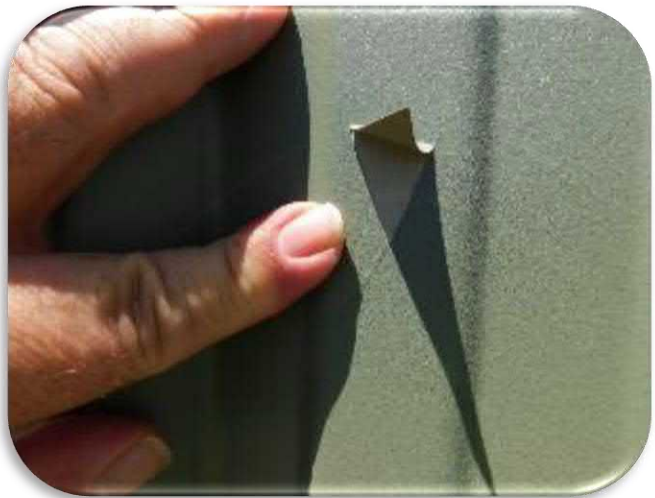
The coating is flat and faded. There are blisters all over the siding on the east façade (Figure 5-73). There are no blisters or other coating defects on the remaining facades. Coating adhesion varies with the tests indicating excellent adhesion (ASTM D6677: 10) on the north and west facades and poor (Figure 5-74) coating adhesion (ASTM D6677: 0 and 2) on the south and east facades. The coating is moderately chalked (ASTM D4214: 4). The coating thickness ranges between 3 and 9 mils. The coating applied to the doors is in good condition, glossy and are free of coating defects and rust (Figure 5-75). However, there is a significant amount of buckling from impacts.

Figure 5-73 shows an example of the blisters that were present.

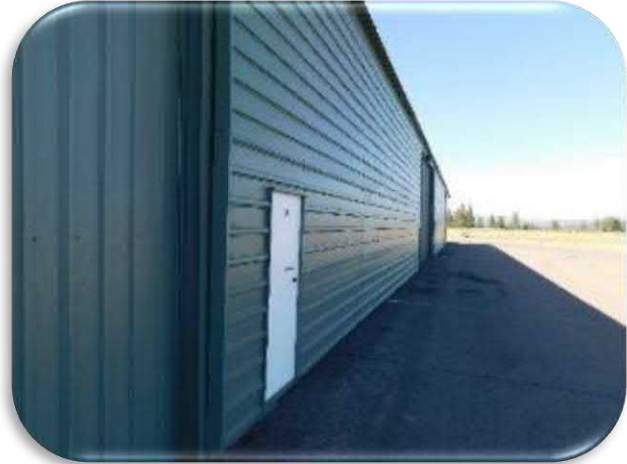
The coating applied to the siding on these hangars is in good condition (Figure 5-77). The coating is glossy, tightly adhered to the substrate (ASTM D6677: 10) and free of chalk (ASTM D4214: 8). The coating thickness on Hangars J and K ranges between 6 and 9 mils while the coating thickness on Hangars L and M ranges between 1 and 2.5 mils.

Figure 5-77 shows a general view of the coating condition on Hangars J through M. Note the freshly painted glossy appearance.

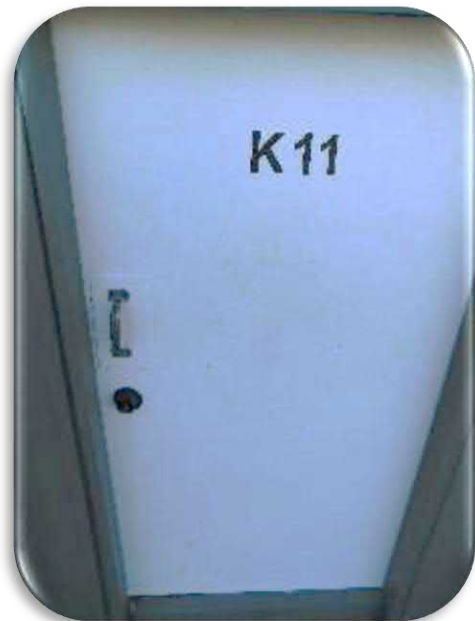
The doors are in similar condition to the siding and are free of coating defects and rust (Figure 5-78). The coating is glossy, tightly adhered to the substrate (ASTM D6677: 10) and free of chalk (ASTM D4214: 8). The coating thickness on Hangars J and K ranges between 4 and 7 mils while the coating thickness on Hangars Land M ranges between 2 and 4 mils.

Figure 5-78 shows the typical condition of the doors on these hangars.

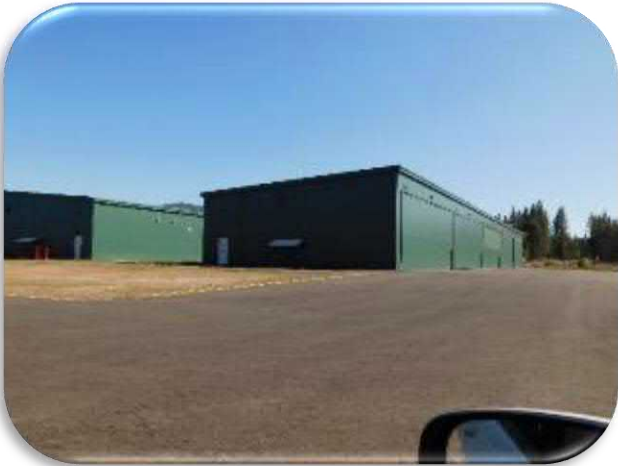
The coating applied to the siding on these hangars is in good condition (Figure 5-79) except for some blotchy discolorations on Hangar P (Figure 5-80). The coating is glossy, tightly adhered to the substrate (ASTM D6677: 10) and free of chalk (ASTM D4214: 8). The coating thickness on Hangars N and P ranges between 0.5 and 1.5 mils.

Figure 5-79 shows a general view of Hangars N and P--Not the glossy appearance of the recently applied coating system.

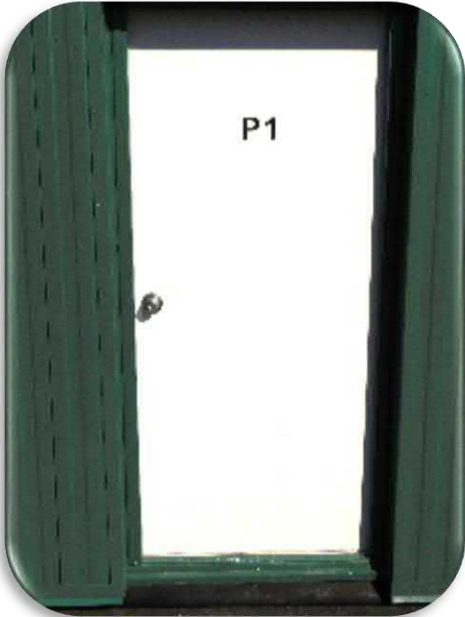
The doors are in similar condition to the siding and are free of coating defects and rust (Figure 5-81). The coating is glossy, tightly adhered to the substrate (ASTM D6677: 10) and free of chalk (ASTM D4214: 8). The coating thickness ranges between 1 and 1.5 mils.

Figure 5-81 shows an example of the condition of the doors on these hangars.

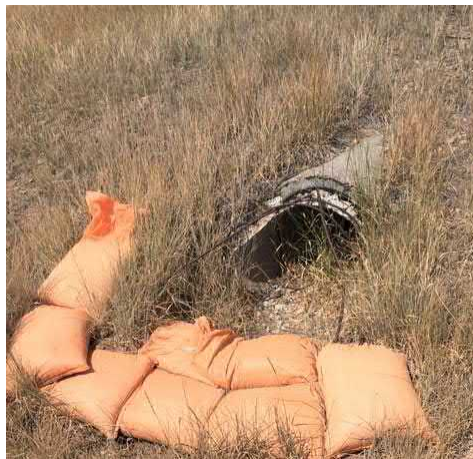
Figure 8-1 Exposed Rebar on Culvert 118

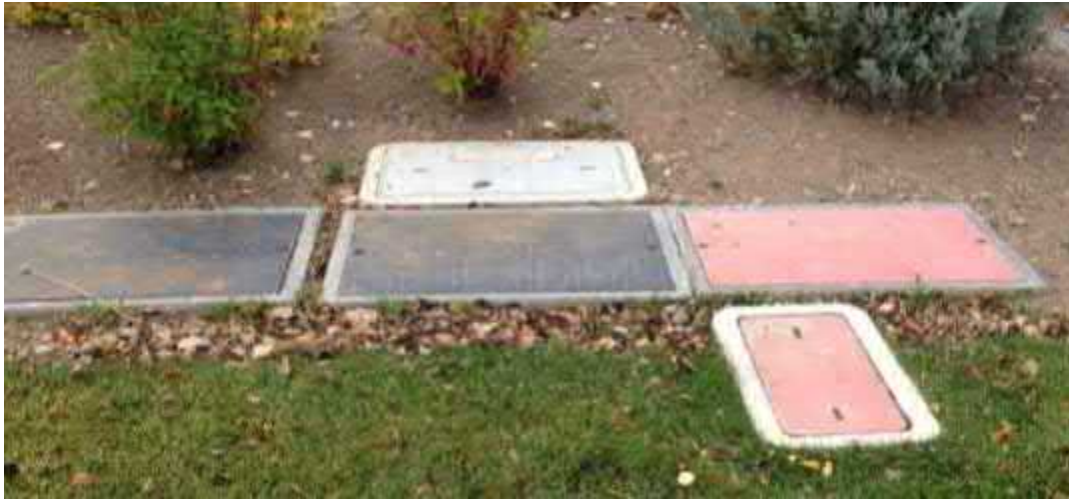
Figure 9-8. Communication and Power Pull-Boxes

1. No communication infrastructure replacement is proposed
2. All at-grade pull-boxes should be inspected at least annually, prior to snow removal activity, to confirm the lids are secure and that the cables are accessible.
3. Label all cables entering and leaving at-grade pull-boxes with the building/system served.
4. Label all above-ground enclosures, inside or outside the cabinet, with the building/system served

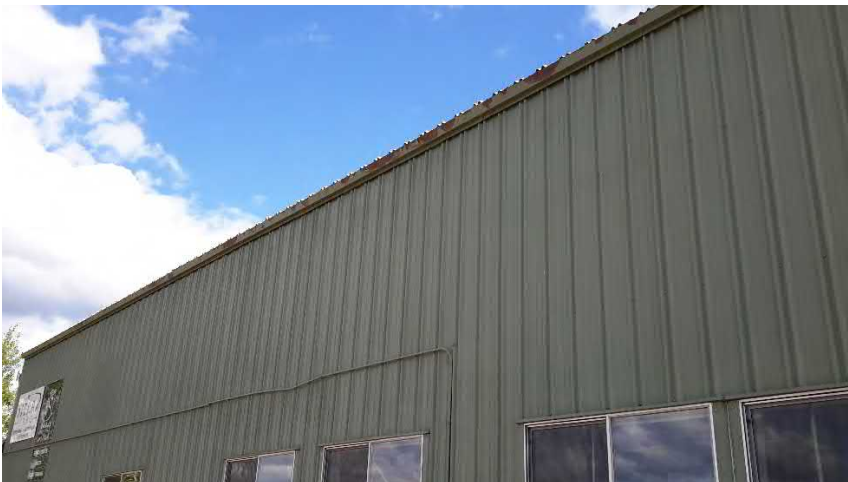
Figure 3 Building 1 - peeling paint on eaves

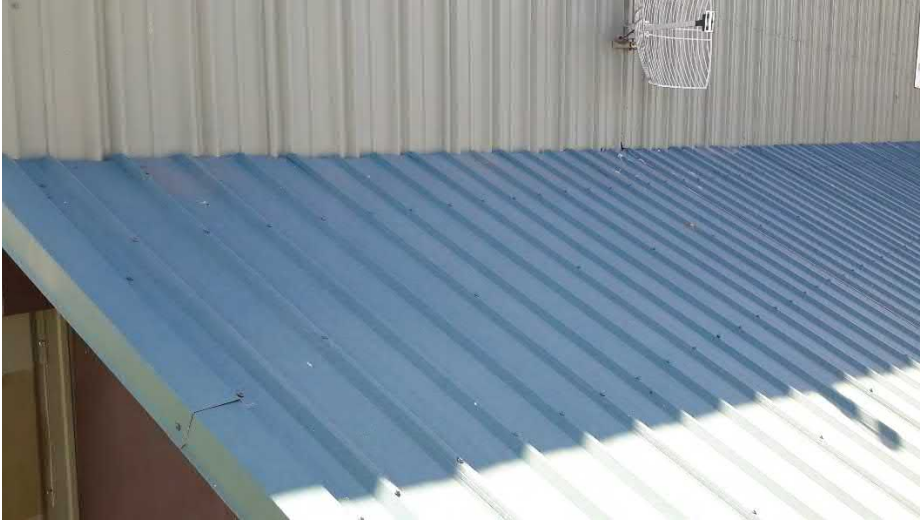
Figure 4 Building 1 - no flashing at top of roof to wall

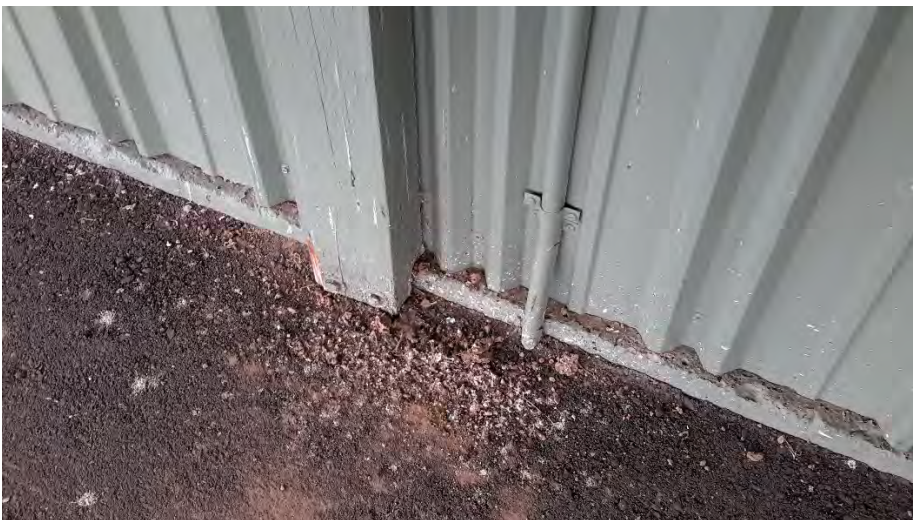
Figure 6 Building 1 - no separation to grade at post base

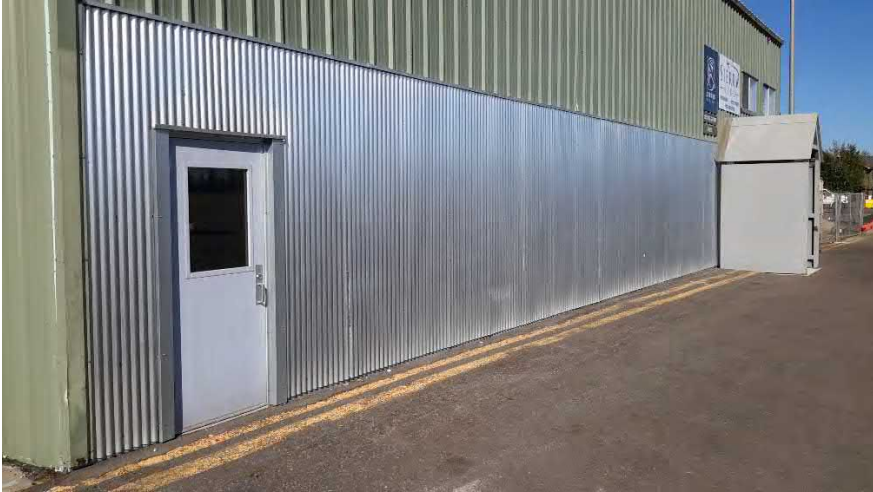
Figure 7 Building 1 - new furred panel area, north wall

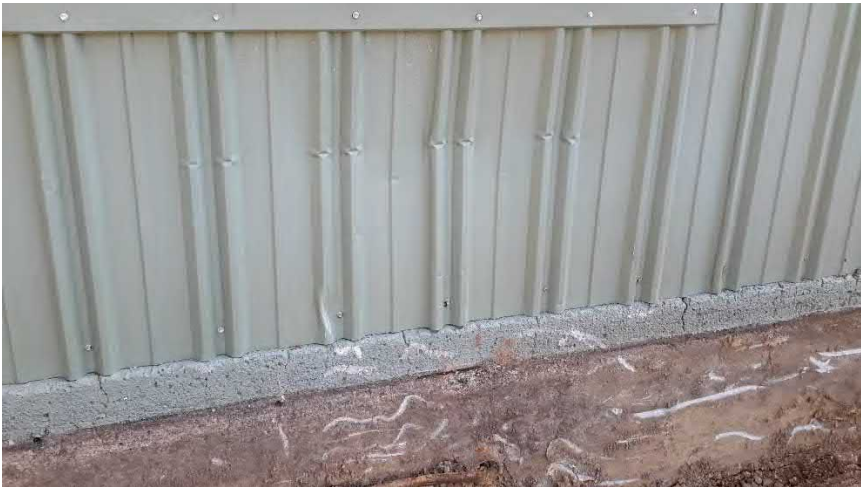
Figure 8 Building 1 - panel damage from snow
