FACILITIES MAINTENANCE PLAN

AUERBACH
ENGINEERING CORP

**Facilities Maintenance Plan
Truckee Tahoe Airport District
October 2020 - FINAL**

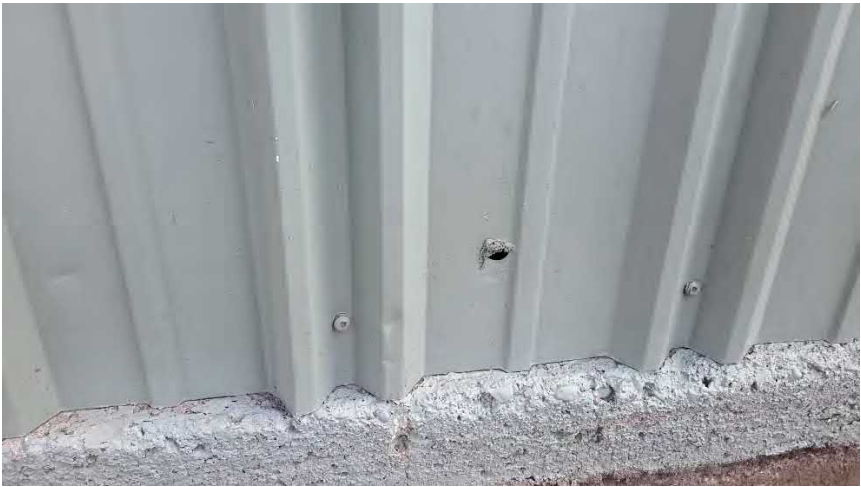
Figure 9 Building 1 - panel damage and loose fasteners

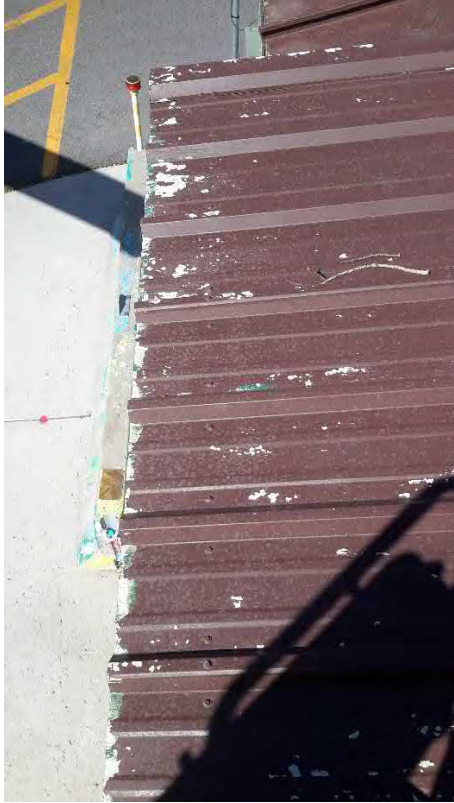
Figure 12 Building 3 - paint missing / corrosion at eaves

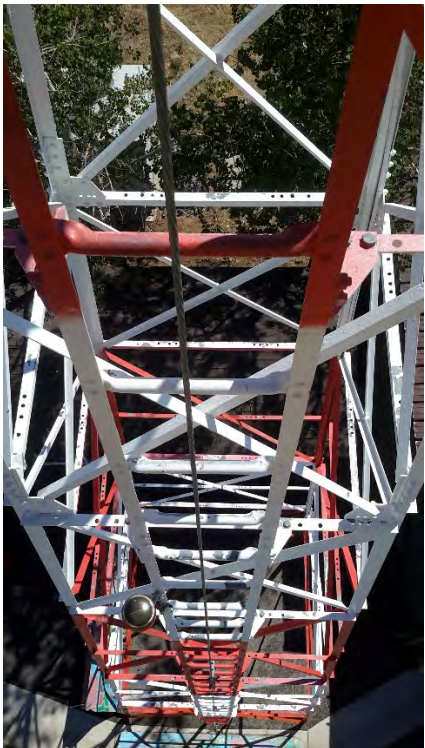
Figure 13 Building 4 - Beacon needs paint

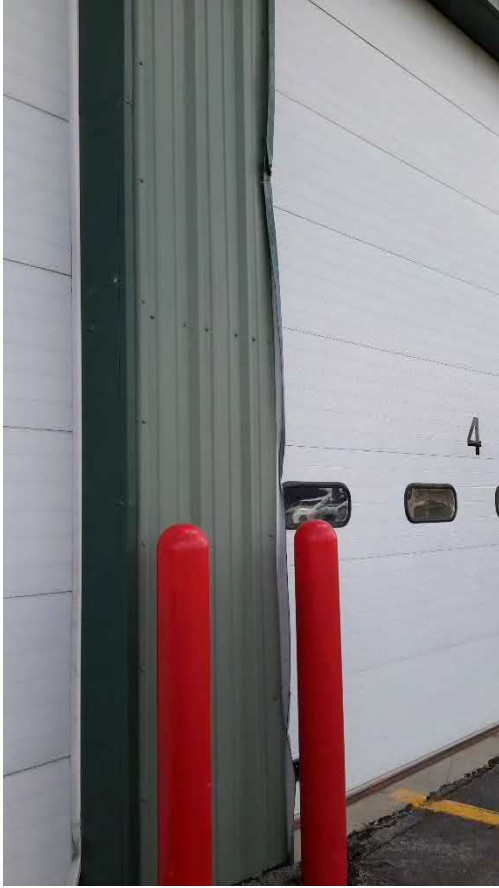
Figure 16 Building 7 - door jamb trim damaged - west side

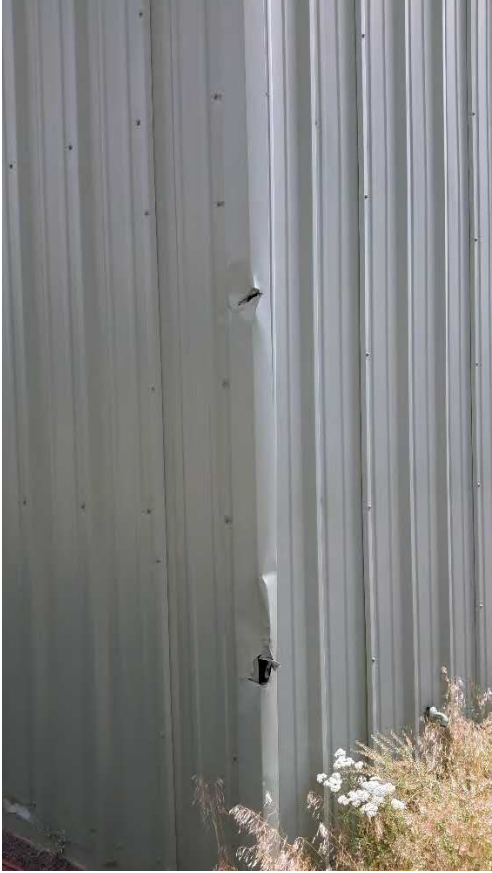
Figure 18 Building 8 - damage at southwest corner

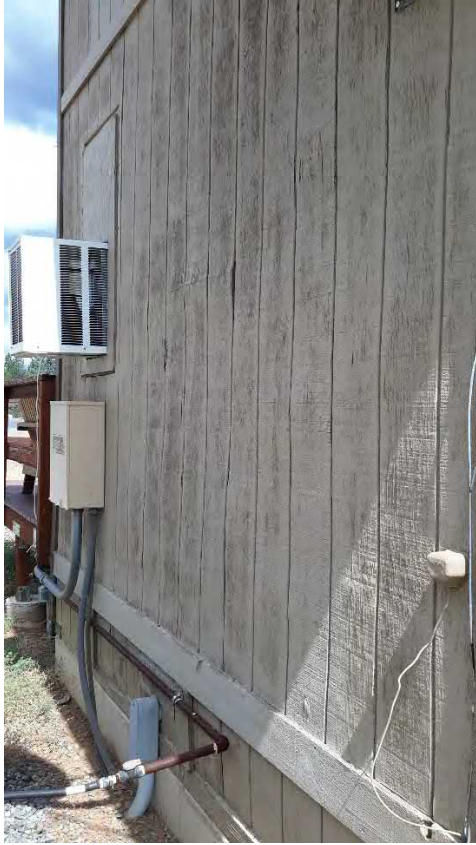
Figure 22 Building 9 - south side wall siding buckled

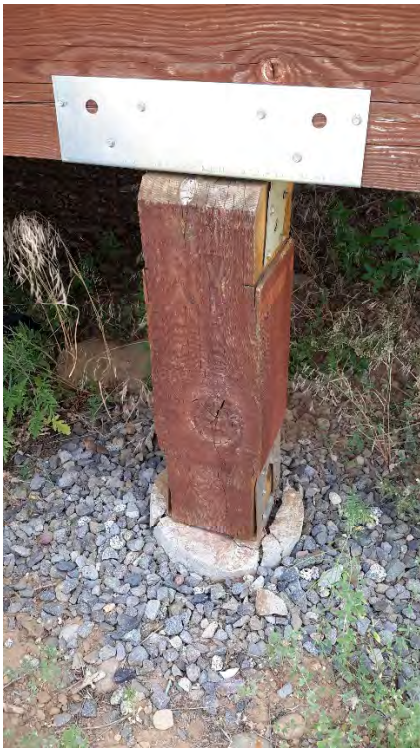
Figure 23 Building 9 - deck pier cracked and failing

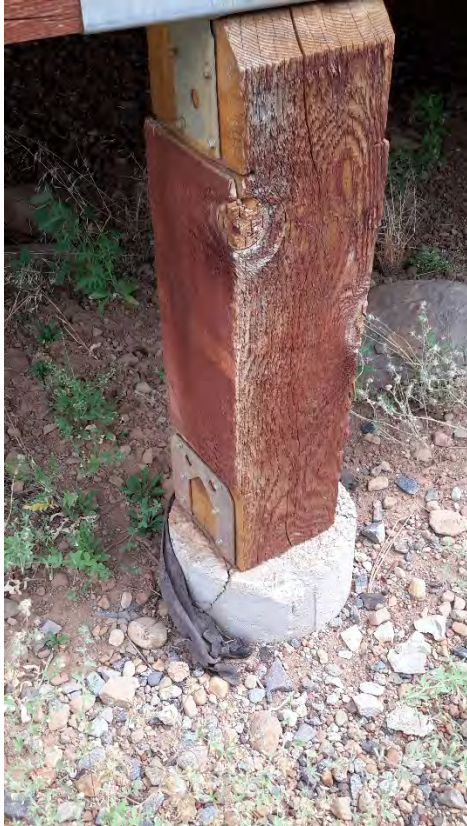
Figure 24 Building 9 - south west deck - pier cracked and failing

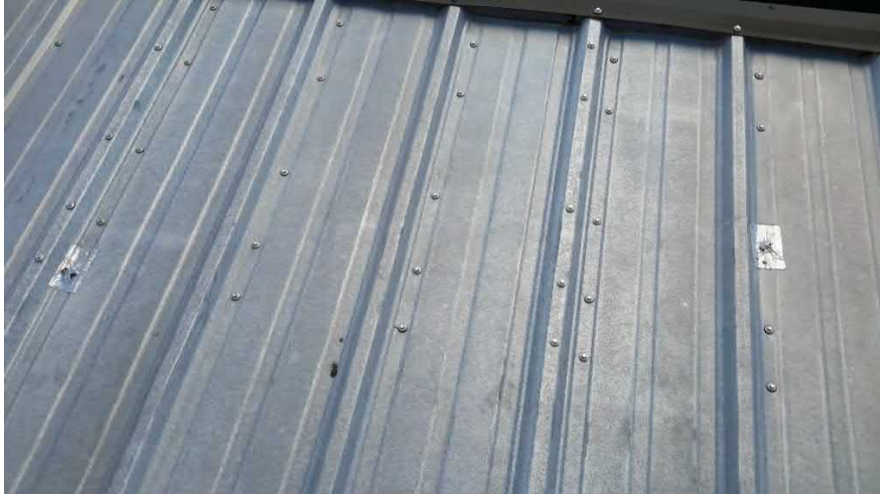
Figure 26 Building 10 - foil-faced adhesive patches damaged.

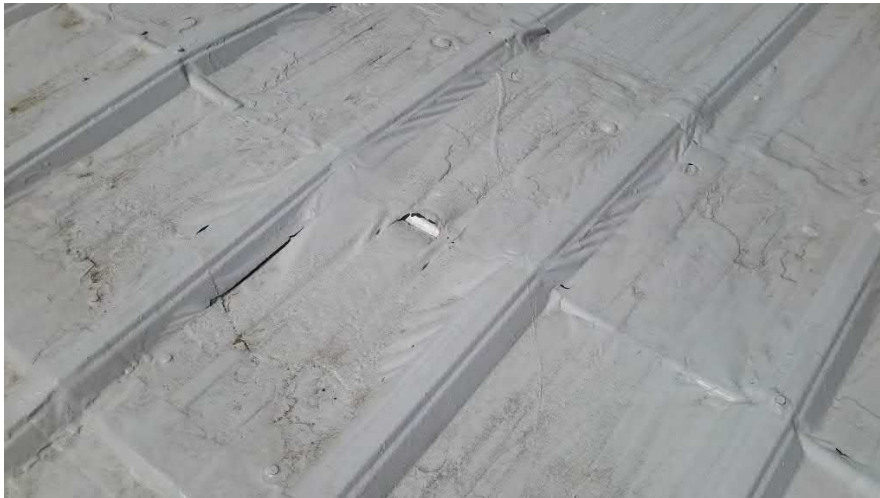
Figure 27 Building 11 - roof coating damaged and delaminating

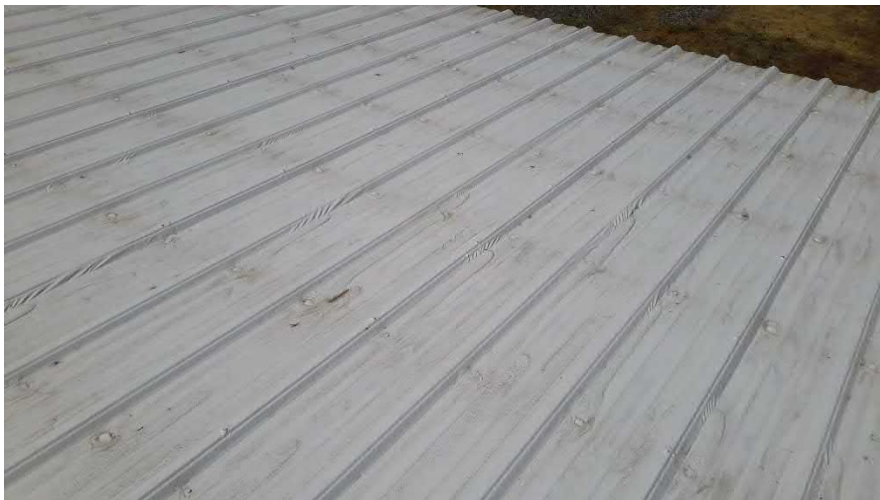
Figure 28 Building 11 - roof coating delamination

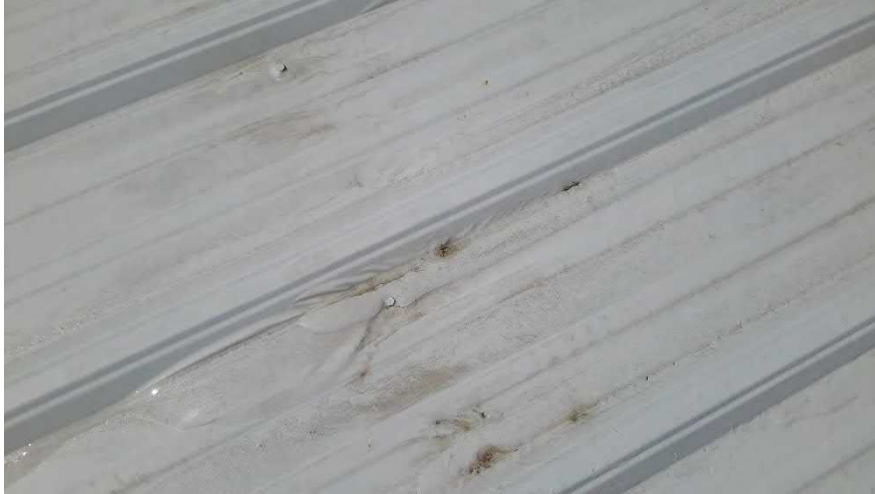
Figure 29 Building 11 - pockets of water under roof coating

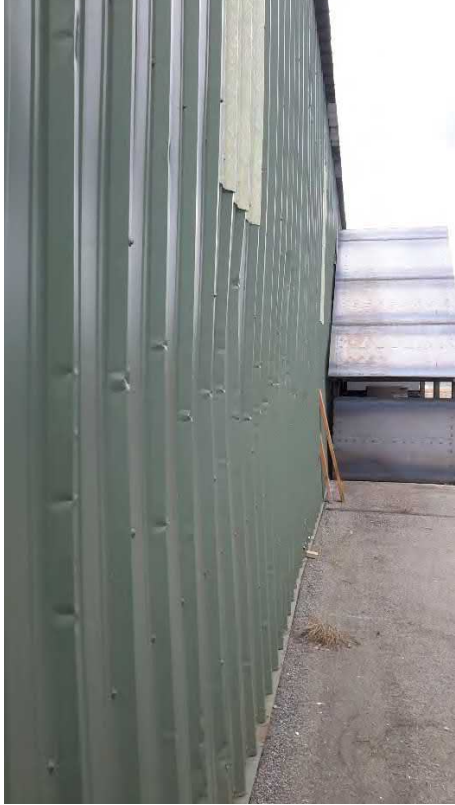
Figure 31 Building 11 - panel damage, north side

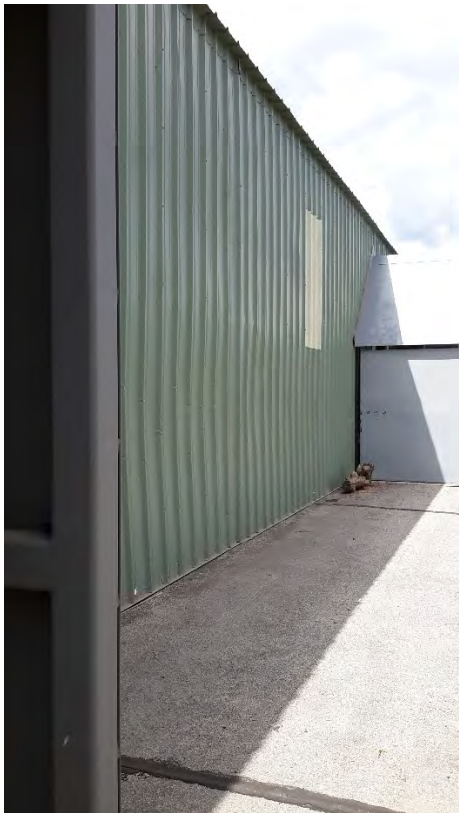
Figure 32 Building 11 - panel damage, north side

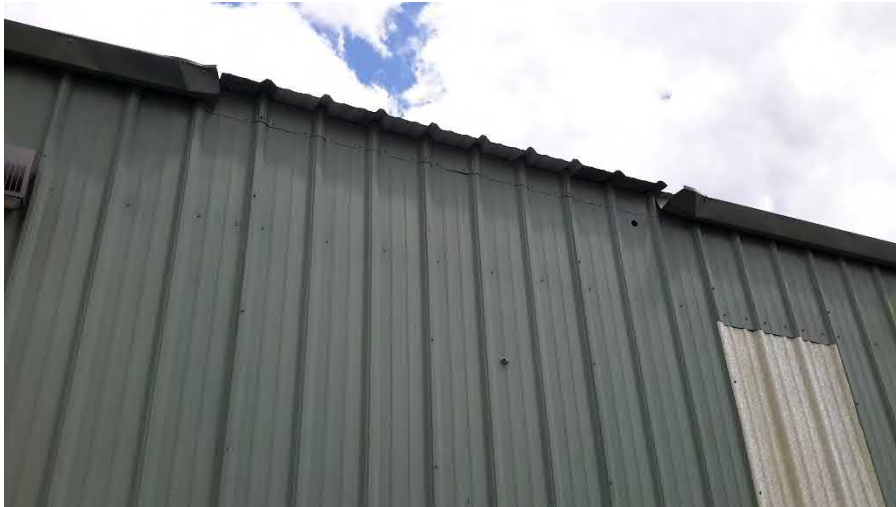
Figure 33 Building 11 - gutter damage on south side

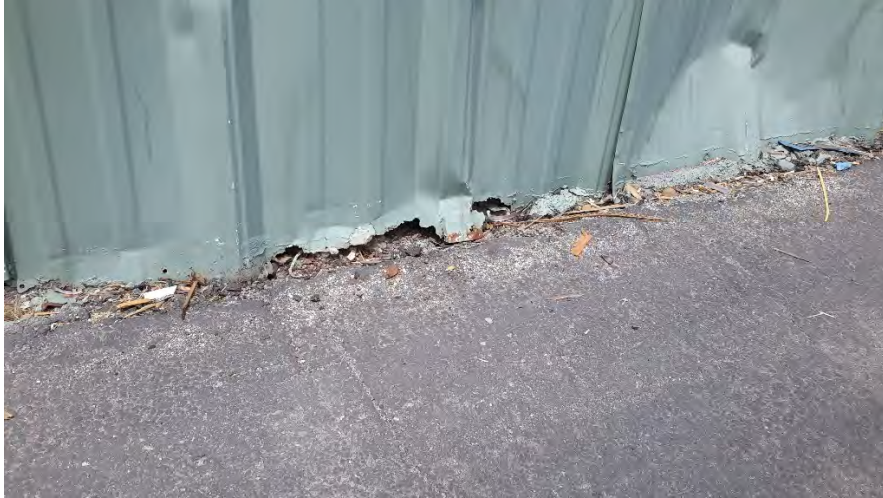
Figure 37 Building 11 - panel damage / corrosion on east side

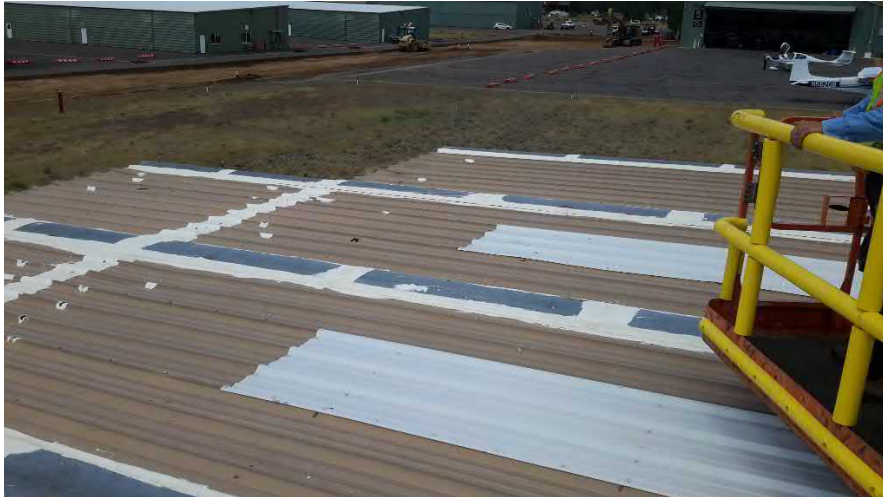
Figure 38 Building 12 - roof patchwork

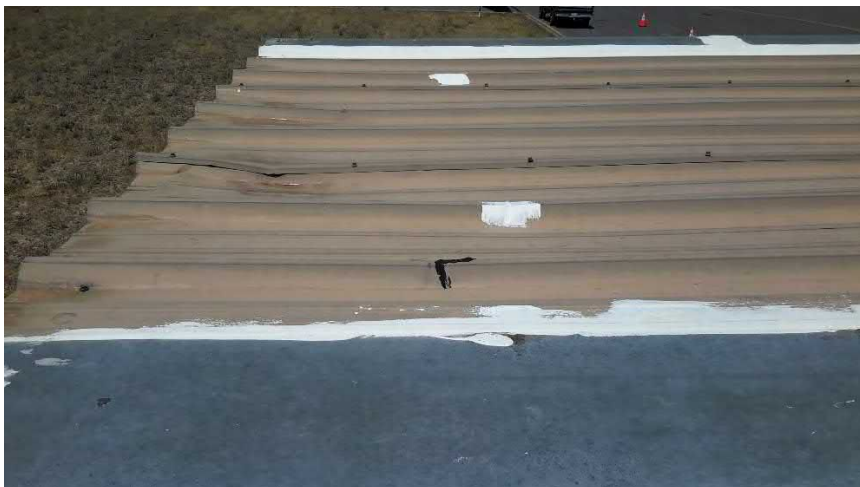
Figure 39 Building 12 - roof is in poor condition

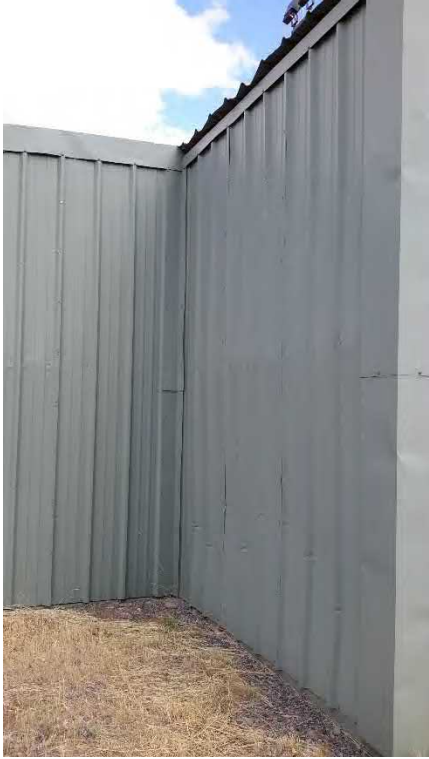
Figure 42 Building 12 - wall panel damage from snow and ice

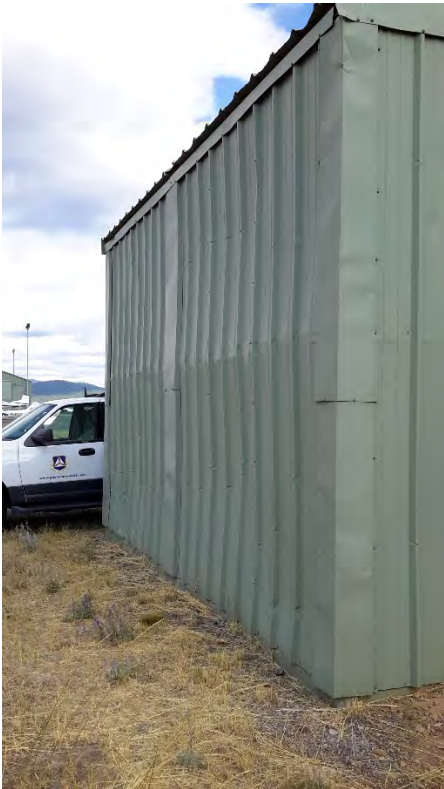
Figure 43 Building 12 - wall panel damage from snow and ice, south side

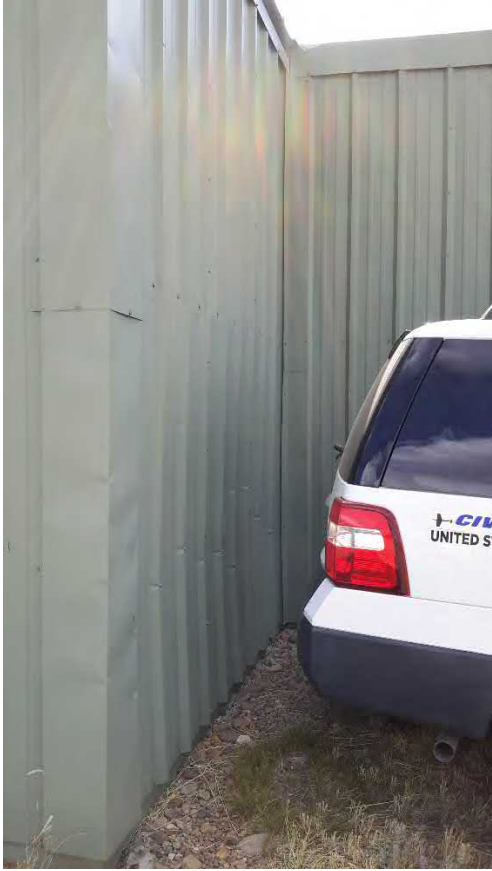
Figure 44 Building 12 - wall panel damage from snow and ice

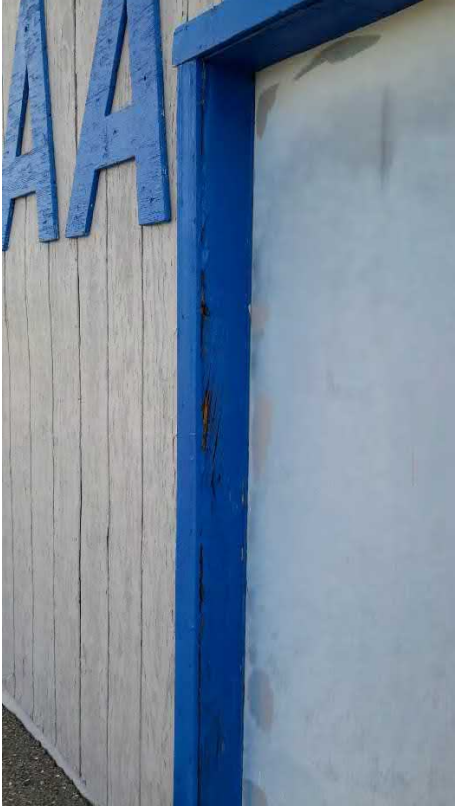
Figure 48 Building 13 - trim, door jamb, paint damaged

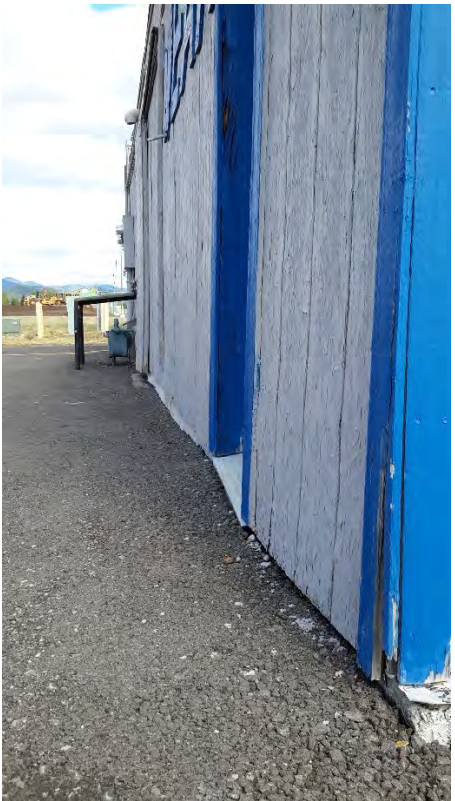
Figure 49 Building 13 - siding corner trim damaged, south east corner

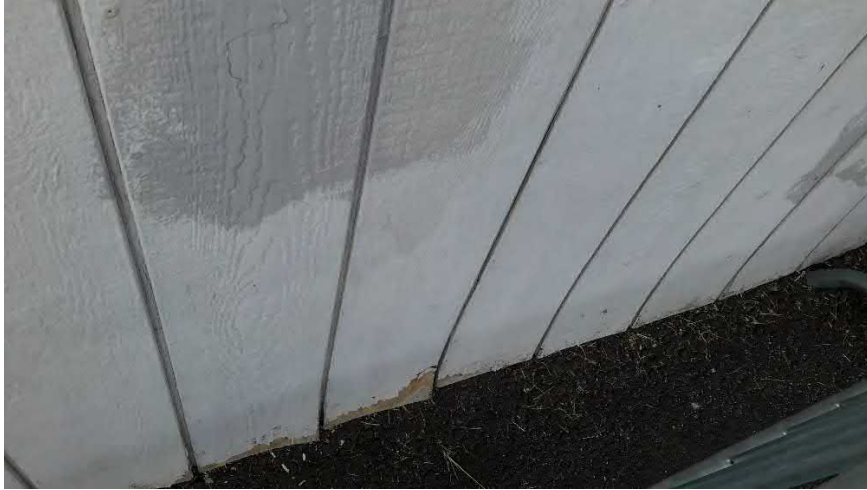
Figure 50 Building 13 - north side of building, siding is buckled, wood siding extends down to grade level

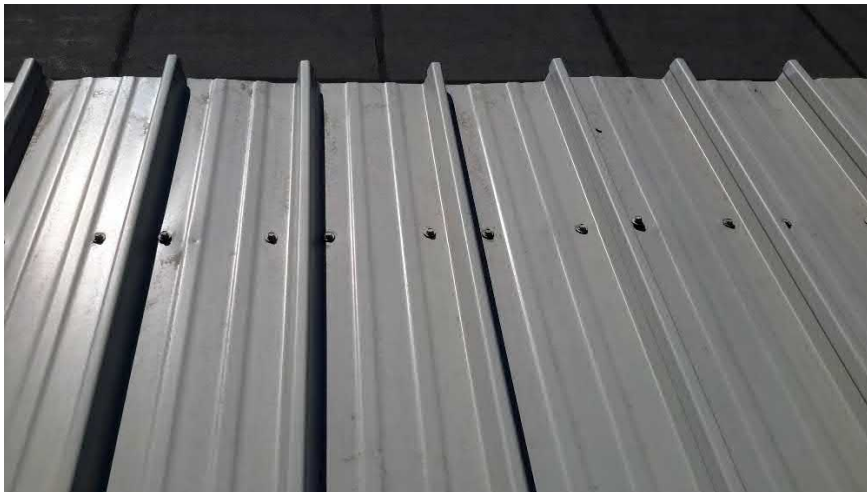
Figure 52 Hangar A - loose screws need to be tightened and/or replaced

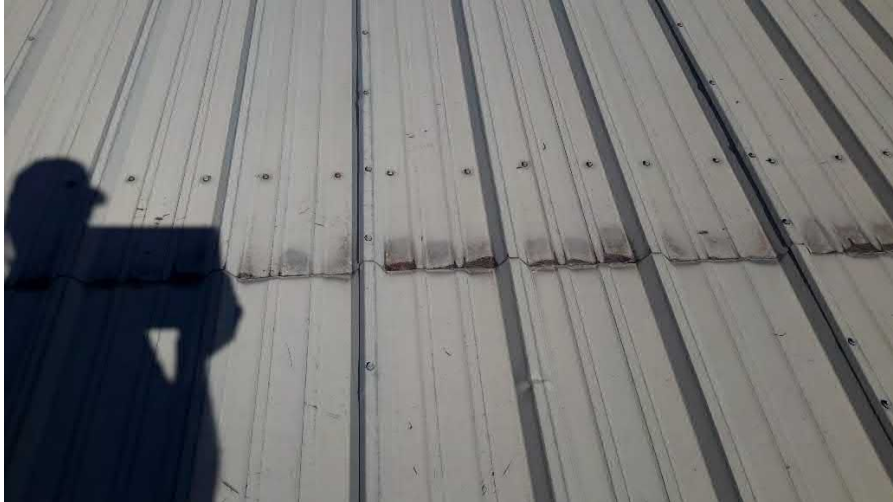
Figure 53 Hangar A - corrosion at lap seam in middle of roof

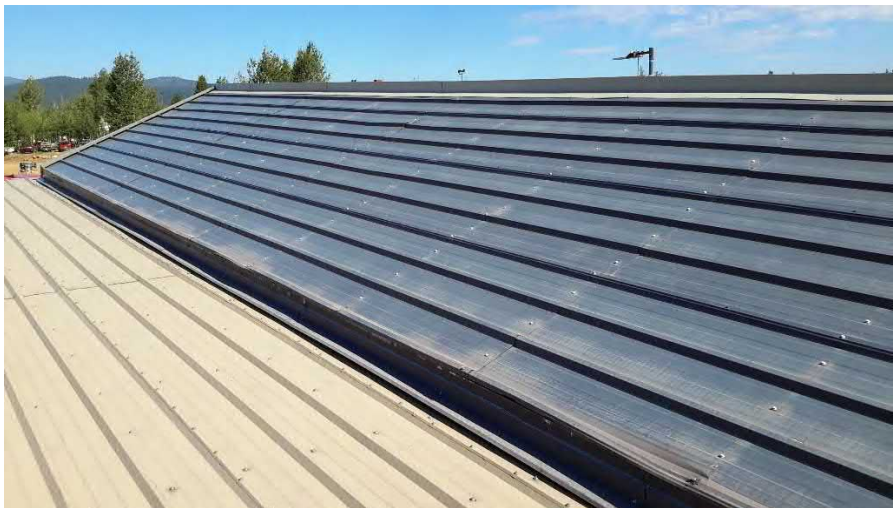
Figure 54 Hangar A - paint coat worn off at over-frame area

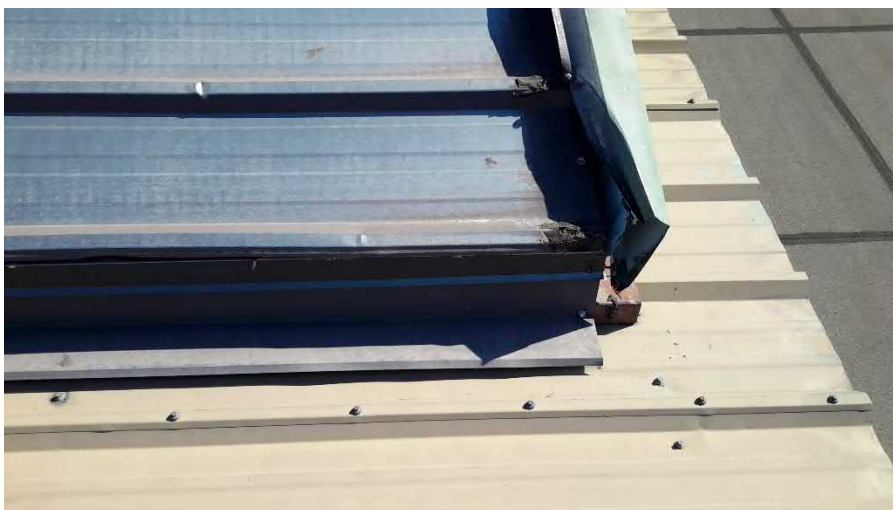
Figure 55 Hangar A - damage to roofing / trim at over-frame area, south east corner

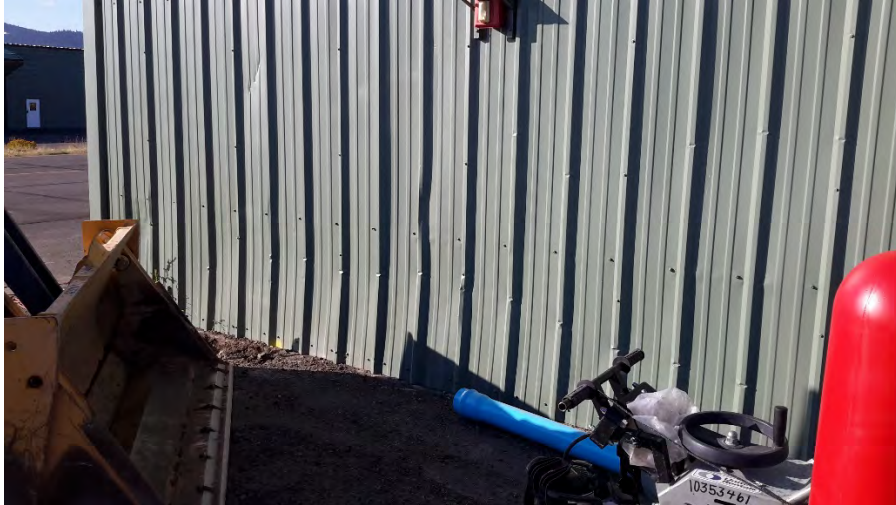
Figure 56 Hangar A - north end wall panels damaged from snow and ice

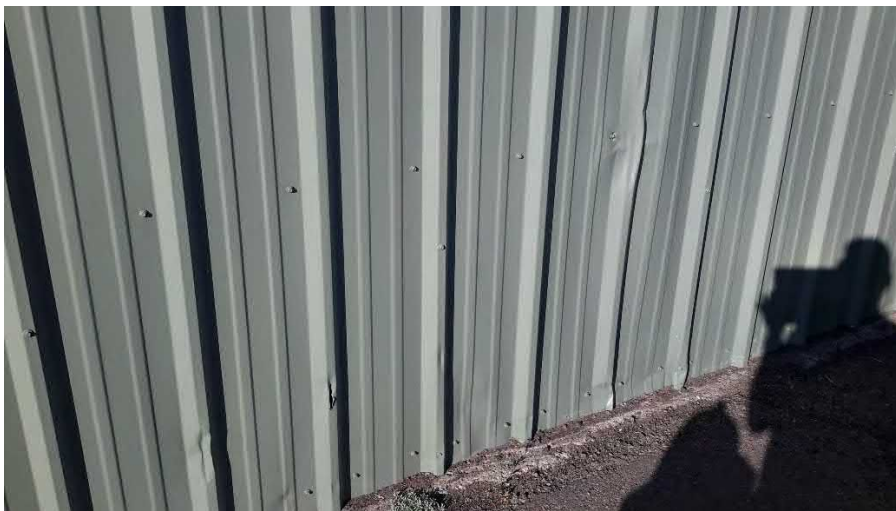
Figure 57 Hangar A - wall panel damage on north end

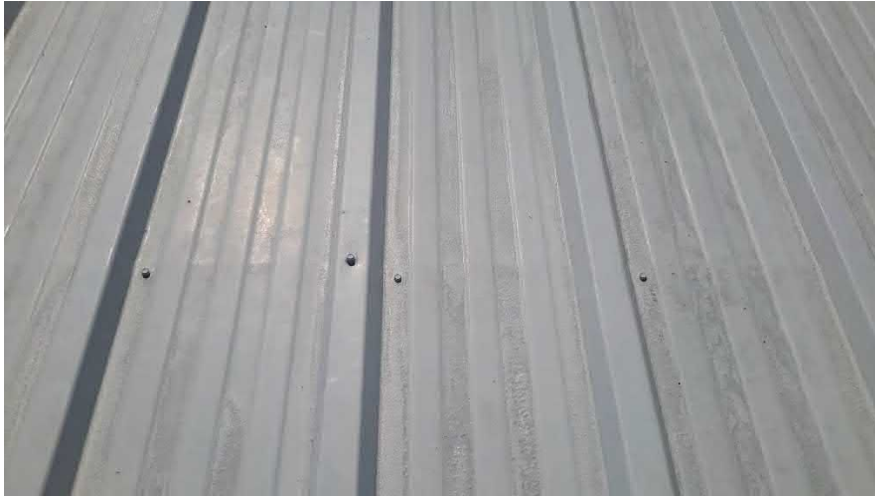
Figure 61 Hangar B - roof was coated over older screws some missing washers

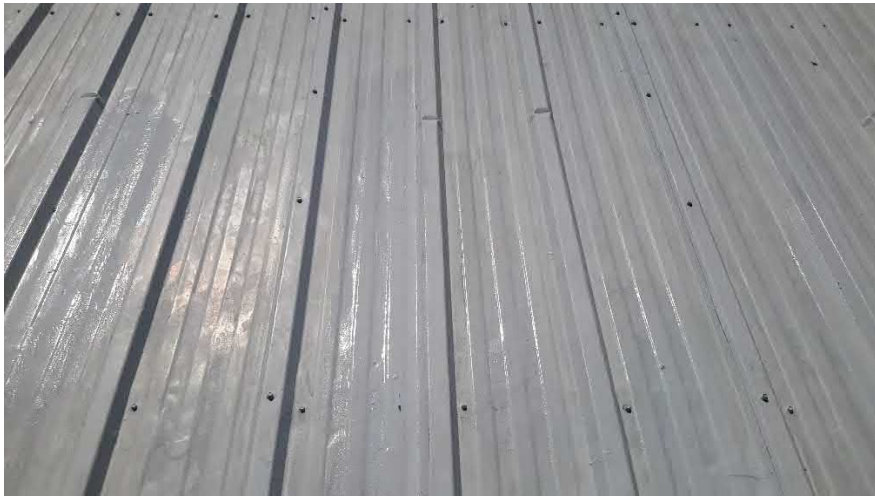
Figure 62 Hangar B - roof panels crimped / kinked from snow and ice damage

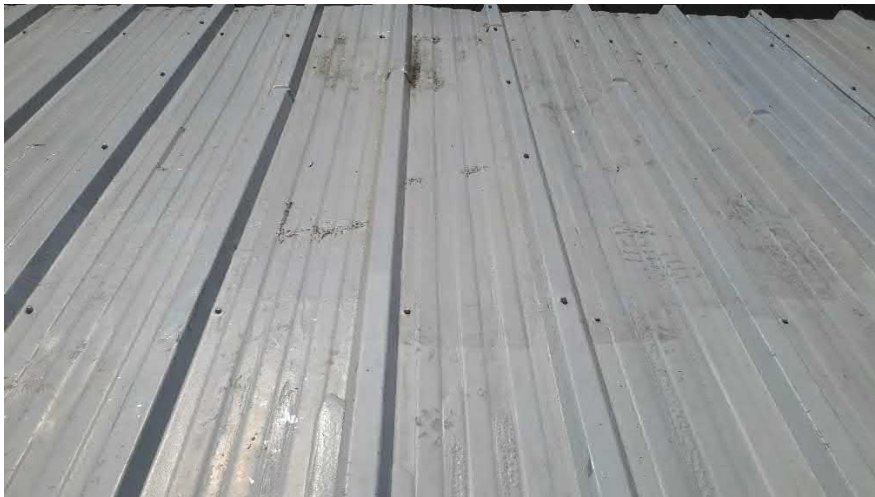
Figure 63 Hangar B - roof panels crimped / kinked from snow and ice damage

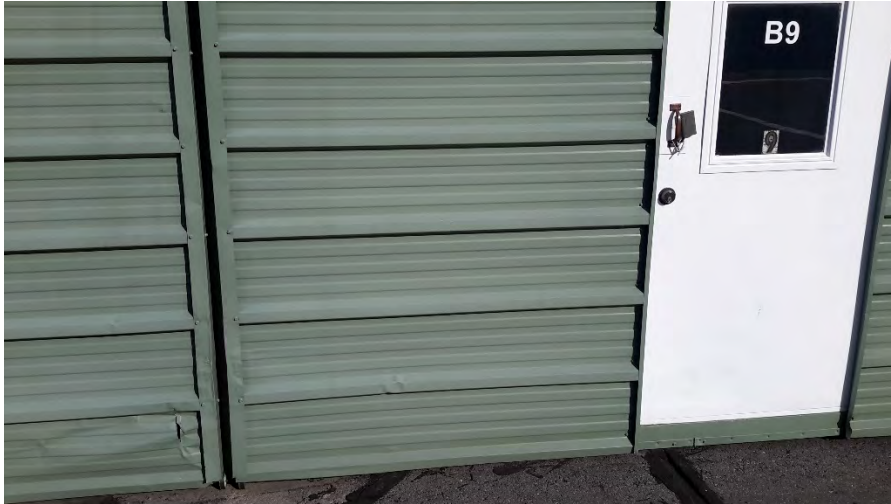
Figure 68 Hangar B - panel damage - east side

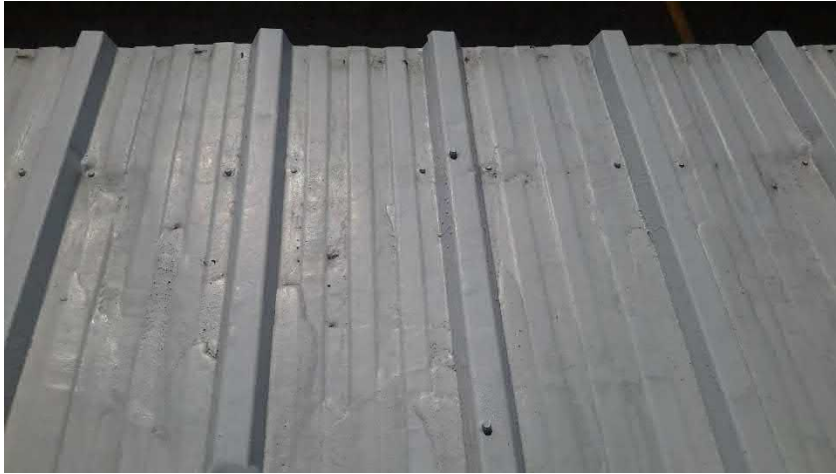
Figure 70 Hangar C - roof was coated over older screws, some missing washers

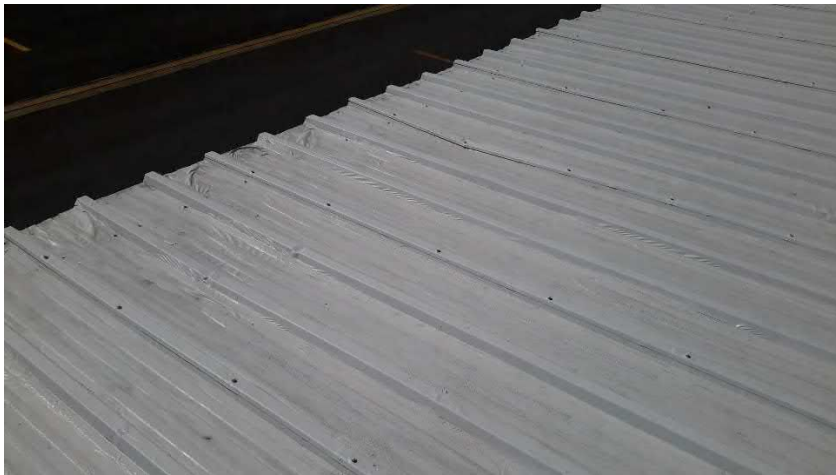
Figure 71 Hangar C - roof panels damaged from snow and ice

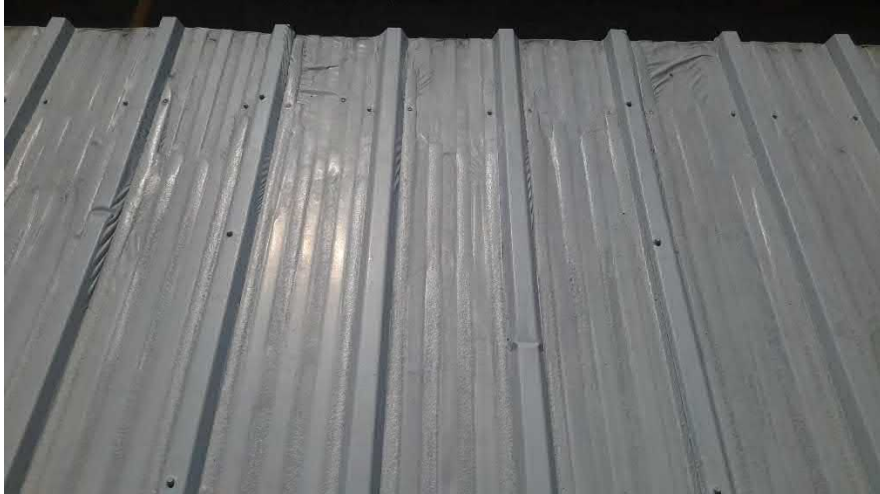
Figure 73 Hangar C - roof coating delaminating from roof panels

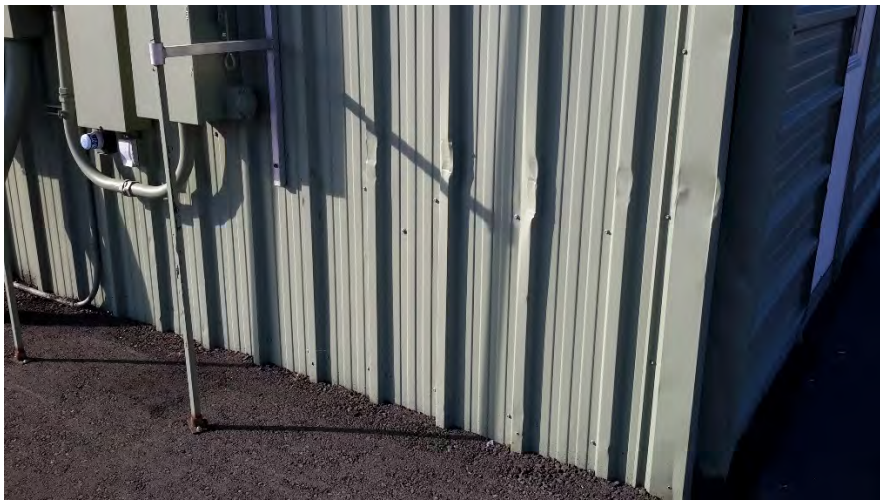
Figure 74 Hangar C - wall panel damage on north end

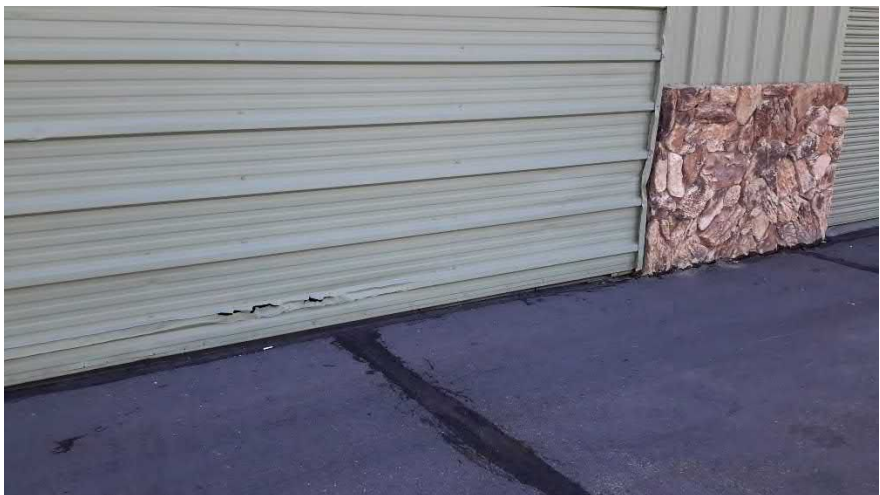
Figure 75 Hangar C - wall panel damage - west side (C24)

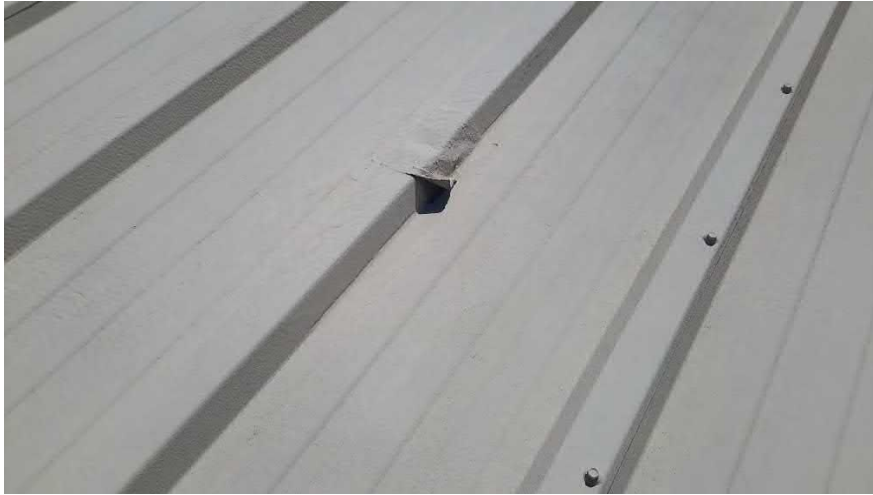
Figure 78 Hangar D - roof coated over older screws, some without washers, fabric patches failing

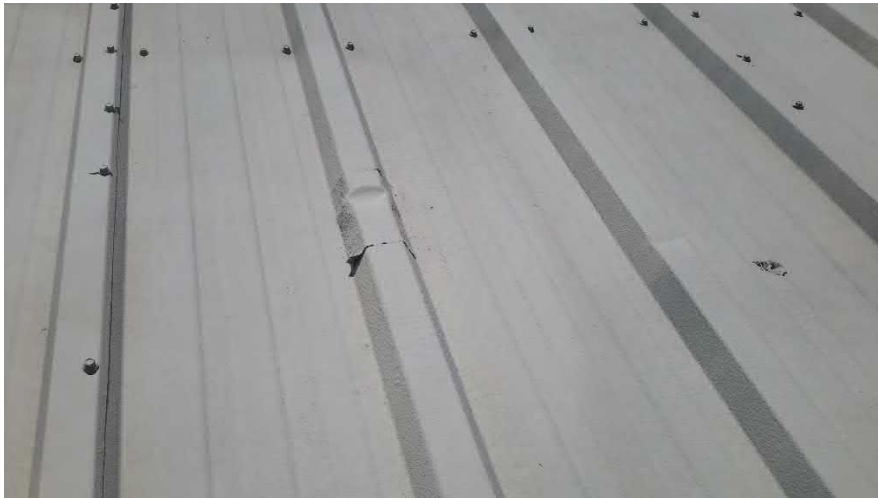
Figure 79 Hangar D - fabric patches failing, roof panels kinked / crimped

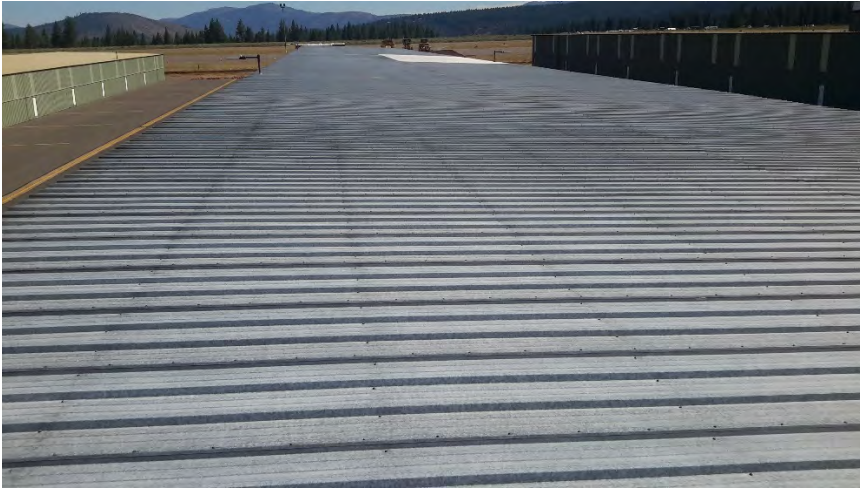
Figure 83 Hangar E - paint coat on roof non-existent

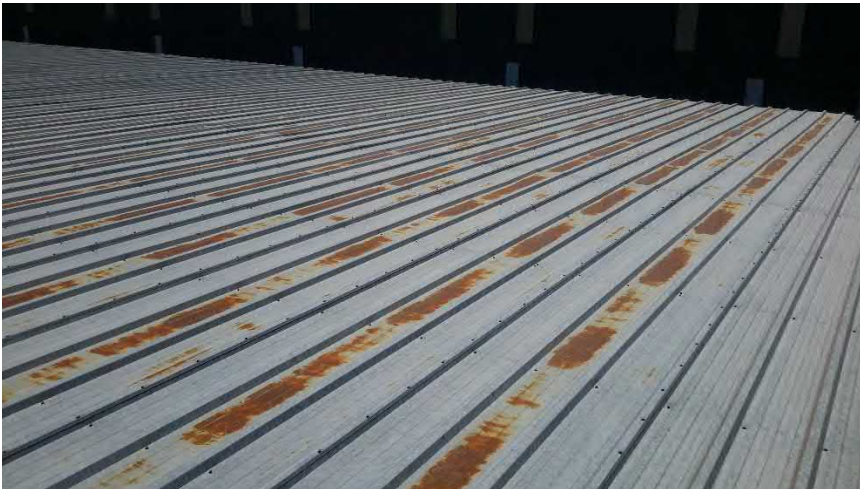
Figure 84 Hangar E - large areas of rust on roof panels

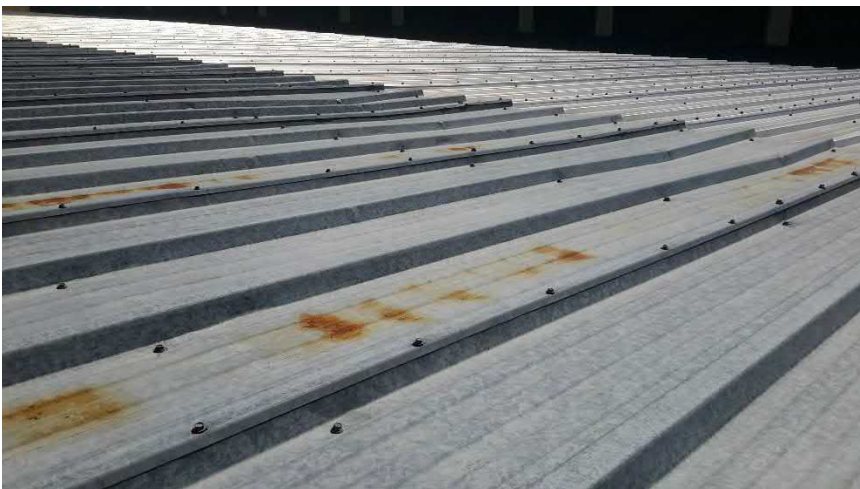
Figure 85 Hangar E - roof panel damage, crimped and kinked from snow and ice damage

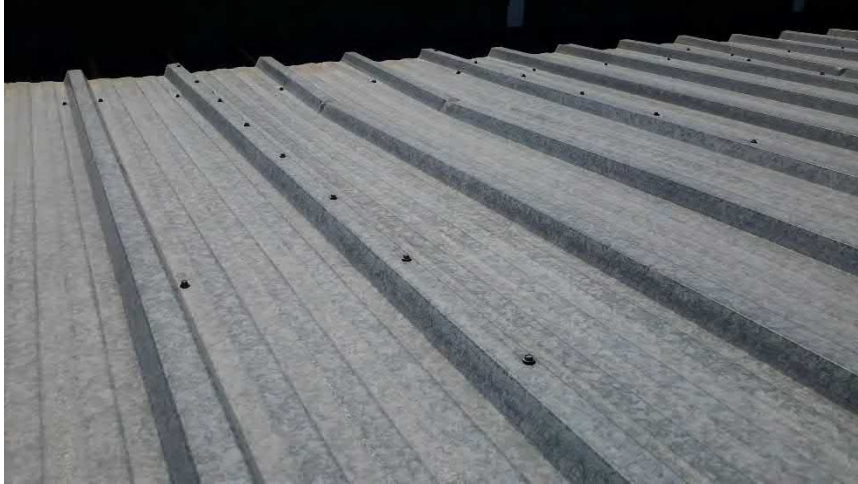
Figure 86 Hangar E - roof panel damage, crimped and kinked from snow and ice damage

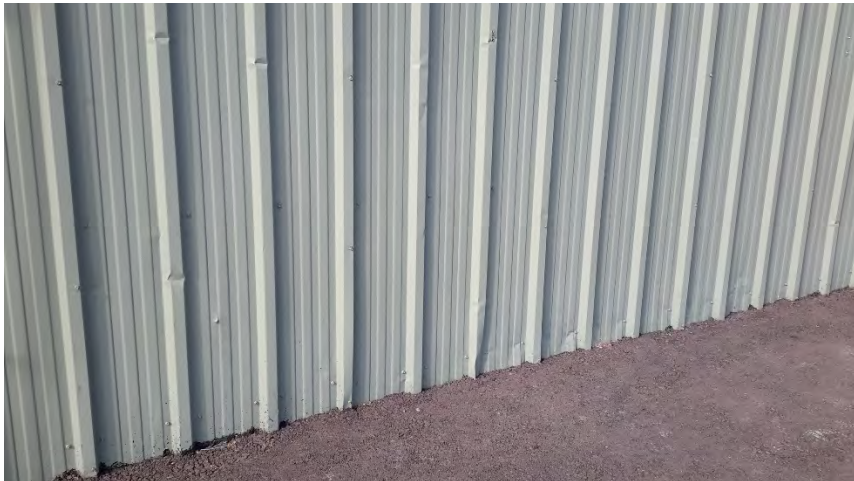
Figure 87 Hangar E - wall panel damage on north end from snow and ice

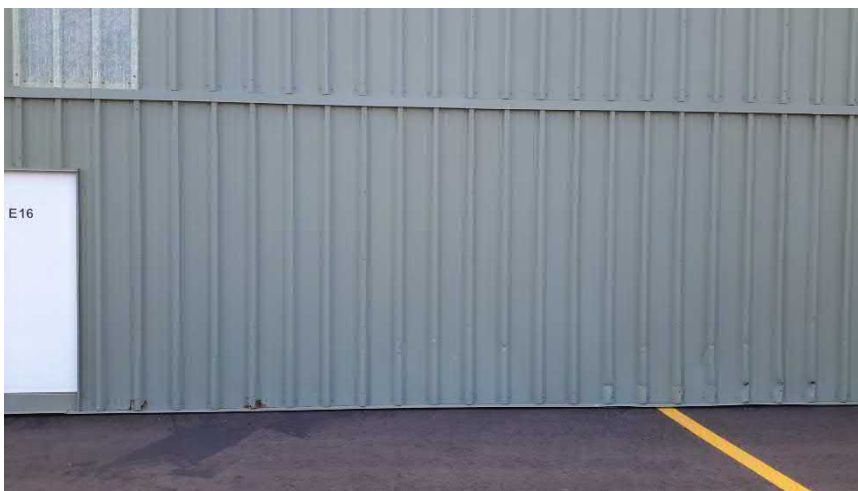
Figure 88 Hangar E - base of door (E16) has damage and rust evident

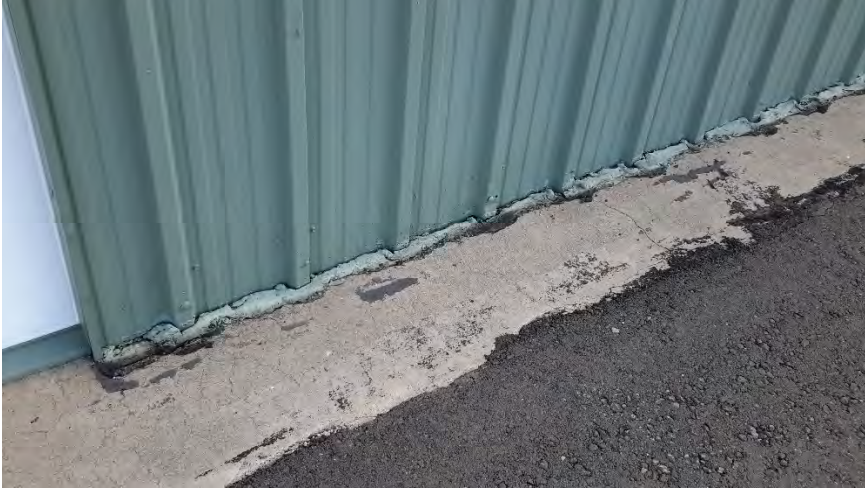
Figure 89 Hangar E - sealant at base of south wall ineffective and will trap moisture against panel base.

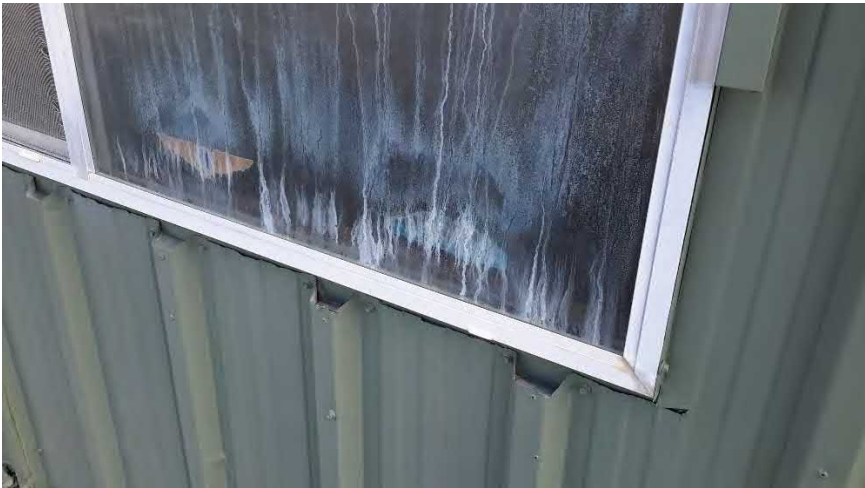
Figure 90 Hangar E - window trim on south wall missing

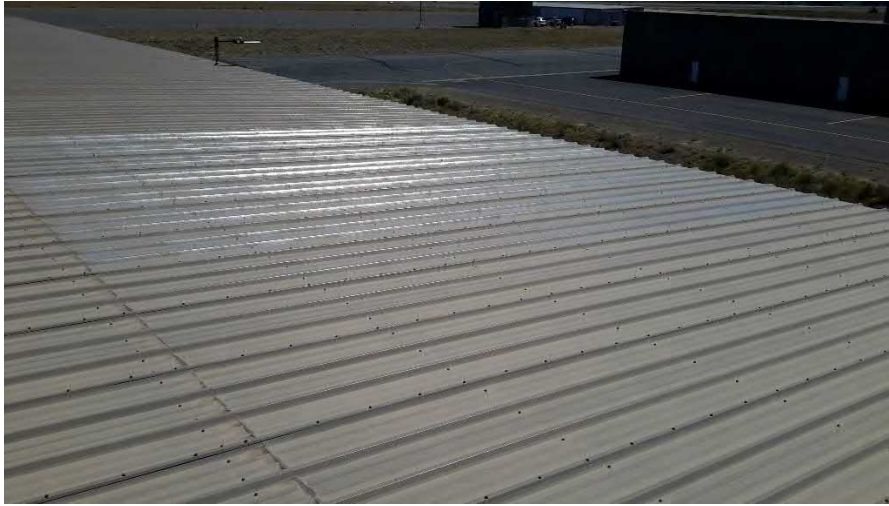
Figure 93 Hangar F - roof panel paint coat badly worn

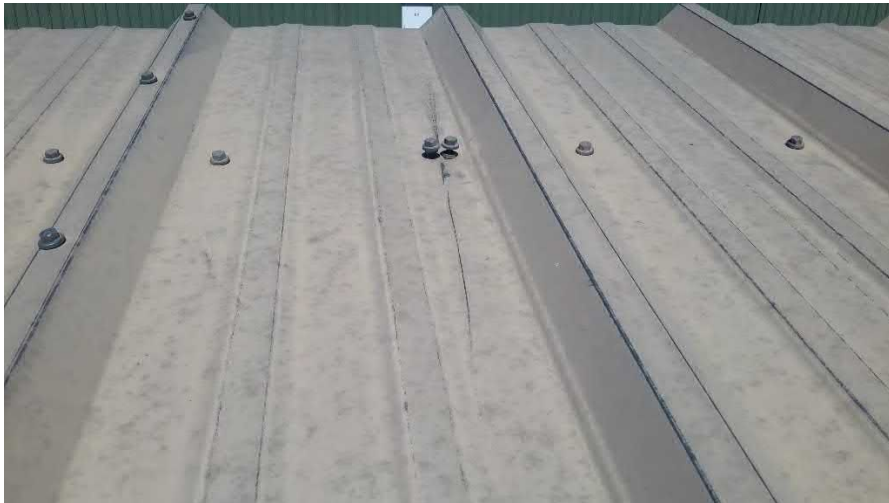
Figure 94 Hangar F - loose screws evident on roof

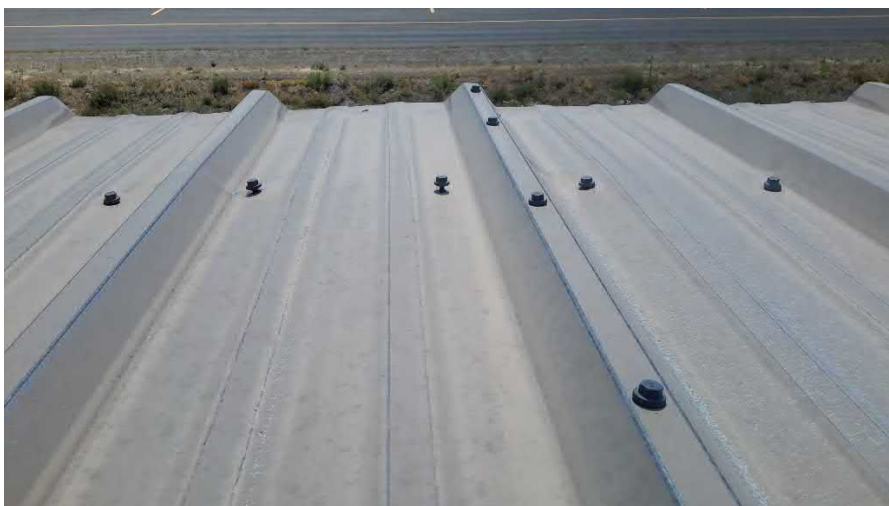
Figure 95 Hangar F - loose screws evident on roof

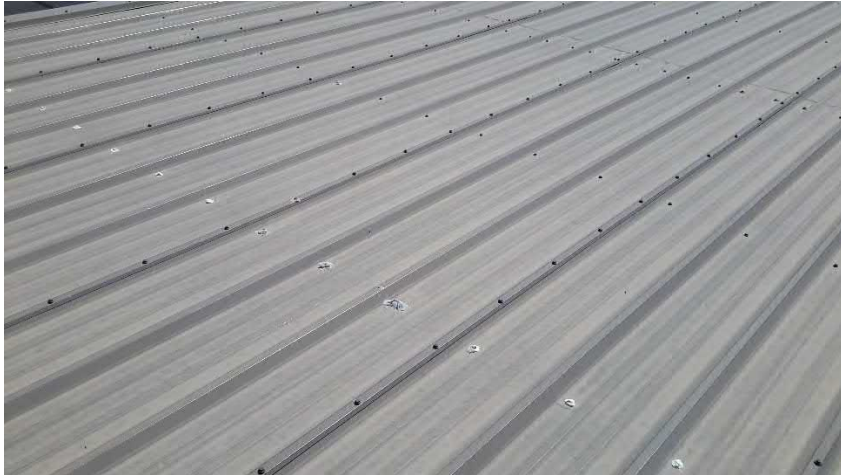
Figure 96 Hangar F - roof panels show crimping and kinking damage from snow and ice
