FACILITIES MAINTENANCE PLAN

AUERBACH
ENGINEERING CORP

**Facilities Maintenance Plan
Truckee Tahoe Airport District
October 2020 - FINAL**

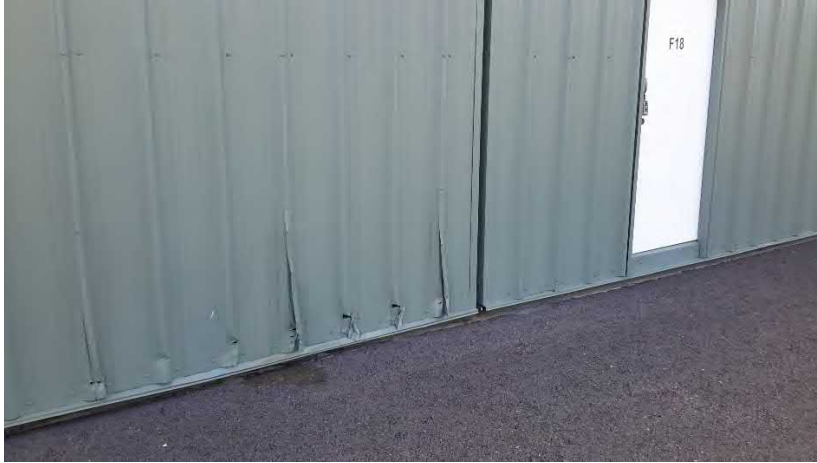
Figure 100 Hangar F - door panel damage (F16)

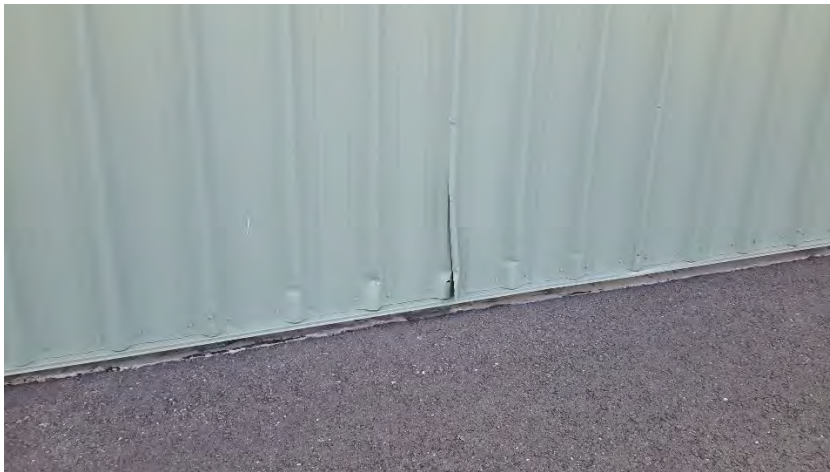
Figure 101 Hangar F - door panel damage (F18)

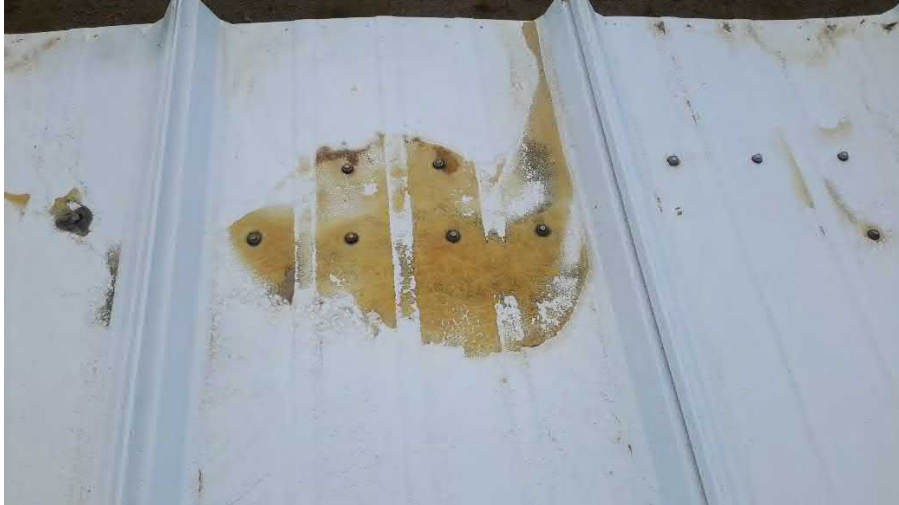
Figure 107 Hangar H - leak patch cracking, low end, east side

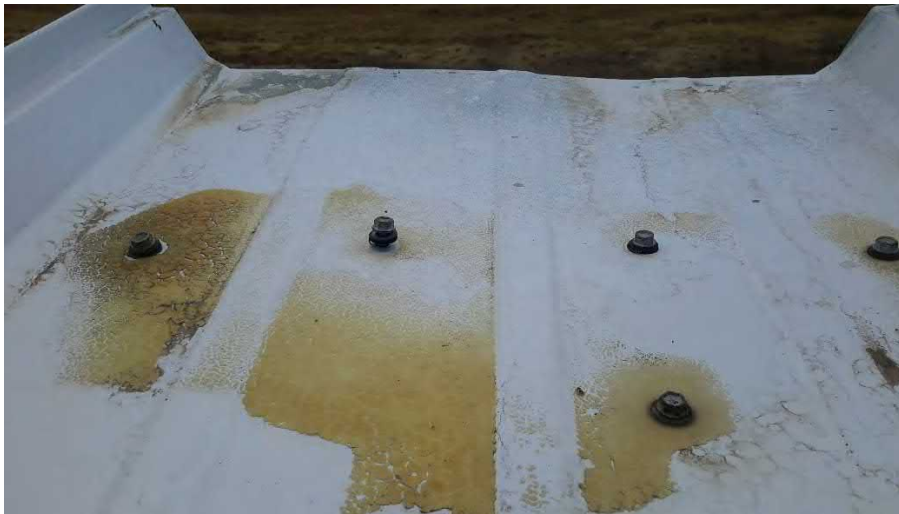
Figure 108 Hangar H - low end (east side) screws loose and leak patch failing

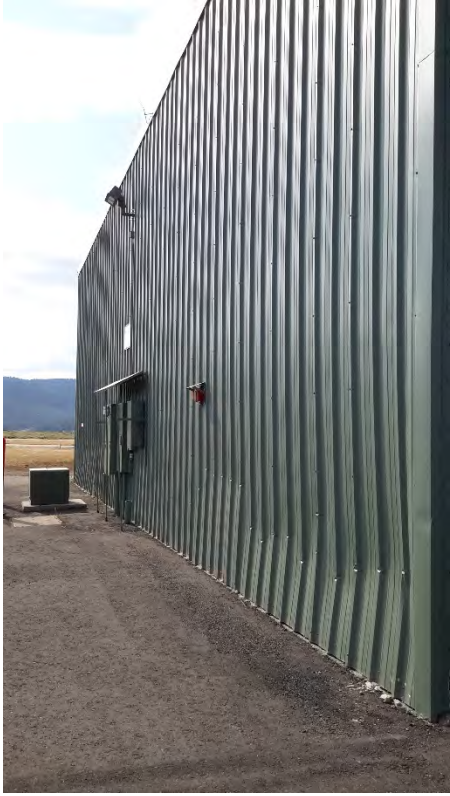
Figure 110 Hangar H - wall panel damage on north end

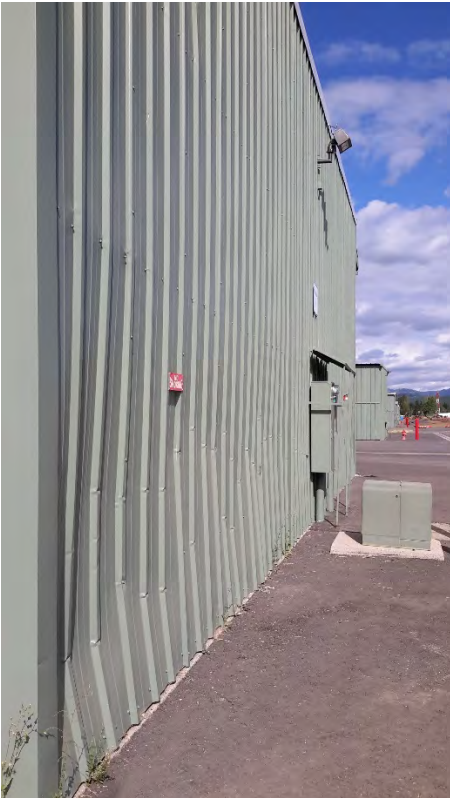
Figure 111 Hangar H - wall panel damage on north end

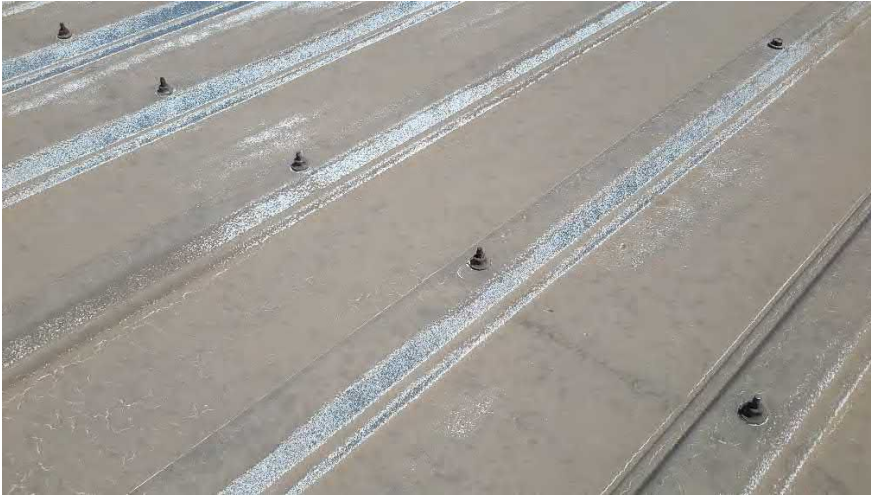
Figure 116 - Hangar J - unconventional fastening system - but no reported leaks

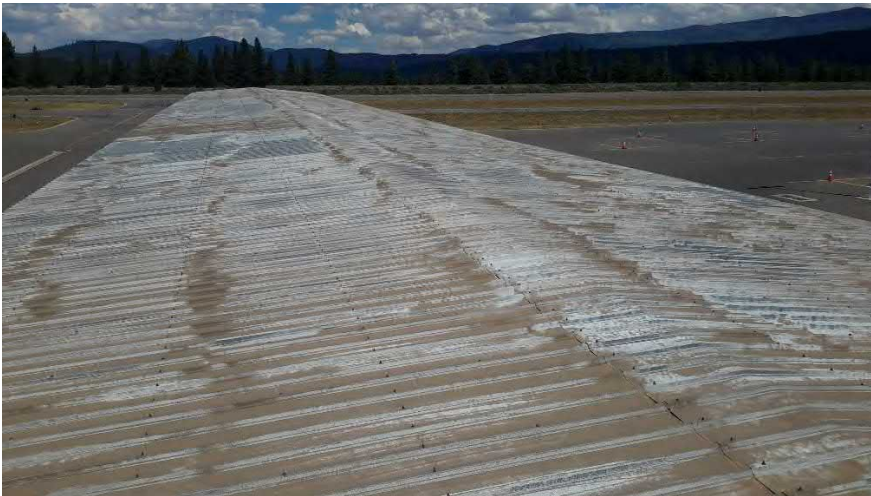
Figure 117 Hangar J - roof panel paint coat badly worn

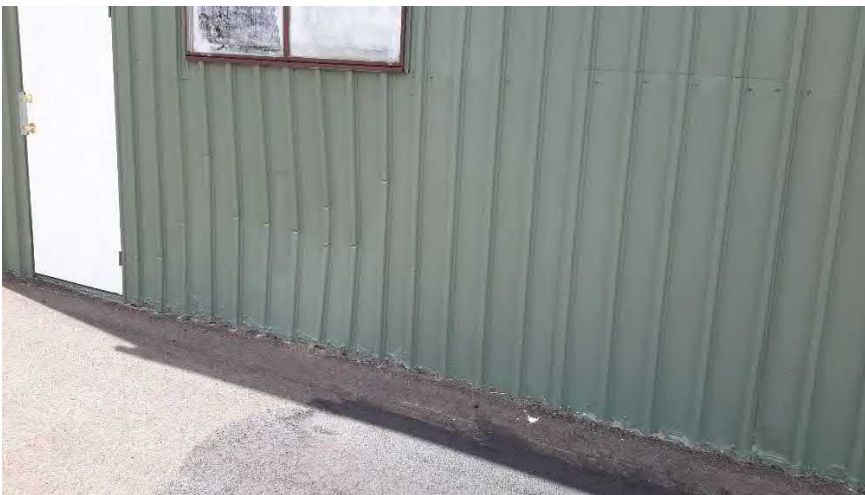
Figure 118 Hangar J - wall panel damage north end

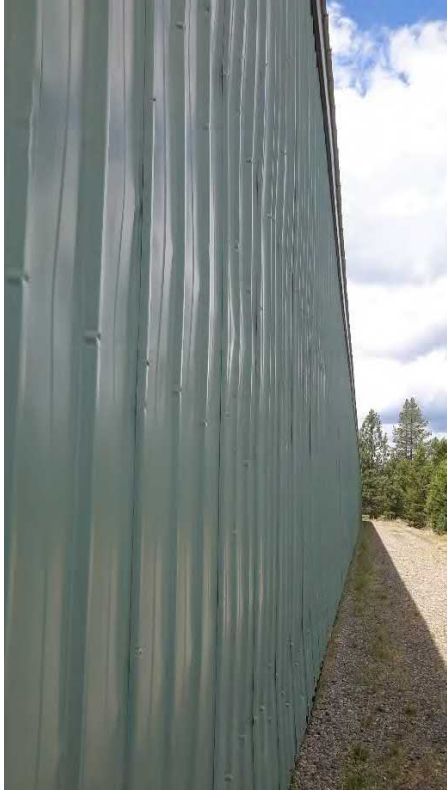
Figure 131 Hangar L - wall panel damage on north side

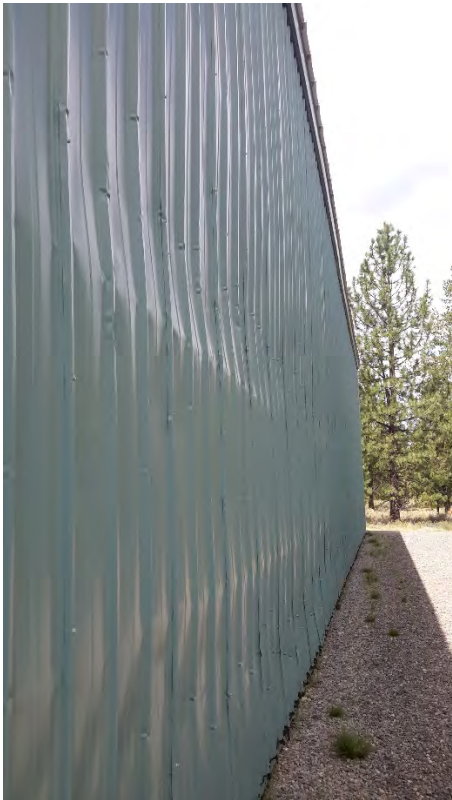
Figure 132 Hangar L - wall panel damage on north side

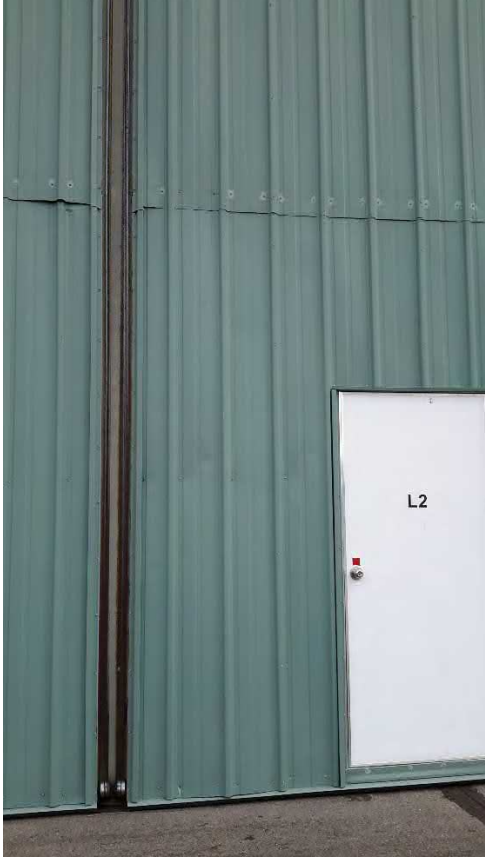
Figure 135 Hangar L - rust at door track / column
