# **TRUCKEE TAHOE AIRPORT Pavement Evaluation Study Pavement Maintenance/Management Plan (PMMP)**

**PREPARED FOR  
TRUCKEE TAHOE AIRPORT DISTRICT**

**JULY 2021**

*Prepared by:  
Brandley Engineering, Inc.*

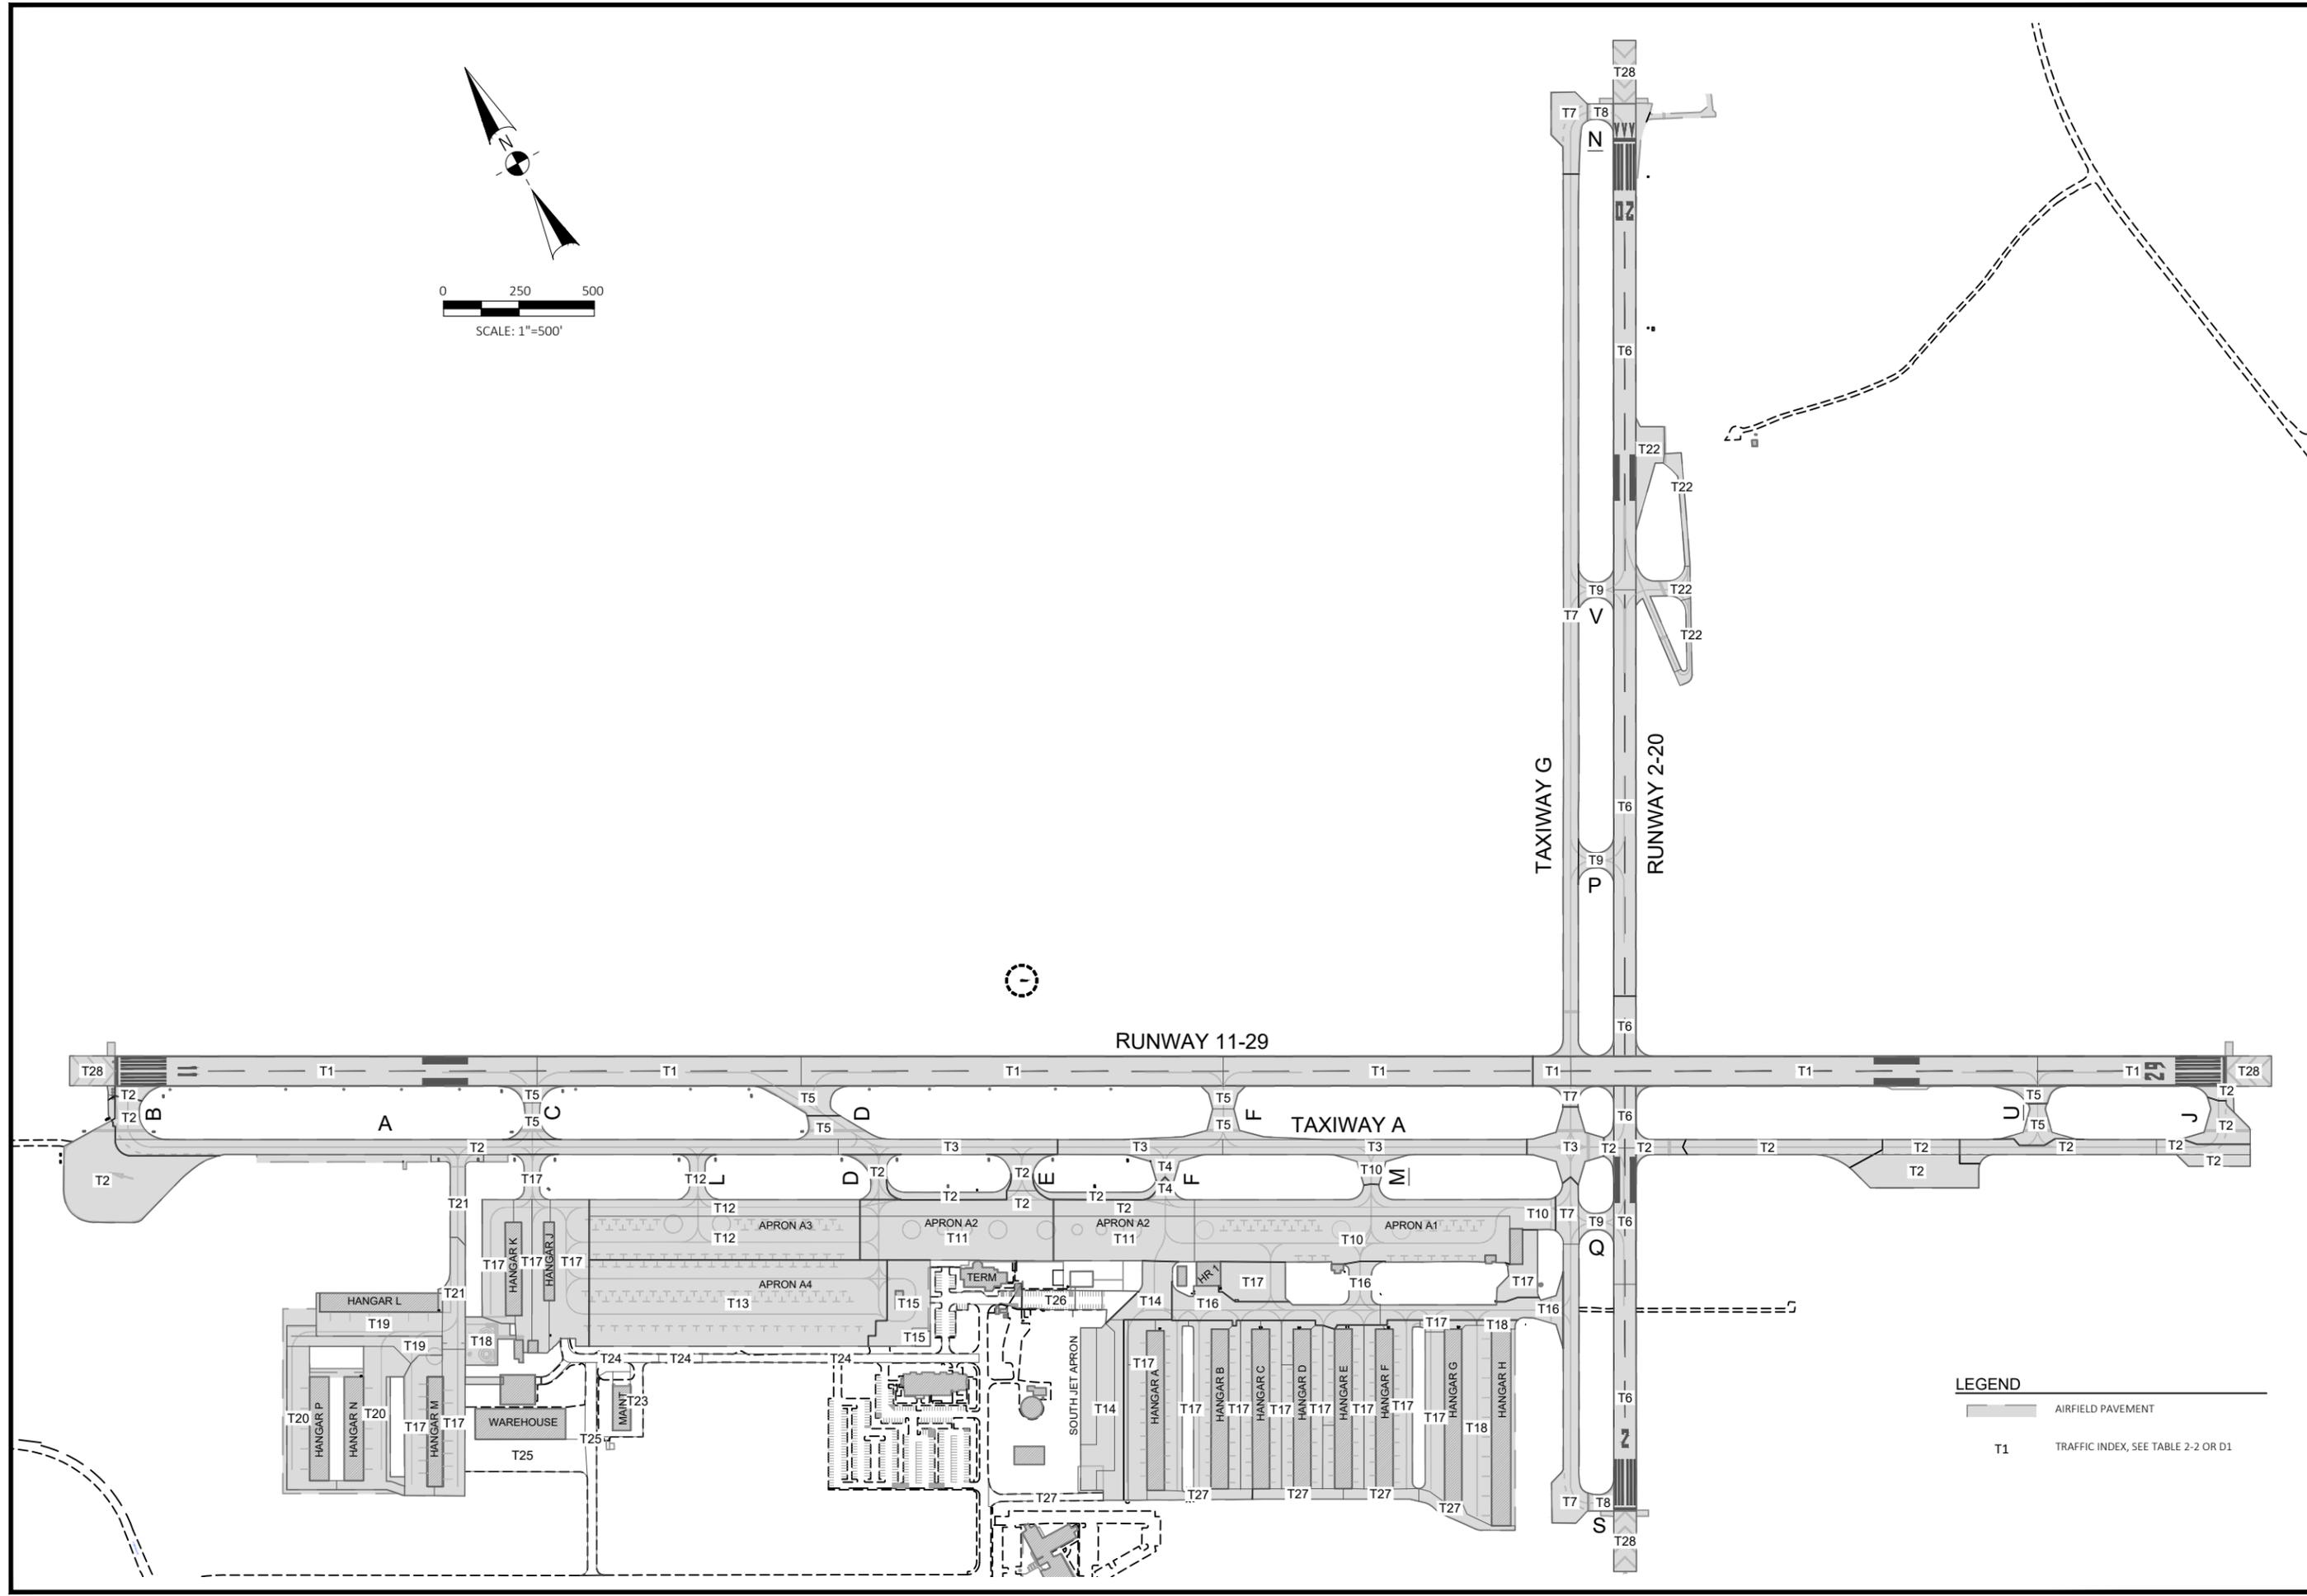
DATE	4/15/2021
DRAWN	KDC
CHECKED	DB
FILE	4004-20-2-3.PCI
SCALE	1"=500'
PLATE No.	2-3

Pavement condition surveys (PCI) were conducted in 2011, 2013, and 2020. The PCI of each segment of pavement is shown on Plate 2-1 for 2011, Plate 2-2 for 2013, and Plate 2-3 for 2020. The results of this study are summarized in Chapter 5, Table 5-3. The results of this comparison study show that the PCI of any sections that did not have any rehabilitation completed since 2011 have decreased and the sections that had rehabilitation projects completed have increased in PCI. This data indicates that some of the old pavements are experiencing significant surface distress and will require significant surface treatment earlier than deep-seated distress treatment is required.

**TRUCKEE TAHOE AIRPORT**  
**2020 PAVEMENT MANAGEMENT PLAN**  
 PAVEMENT CONDITION INDEX (2020)

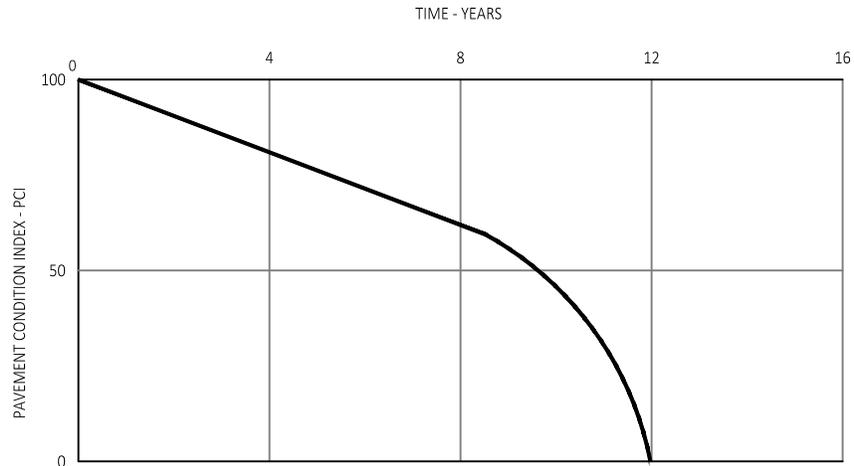
NOTE:  
 THESE GRAPHS DEPICT AN EXAMPLE OF HOW PCI CHANGES OVER TIME. ACTUAL TIME OF FAILURE IS DEPENDENT ON EXISTING PAVEMENT SECTION AND SUBGRADE STRENGTH/CONDITION. TIME INDICATED ON THESE CHARTS IS A TYPICAL EXAMPLE, SEE REMAINING LIFE OF EACH PAVEMENT SECTION DUE TO DEEP SEATED DISTRESS FOR ESTIMATED TIME OF FAILURE OF SPECIFIC PAVEMENT SECTIONS ON THE AIRPORT.

ASPHALT CONCRETE PAVEMENT SECTION  
PCI VS. TIME - RELATIONSHIP

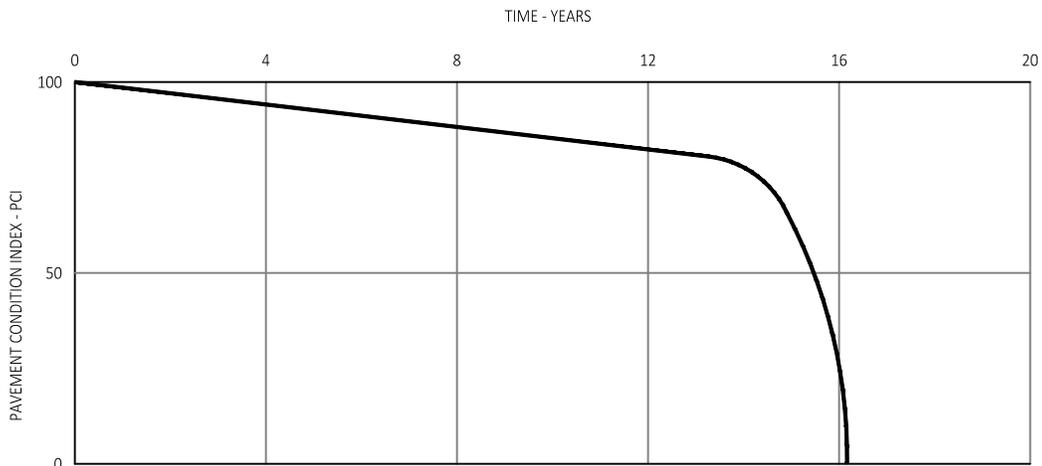
PORTLAND CEMENT CONCRETE PAVEMENT SECTION  
PCI VS. TIME - RELATIONSHIP
