TRUCKEE TAHOE AIRPORT Pavement Evaluation Study Pavement Maintenance/Management Plan (PMMP)

**PREPARED FOR
TRUCKEE TAHOE AIRPORT DISTRICT**

**TRUCKEE TAHOE AIRPORT
PAVEMENT EVALUATION STUDY
PAVEMENT MAINTENANCE/MANAGEMENT PLAN (PMMP)**

*Prepared for
Truckee Tahoe Airport District, Truckee, California*

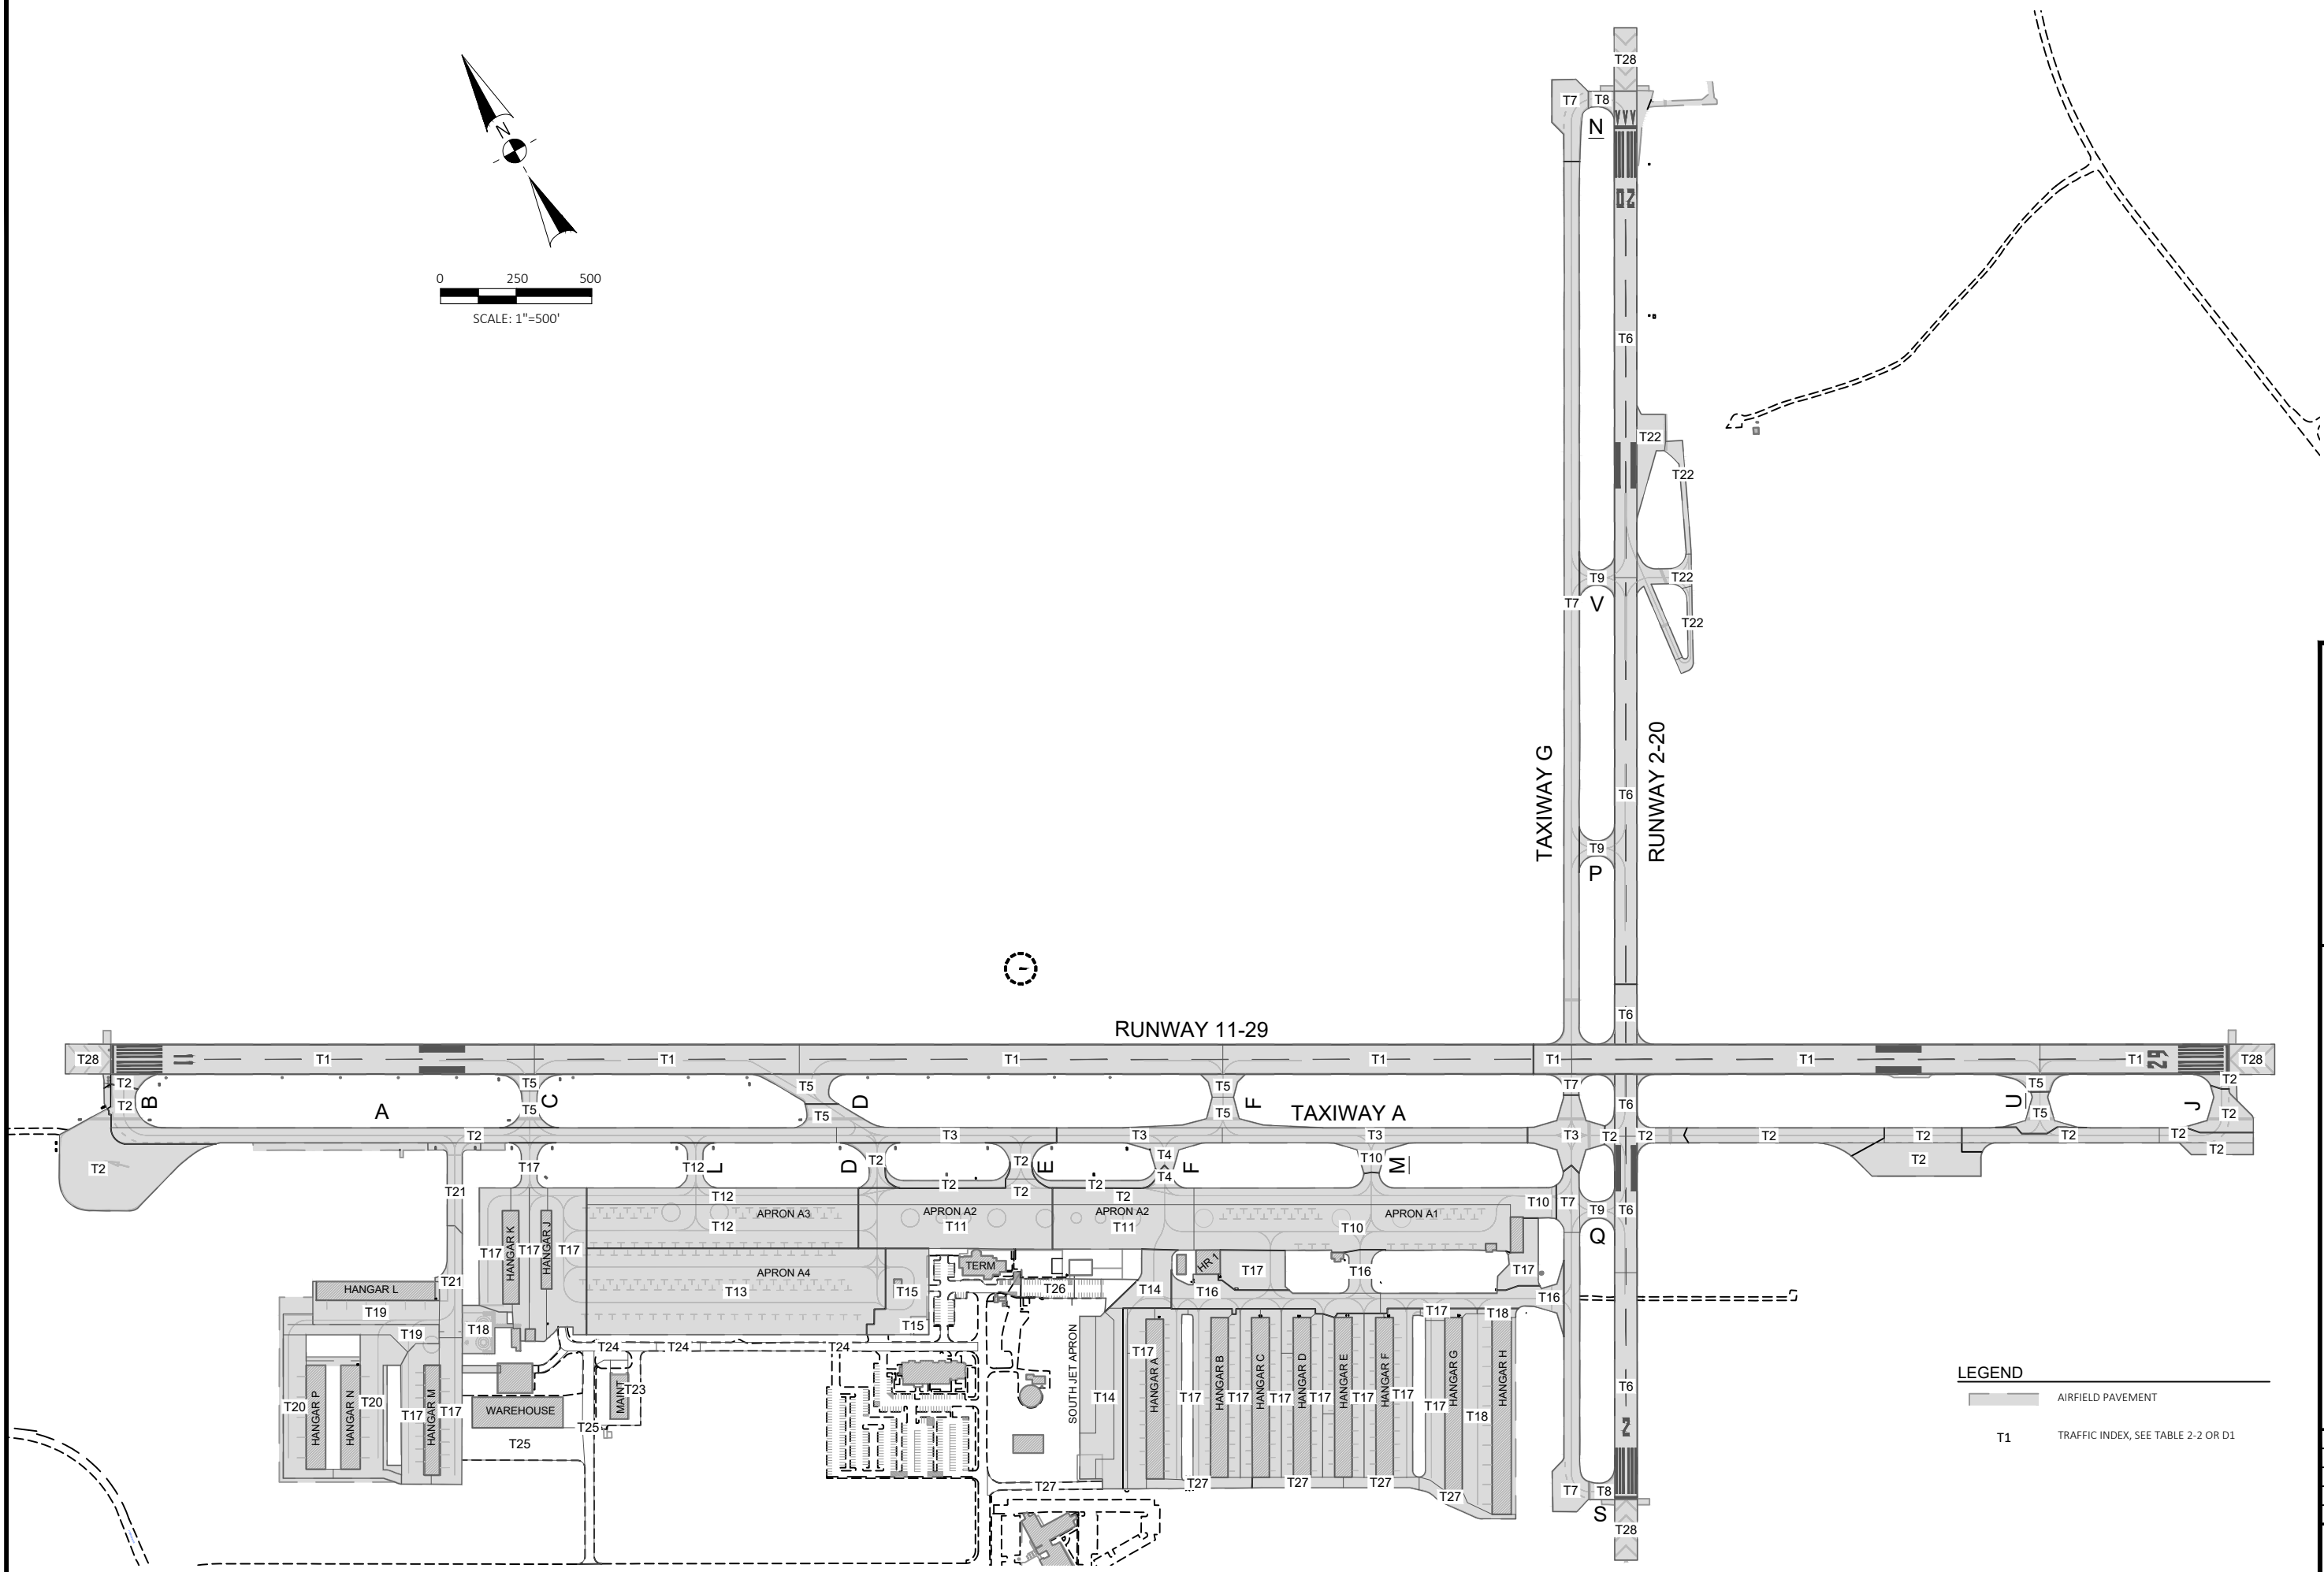
DATE	4/15/2021
DRAWN	KDC
CHECKED	DB
FILE	4004-20-2-3.PCI
SCALE	1"=500'
PLATE No.	2-3

Pavement condition surveys (PCI) were conducted in 2011, 2013, and 2020. The PCI of each segment of pavement is shown on Plate 2-1 for 2011, Plate 2-2 for 2013, and Plate 2-3 for 2020. The results of this study are summarized in Chapter 5, Table 5-3. The results of this comparison study show that the PCI of any sections that did not have any rehabilitation completed since 2011 have decreased and the sections that had rehabilitation projects completed have increased in PCI. This data indicates that some of the old pavements are experiencing significant surface distress and will require significant surface treatment earlier than deep-seated distress treatment is required.
