March 26 2026 Hangar Update for Board

A summary of the current state of the hangars and our way forward

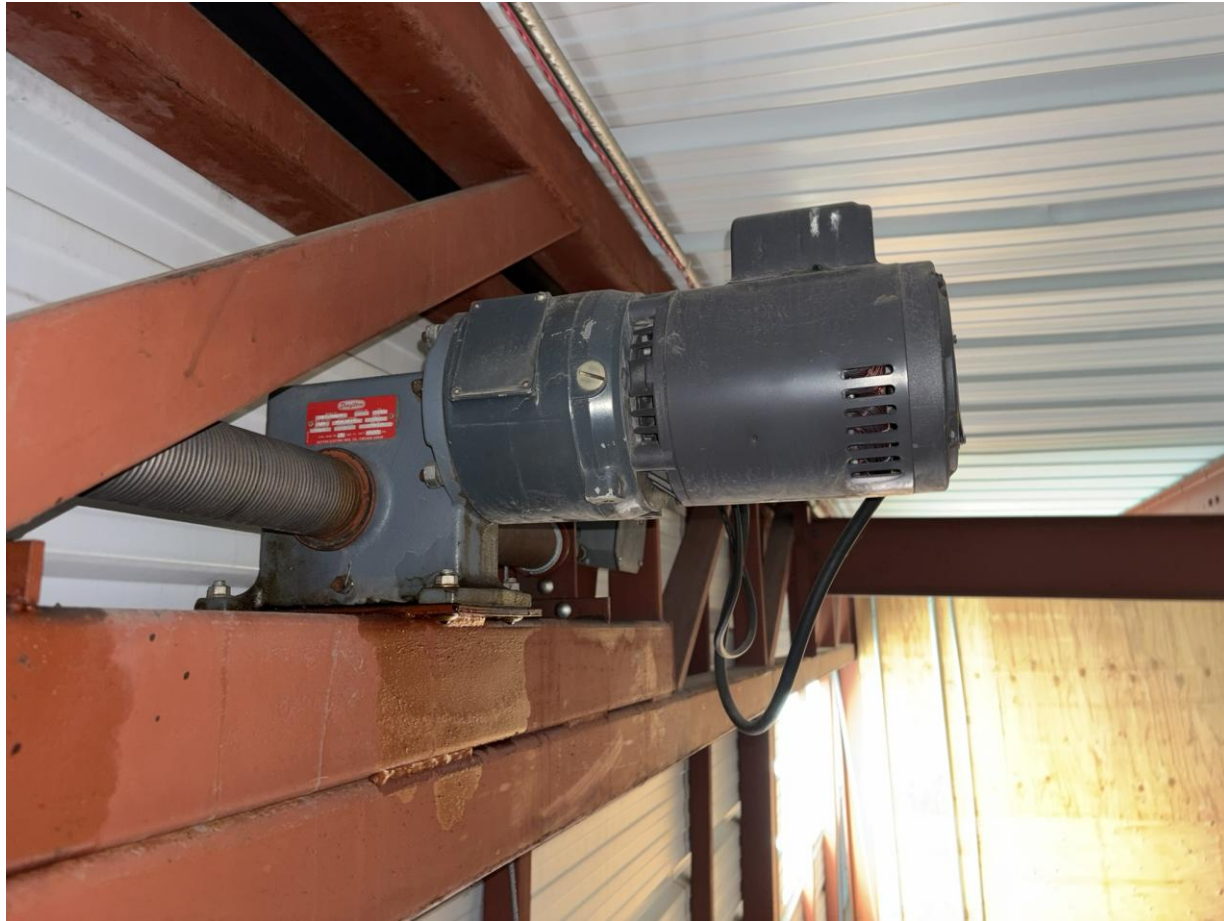
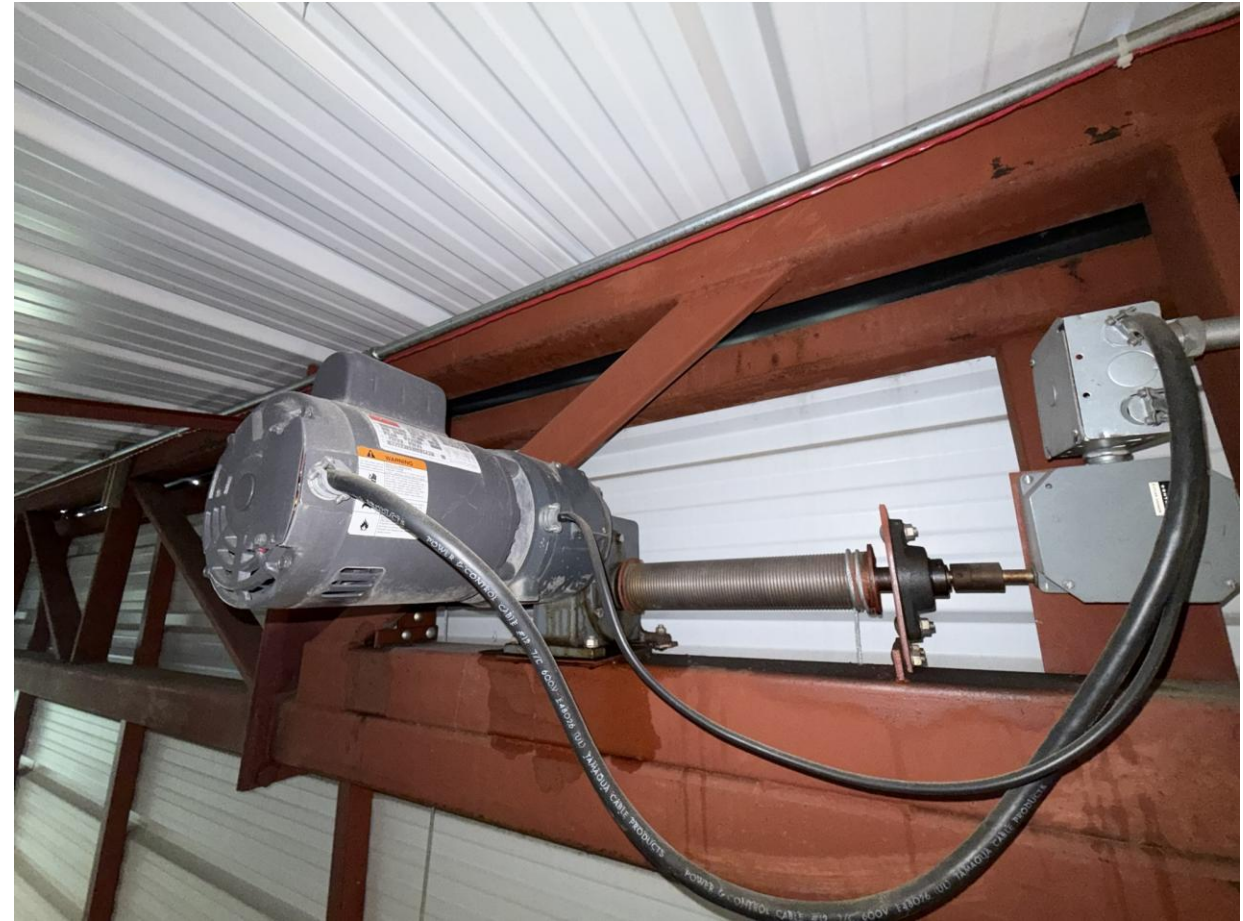
Bravo Row Direct Drive

- 2026 Delta row – Door Fell (SPF). Chain failure resulting in free fall - **SEVERE** Mitigation underway, decisions pending
- 2026 Bravo and 2023 Charlie row – Manual Latch Injury. Doors lifted without unlatching manual latches. At least two injuries to persons after tenants tried to unlatch tensioned doors. **MAJOR** Mitigation: Momentary switch, Policy, Retrofit with 'Auto-latches?'

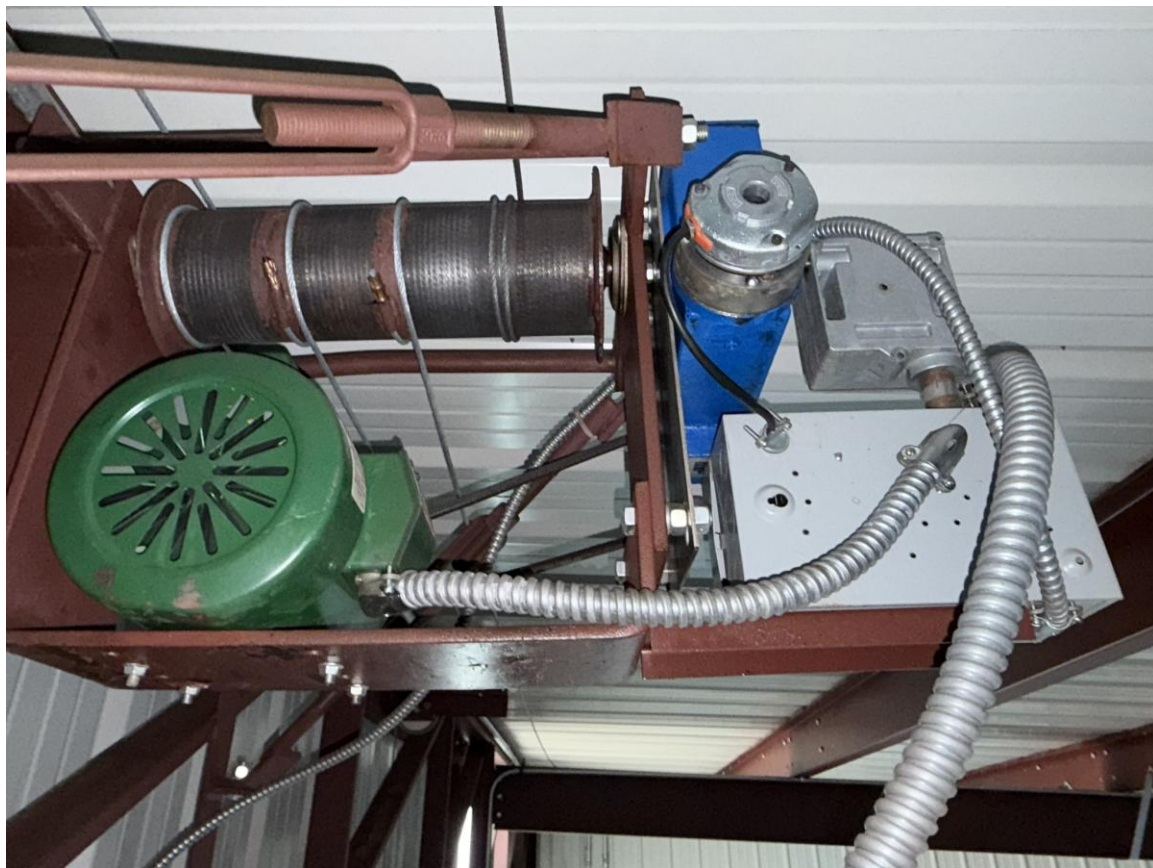
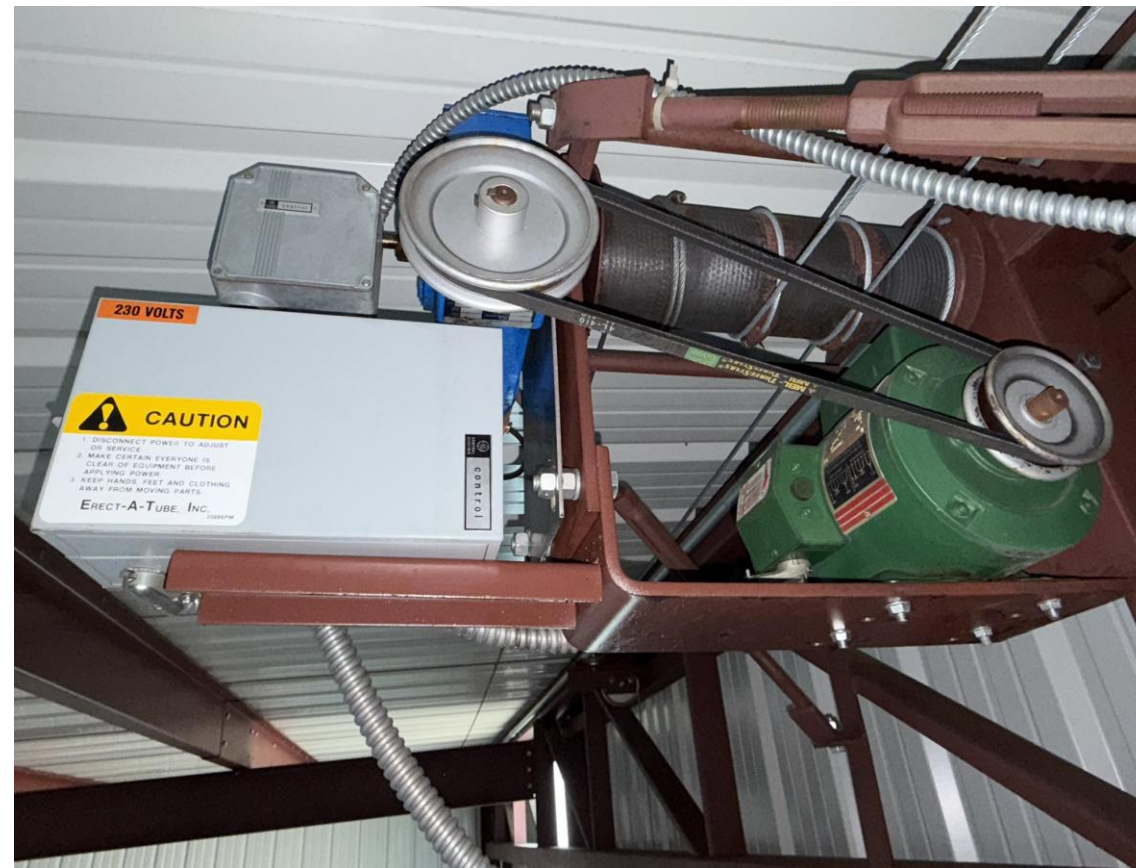
Golf Row Direct Drive w/belt

- 2018 Golf, Hotel rows – Lift Failure. Poor welding construction led to cable failure – **SEVERE** Mitigation: Inspected all doors for insufficient construction, rewelded / restructured 1,000 hrs of mechanical maint.

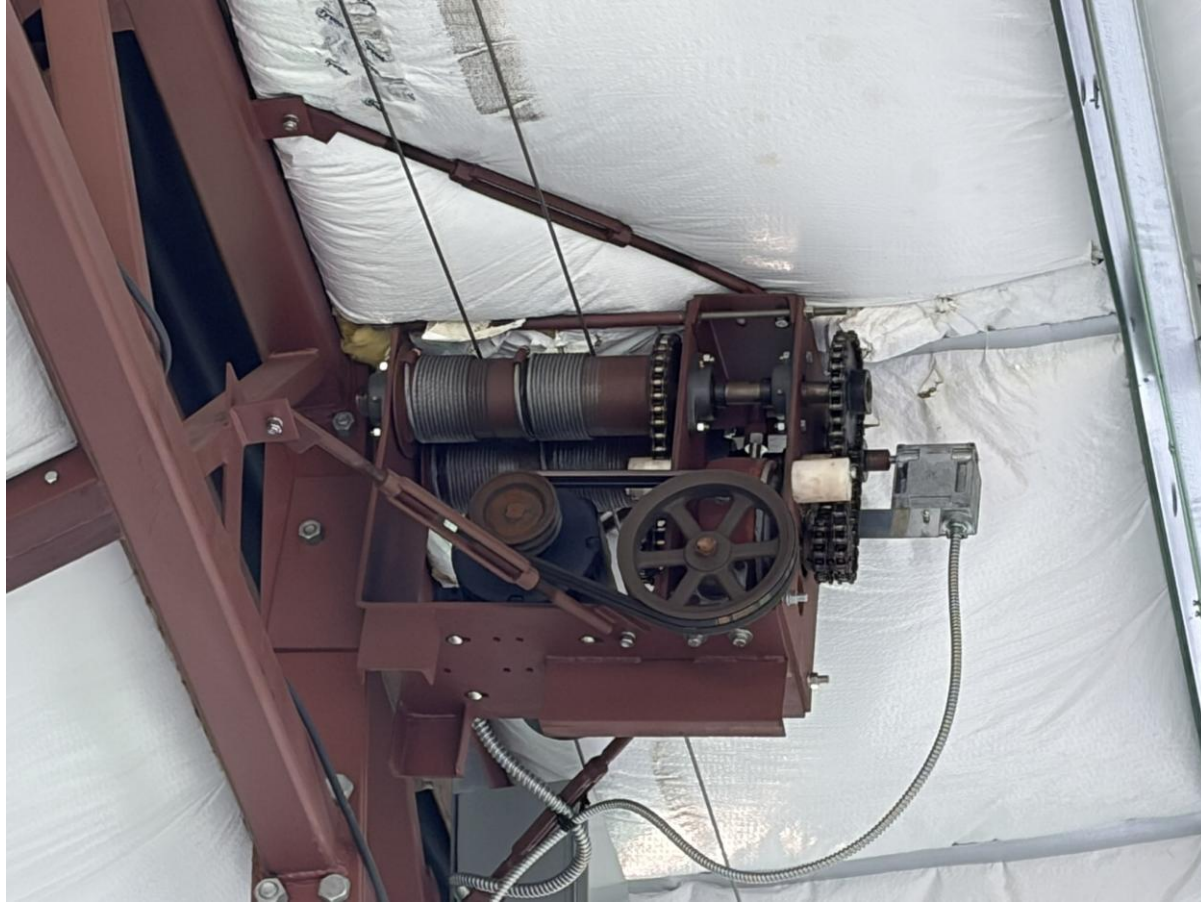
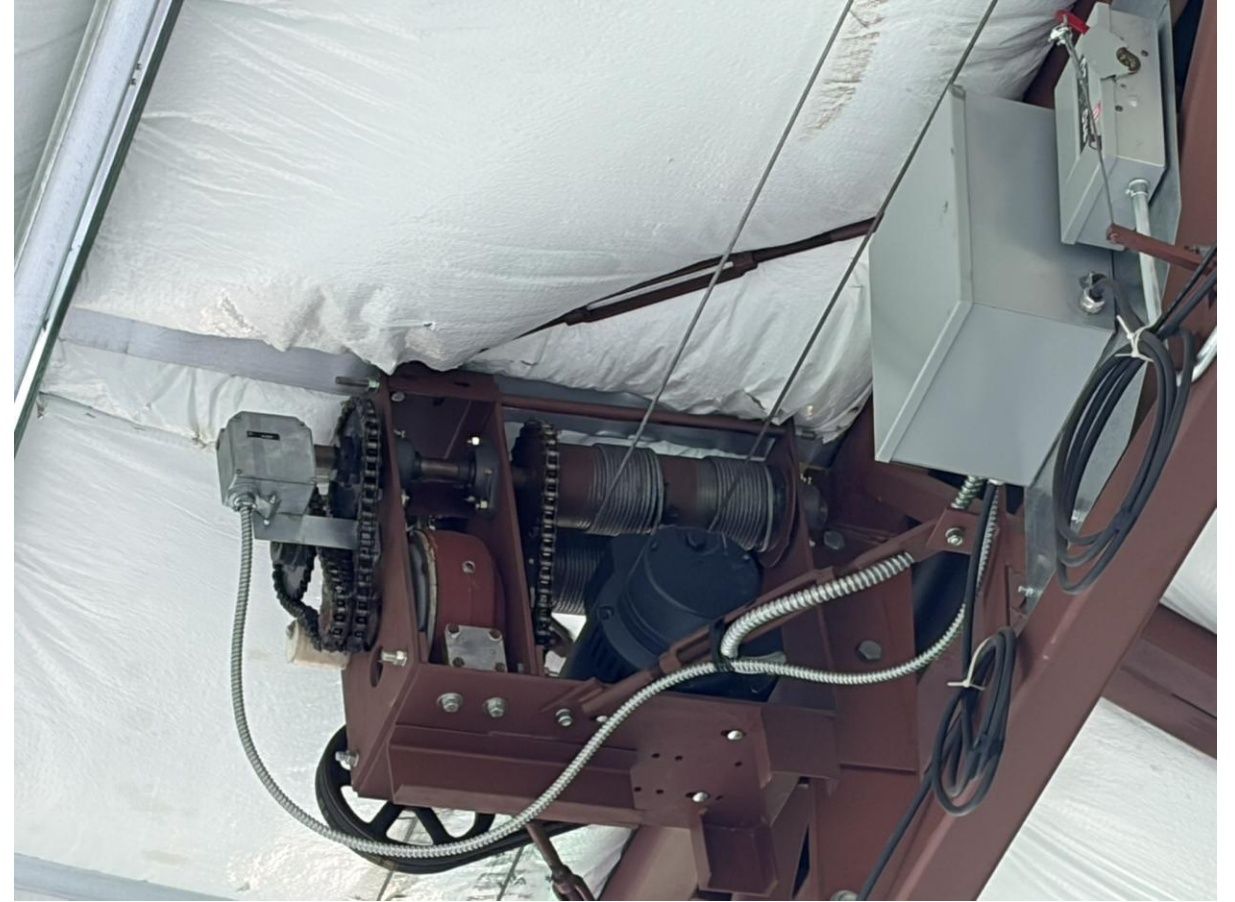
Hotel Row Dual Chain Drive

- 2014 Hotel – Door Fell. Cable clamp failure. **SEVERE** Mitigated by changing cable clamps throughout all hangars, inspections
- 2007 Lima Row – Door Fell. Rigging problem, door missed tripping its upper limit switch - **SEVERE** Mitigation: A second, backup limit switch was added, eventually entire system replaced with a Schweiss strapped door to accommodate Care Flight's frequency of use.

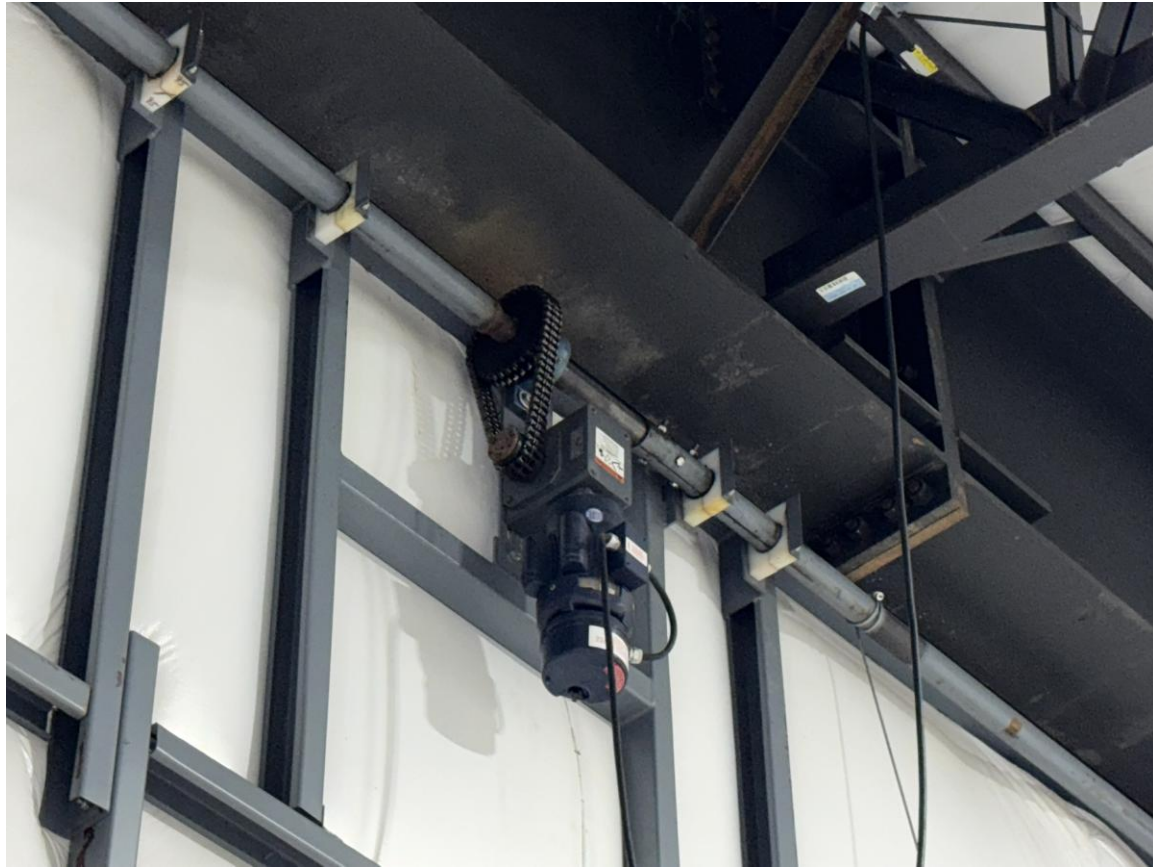
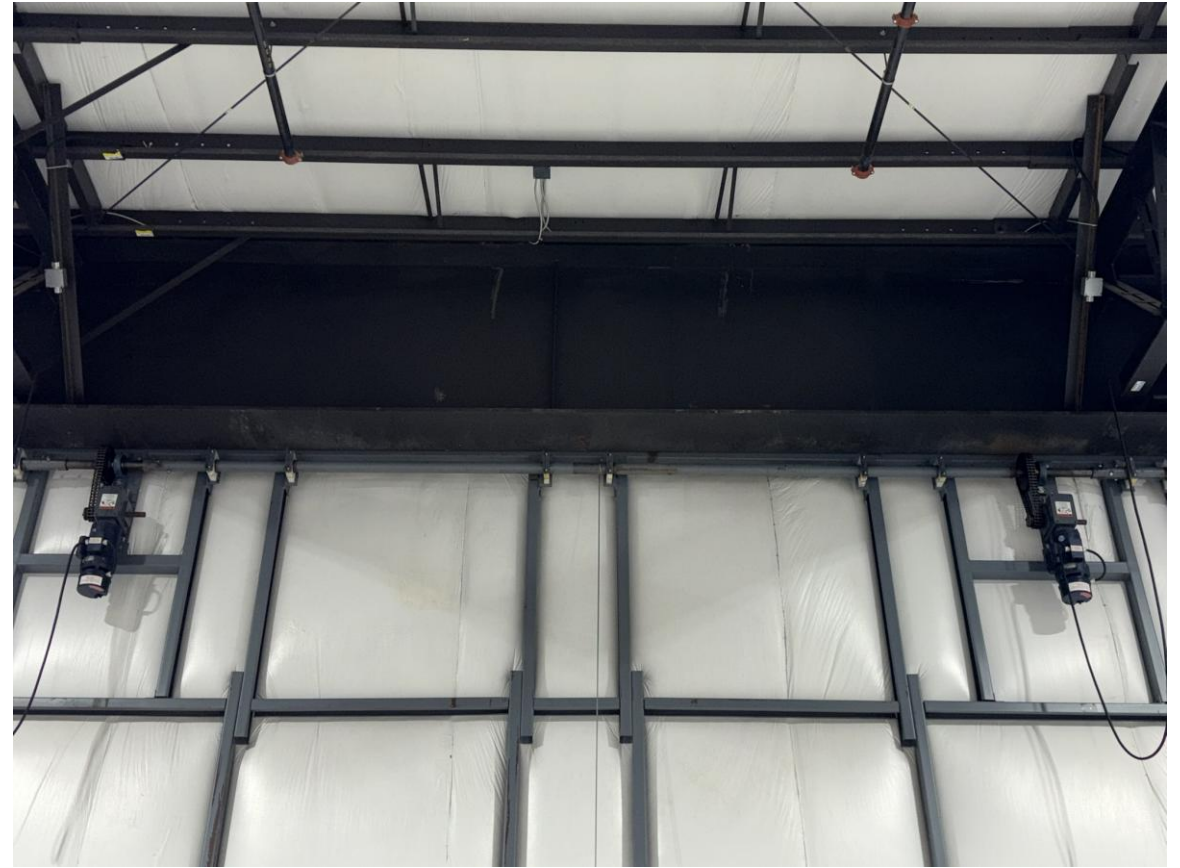
Lima Row Dual Motor Dual Chain

- Juliet row – follower arm torn out of door structure – fatigue and rust
- Lima Row – original design allows closing cable to wear against sharp metal edge causing premature damage – most have been remedied

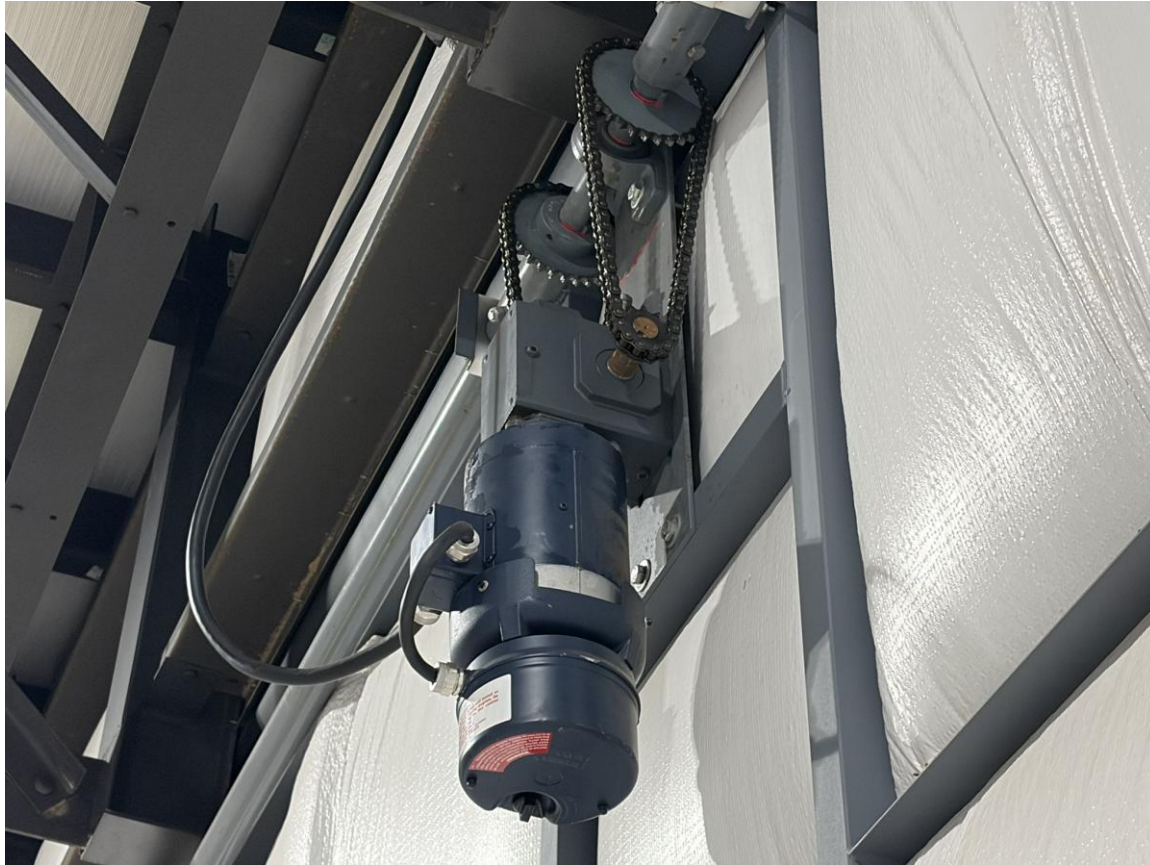
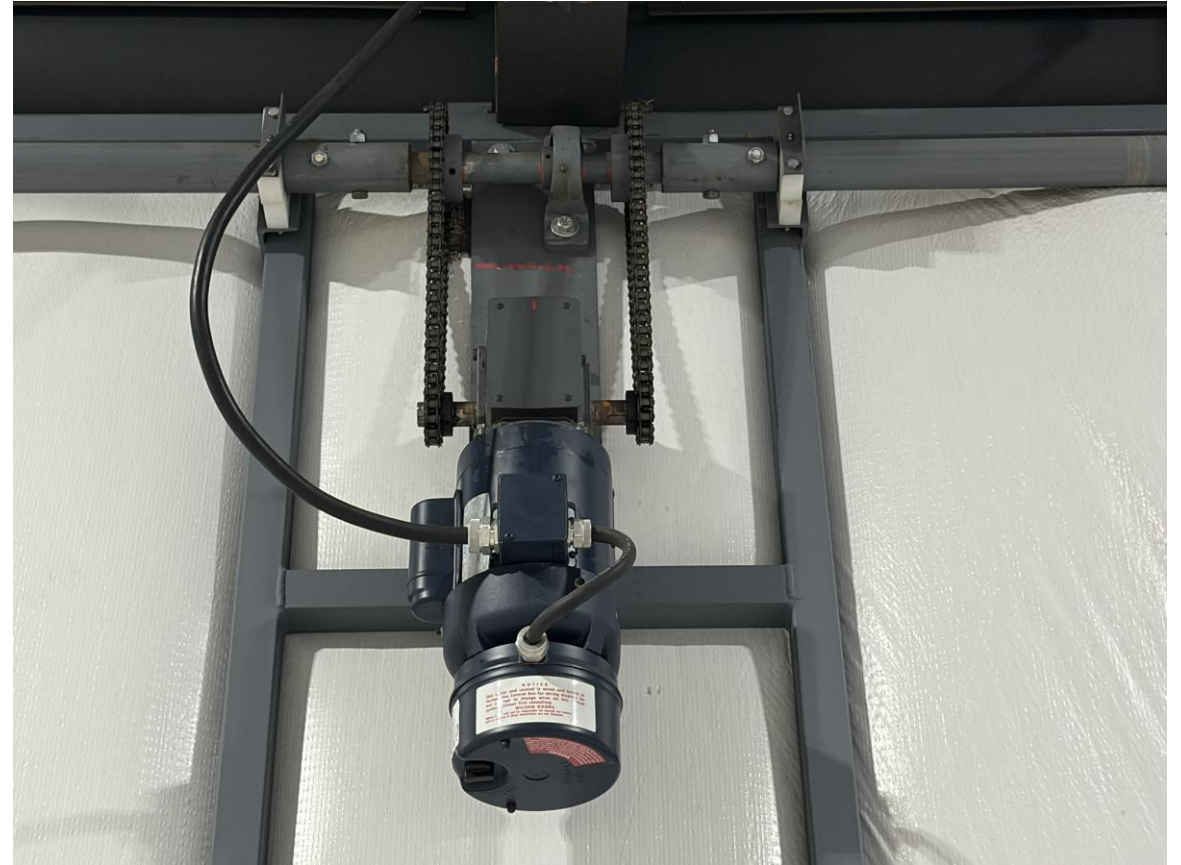
Mike Row Dual Chain

- 2005 and Ongoing Mike row – Leaking Roof. Roof construction deficient, cannot withstand designed snow load without leaks – MINOR **Mitigation decision pending**

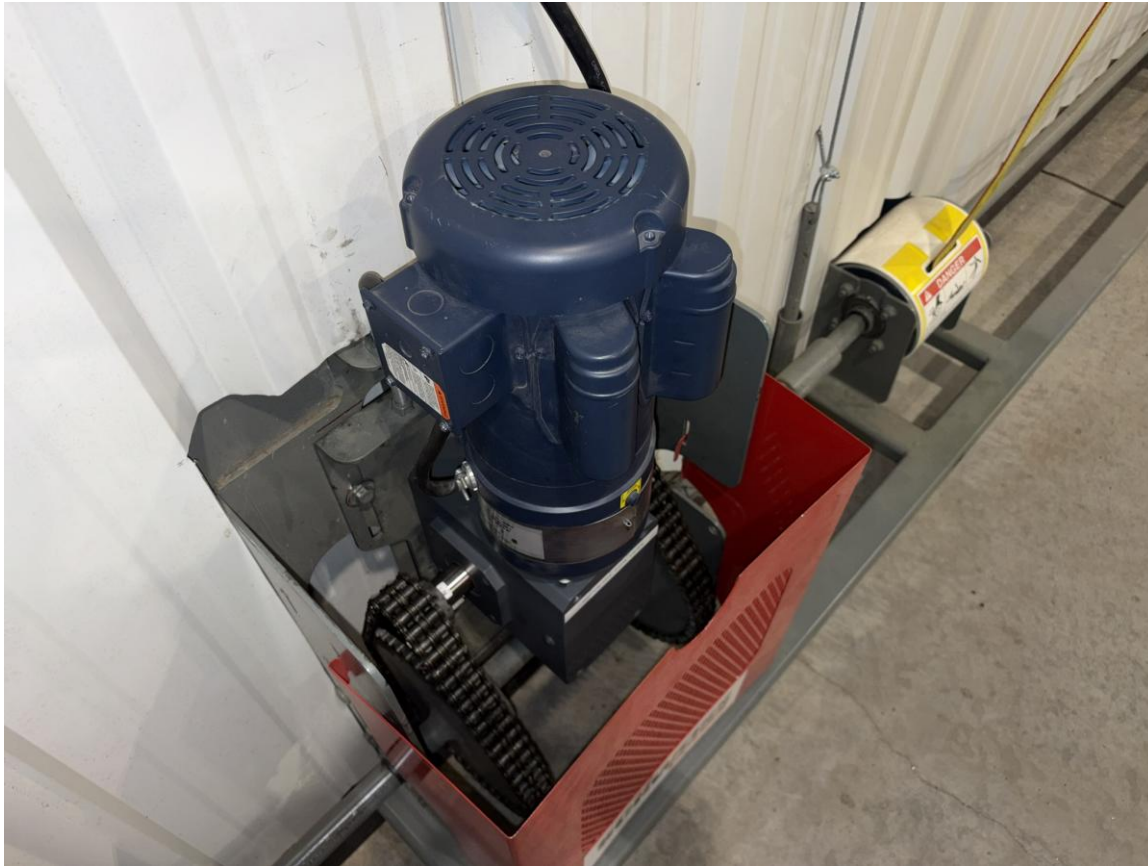
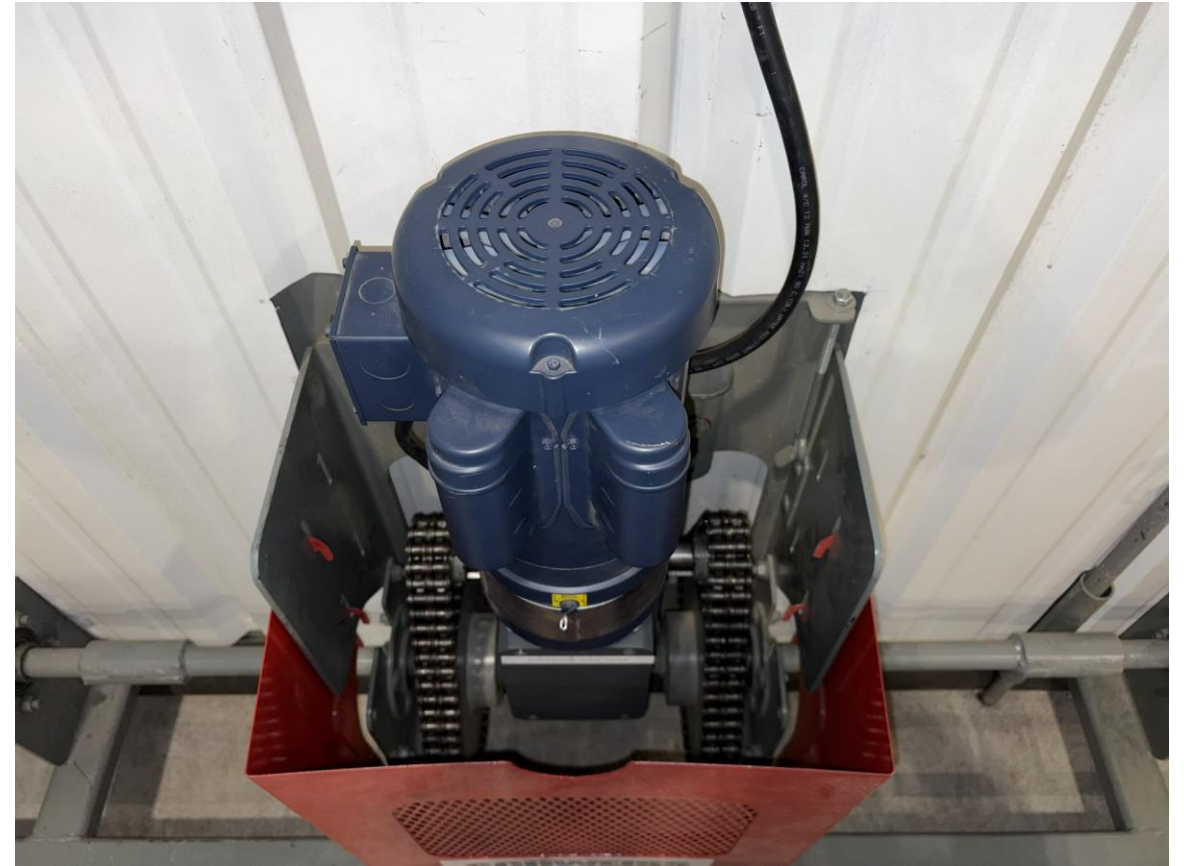
Papa Row Dual motor Quad Chain

- November and Papa Row – tripping electrical contactors causes door to stop and must be reset by maintenance
- Papa Row – failed gearbox would not allow door to open – all gearboxes have been inspected and replaced if necessary

- Papa Row – Strap pins were bent which caused one to fail – door remained operational due to number of straps – all pins have been upgraded
- Before momentary switch, many doors were lowered onto objects, cable would slack and cause uneven wrapping in later cycles. This led to many premature failures of cables. Also causing damage to vehicles and planes.
