TRUCKEE-TAHOE AIRPORT Pavement Evaluation Study Pavement Maintenance/Management Plan

NOVEMBER, 2011 (UPDATED DECEMBER 2014)

**TRUCKEE TAHOE AIRPORT
PAVEMENT EVALUATION STUDY
PAVEMENT MAINTENANCE/MANAGEMENT PLAN**

*Prepared by:
Reinard W. Brandley
Consulting Airport Engineer*

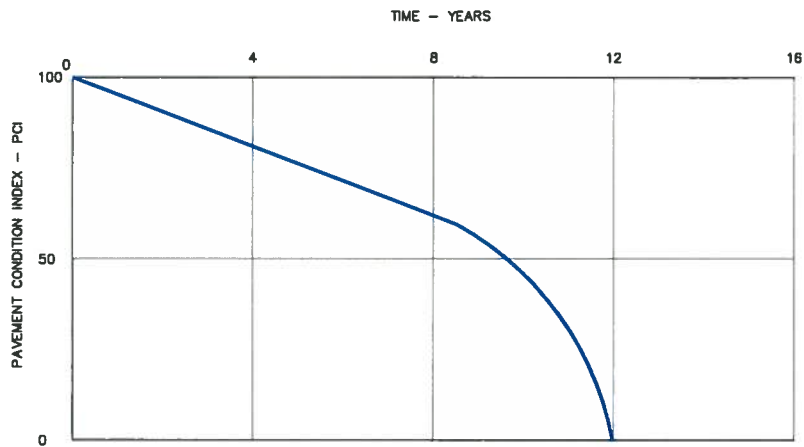
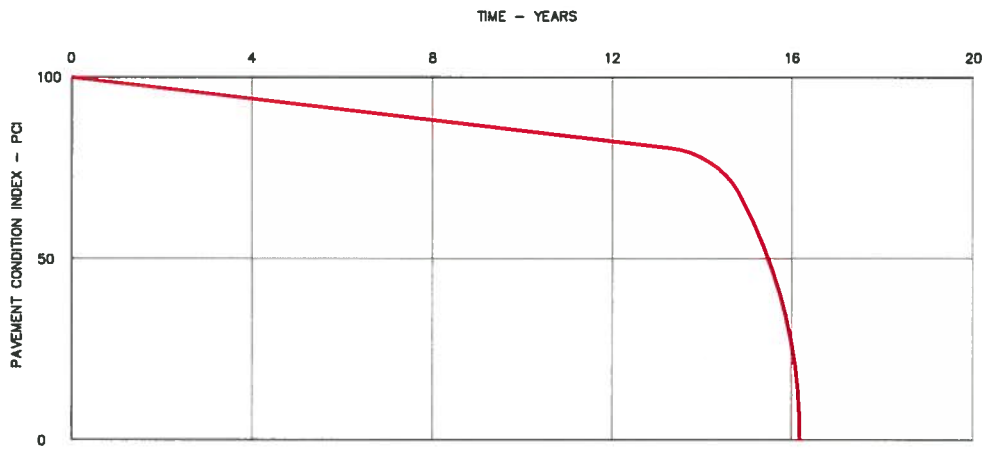
PLATE NO. 3-3	TRUCKEE, CALIFORNIA TRUCKEE TAHOE AIRPORT PAVEMENT EVALUATION PCI vs. TIME	NO. REVISION DT DATE	ENGINEER OF RECORD

(PCI) can be determined for each segment to indicate the degree of distress. A typical plot of PCI vs. Time is included as Plate No. 3-3. On this plate a typical pavement index plot for asphalt concrete pavement and for Portland cement concrete pavement is shown. In both diagrams the PCI gradually decreases with time and when it reaches a certain point, it decreases at a much faster rate. The gradual decreasing portion of the curve indicates surface distress only. The sharp break off is generally caused by deep-seated distress. There is no way to predict when the deep-seated distress or failure of the section is going to occur and, therefore, it is not possible to predict when major rehabilitation or reconstruction will be required. If one waits until the PCI vs. Time curve shows deep-seated distress by the sharp break off, then failure has already occurred and it is not possible to extend the life of the section by overlays or adding to the surface of the existing pavement section. As a result, the Pavement Condition Index (PCI) cannot be successfully used to predict deep-seated distresses and failures but is effective in determining when surface rehabilitation and repairs are necessary.

ASPHALT CONCRETE PAVEMENT SECTION
PCI VS. TIME - RELATIONSHIP

PORTLAND CEMENT CONCRETE PAVEMENT SECTION
PCI VS. TIME - RELATIONSHIP
