Re: Truckee Tahoe Regional Airport
Facilities Maintenance Plan

The following is our preliminary report concerning the review of the 25 existing structures and recommendations for a short term (1-5 years) maintenance plan. A long term (5-20 years) maintenance plan was requested, but in this case, if the 5 year plan is followed, there will be minimal maintenance required for the following 15 years, thus we have not provided long term maintenance plan. We have numbered the buildings according to site map provided by your office.

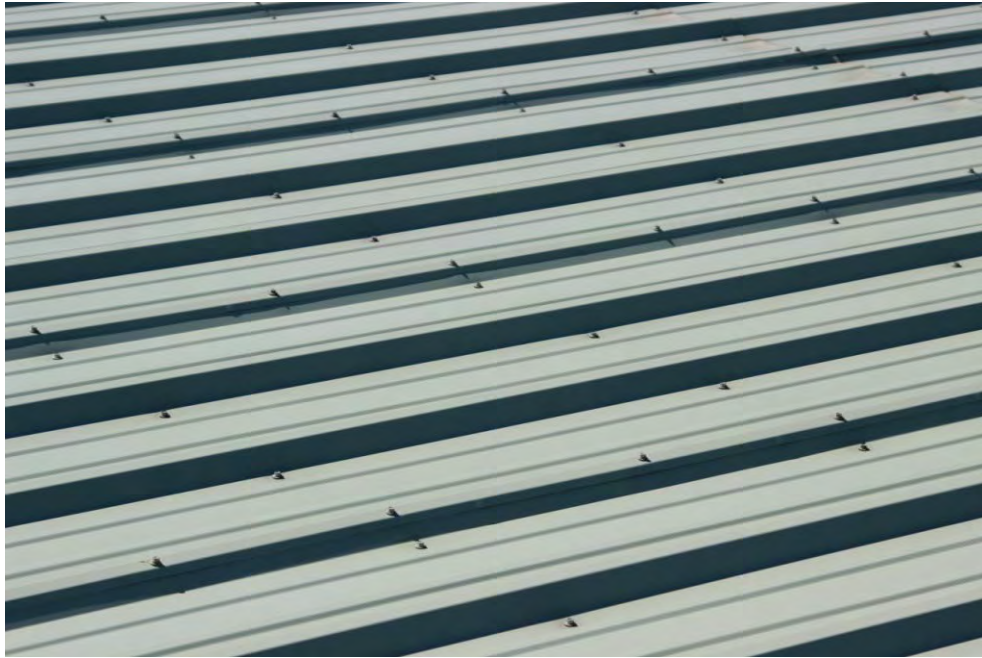
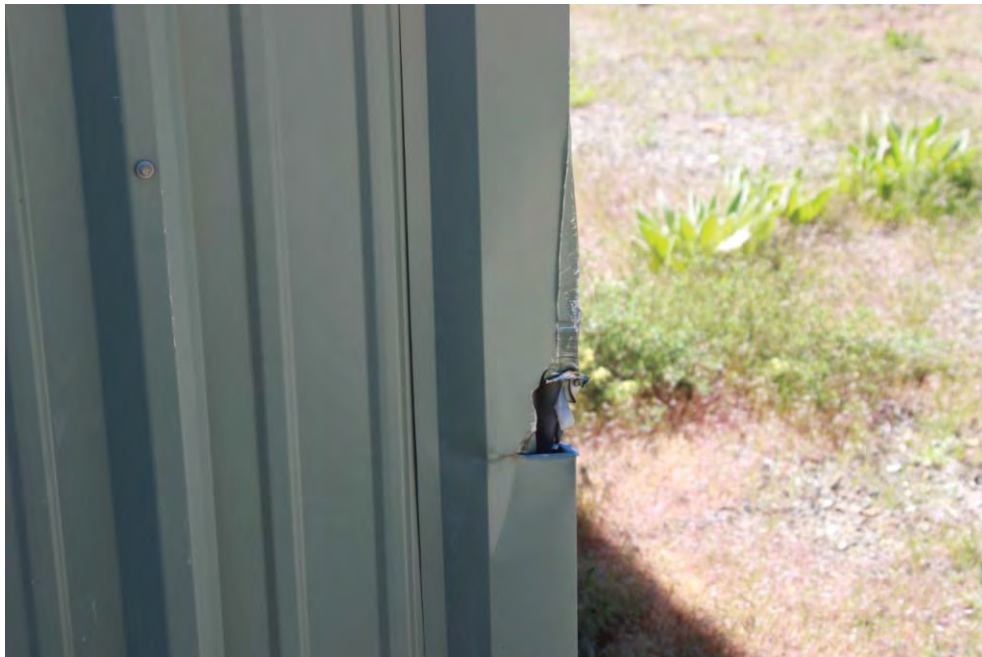
Building 6 – (Garage) - 1991. There is a gash in the rear southwest corner of the building corner trim. There is a big dented panel in the front northeast corner from some kind of impact. The roof screws are an old style of screw with neoprene washers. They will probably leak within 5 years.

5 Year maintenance: Replace all screws with shielded screws. Repair the southwest rear corner trim and replace the northeast lower section of wall panel that has been severely dented.

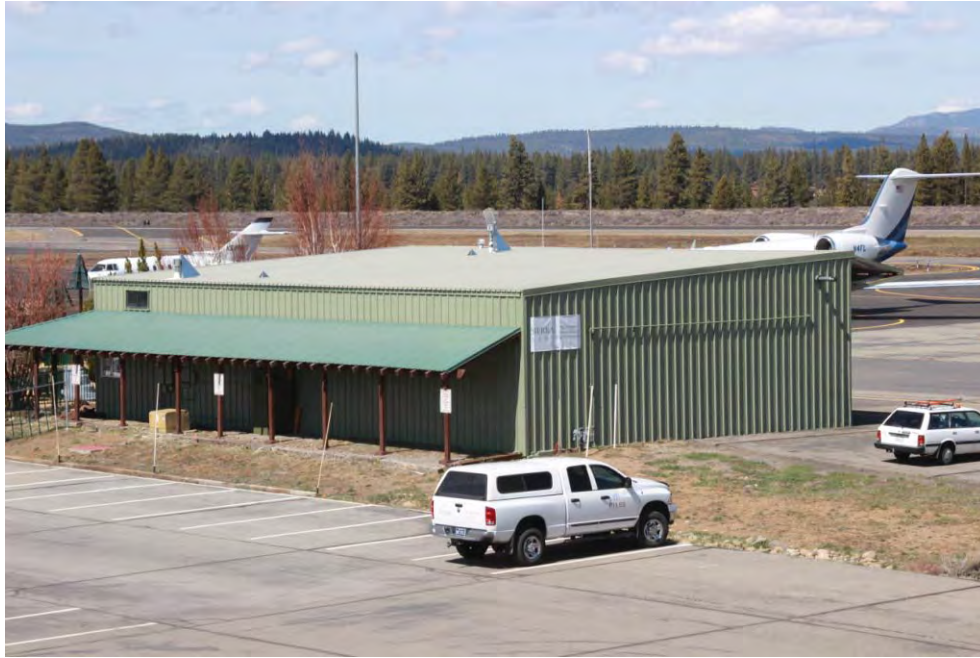
Building 4 – (Hangar 2) - 1966. This is a metal building with a lower section on the south side of wood framing. The condition of the main and low roof looks good.

5 Year Maintenance: Replace screws on lower roof.

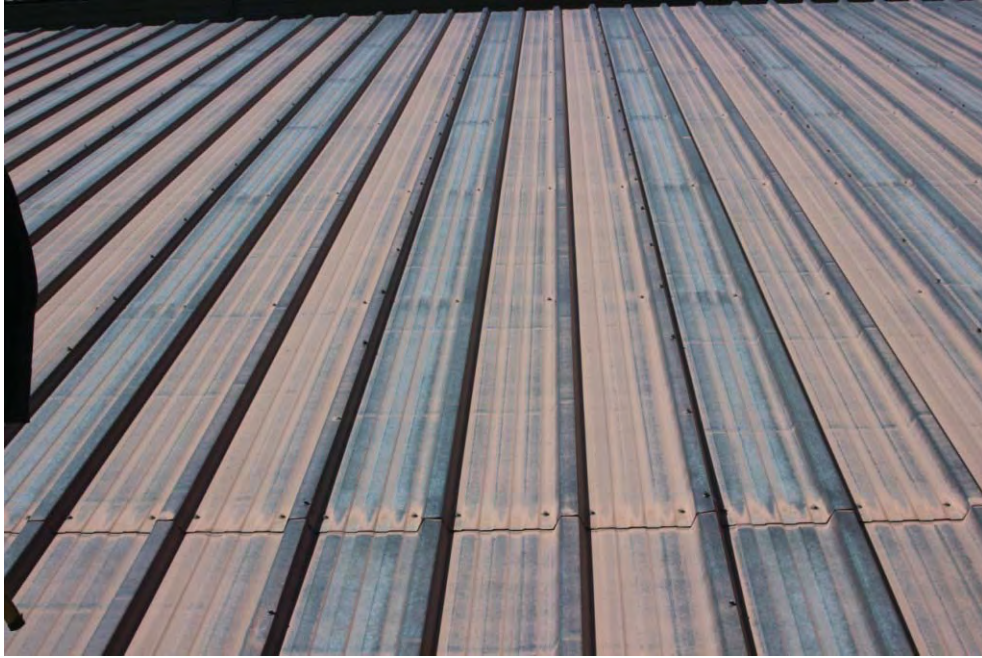
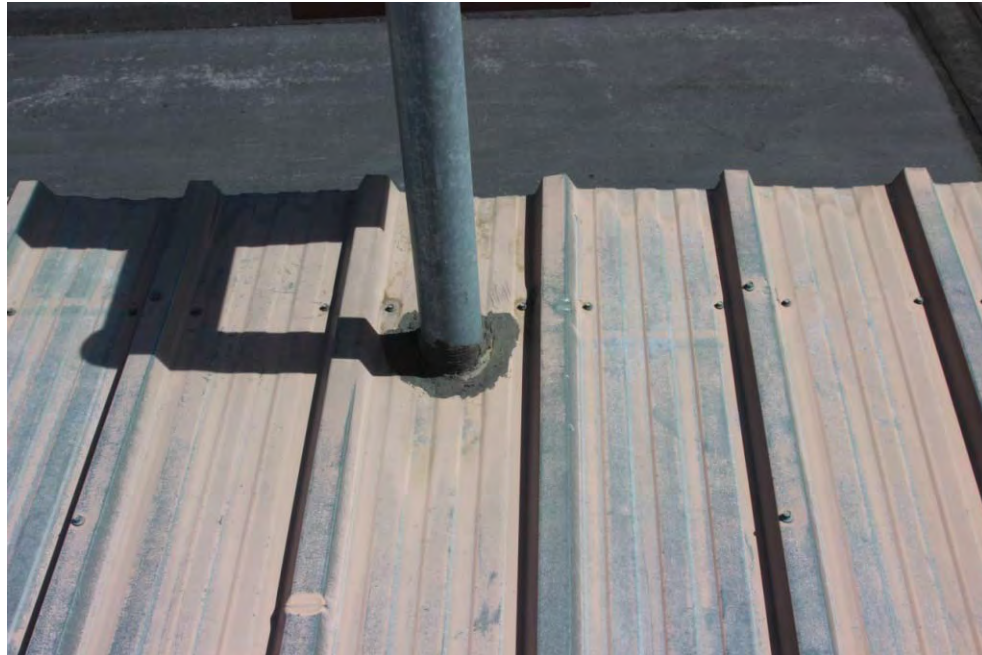
Building 10 – (Hangar C) - 1976. This is the oldest building in the east side row of hangars. The enamel coating has disintegrated. See comments for building 9. This building has reported numerous leaks so many of the screws are no longer functioning.

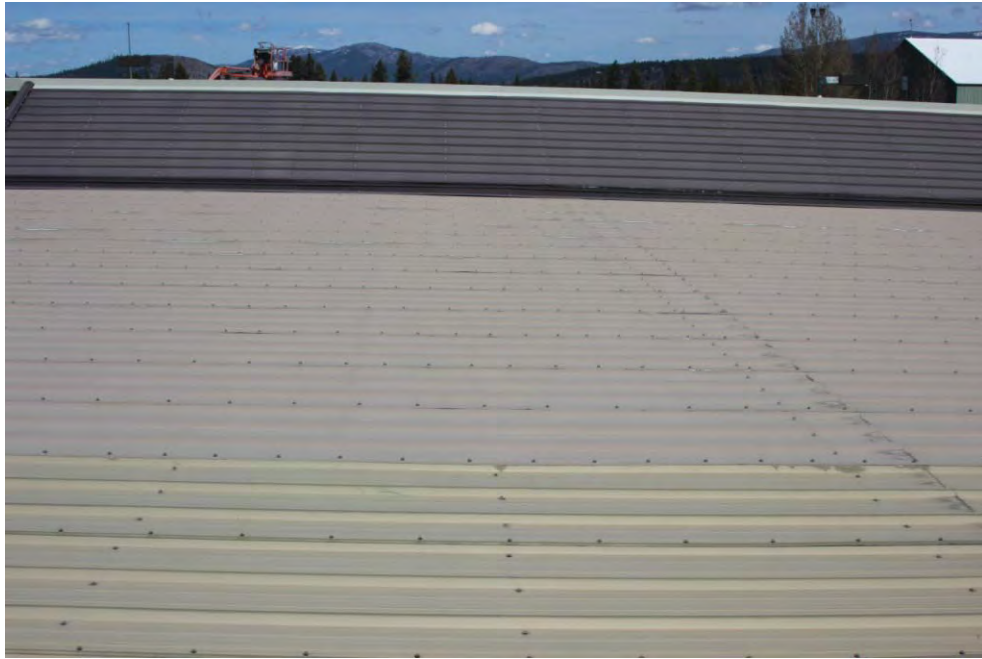
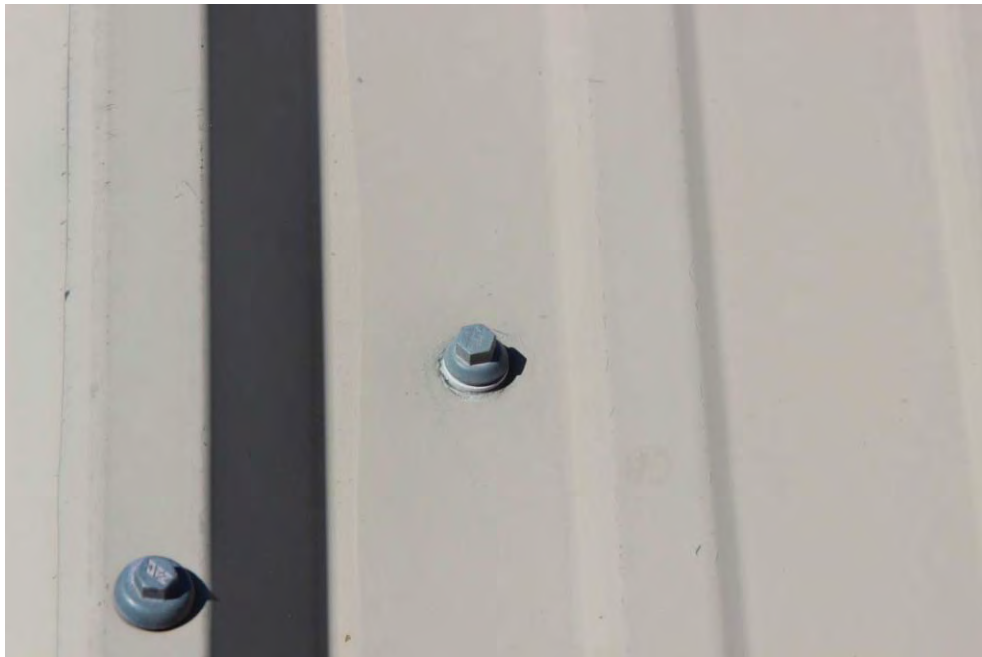
Building 8 – (Hangar A) - 1984. This building has a high and low roof section. The enamel coating on the roof panels is still in reasonable condition. Old style screws were used with this roof and some appear to be over tightened with washer disintegration. The light pole roof penetrations were caulked with black jack mastic which is ineffective for the long term. This situation occurs at all east side hangars A thru H.

5 Year Maintenance: Replace all screws with shielded screws. Flash light pole penetrations with Deck Tight rubber boots.

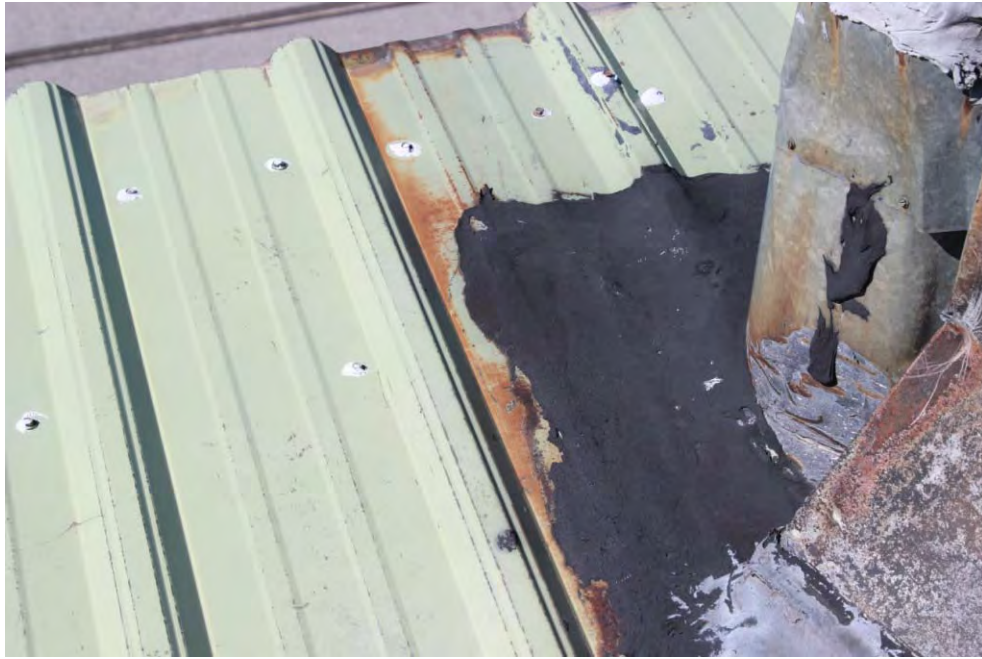
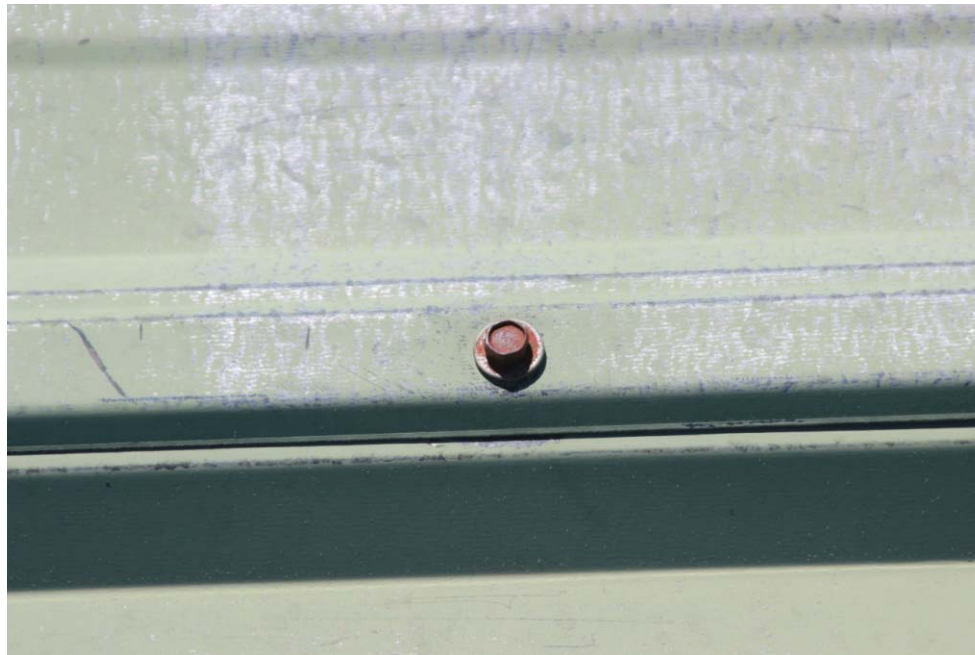
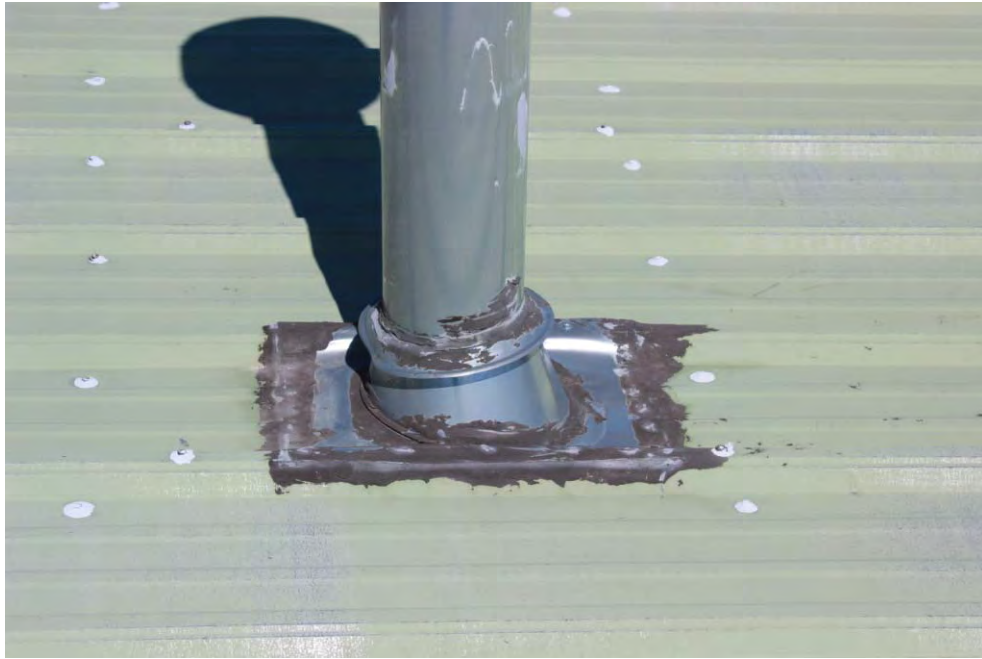
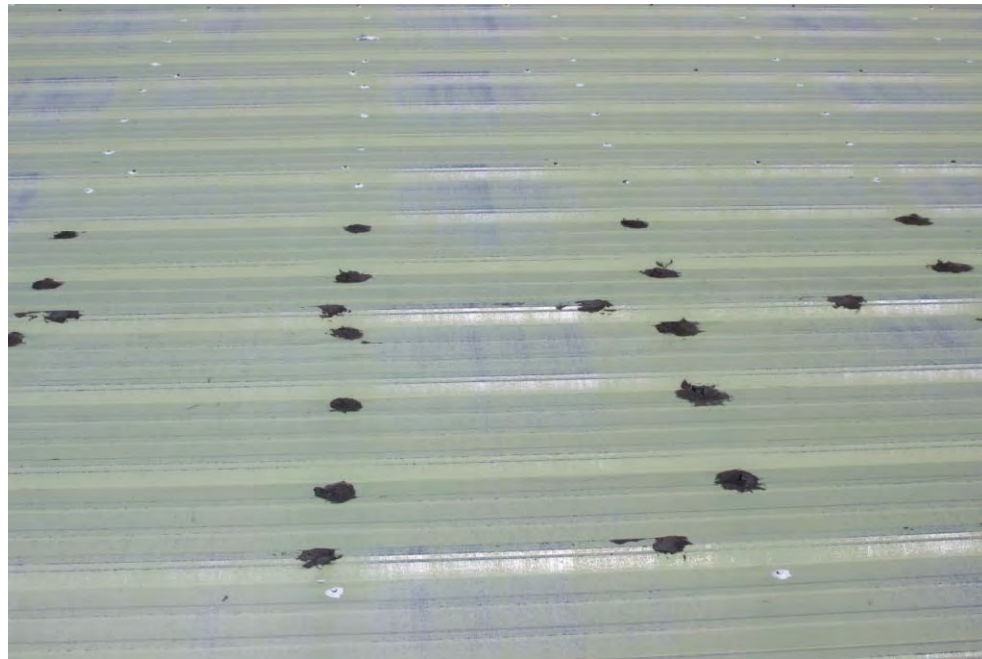
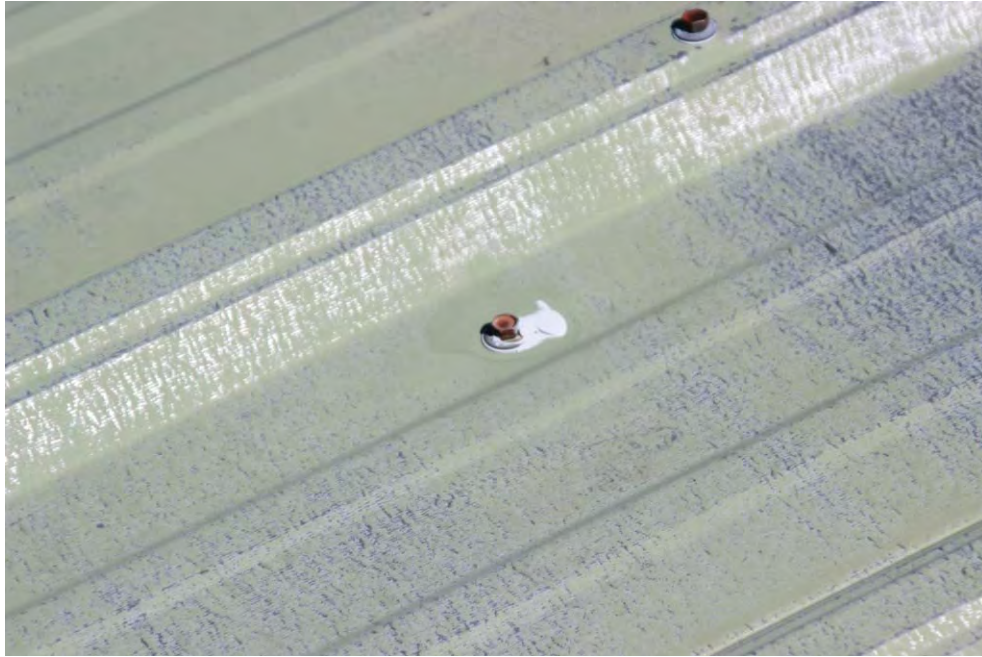
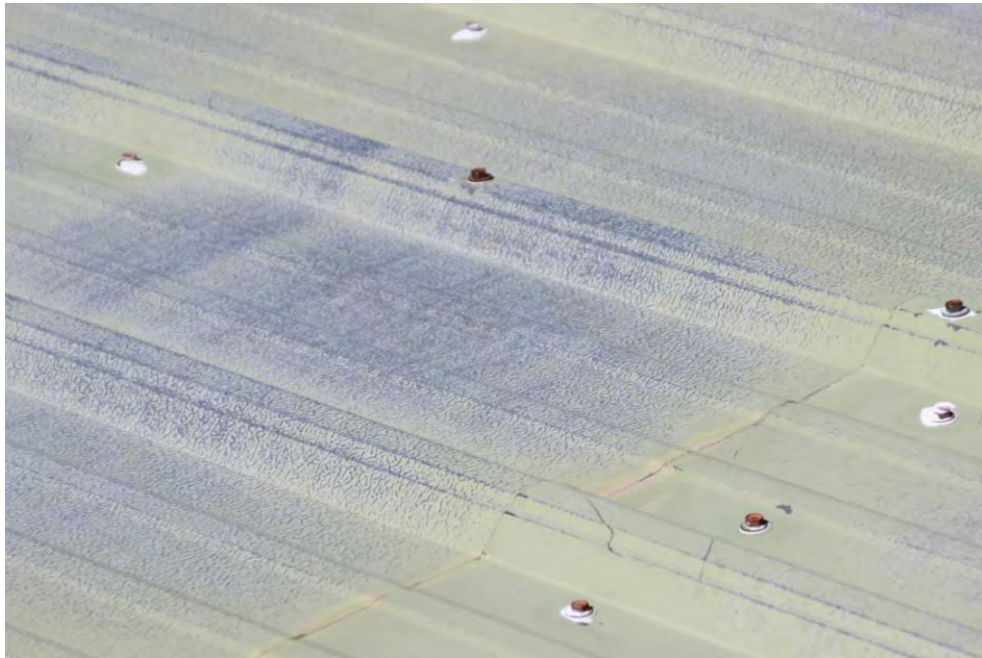
Building 7 – (Warehouse) - 1974. – This building is full of unbraced ceiling high shelving full of materials. There is a modular trailer supported on jacks as well. Current codes require all shelving above 4 ft. in height to be braced for seismic forces. The modular trailers need seismic restraint as well. The roof panels are in reasonable condition but the screws are an old style screw that has already been caulked. The caulking is ineffective for the long term. The screws not caulked show evidence of being over tightened or the washer has disintegrated.

5 Year Maintenance: Replace all existing screws with shielded screws. An alternative longer term repair would be to coat the entire roof with a coating system.

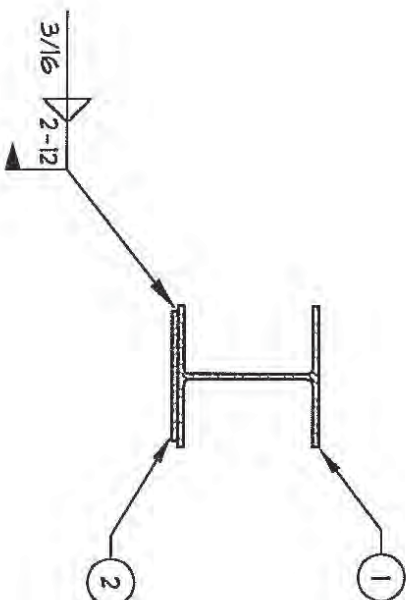
DETAIL A

Buildings 8 through 14 and buildings 16 and 17 have bent column flanges in some of the units at the bi-fold doors where the rollers run up and down the columns flanges when the doors are opened. There are approximately 40 units where some flange bending has been noted. A chart is attached which catalogues which units and how much the flanges appear to be bent out of plumb. Photos of the bent flanges appear in building 9 photos. This type of bending is typical for all the units noted. Most of the flange bending is located where the lower roller bears against the column flange when the door is in the open position. The top and bottom rollers create a force couple which resists the weight of the door as it is raised. As the distance between the rollers decrease, (i.e. the door is raised) the force increases thus the maximum amount of force the roller exerts on the flanges is when the door is in the raised position. This is where we see nearly all of the flange bending. It is clear the flanges are not thick enough to resist this force level. These buildings have been designed for 40 psf snow load and thus the columns are lighter sections than some of the buildings on the west side of the airport that were designed for heavier snow loads. There was no noticeable bending of the flanges at buildings 18 and 19 where the flanges are thicker. Another possible cause of flange bending in the east hangers is the thermal expansion of these longer buildings. This would cause the columns to be more out of plumb and the door rollers closer to the outside edge of the flanges. The solution is to increase the thickness of the flange by adding addition material. Adding a small angle on the inside of the column is one solution and that has already been done in Hanger B11. Another option would be to install a thicker plate full height along the outside column

flange. Detail SK-2, attached to this report, shows a schematic section of the two repair options. This should solve the problem of flange bending.
