WEST COAST COATING CONSULTANTS

Subject: Budgetary Cost Estimates for Painting Work at Truckee Airport

Acumen Engineering contracted with West Coast Coating Consultants (WCCC) to conduct coating/corrosion assessments on numerous structures at the Truckee Airport in Truckee, CA. The assessments were deemed necessary since the airport is in the process of preparing a twenty year maintenance plan. A detailed plan for maintenance painting was desired to be part of the overall plan. Mr. Ray Tombaugh, Senior Consultant for WCCC was assigned to perform the investigation and prepare this report.

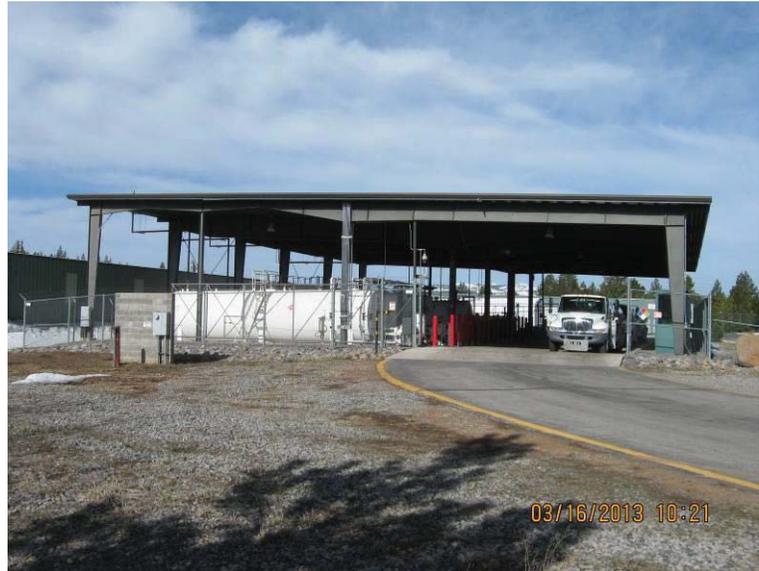
There a number of different components that are included in the fuel farm located at the northwest end of the airport property (Photo 1). The components include an overhead structure, four fuel tanks (labeled 1 to 3 starting at the northeastern end of the tank farm and a diesel tank) and associated piping, stairways and walkways leading up to and across the tops of the tanks, two concrete tanks, two pumping stations and a guard shack.

Photo 1 shows a general view of the Fuel Farm.

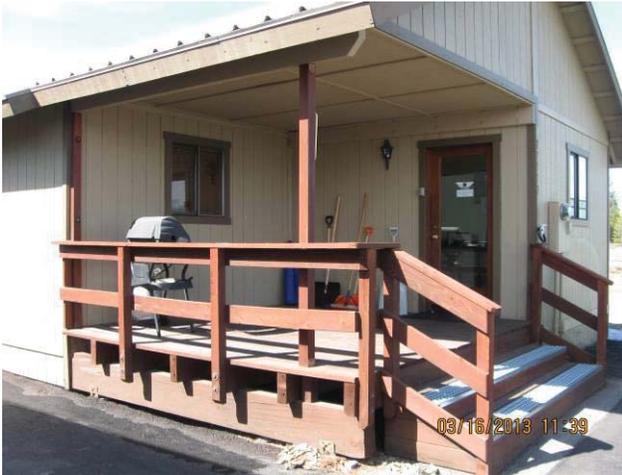
Photo 13 shows a general view of the West Side Modular.

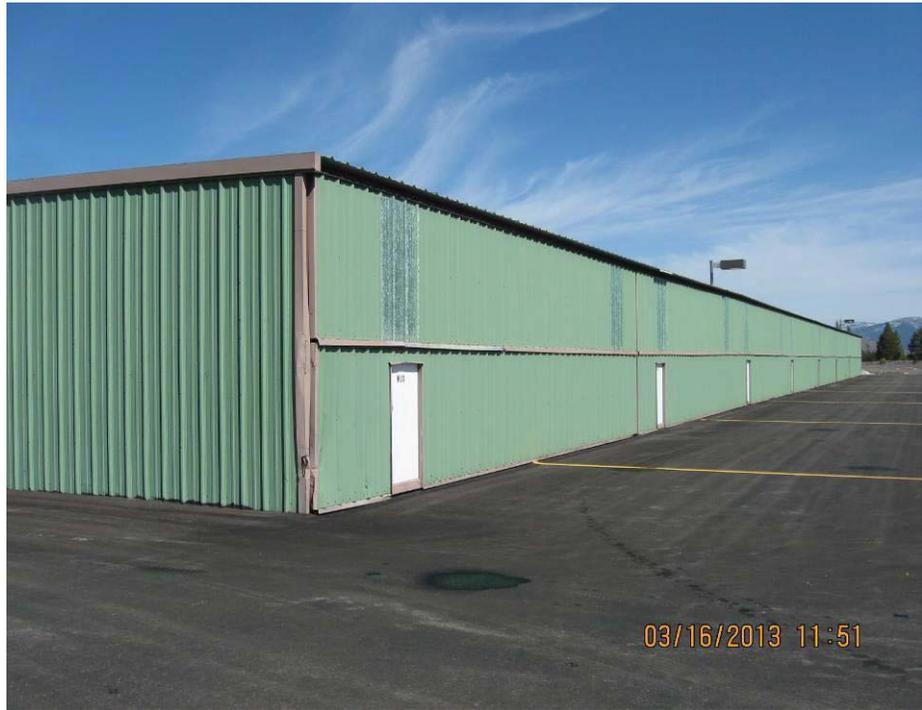
Hangar K is also constructed of corrugated siding with some opaque fiberglass panels inserted at a few locations (Photo 19). The corrugated panels have the original factory finish and are free of chalk. There is some galvanized steel trim included in the structure that is rusting.

The coating adhesion on the doors varies from excellent to poor. **Photo 19 shows a general view of Hangar K).**

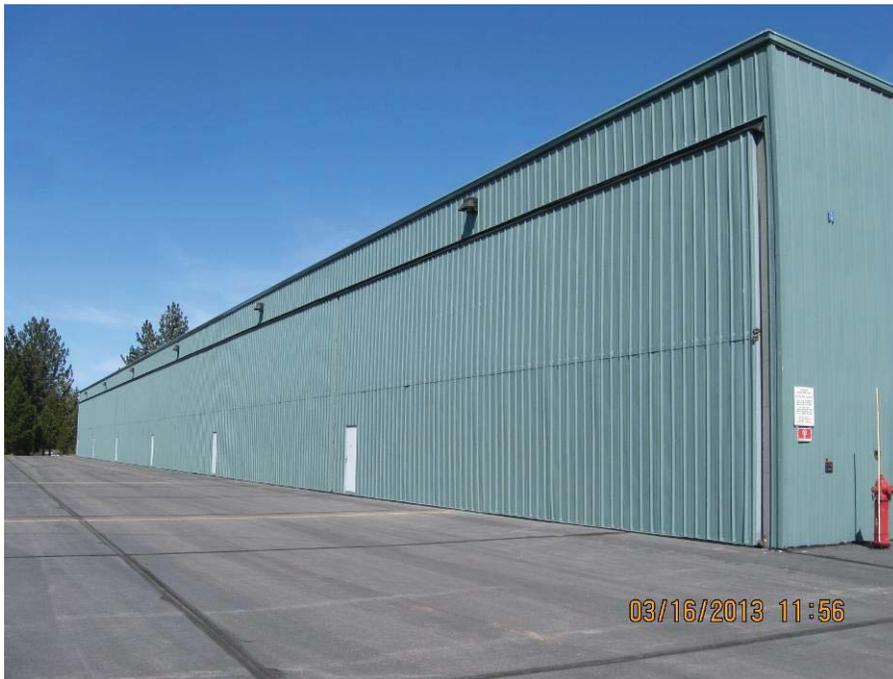
Hangar L is constructed of shop painted corrugated siding. The corrugated panels have only mild chalk (Photo 20). There is some galvanized steel trim included in the structure that is rusting.

Photo 20 shows a general view of Hangar L.

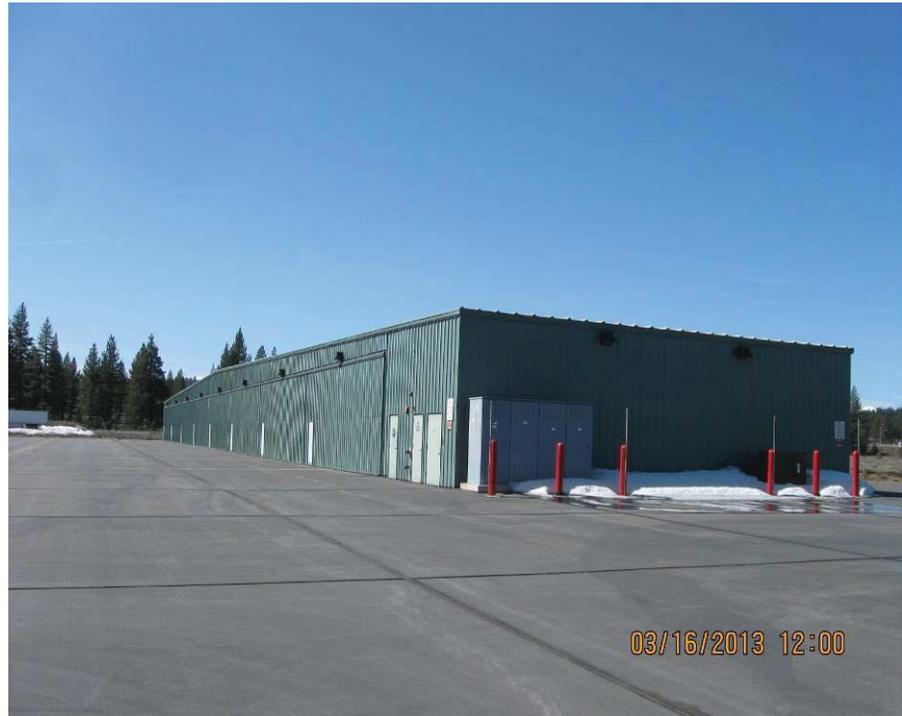
Hangar M, also constructed of corrugated panels has the original factory finish (Photo 21). The coating is tightly adhered to the surface and is free from chalk.

Photo 21 shows a general view of Hangar M.

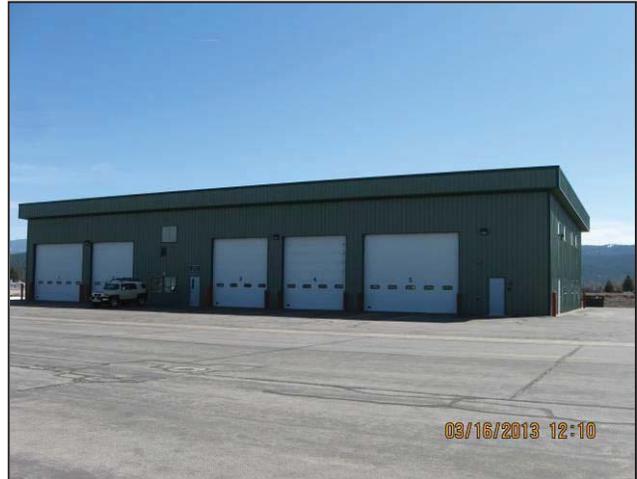
The maintenance building and adjacent shed siding has the original factory finish (Photo 26). This coating is free of rust and chalk and tightly adhered to the substrate. The roll-up doors have the factory finish which is free of chalk.

Photo 26 shows a general view of the Maintenance Building.

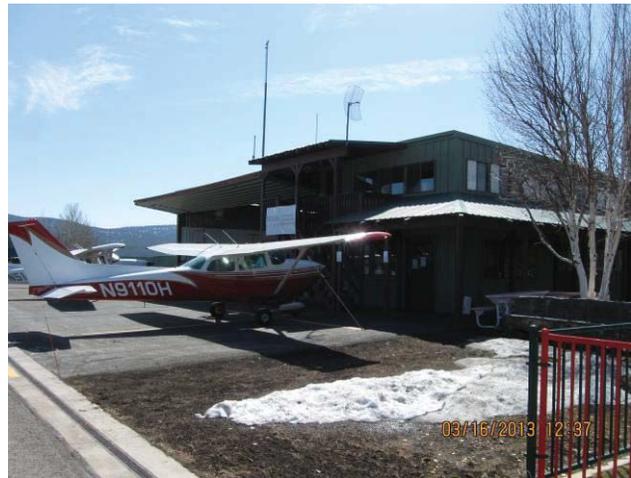
Hangar 2 is sheathed in corrugated siding with the original factory finish (photo 28). There is good color retention and it is free of chalk. The doors are finished with a factory applied coating and are free of rust and chalk.

Photo 28 shows a general view of Hangar 2.

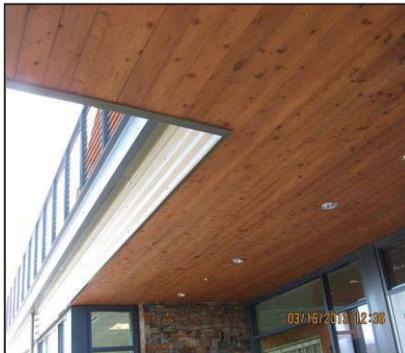
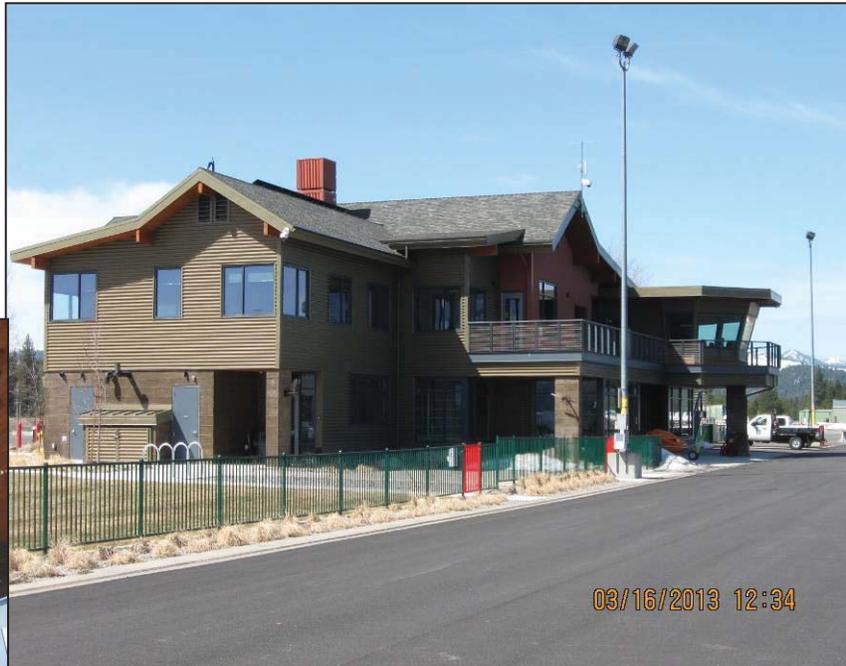
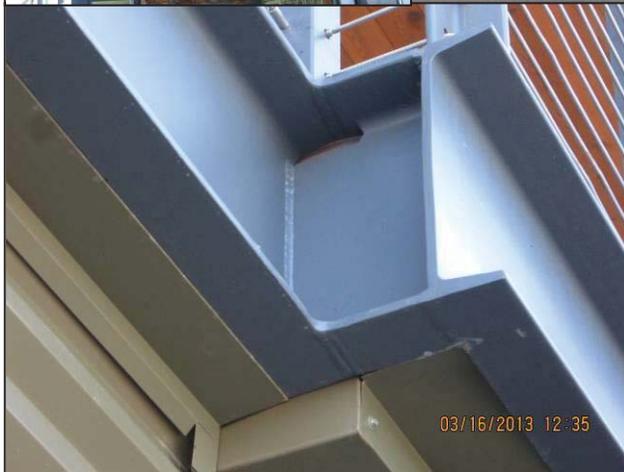
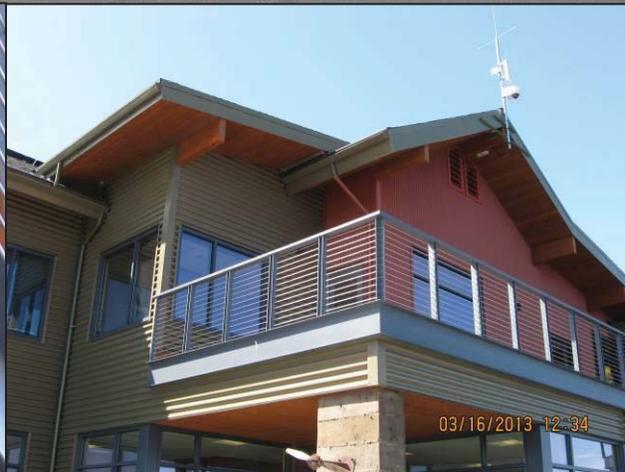
The administration building was recently constructed and the coatings are in excellent condition. The coating surfaces include structural steel, siding and stained wood (Photos 30 through 33).

Photo 30 (upper, right) shows a general view of the Administration Building. As indicated the painted surfaces on the building are in excellent condition. Photo 31 (upper, left) shows stained wood underneath a balcony, There was no evidence of coating failure or discoloration of the wood on these surfaces. Photo 32 (lower, left) shows an example of the painted steel which is also pristine. Steel surfaces are also found on the stairway structure. Photo 33 (lower, right) shows a general view of the railing that runs along the observation deck. It too is in good condition and free of rust.

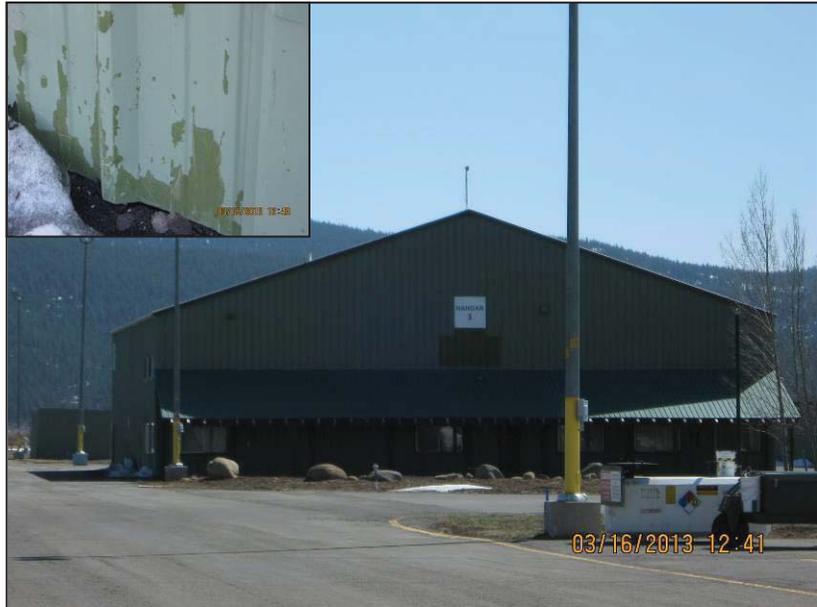
Hangar 1 is similar in construction to hangar 2 except that there is no stairway or second floor porch (Photo 34). The siding on the building has been repainted several times. There are numerous delaminations on the siding applied to the north façade. The coating adhesion on the siding varies depending upon the location. The coating applied to the north façade is poorly bonded while the coating on the other three facades is tightly adhered.

Photo 34 shows a general view of Hangar 1.

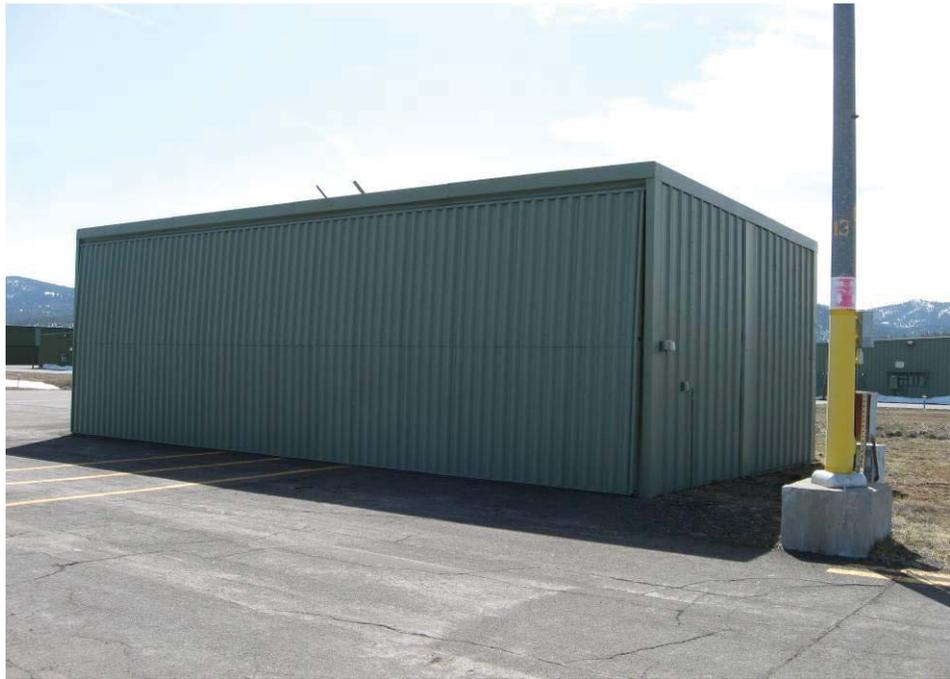
Another corrugated sided structure, the Phoenix Hangar was repainted in 2012 (Photo 37). It is in excellent condition with no evidence of rust, delamination or chalking. There is a textured aluminum door with an original factory finish that has been repainted. The applied paint is in good condition. Coating adhesion is excellent.

Photo 37 shows a general view of the Phoenix Hangar.

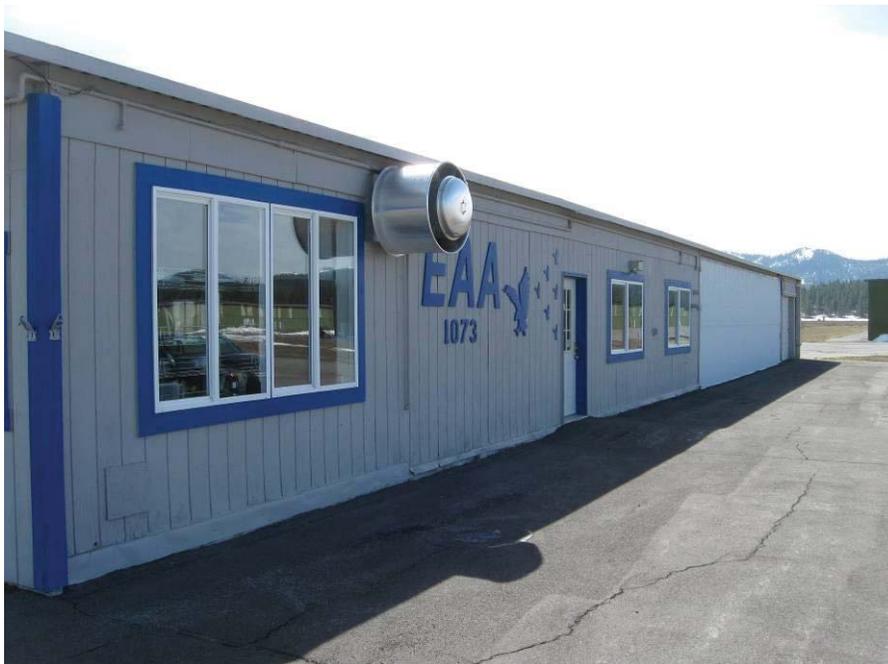
Photo 38 shows a general view of the front of the building. The coating and wood on this façade is in good condition

The front of the building is in good condition. There is no evidence of any coating delamination or damaged wood. The only evidence of damage is along the base of the building where the wood grain is lifting (Photo 38). The joint between the siding and the flashing is uncaulked and is allowing moisture to penetrate into the wood, subsequently resulting in coating delaminations and wood rot. The other sides of the building have many coating delaminations on the siding (Photo 39), the window trim (Photo 40) and the plywood (Photo 41). The plywood is degraded. Adhesion test conducted on the wood surfaces indicated poor coating adhesion in the heavily failed areas.

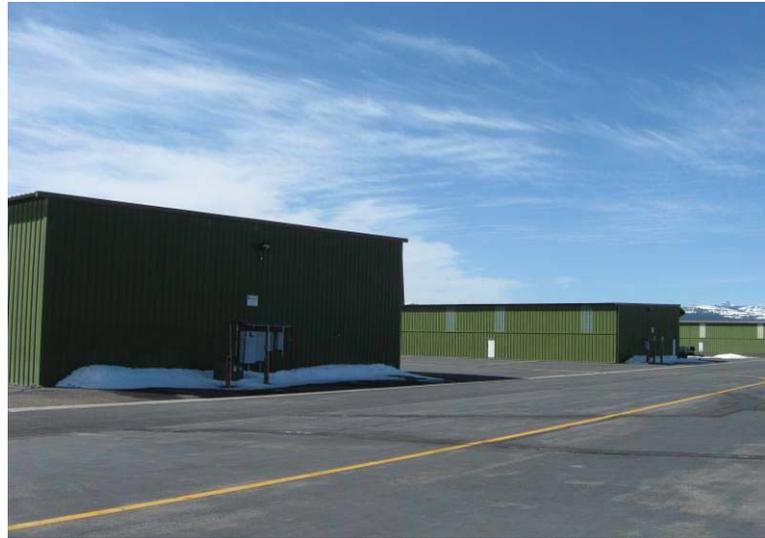
Hangars F, G and H are sided with corrugated panels (Photo 42). The panels have the original factory finish. The coating is free of rust, has not faded and is not chalky.

Photo 42 shows a general view of Hangars F, G and H

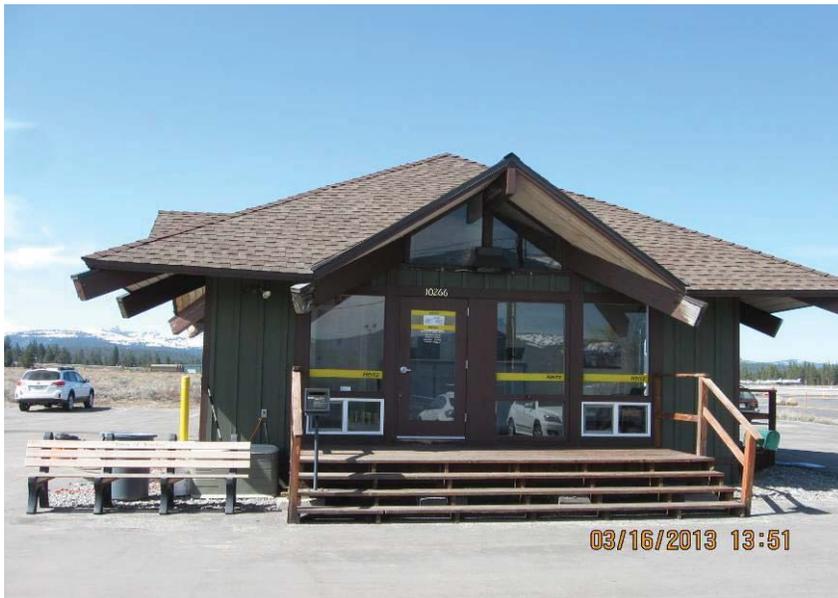
Photo 51 shows a general view of the Auto Rental Building.

The auto rental building is a wood structure with board and batten siding and large timber exposed rafters. There is also a wood porch erected in the front of the building (Photo 51).
