FACILITIES MAINTENANCE PLAN

AUERBACH
ENGINEERING CORP

**Facilities Maintenance Plan
Truckee Tahoe Airport District
October 2020 - FINAL**

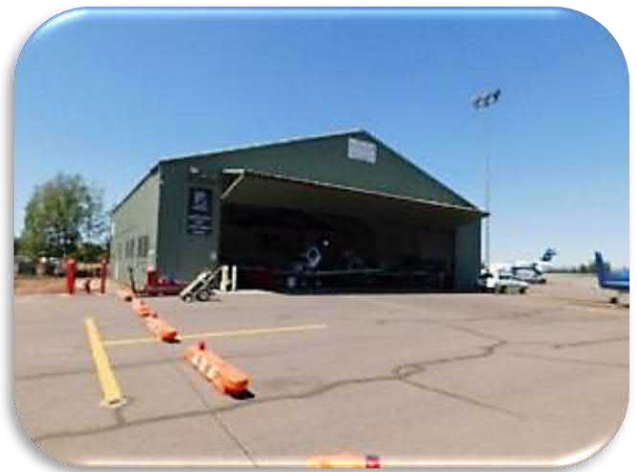
Hangar 1 is sheathed in corrugated siding that has been painted numerous times (Figure 5-1). There is also uncoated galvanized siding that has been installed on the north side of the building (Figure 5-2). The painted siding has good color retention, is glossy and it is free of chalk (ASTM D4214: 8). The coating is tightly adhered (ASTM D6677: 10) and ranges between 10 and 12 mils in thickness. The siding appears to have been painted since the last assessment in 2014. There is some impact damage at the base of the siding (Figure 5-3) and a few isolated coating delaminations.

Figure 5-1 shows a general view of Hangar 1.

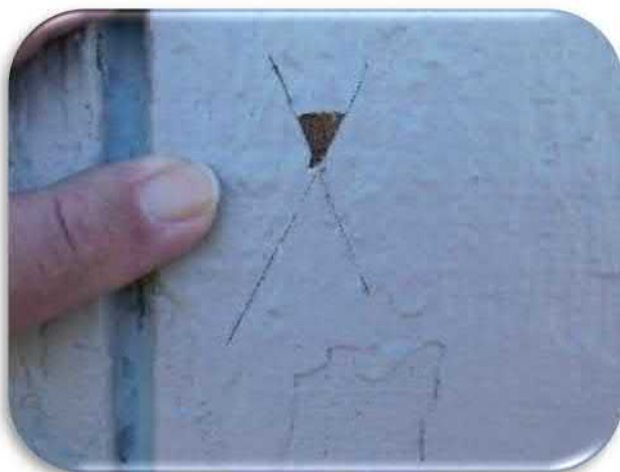
Figure 5-59 shows the results of an adhesion test indicating poor adhesion.

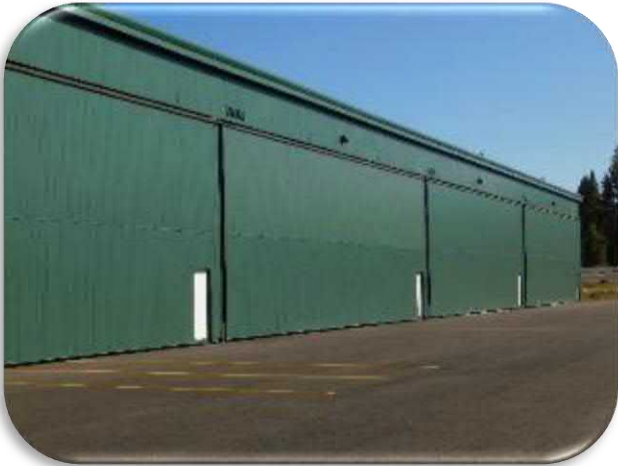
The coating applied to the siding on these hangars is in good condition (Figure 5-79) except for some blotchy discolorations on Hangar P (Figure 5-80). The coating is glossy, tightly adhered to the substrate (ASTM D6677: 10) and free of chalk (ASTM D4214: 8). The coating thickness on Hangars N and P ranges between 0.5 and 1.5 mils.

Figure 5-80 shows an example of the color variations on Hangar P.

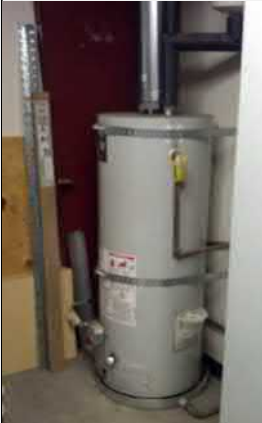
Water Heater	1	Bradford White	MI50456LN10	Natural Gas	50,000 BTU	40,000 BTU	80%	50 Gallons	1997	yes although wall screws may not be sufficient	seems tight	Auto/ Water temp	yes	Drain pan, PTRV, no Insulating blanket	2020 with a condensing water heater, could be an instantaneous so that the room doesn't heat up where electronics are.	\$2,500	Inspect Yearly	\$100

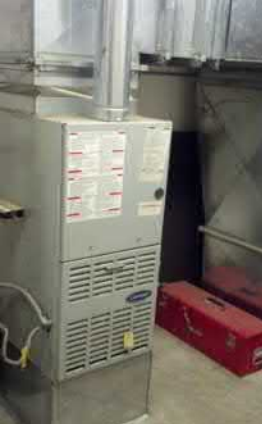
Furnace	1	Carrier	58RAV095-12	Natural Gas	92,000 BTU	74,000 BTU	80%		1997	Duct is hung, not braced although this probably is sufficient	seems tight, Needs lateral bracing	Honeywell Programable Thermostat	Yes	Filter needs to be changed, duct work should be cleaned Both outside air vents need to be open	2020 With a 92% efficient furnace and add condensate drain line, reconfigure flues and new Wi-Fi capable thermostat, add AC	\$15,000	Twice yearly Change Filter, CO and flow Inspection	\$150

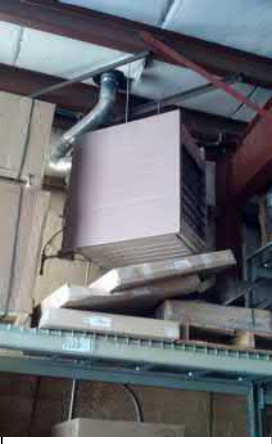
Unit Heaters	2	Reznor		Natural gas					1994?	No lateral bracing		Basic thermostat	Did not attempt, boxes too close, hasn't been started in at least 8 years	10 years life remaining if used	2023 if used again with Reznor UDAS-175	\$6,000	Add lateral brace ASAP 1ft Clearances must be maintained	\$800

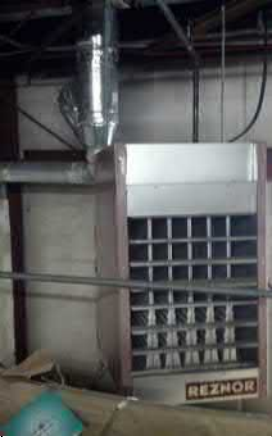
Unit Heaters	2	Reznor	FE 165-H	Natural gas	165,000 BTU	132,000 BTU	80%		1994	No lateral bracing	Seems tight	Basic thermostat	Did not attempt, boxes too close		2024 if used again with UDAS-175	\$6000/ Each	2013 Add lateral brace	800
Warehouse D

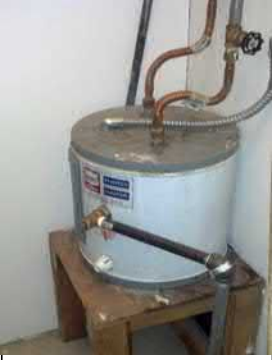
Water Heater	1	Hoyt	6 FC	Electric	1500 Watts			6 Gallons	1980's?	None	N/A		yes	3/4" Pipe running from unit causes too much of a delay to get hot water	2020 with Instahot and 3/8" line from heater	\$ 600	Inspect Yearly

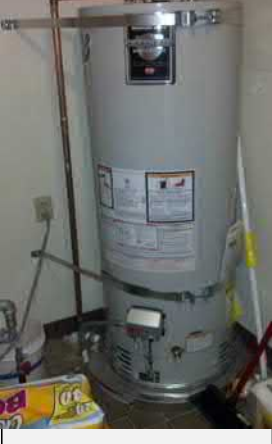
Water Heater	1	Bradford White	M440T6FBN	Natural Gas	40,000 BTU		80%	40	October 2011	Yes	Common with Furnace		yes		2032	\$ 3,000	Brace Flue ASAP	200

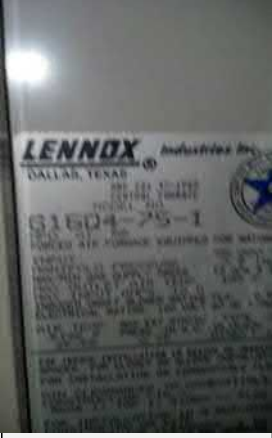
Furnace	1	Lennox	G16Q4-75-1	Natural Gas	75,000 BTU		79%		1985	Flue needs more bracing	Common with Water Heater	Programable Thermostat		Air filter needs to be changed	2020	\$ 6,000	See above for Flue change air Filter twice yearly	60

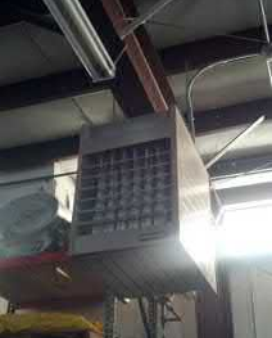
Unit Heater	1	Reznor	FE200-H	Natural gas	200,000 BTU	160,000 BTU	80%		1994	No lateral bracing	Needs to be sealed	Basic thermostat	Yes	Needs to be dusted	2024 with UDAS-175	\$ 6,000	2020 Add Lateral Bracing	800

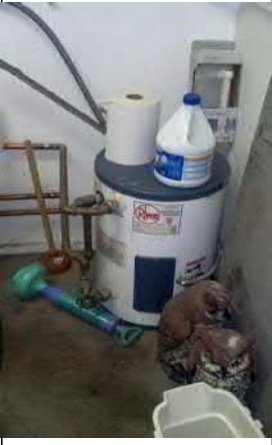
Water Heater	1	Rheem	81VP108	Electric	2000 Watts			10 gallon	1992	None	None		Yes		2025 With Instahot	\$ 600	Add Lateral bracing	50

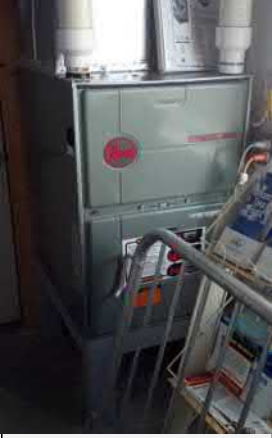
Furnace	1	Rheem	RGRA-10EZAJS	Natural Gas	105,000 BTU	97,000 BTU	92%		2000							\$6,000	Add additional strapping including lateral bracing to duct. Change filter twice yearly. Condensate drain exits side of building and drips onto walkway which is not best practice should go to sewer drain. Add condensate neutralizer. Add 1/4" screen to flues for code pest control	200 & 60

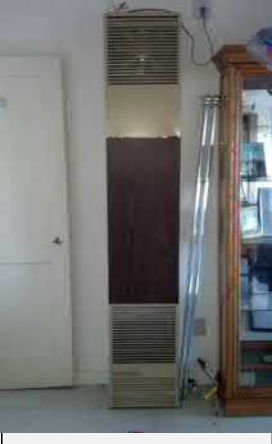
Wall Furnace	1	Louisville Tin & Stove Co.	DVC 5 92	Natural Gas	55,000 BTU		75-80%		1994?			Basic Thermostat	No	Spark ignition but gas did not turn on	2020 By extending duct from furnace and removing this unit	\$ 500

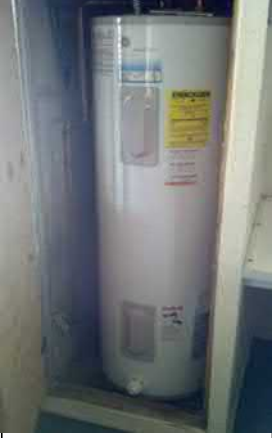
Water Heater	1	GE	GE50T06AAG	Electric	4500 Watts			50 Gal	2006	No Bracing	N/A		Yes		2031 with Natural gas high efficiency condensing model	\$ 3,000	Add lateral bracing ASAP Needs Overflow pan	400

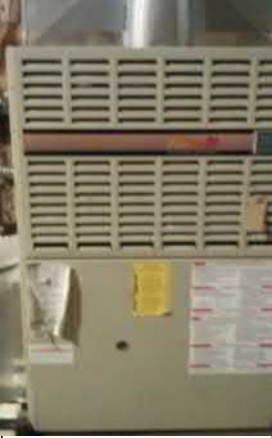
Furnace	1	BDP/Carrier	395CAV060135	Natural Gas	132000 BTU	107,000 BTU	81%		1994			2 thermostats?	lock box over bottom thermostat, top thermostat does not work		Remove 2020 with Remodel	\$ -

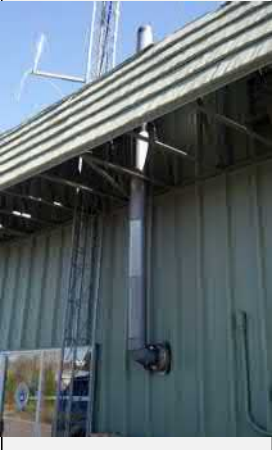
Unused Ducts and Fans	3												No				Remove and close up or get running again	1000
Airport Wide																			
	Plumbing Fixtures (toilets/sinks etc.)															Plan for replacing one fixture/year	\$500 yearly		\$500 yearly
	Natural Gas Lateral Bracing														Various locations are not well secured			Add bracing & Strapping	1000

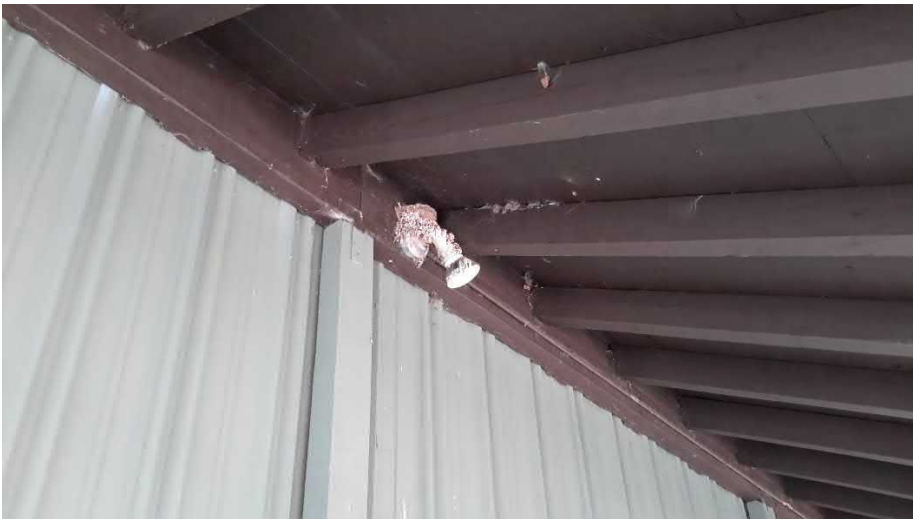
Figure 5 Building 1 - bird nests

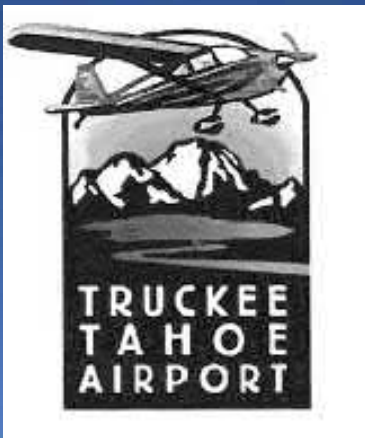
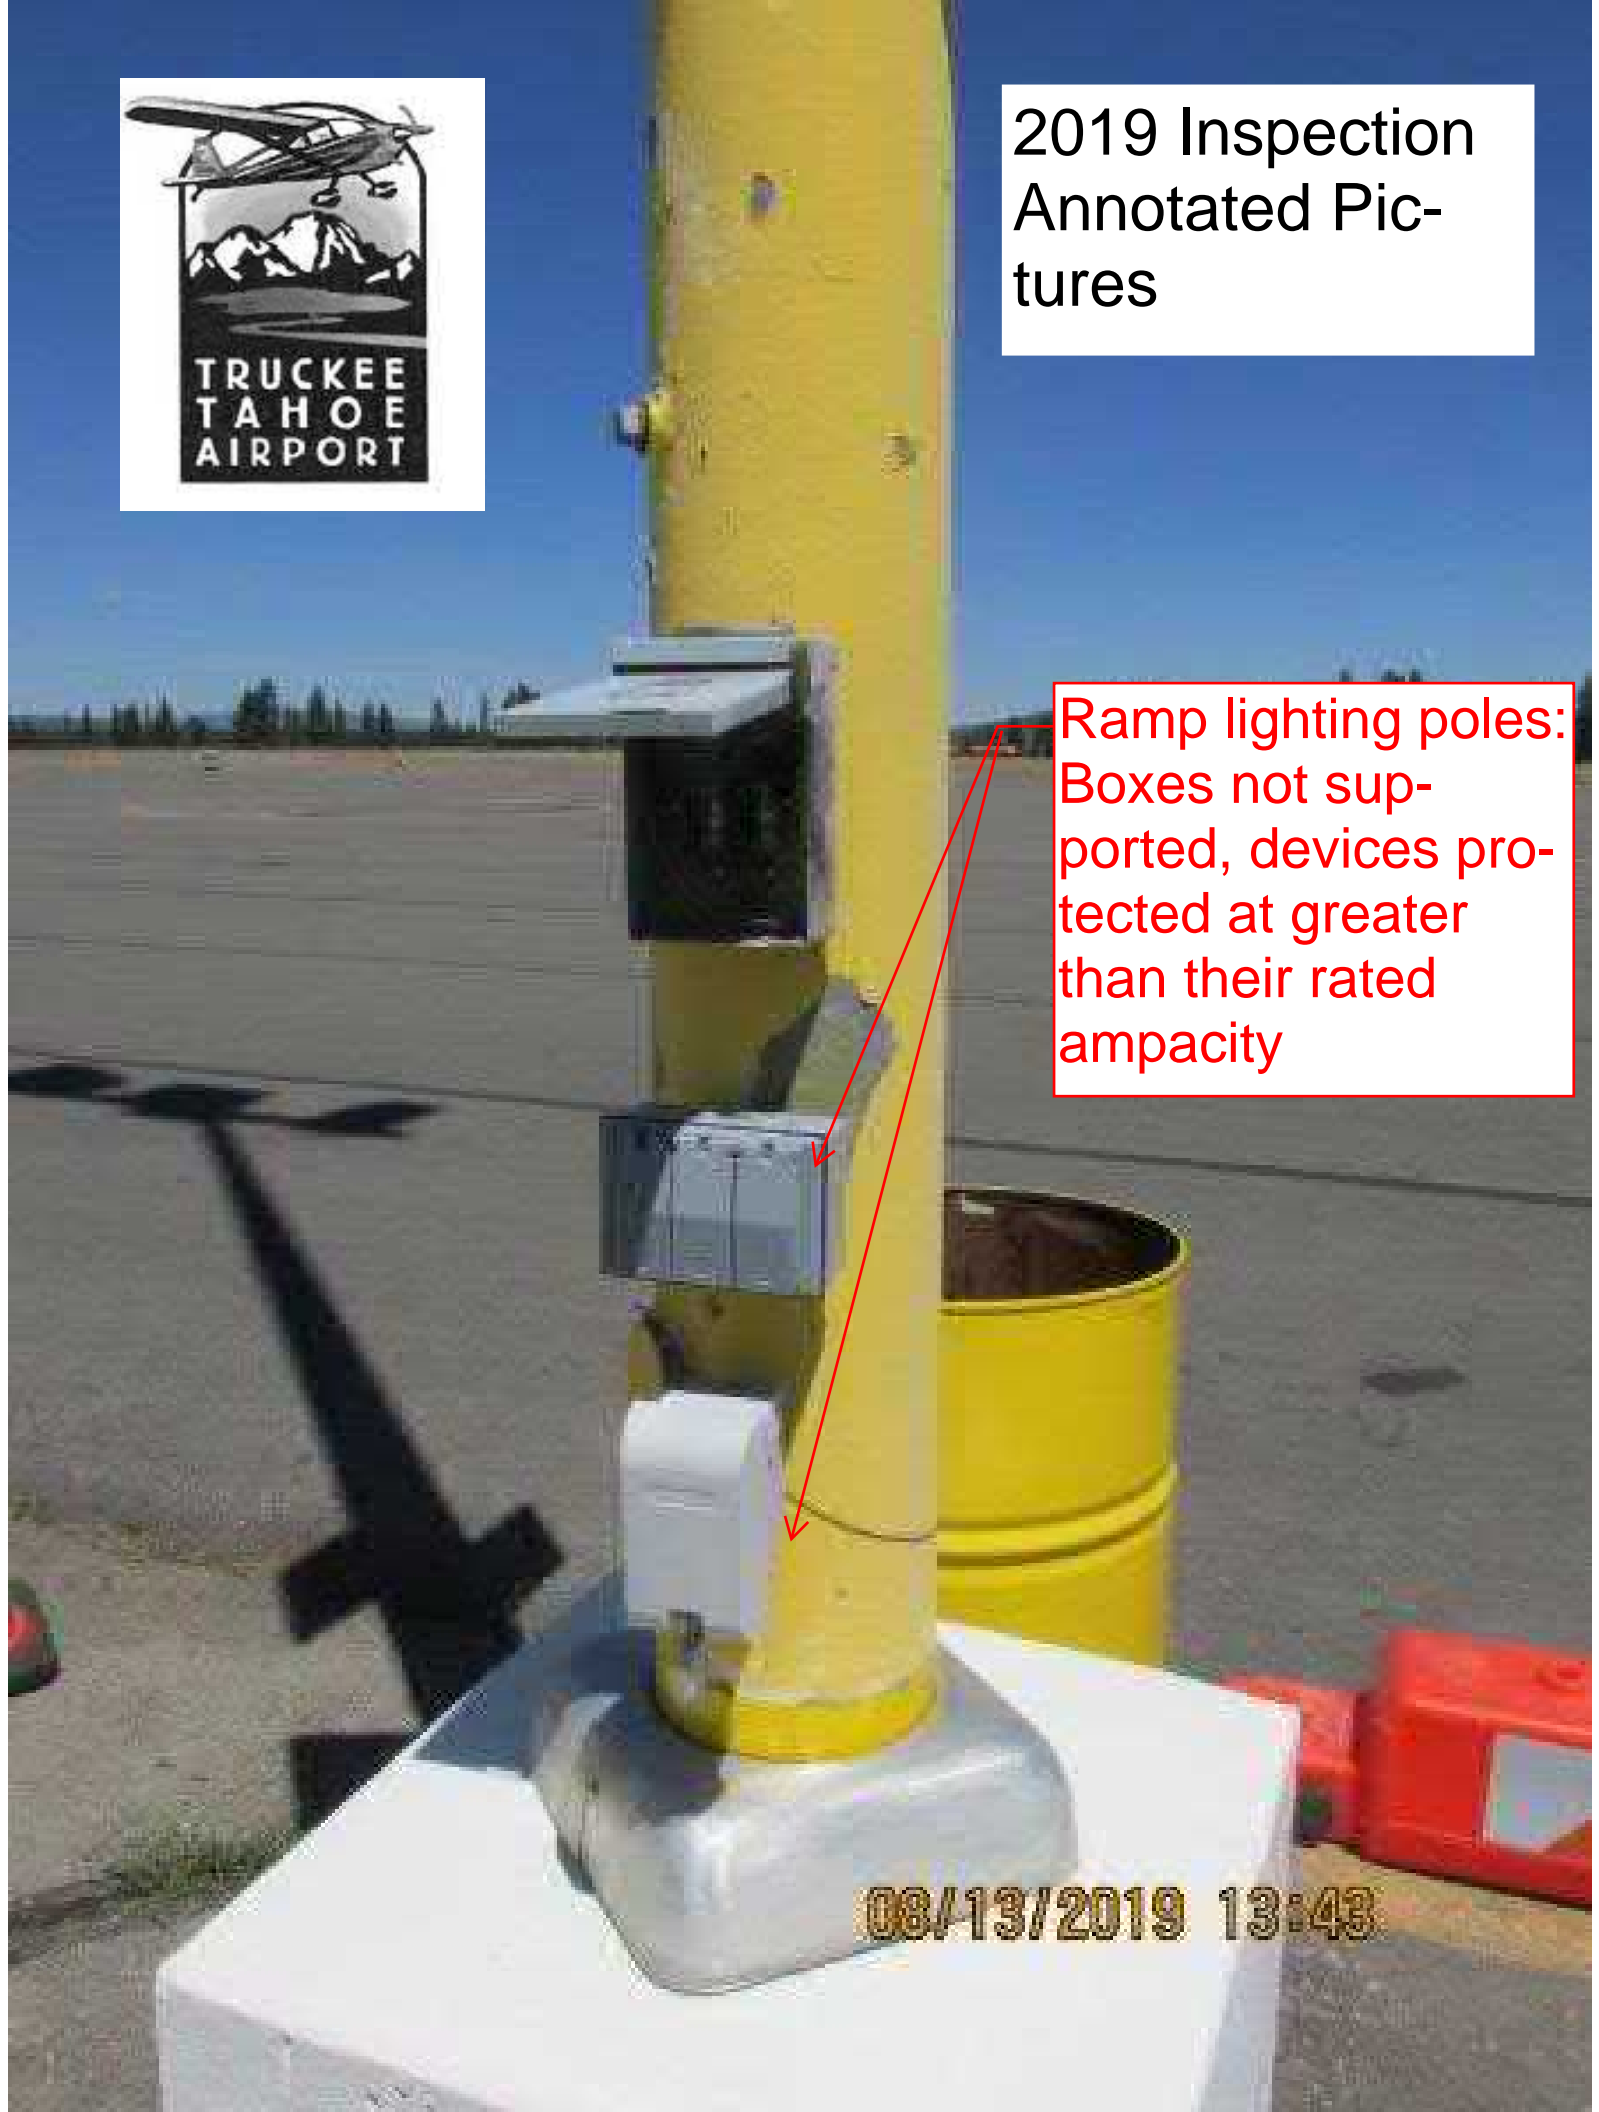
Ramp lighting poles:
Boxes not sup-
ported, devices pro-
tected at greater
than their rated
ampacity

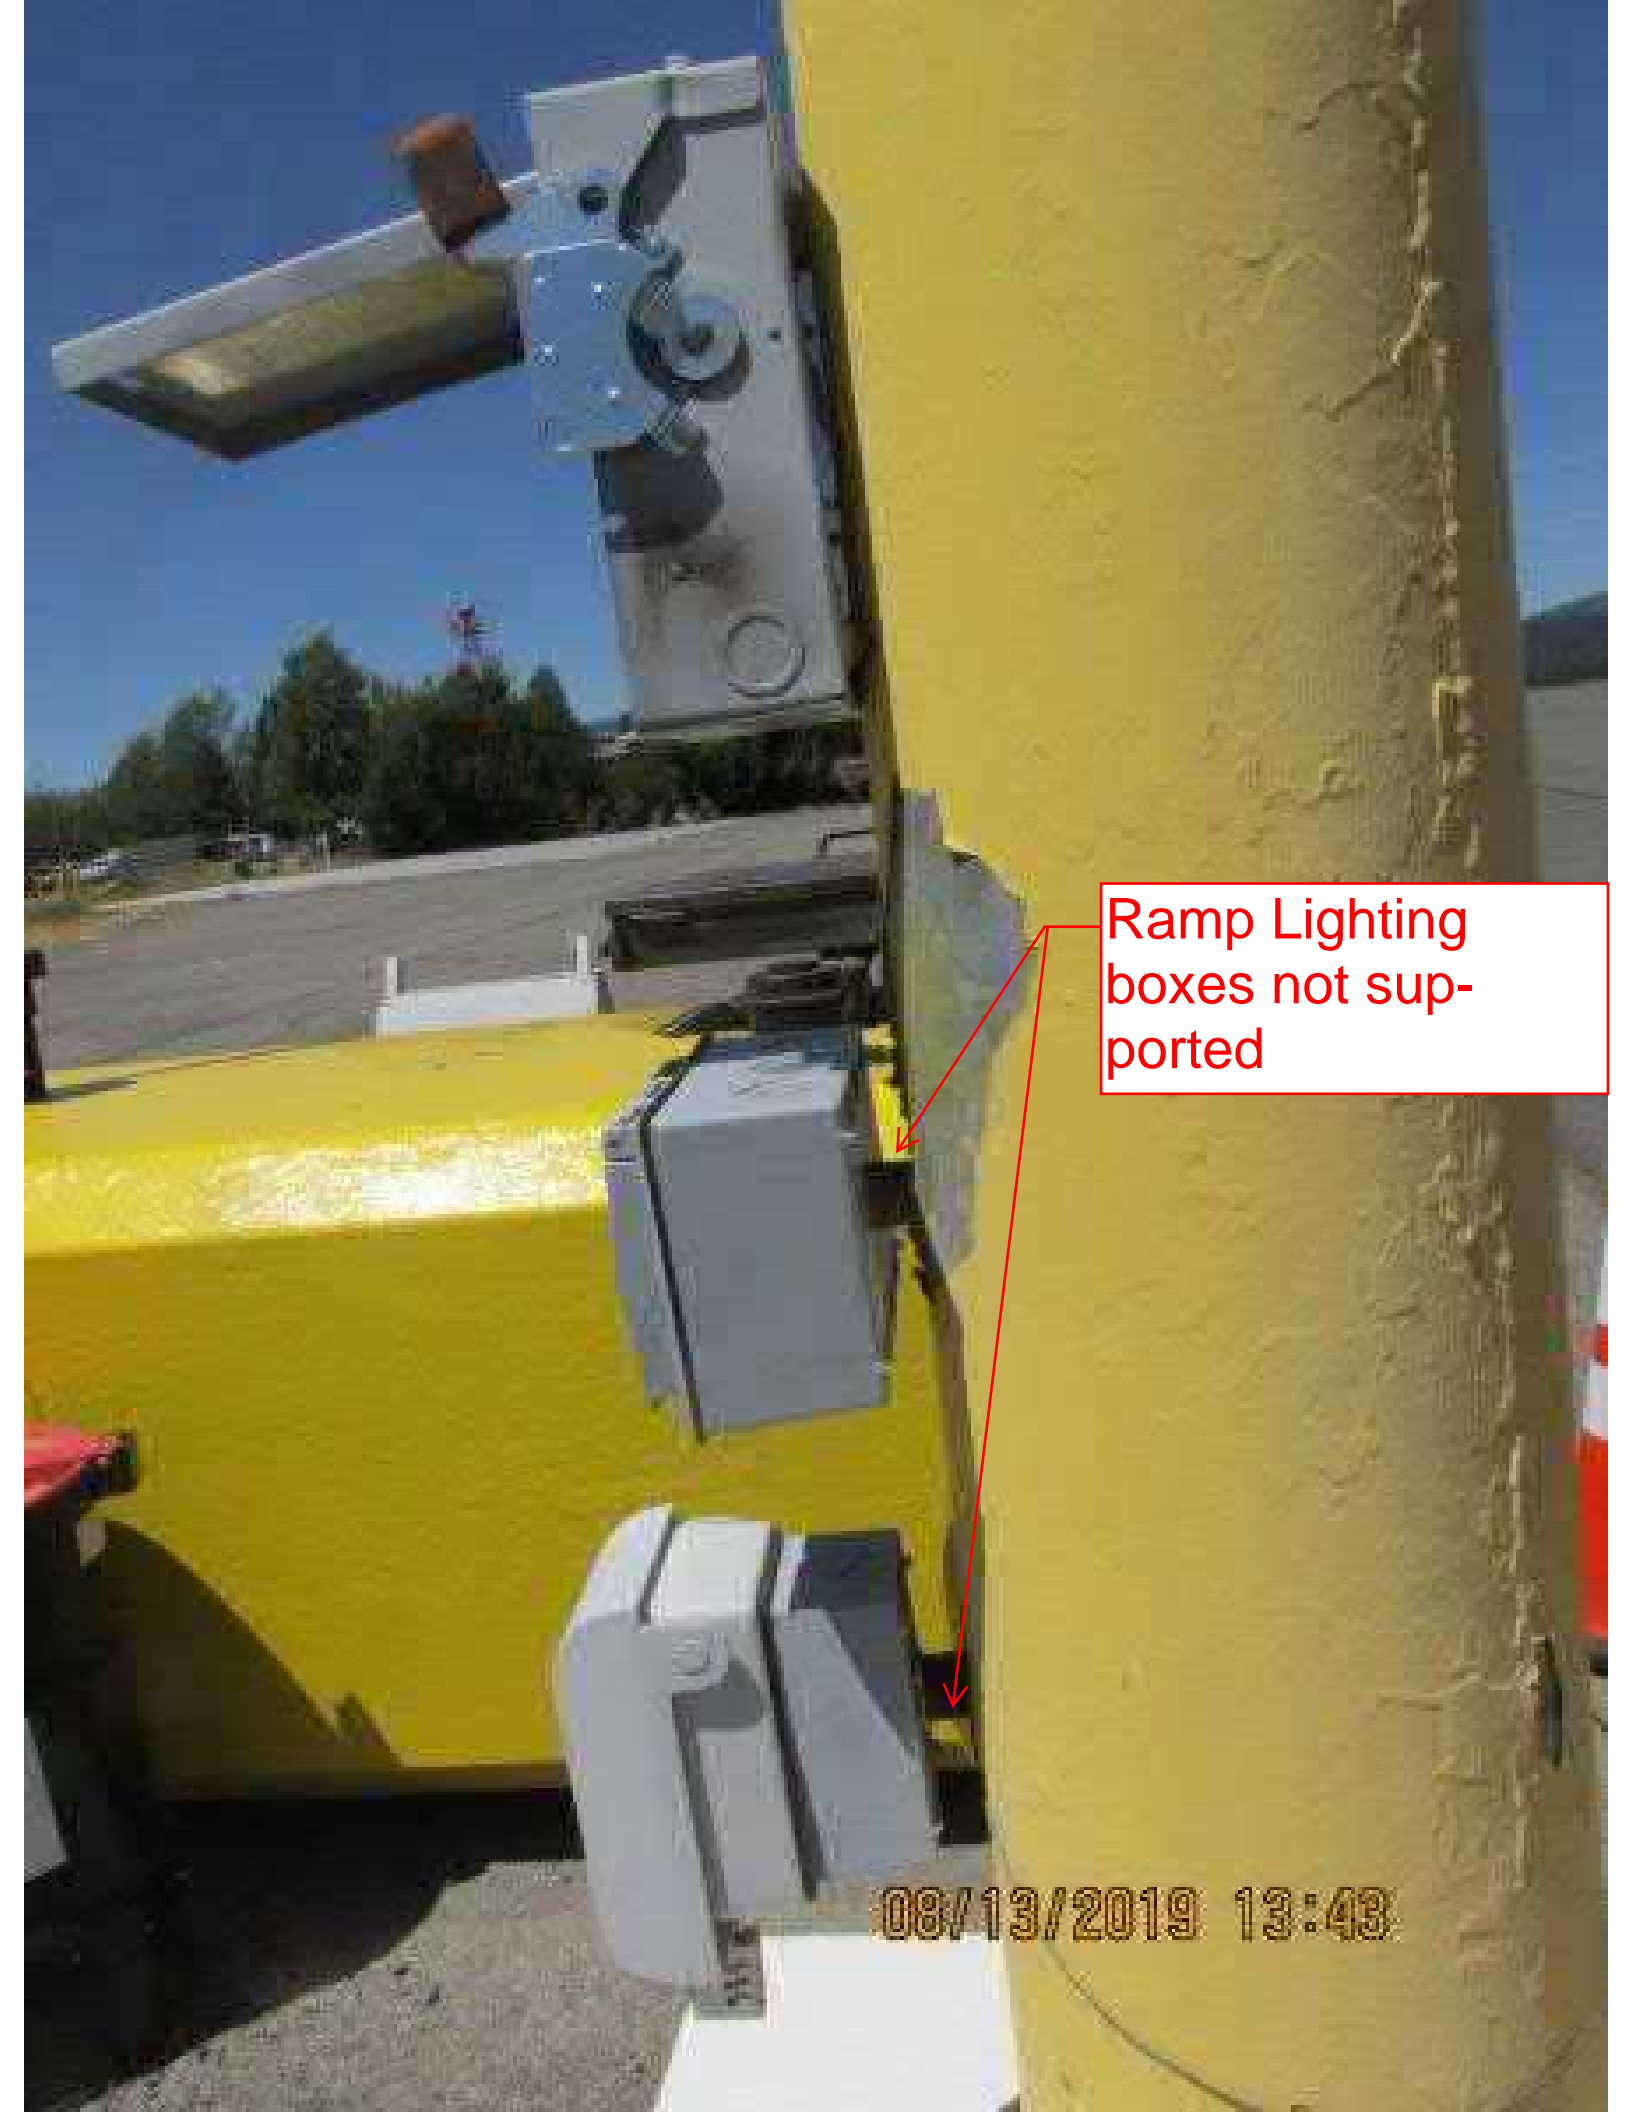
Ramp Lighting
boxes not sup-
ported

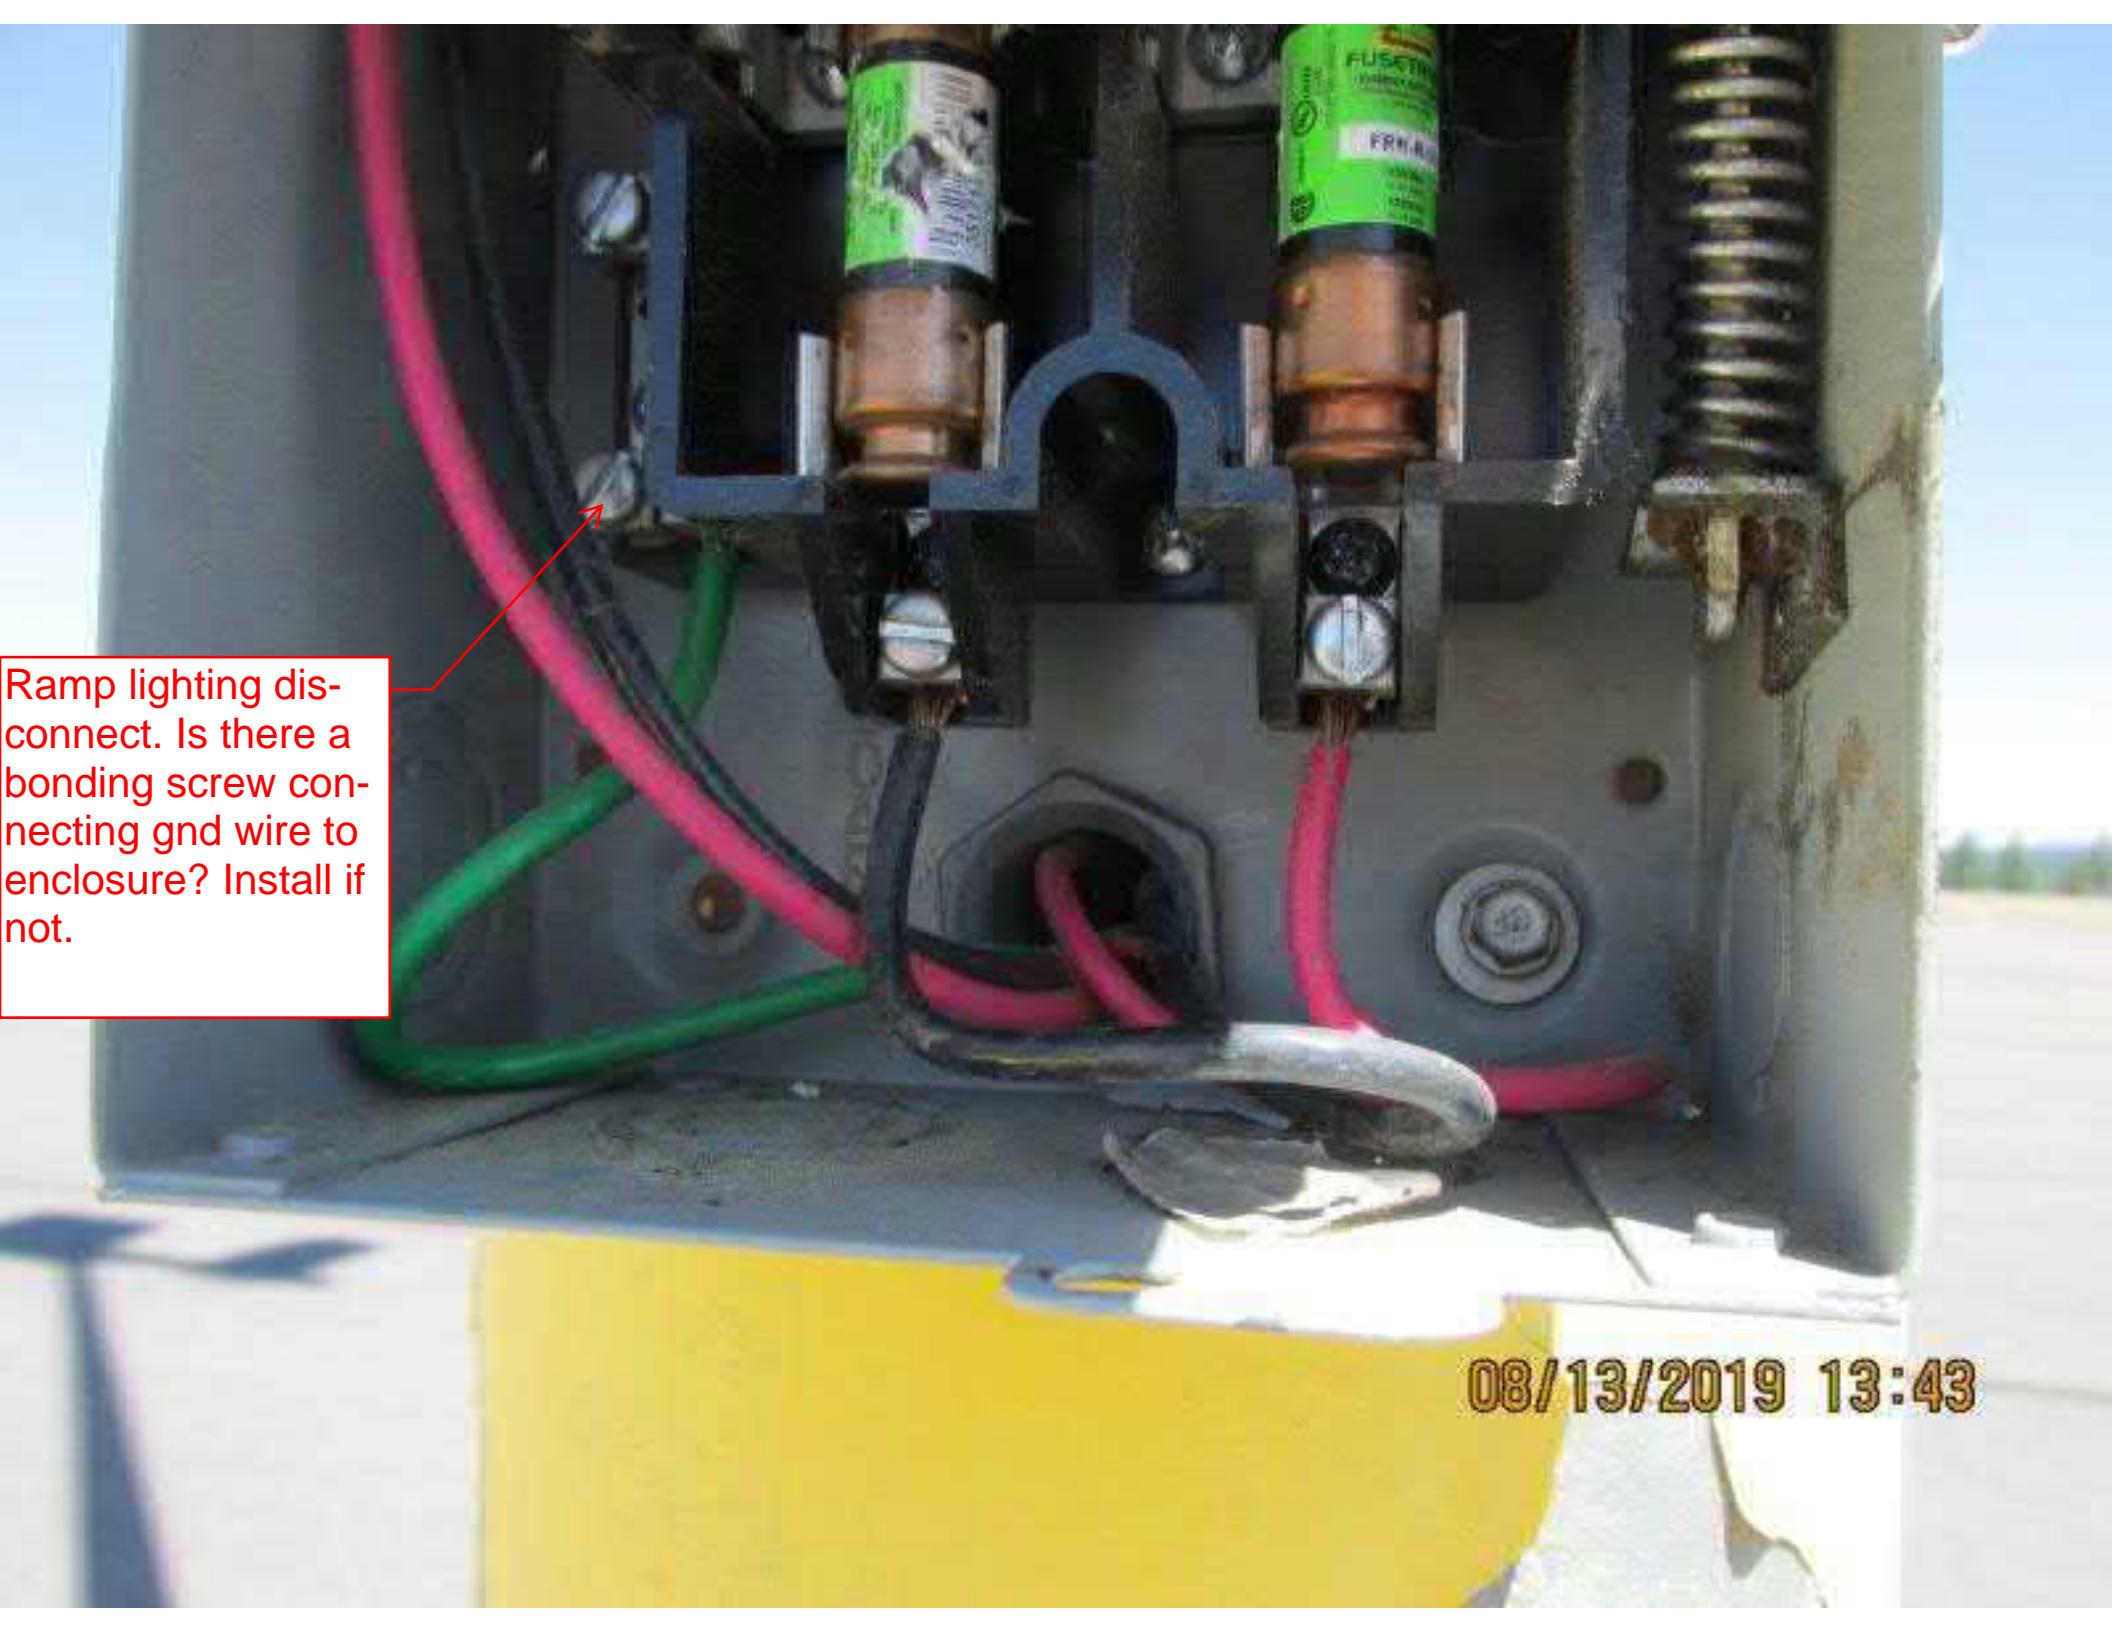
Ramp lighting disconnect. Is there a bonding screw connecting gnd wire to enclosure? Install if not.

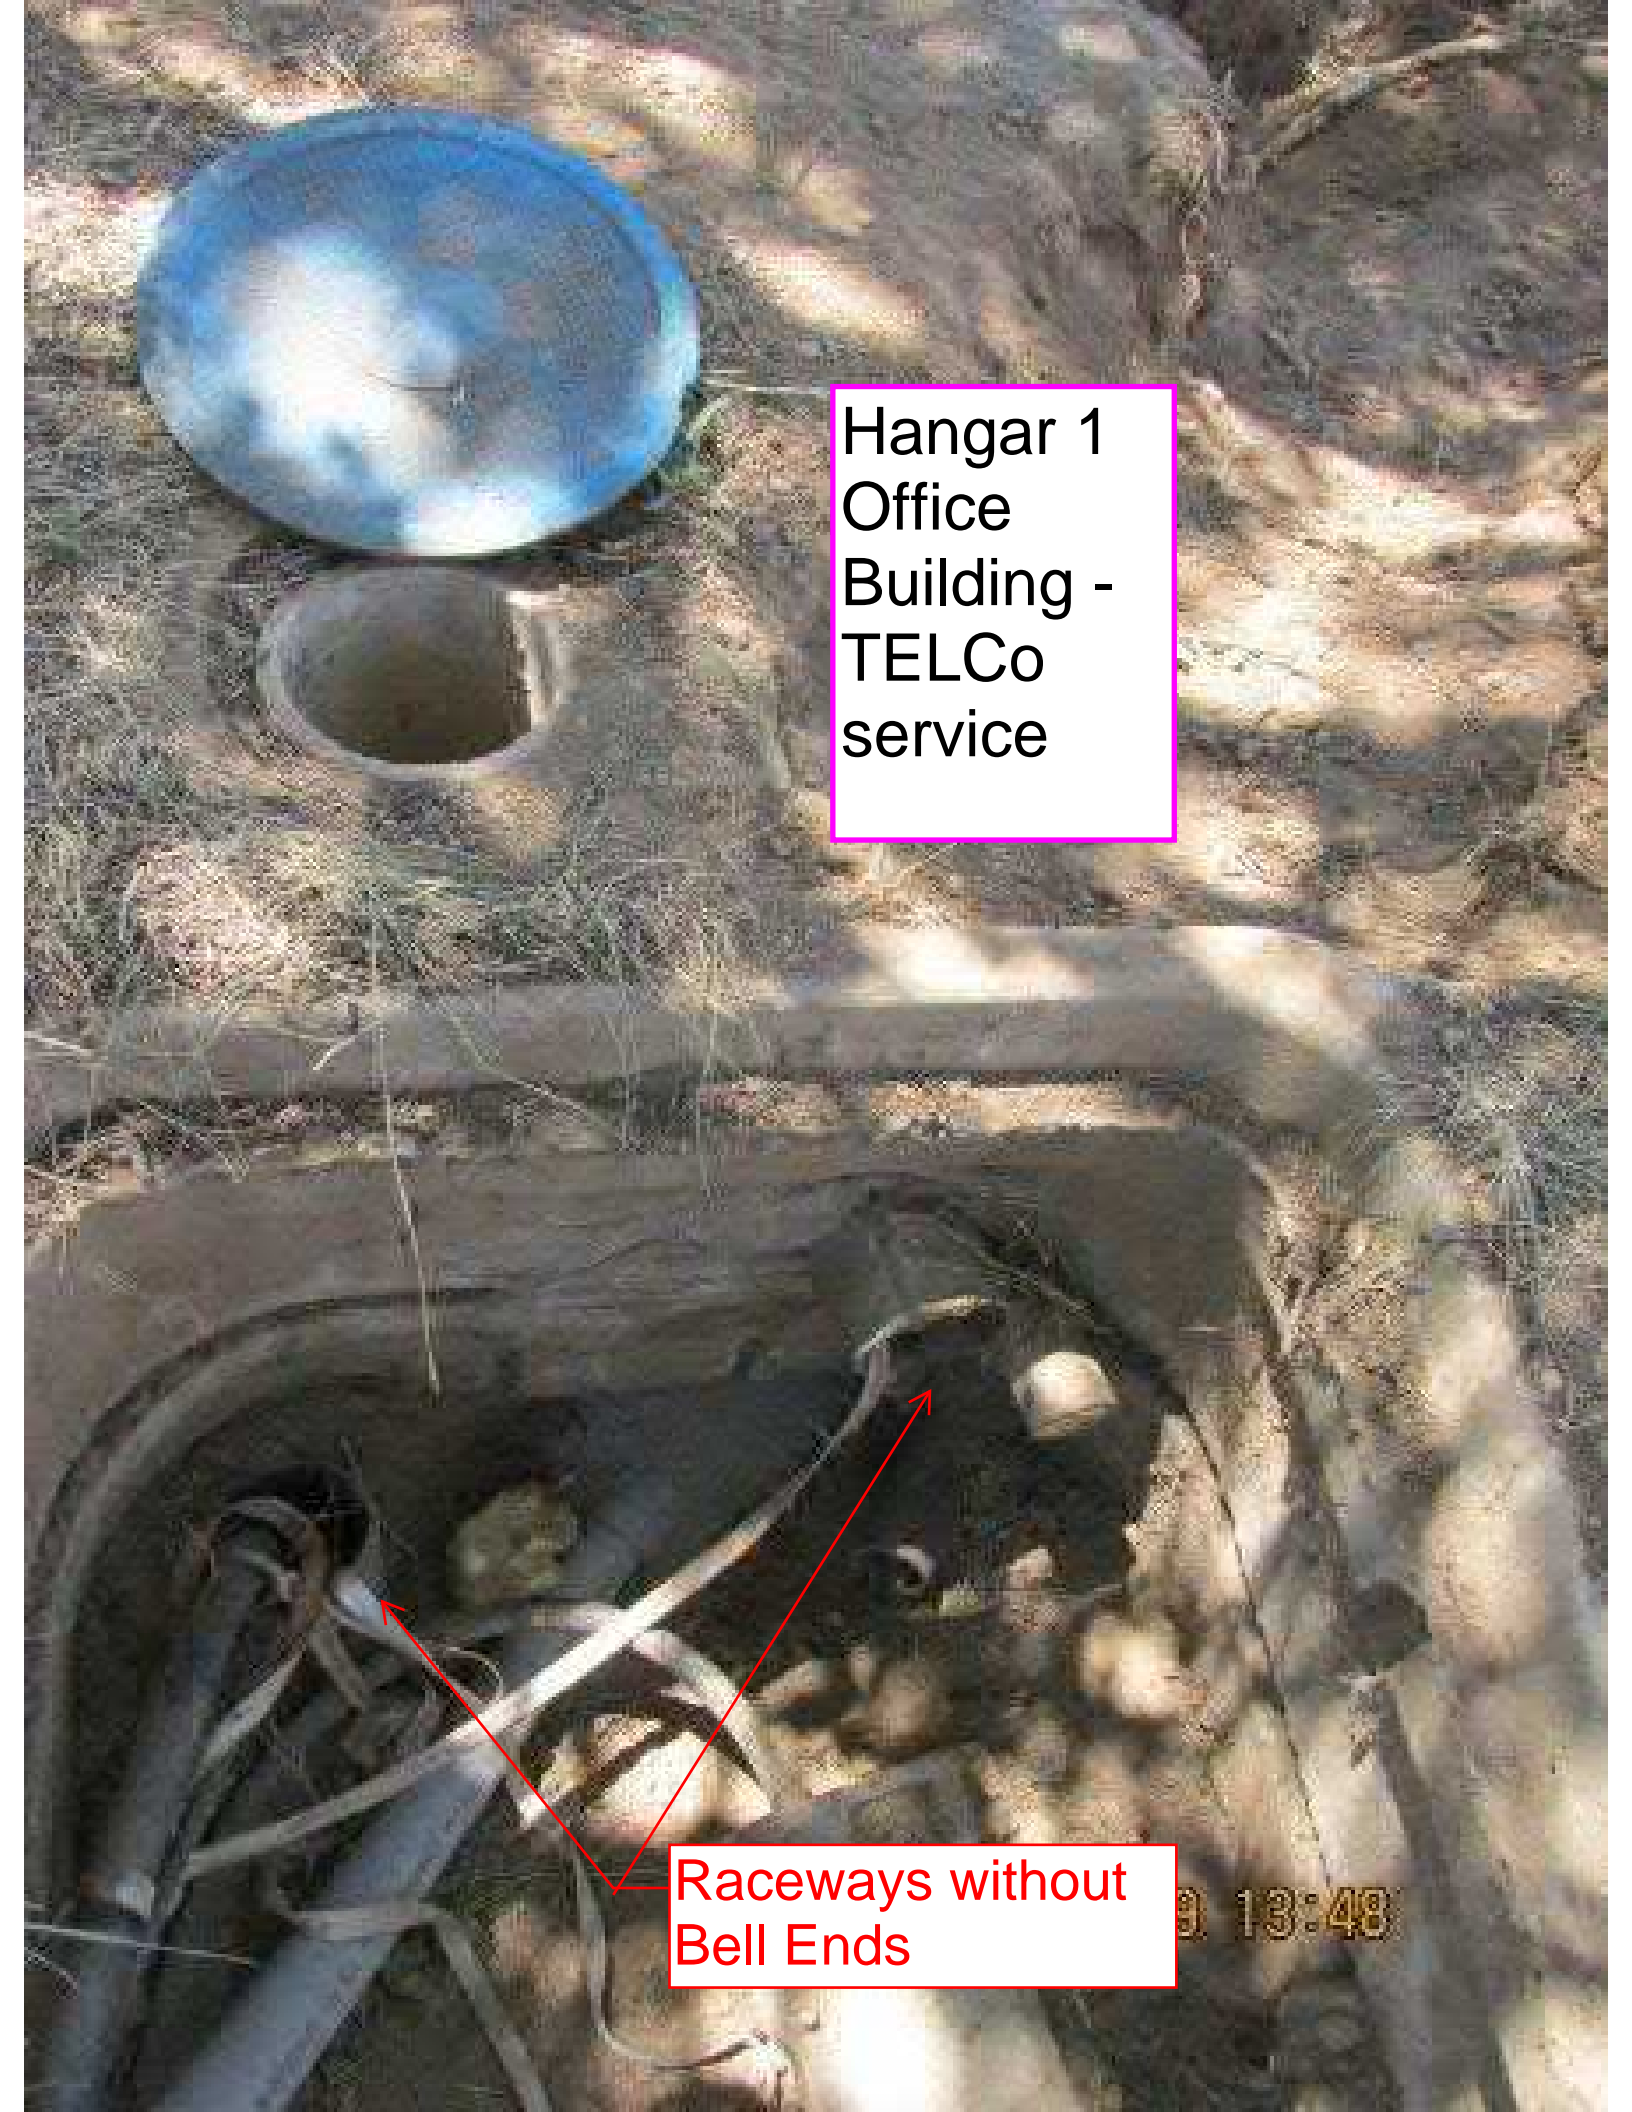
Hangar 1
Office
Building -
TELCo
service

Raceways without
Bell Ends

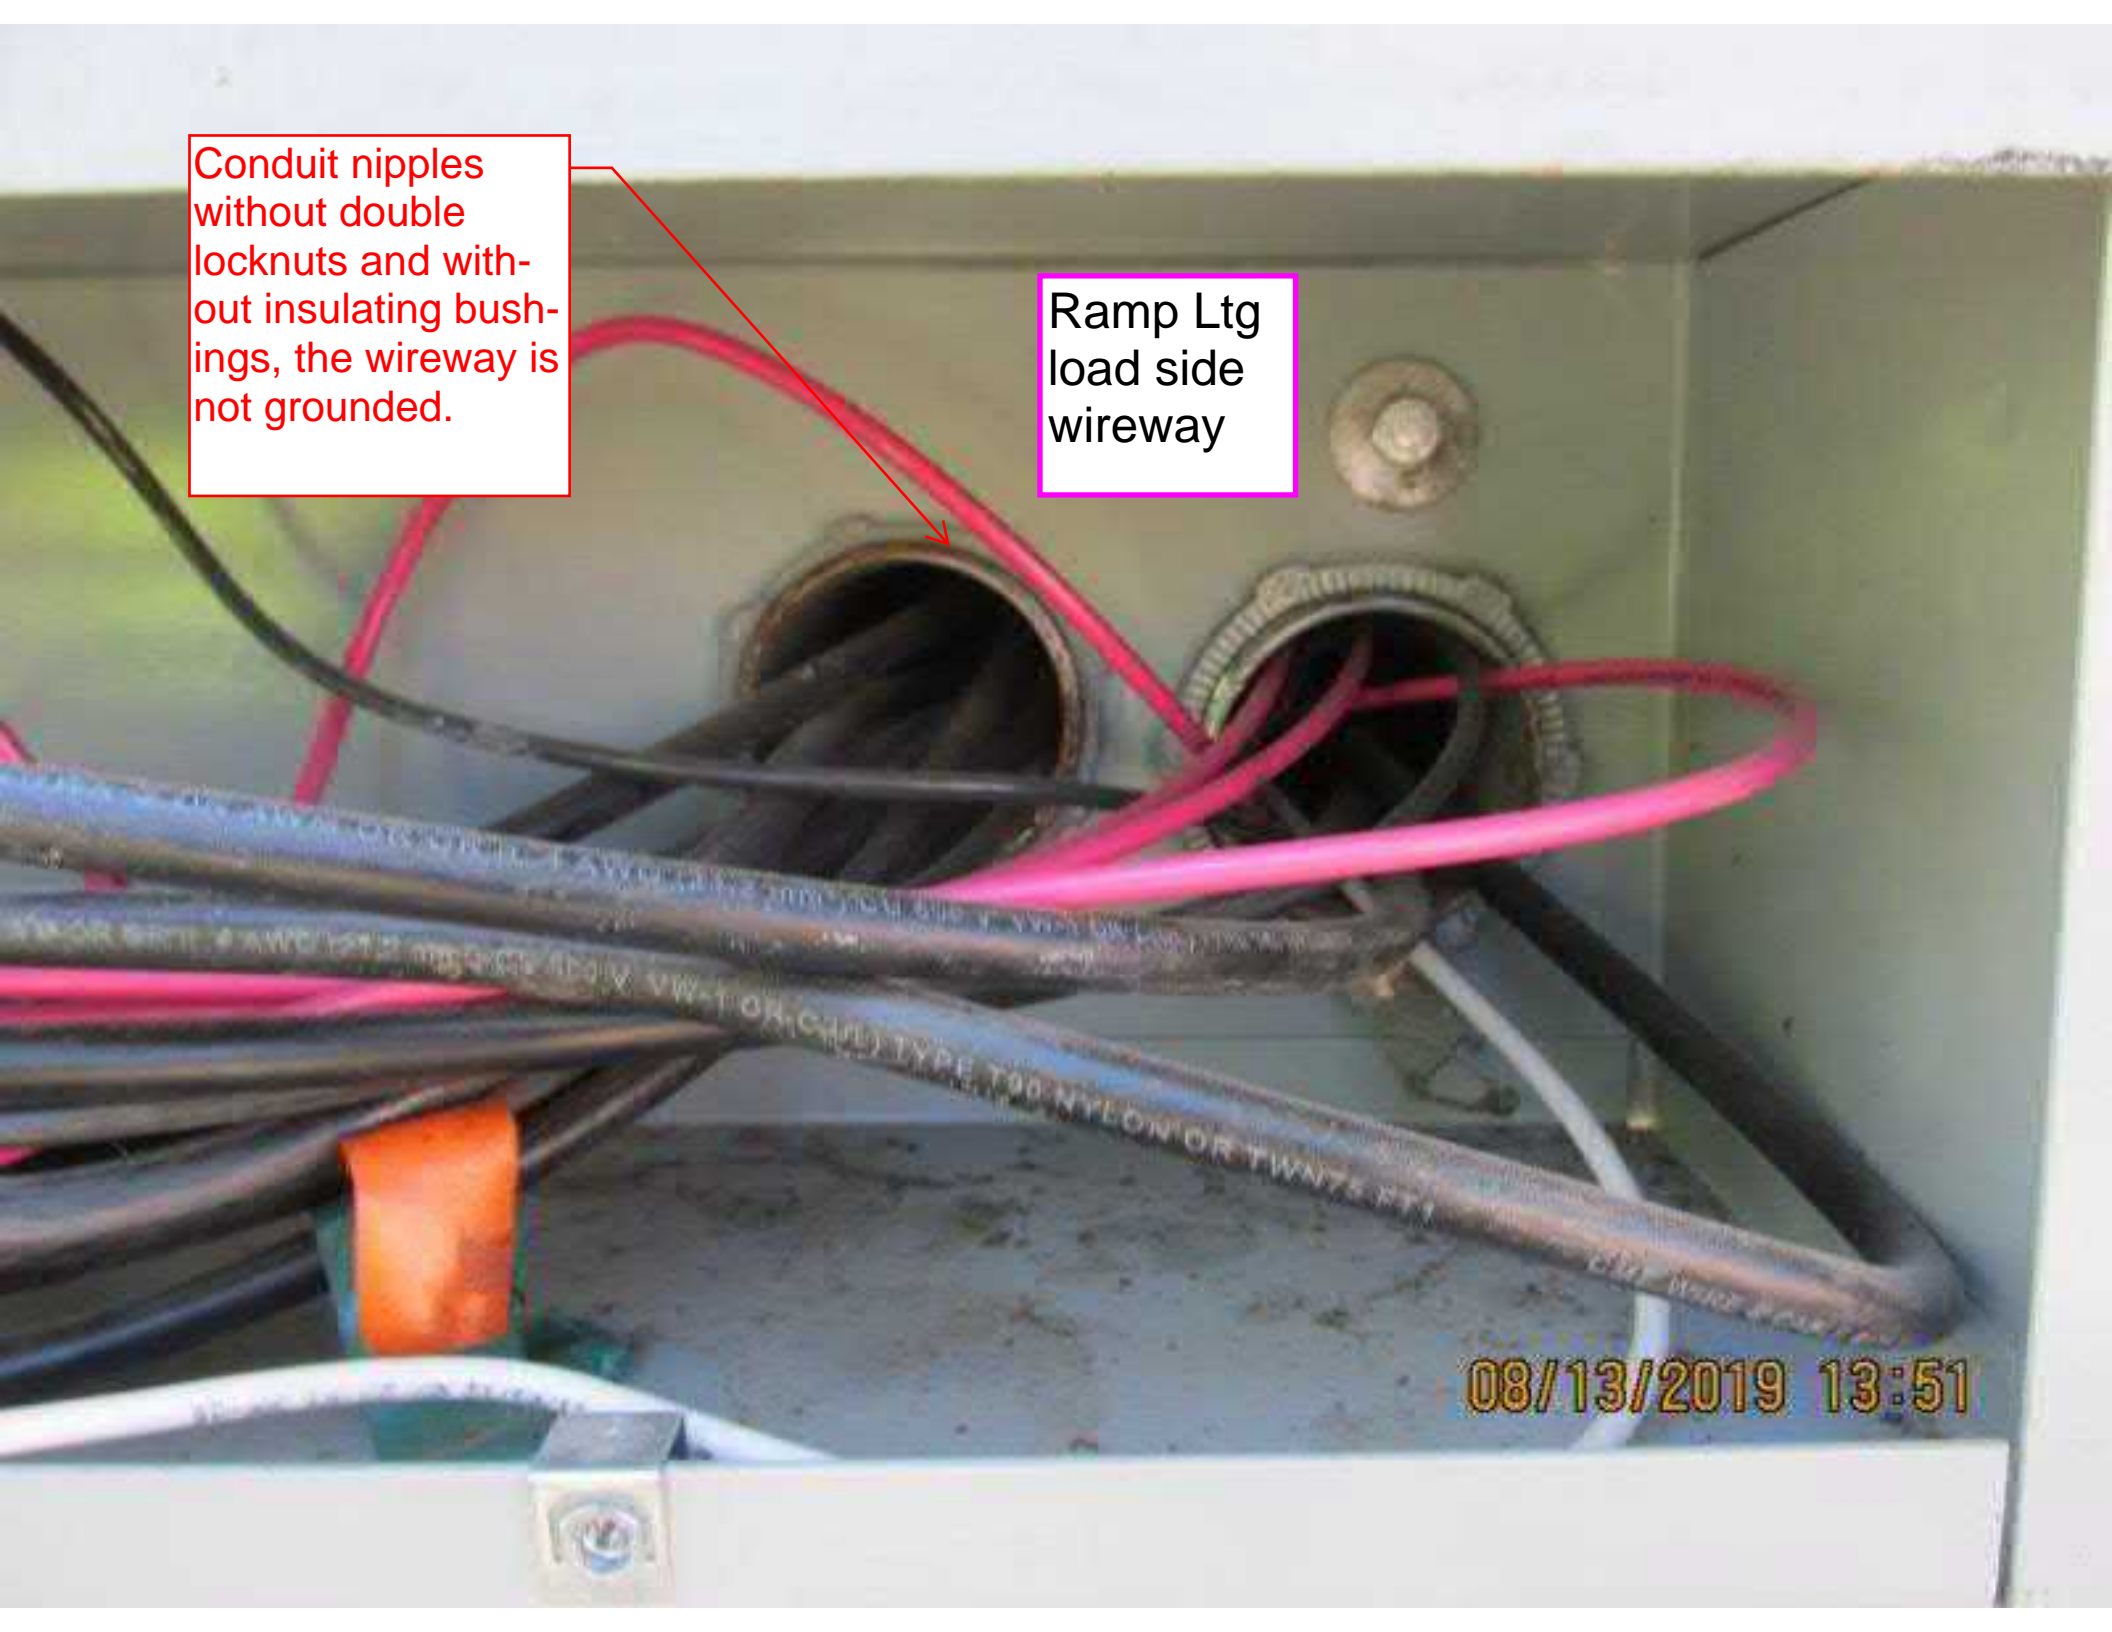
Ramp Ltg
load side
wireway

If there are
grounded circuit
conductors they are
not identified
