FACILITIES MAINTENANCE PLAN

AUERBACH
ENGINEERING CORP

**Facilities Maintenance Plan
Truckee Tahoe Airport District
October 2020 - FINAL**

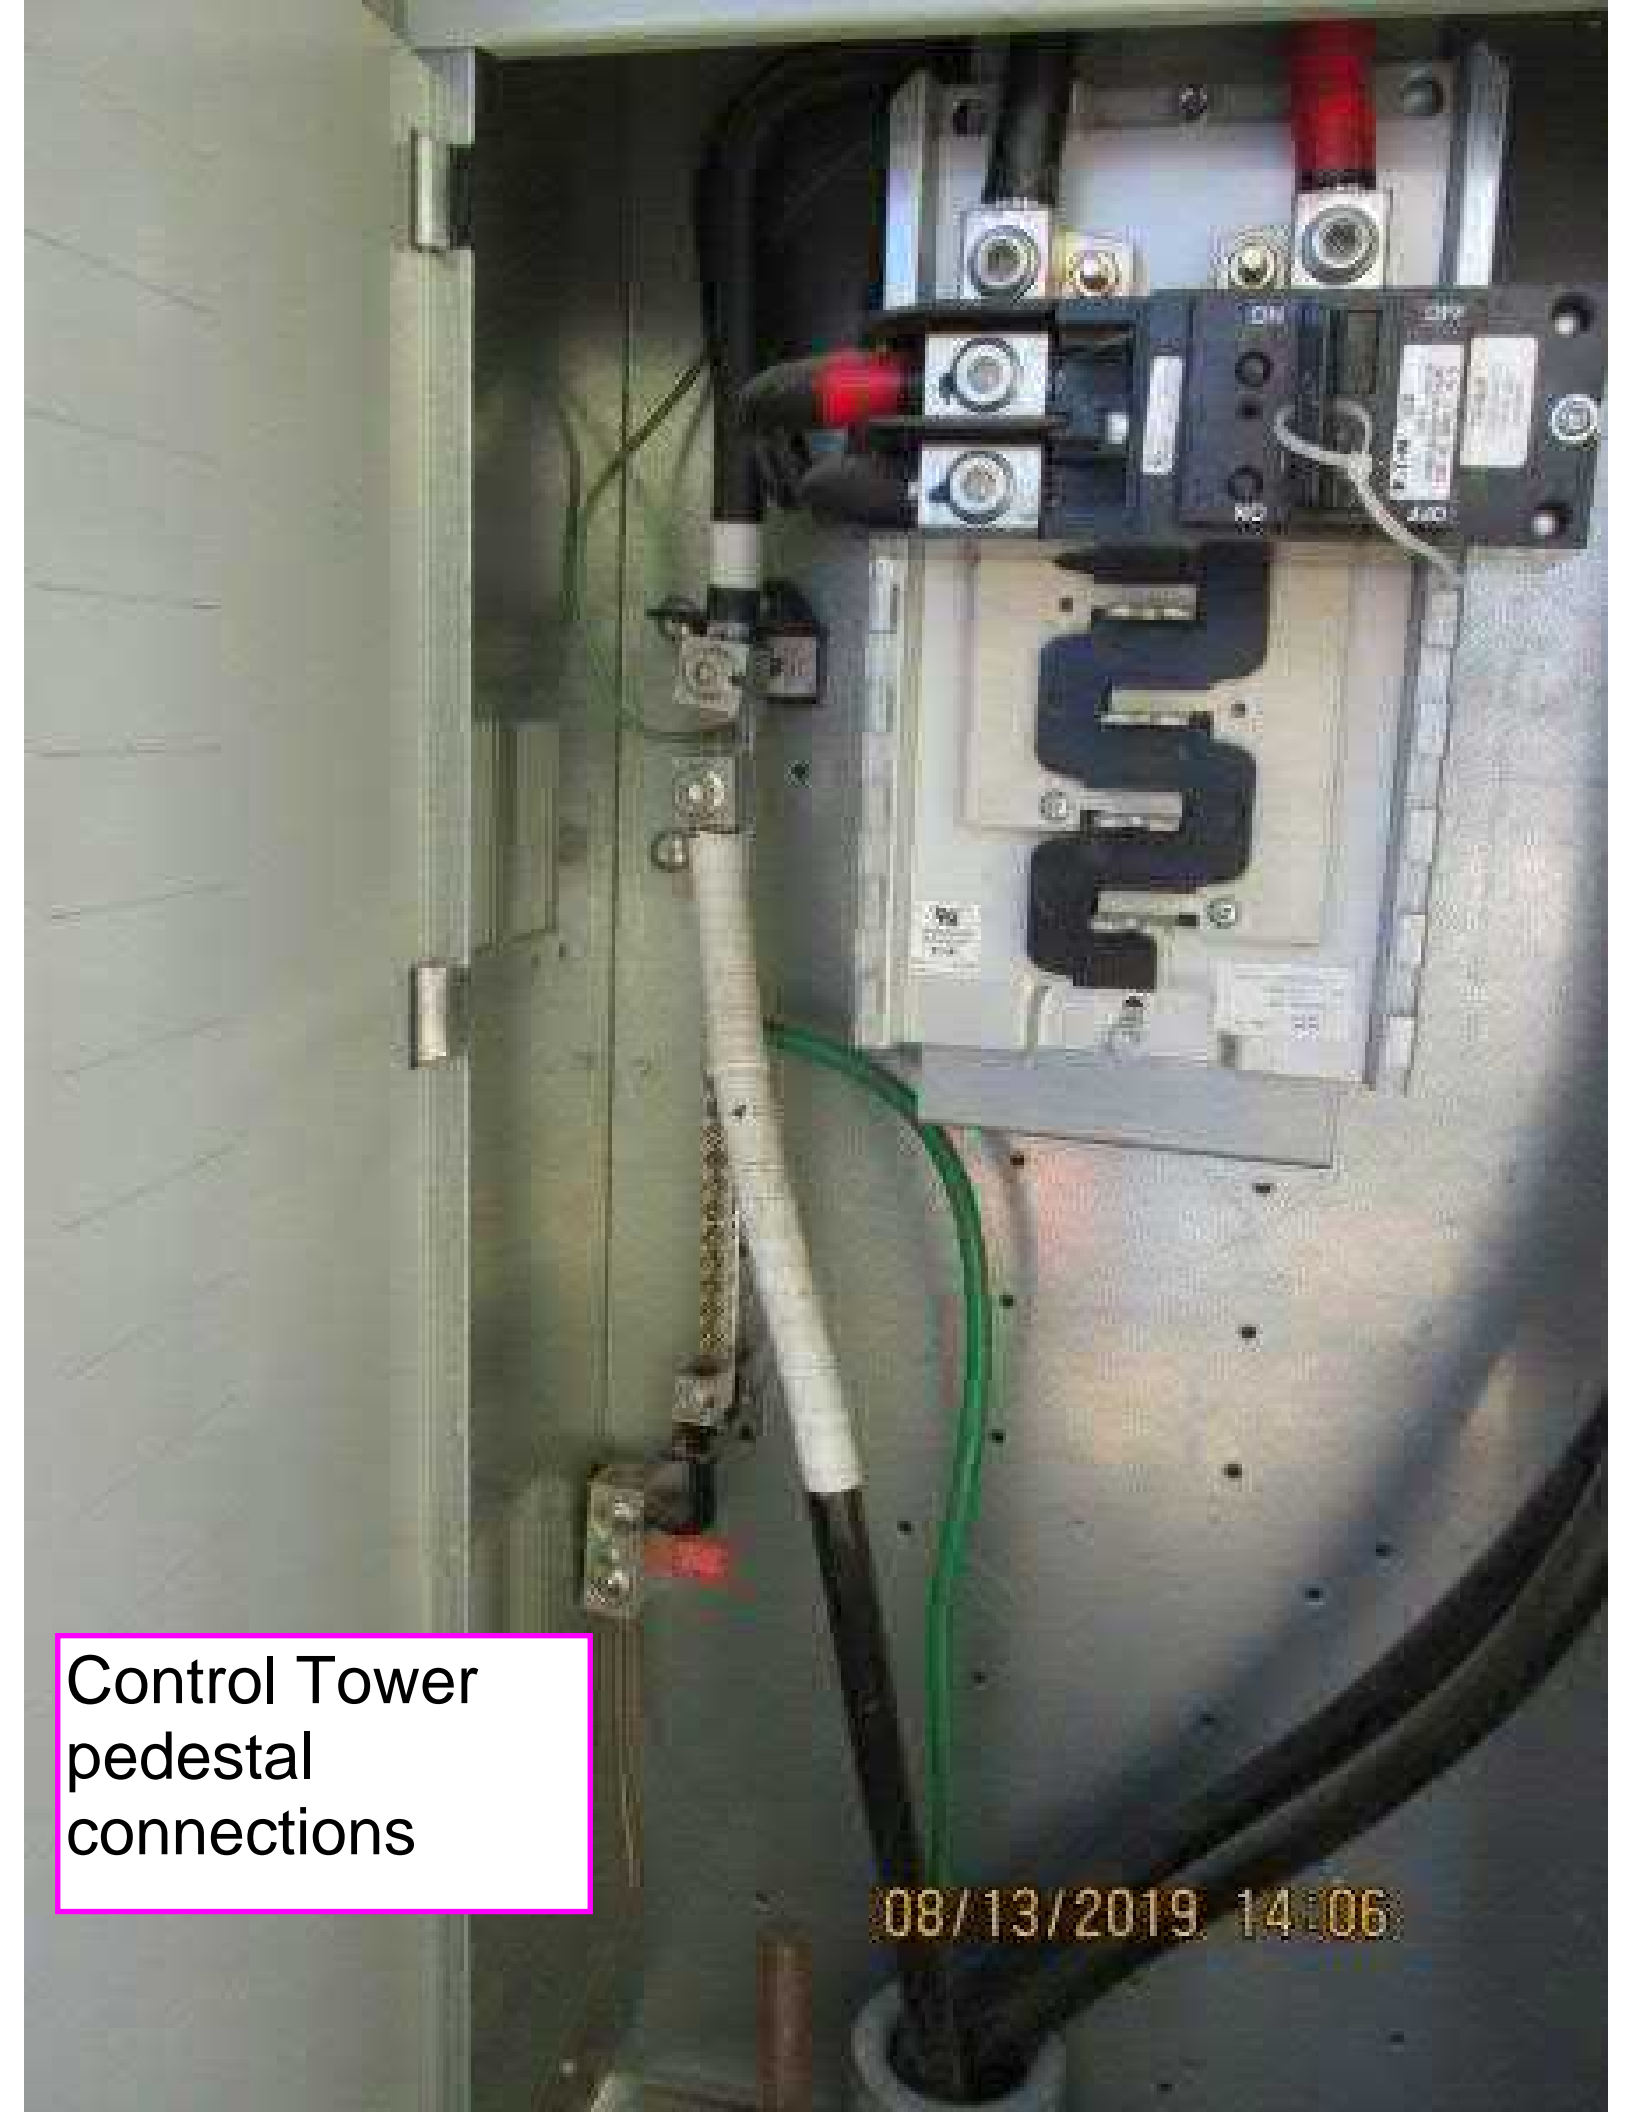
Control Tower
pedestal
connections

8ft ground rod not fully in contact with the soil

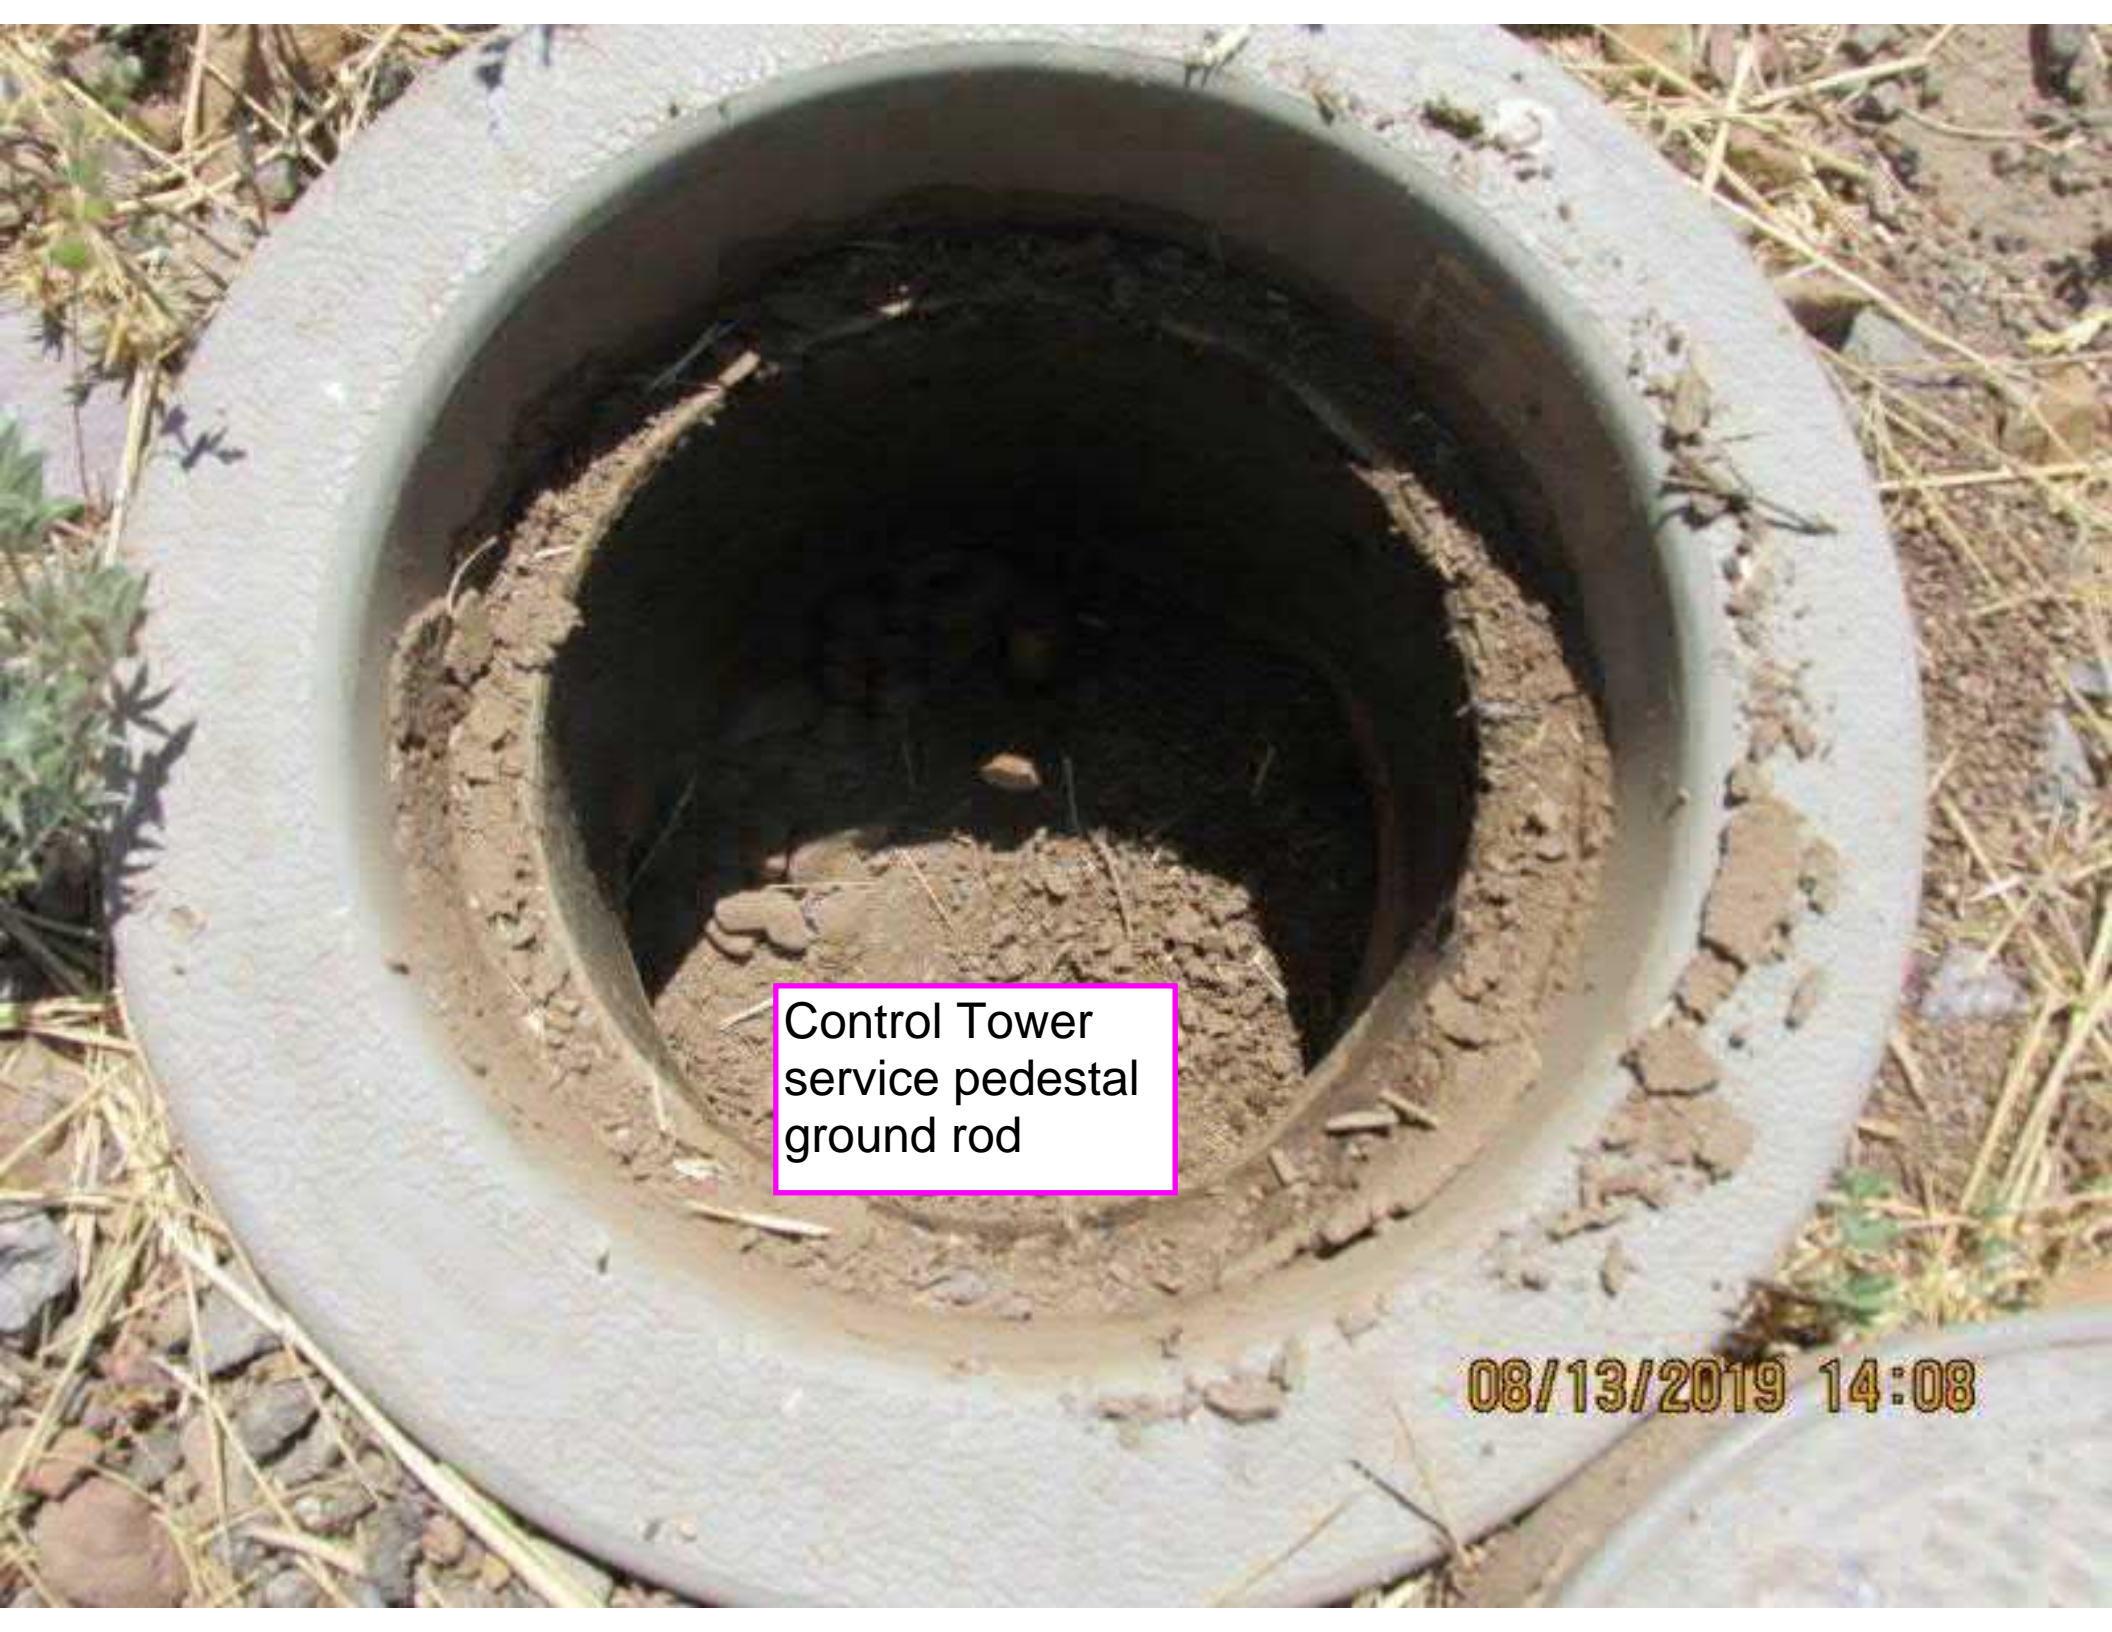
Control Tower
service pedestal
ground rod

This is a bell-end conduit termination

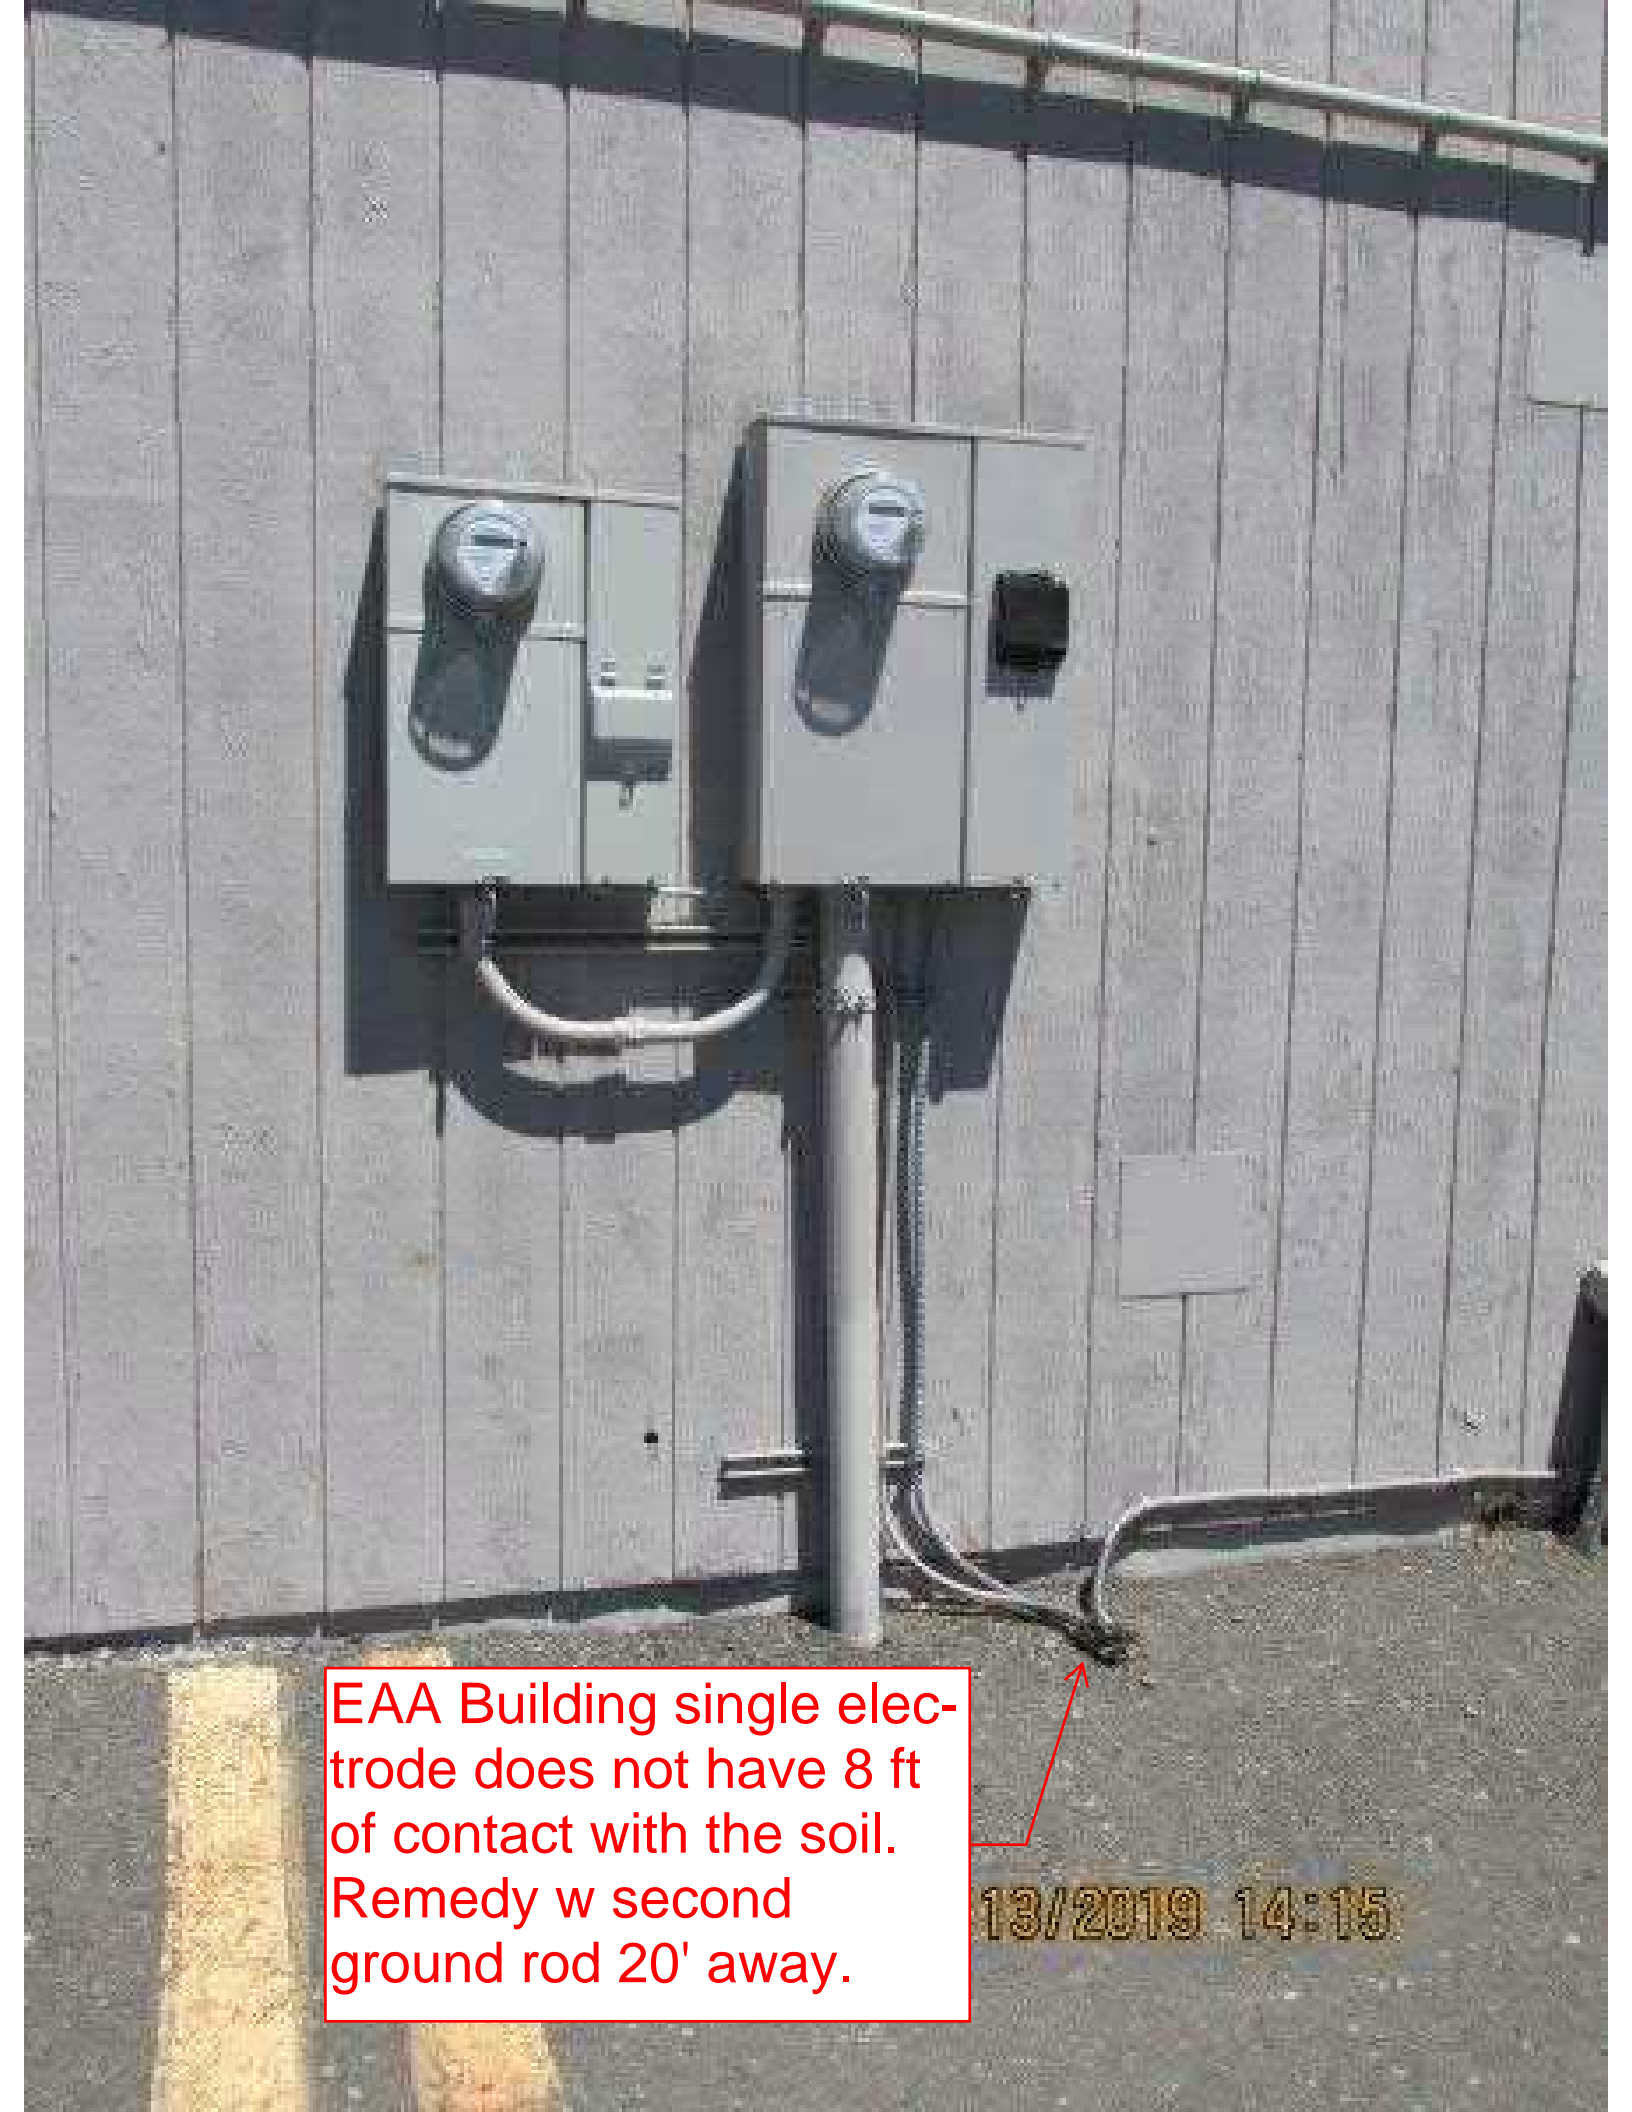
Not supported/fas-
tened to structure

EAA Building single electrode does not have 8 ft of contact with the soil. Remedy w second ground rod 20' away.

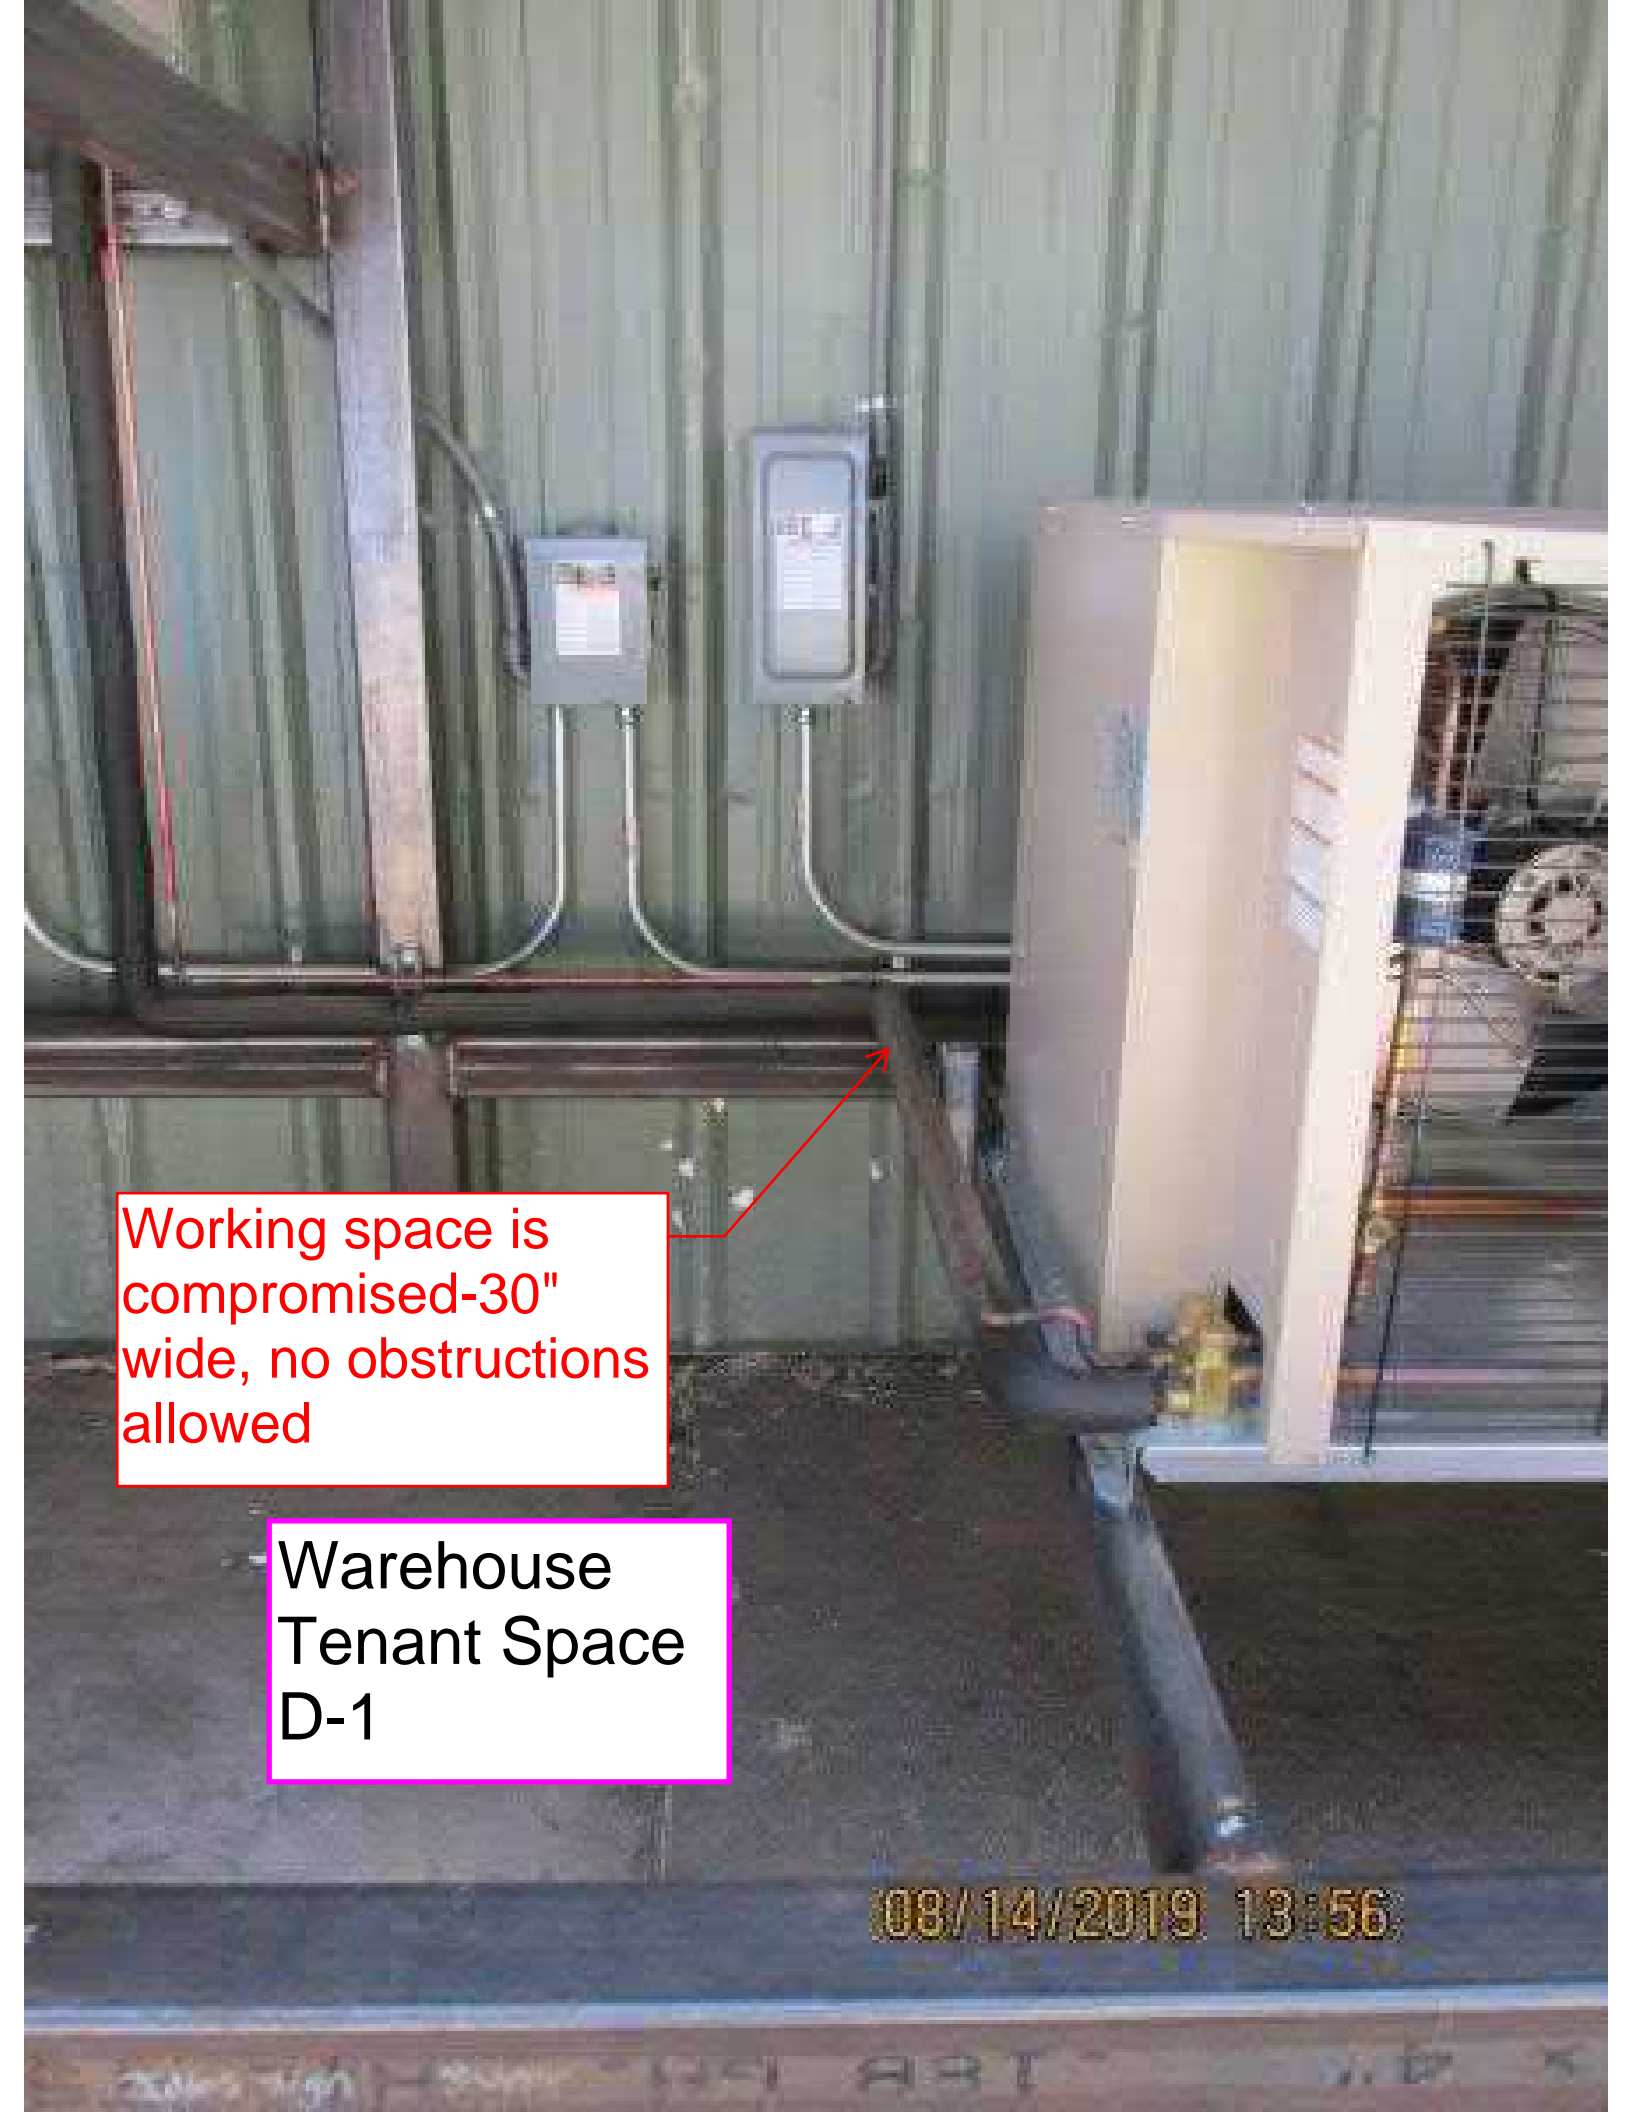
Working space is compromised-30" wide, no obstructions allowed

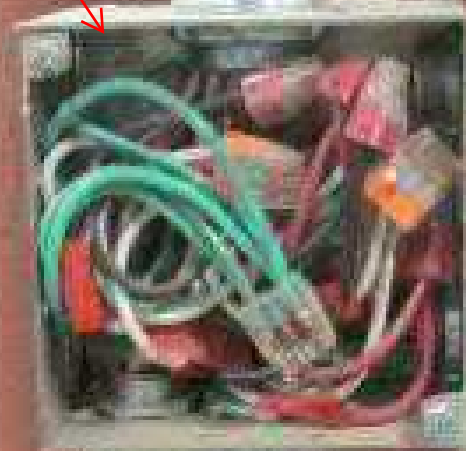
Warehouse
Tenant Space
E-3

Box is overfilled -
larger box required.

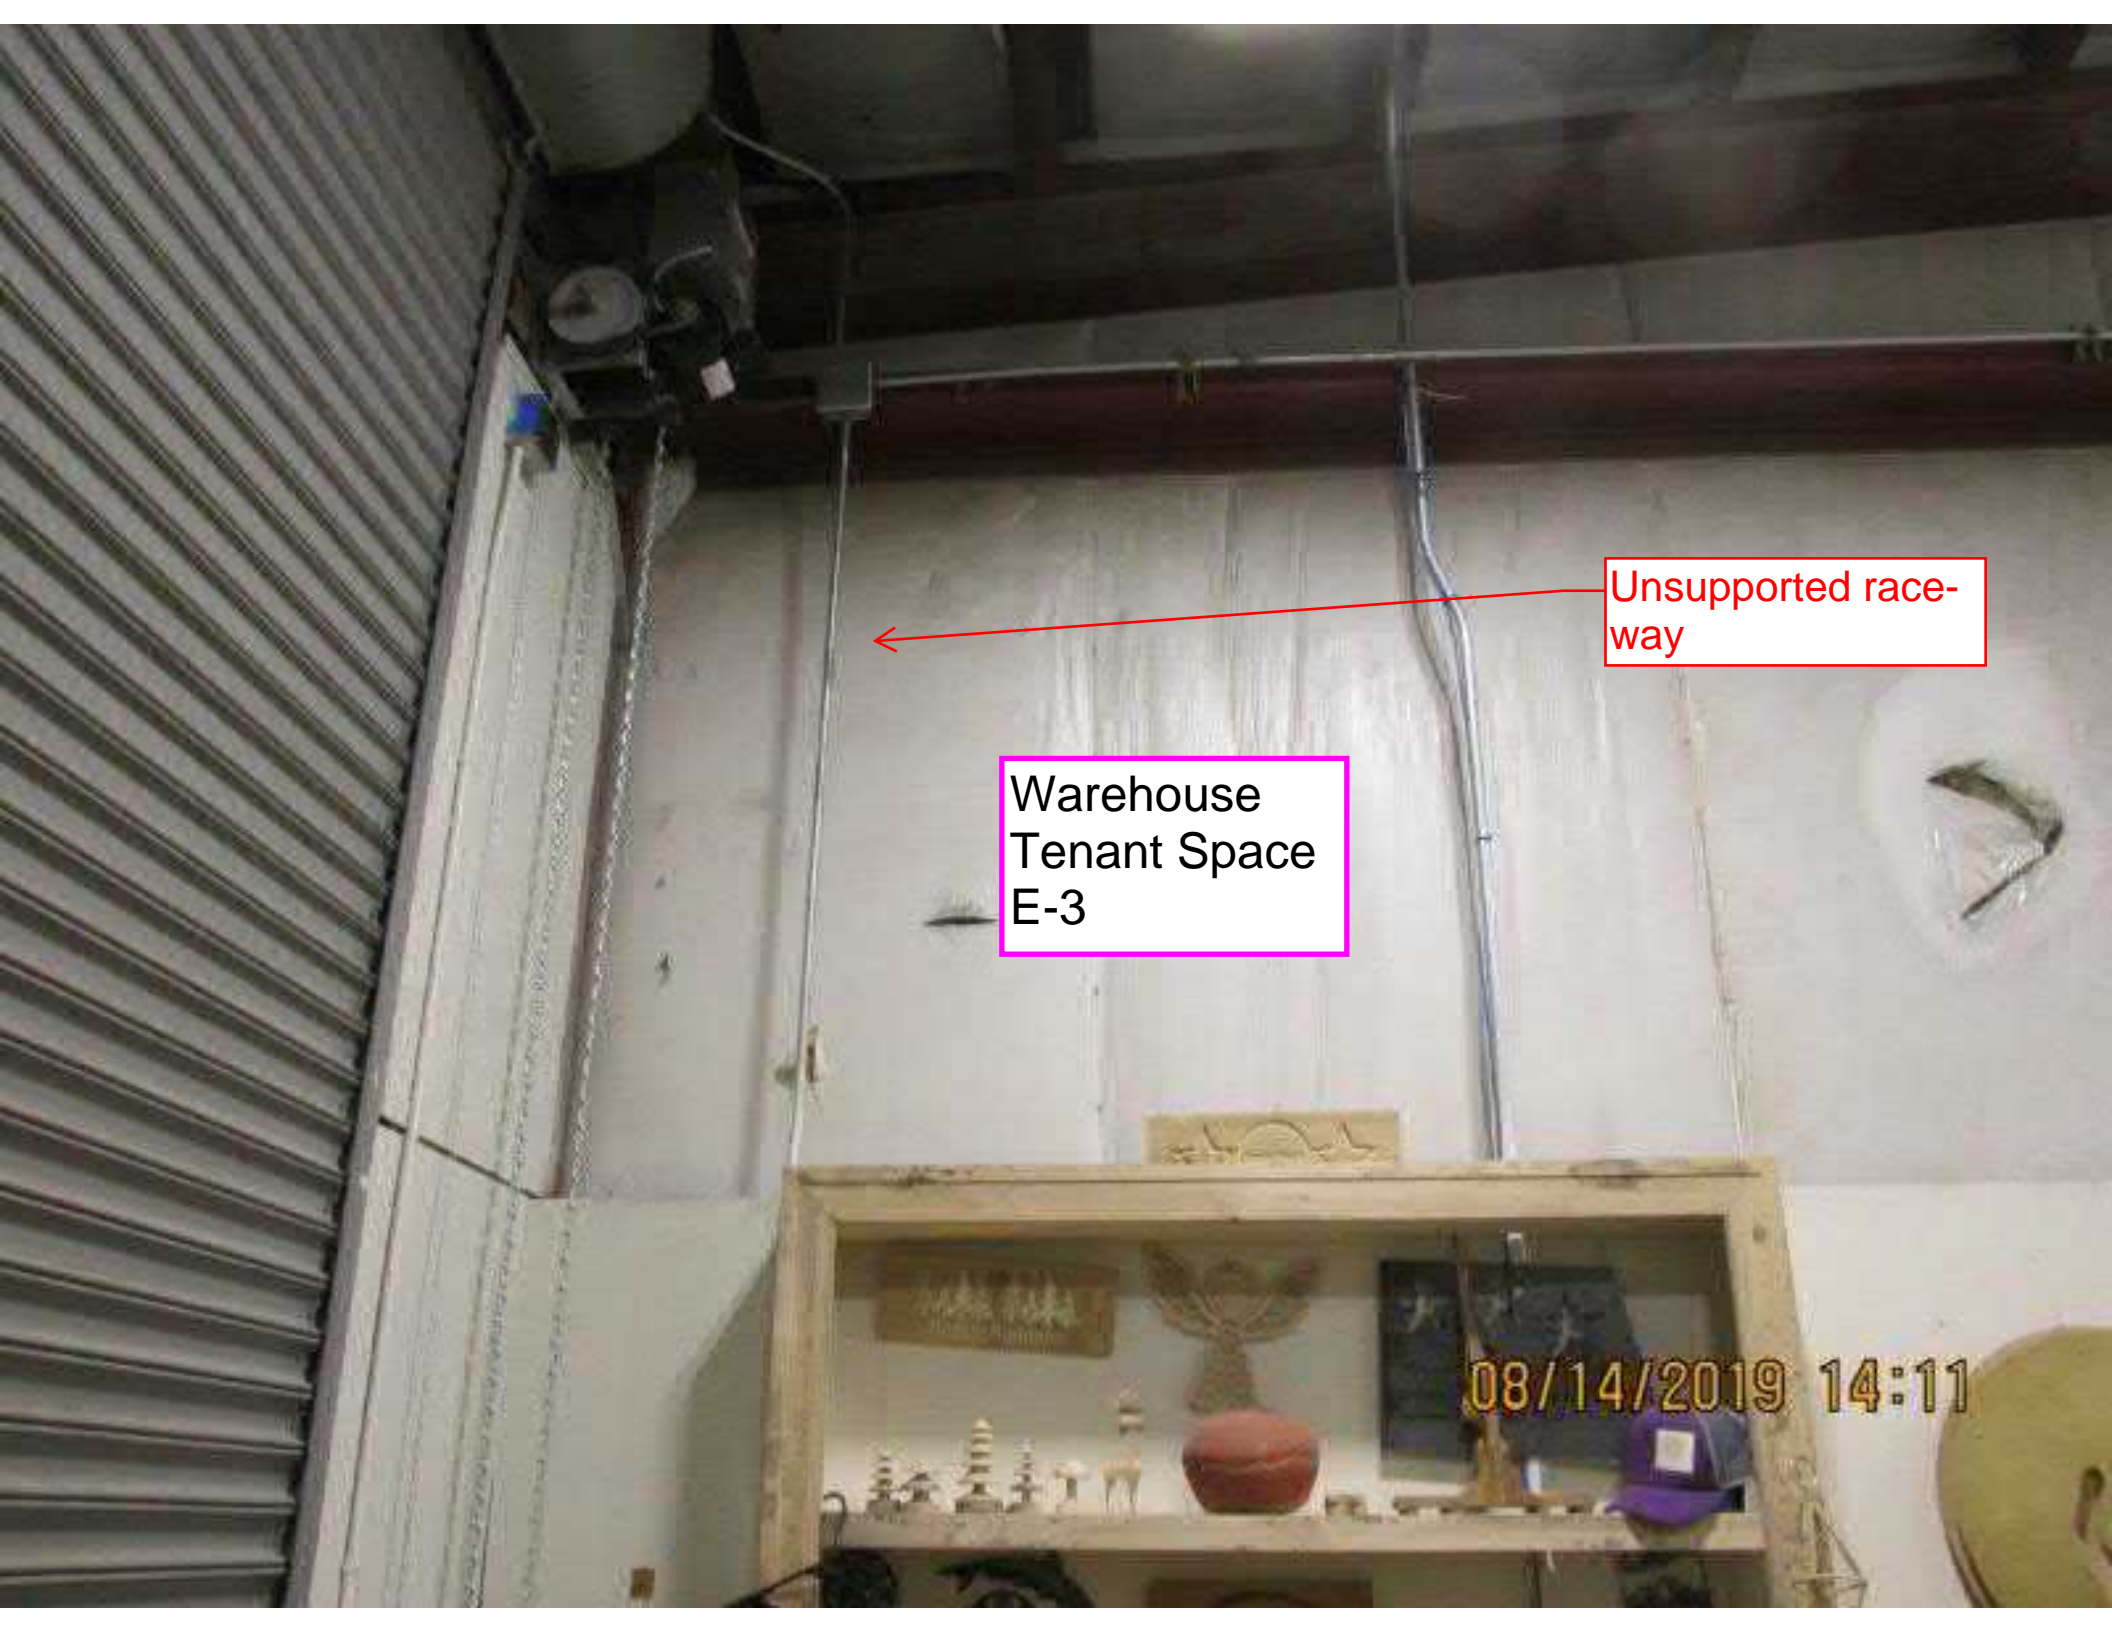
Warehouse
Tenant Space
E-3

Cord pendants for fixtures required a receptacle directly above fixture. Cord may not be fixed to the building surface or structure.

Unsupported raceway

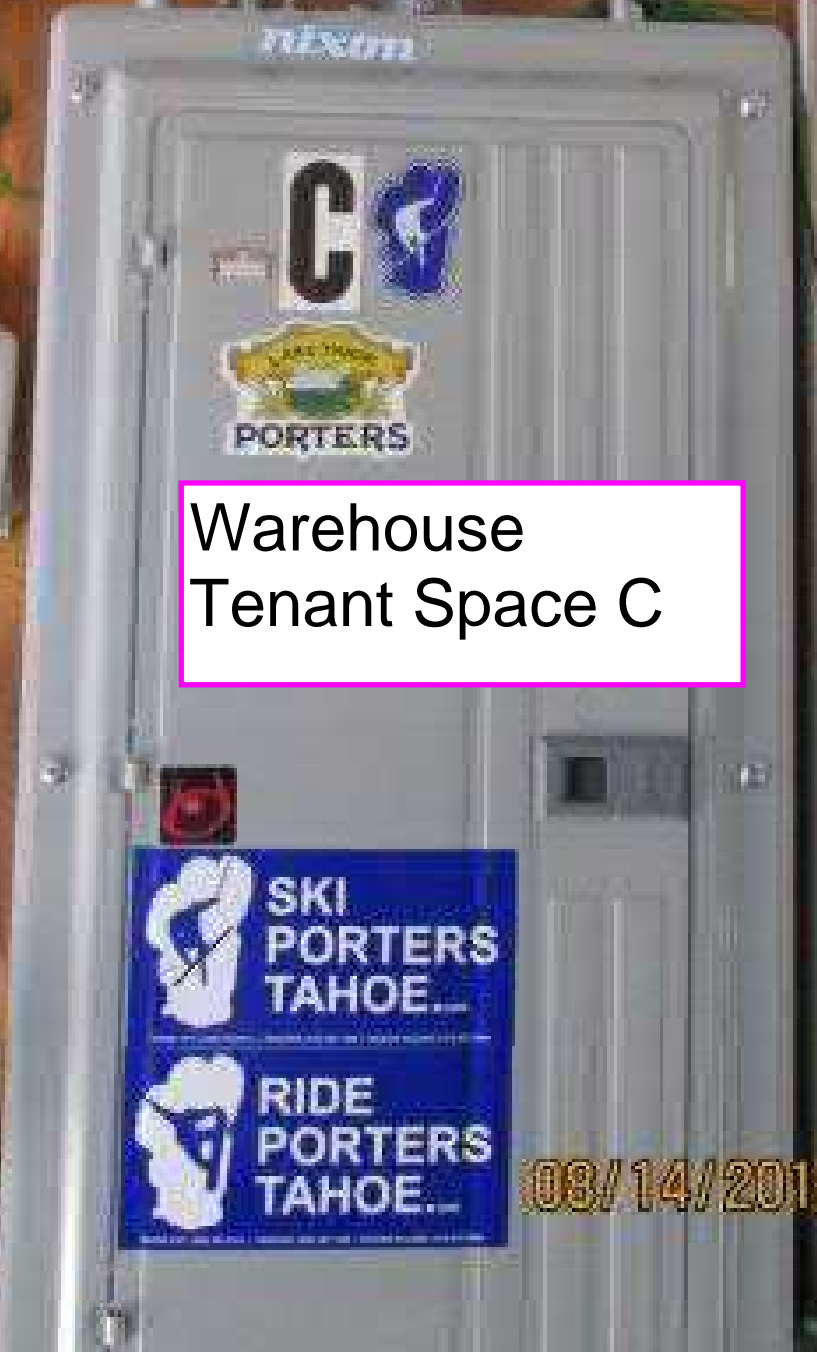
Warehouse
Tenant Space C

Cables not supported

This breaker not listed for use in this load center

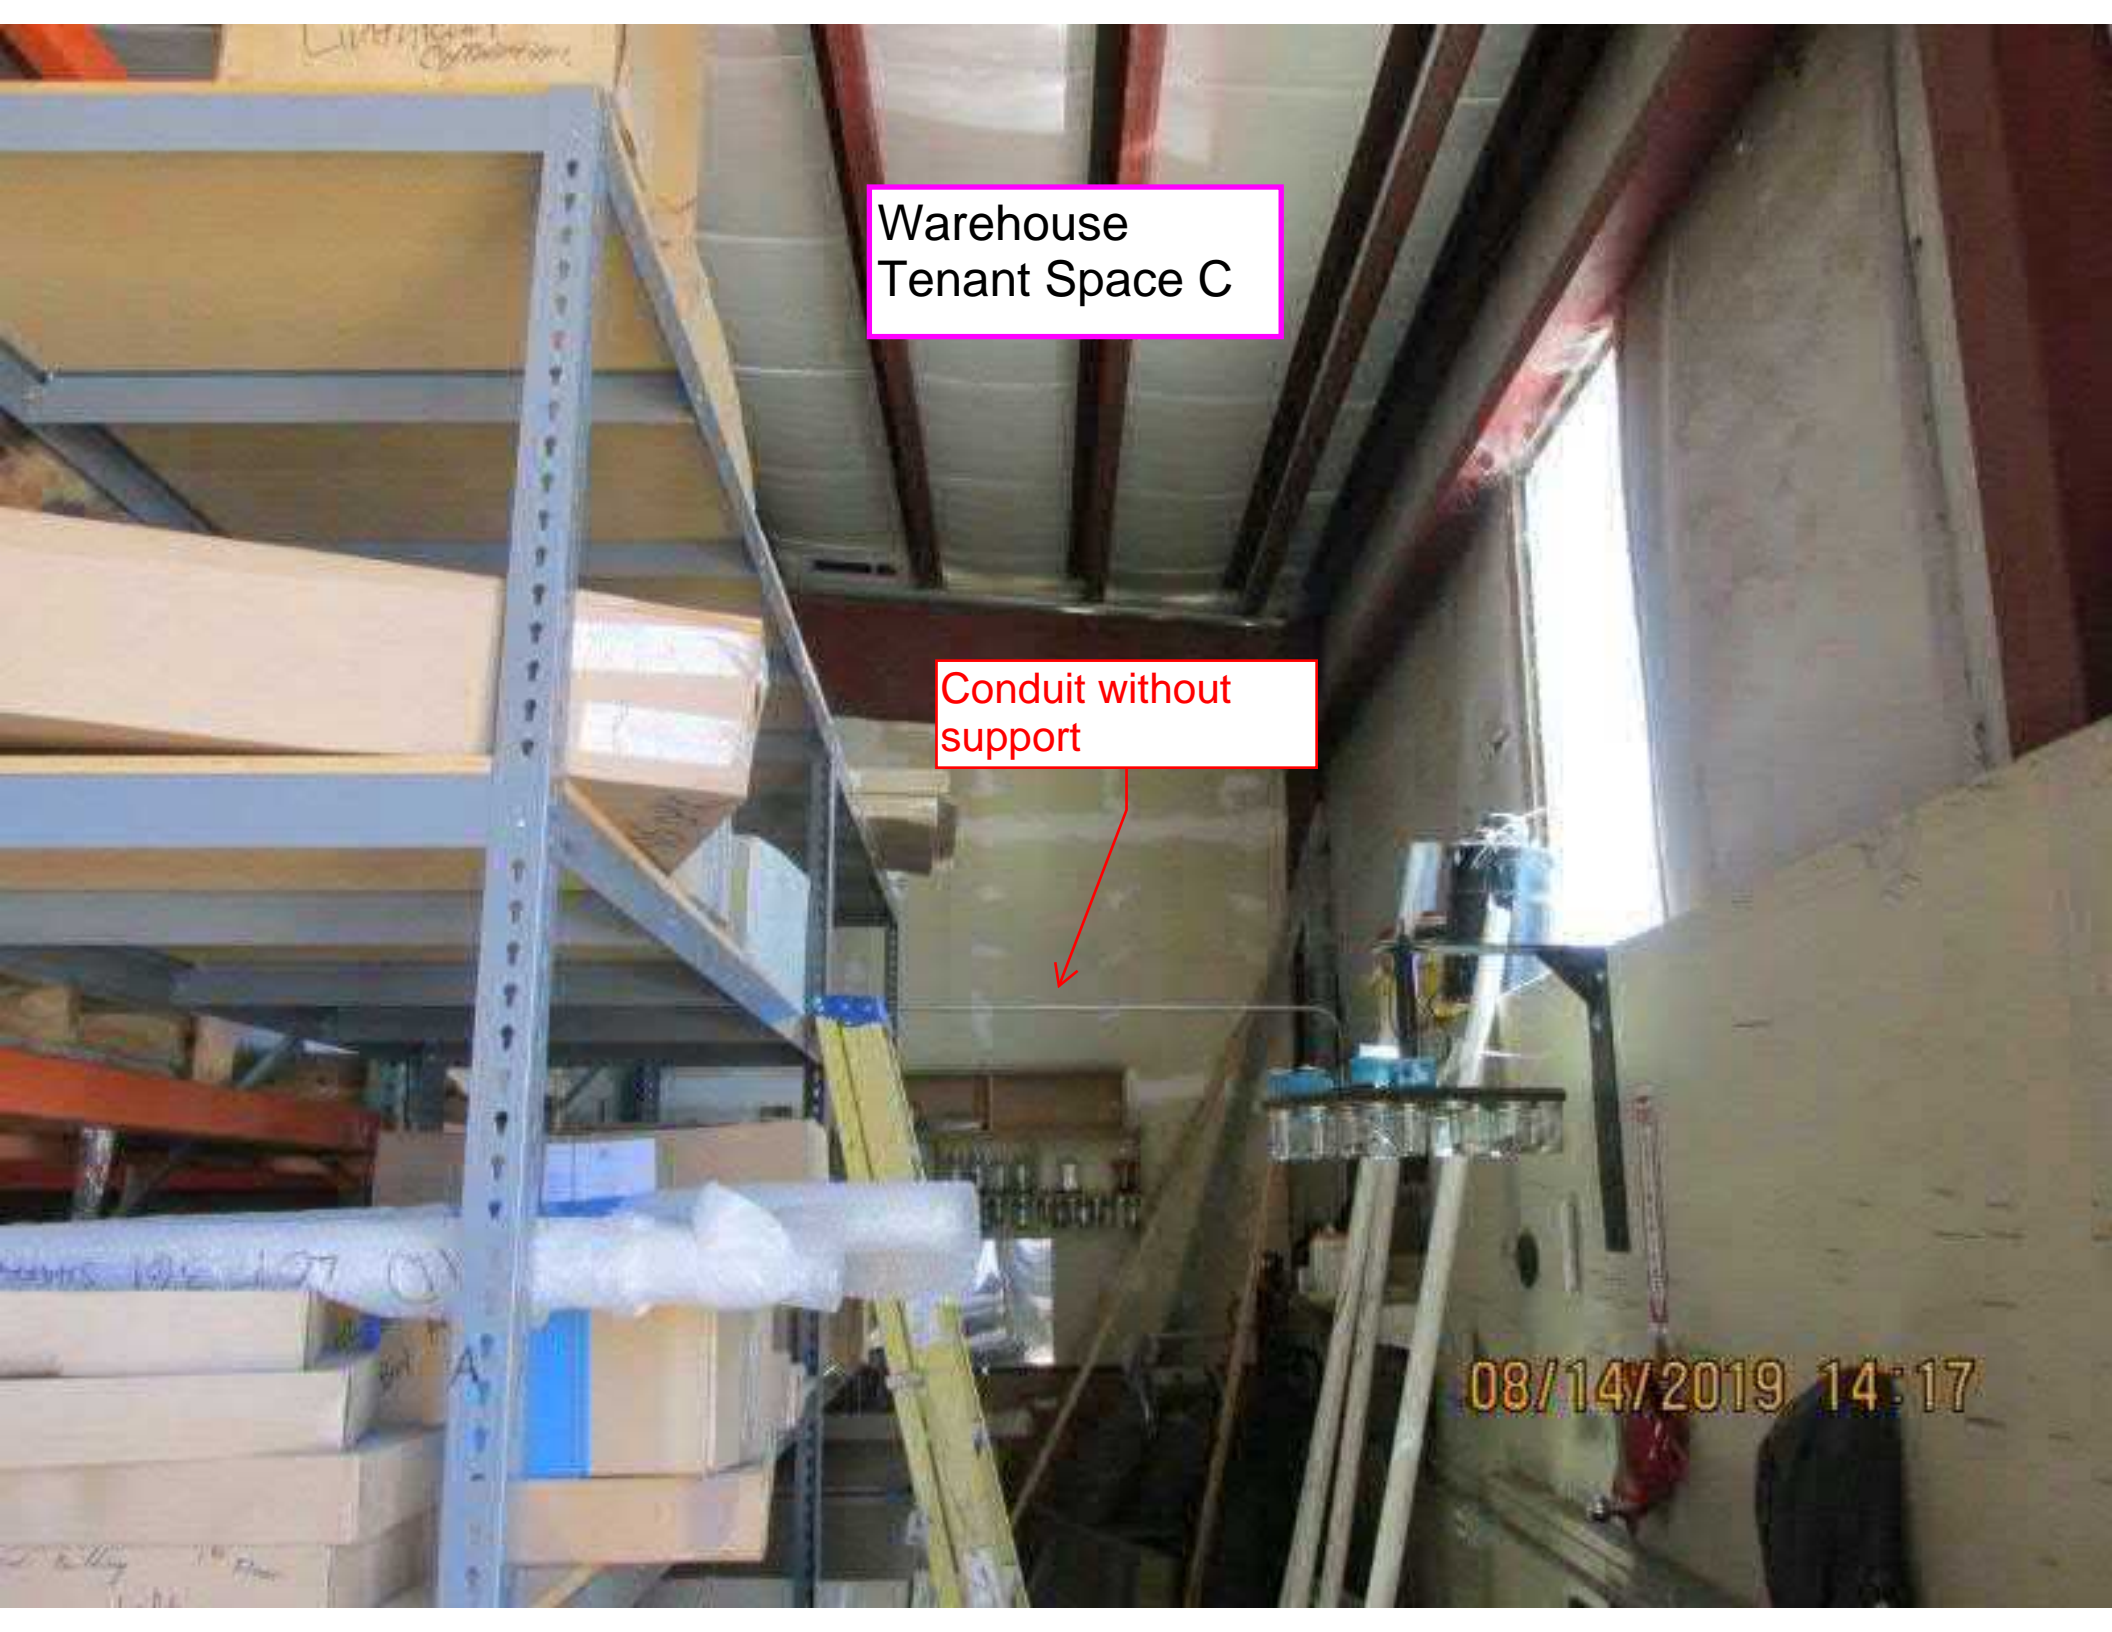
Warehouse
Tenant Space C

Conduit without
support

Raceway cover not fully on
