FACILITIES MAINTENANCE PLAN

AUERBACH
ENGINEERING CORP

**Facilities Maintenance Plan
Truckee Tahoe Airport District
October 2020 - FINAL**

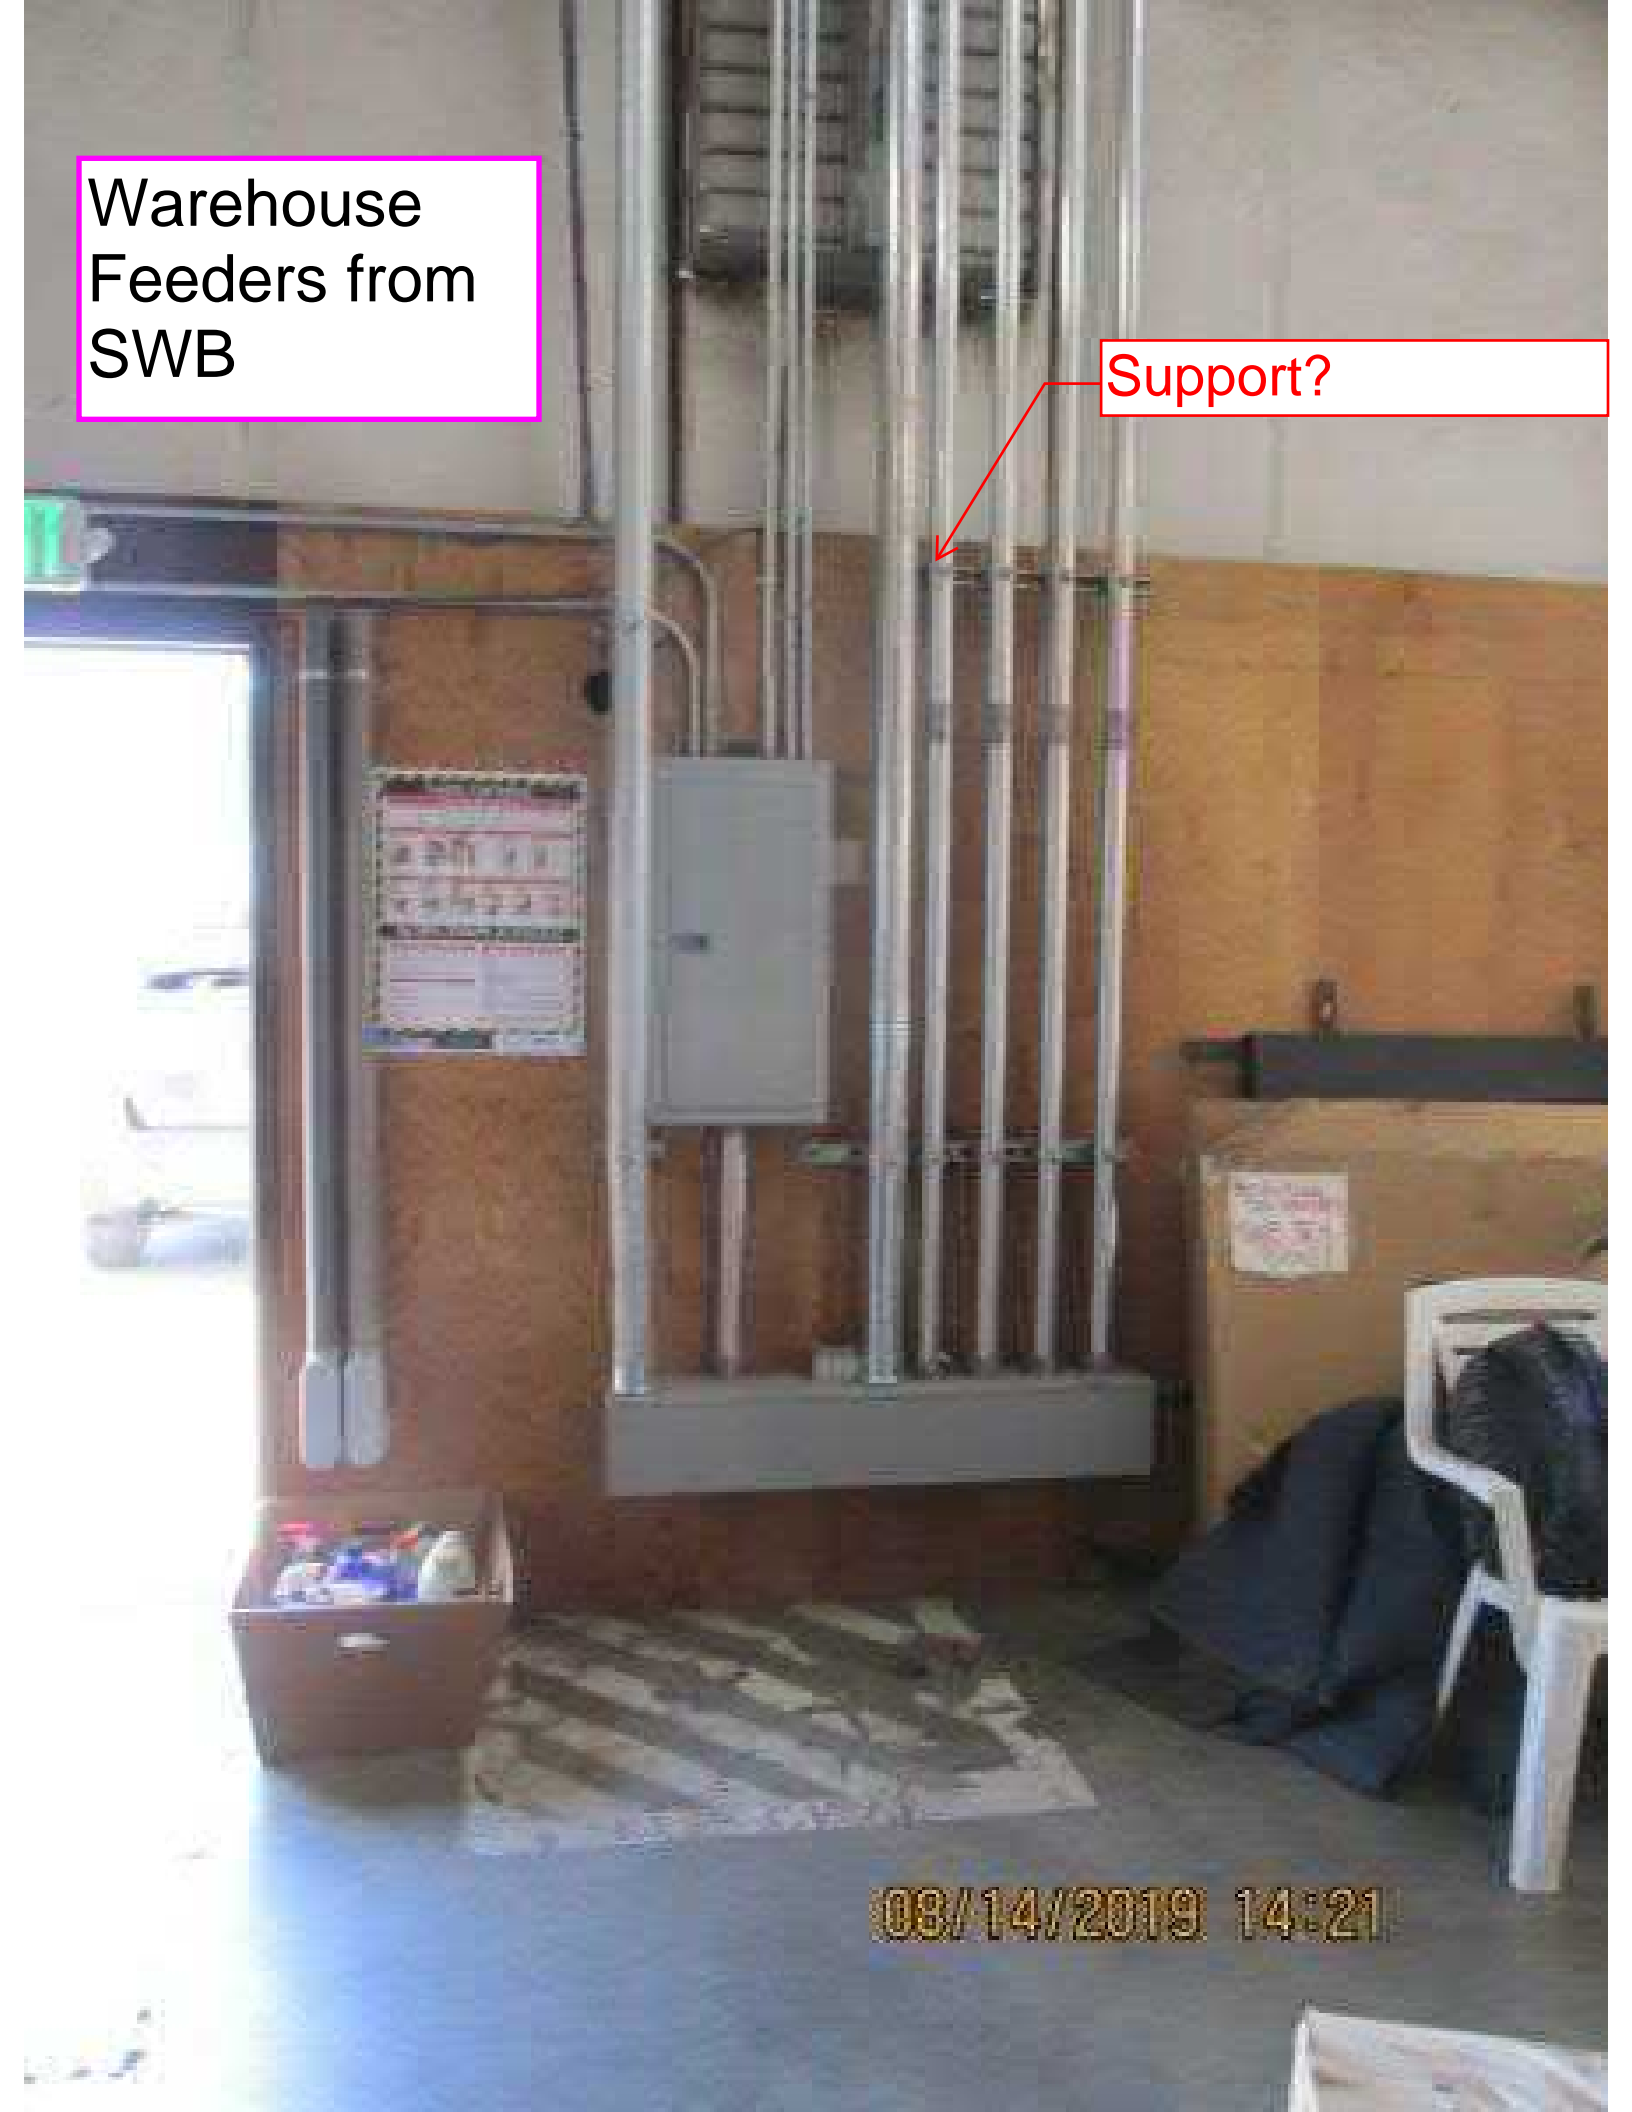
Support?

Equipment ground
not identified

This is pipe, not
conduit, and it does
not have an insu-
lated throat

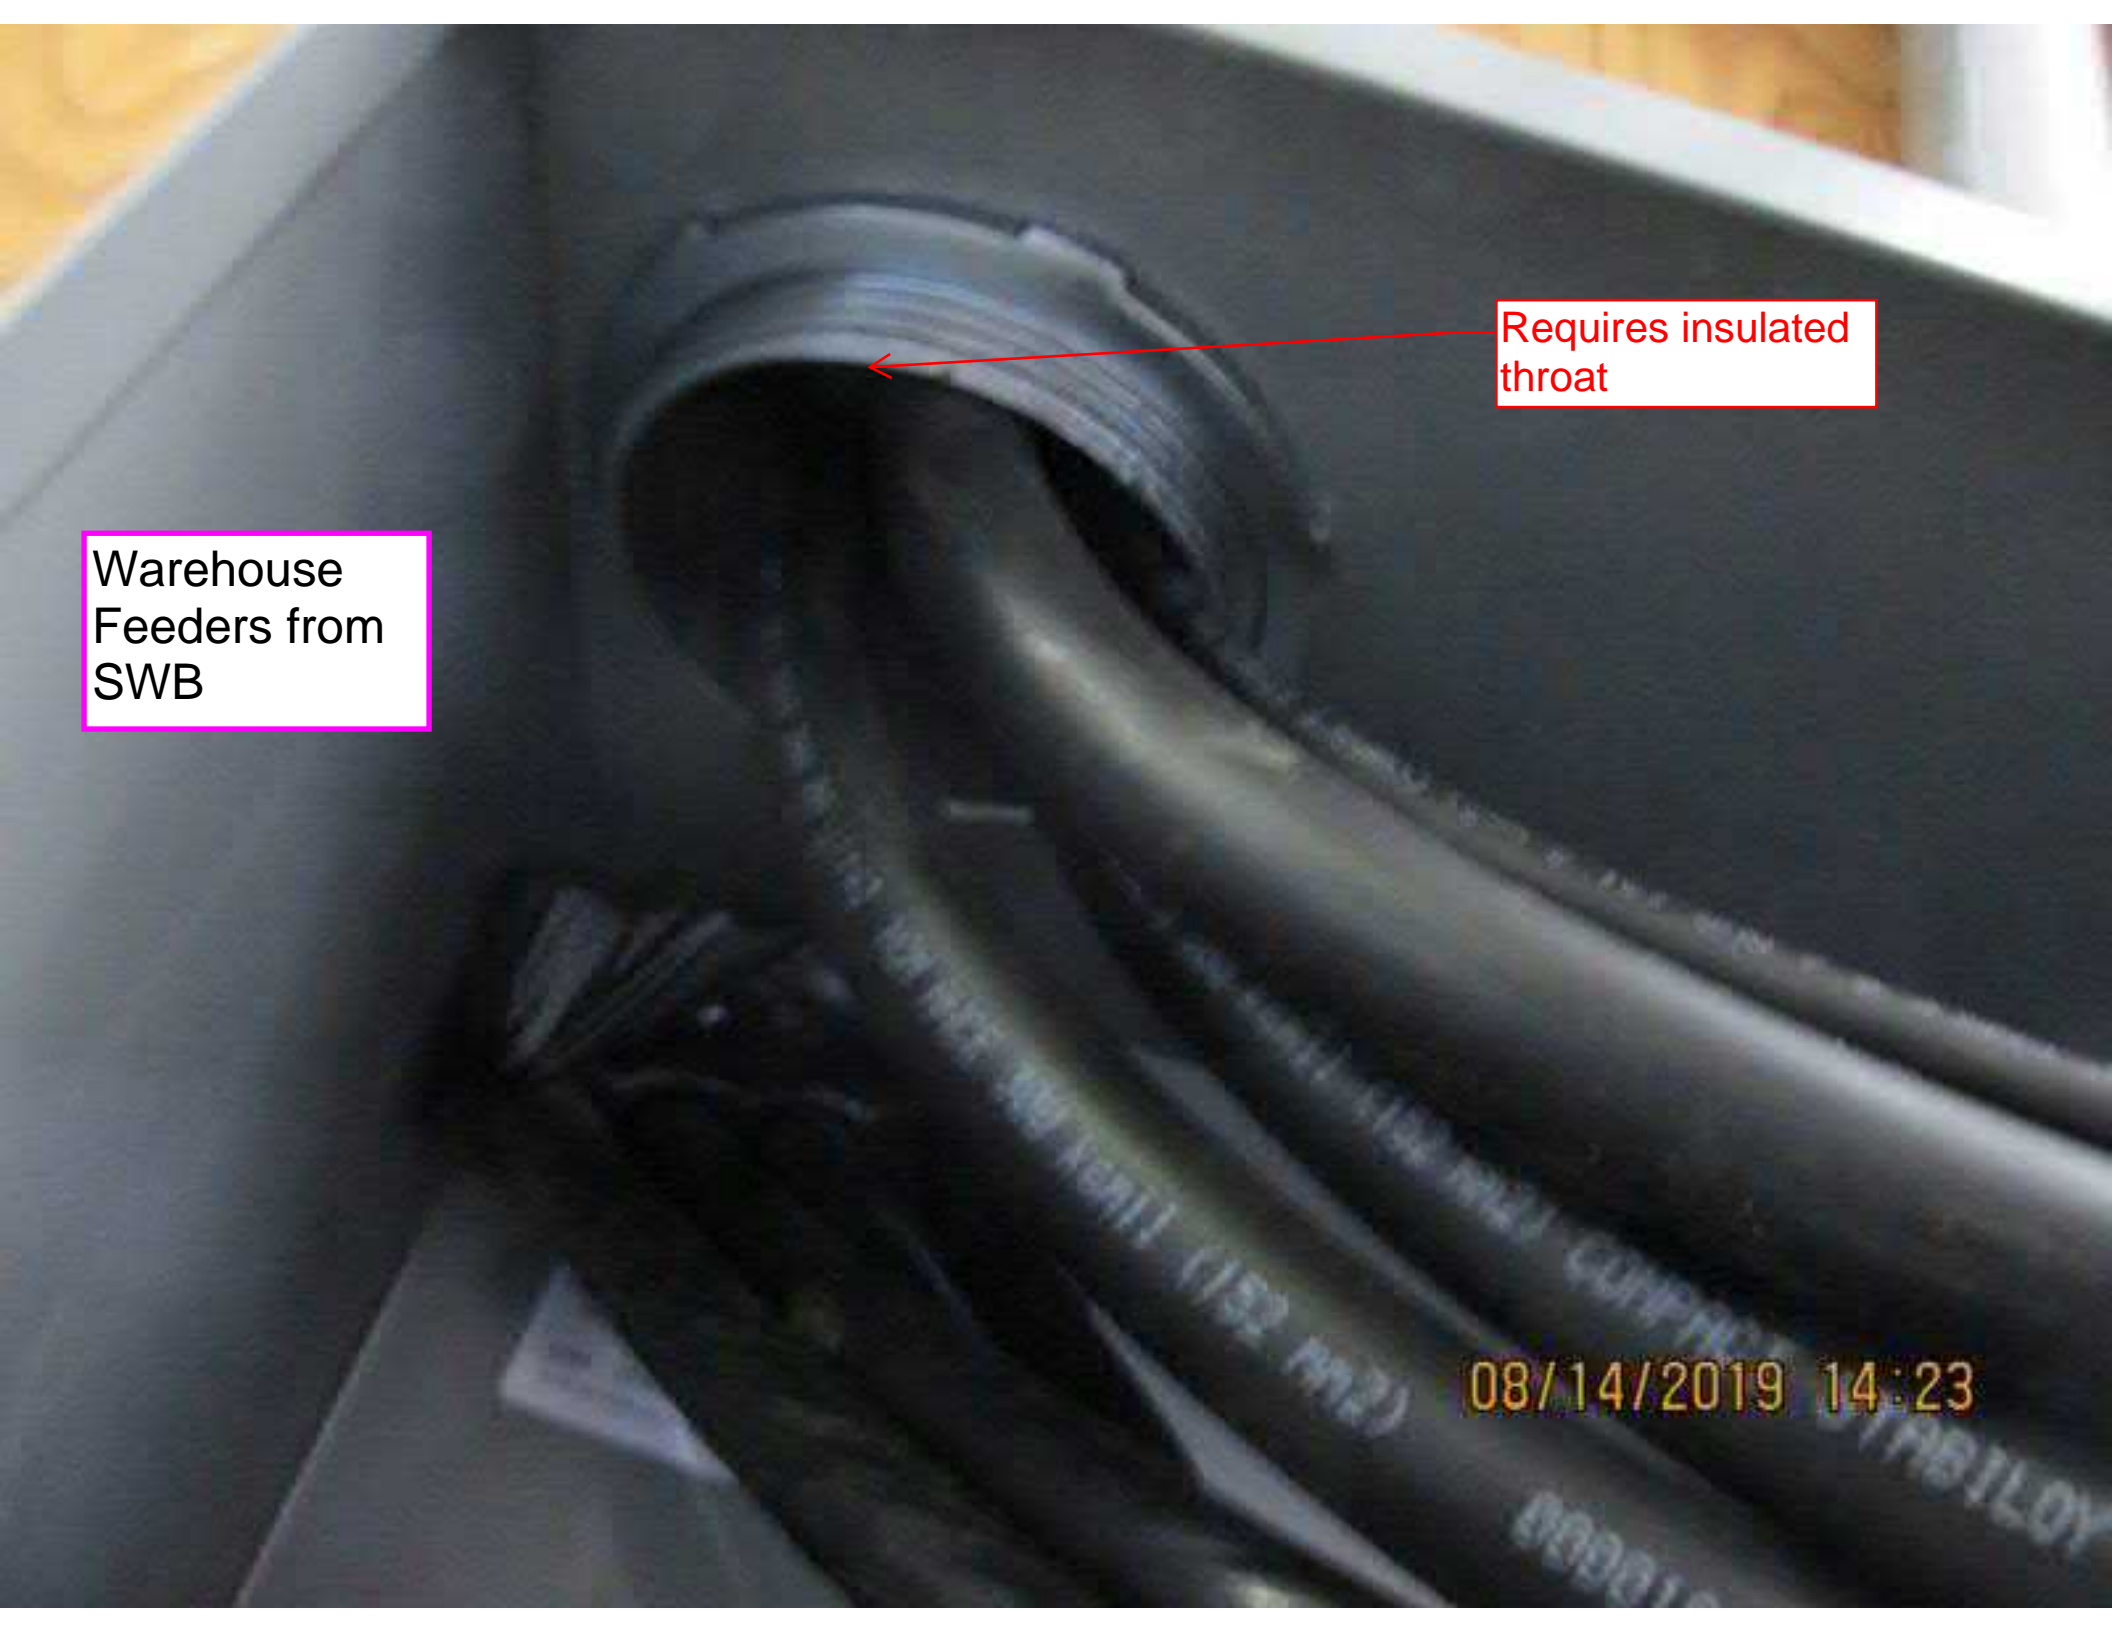
Requires insulated
throat

This is an insulated throat fitting

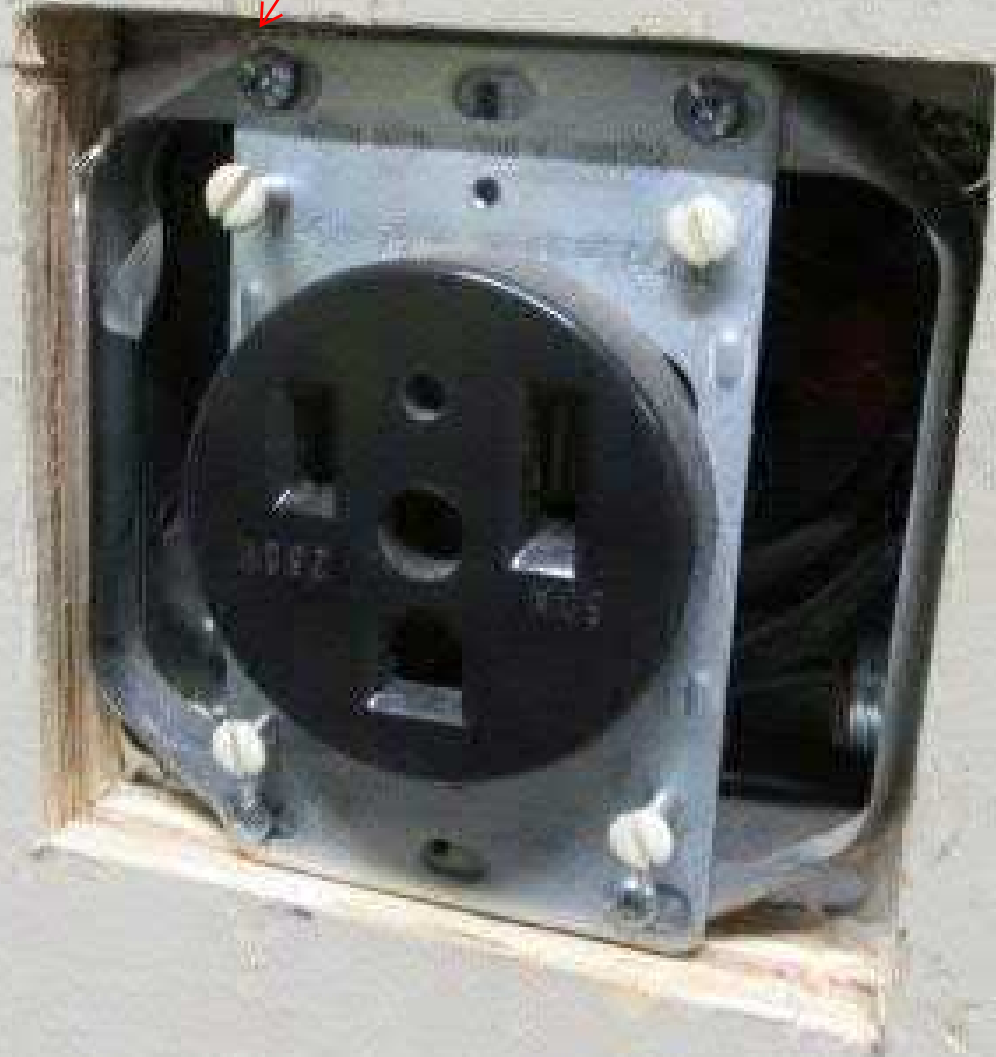
MBA

Outlet ring must be flush with a combustible surface

Outlet required to be directly above the fixture

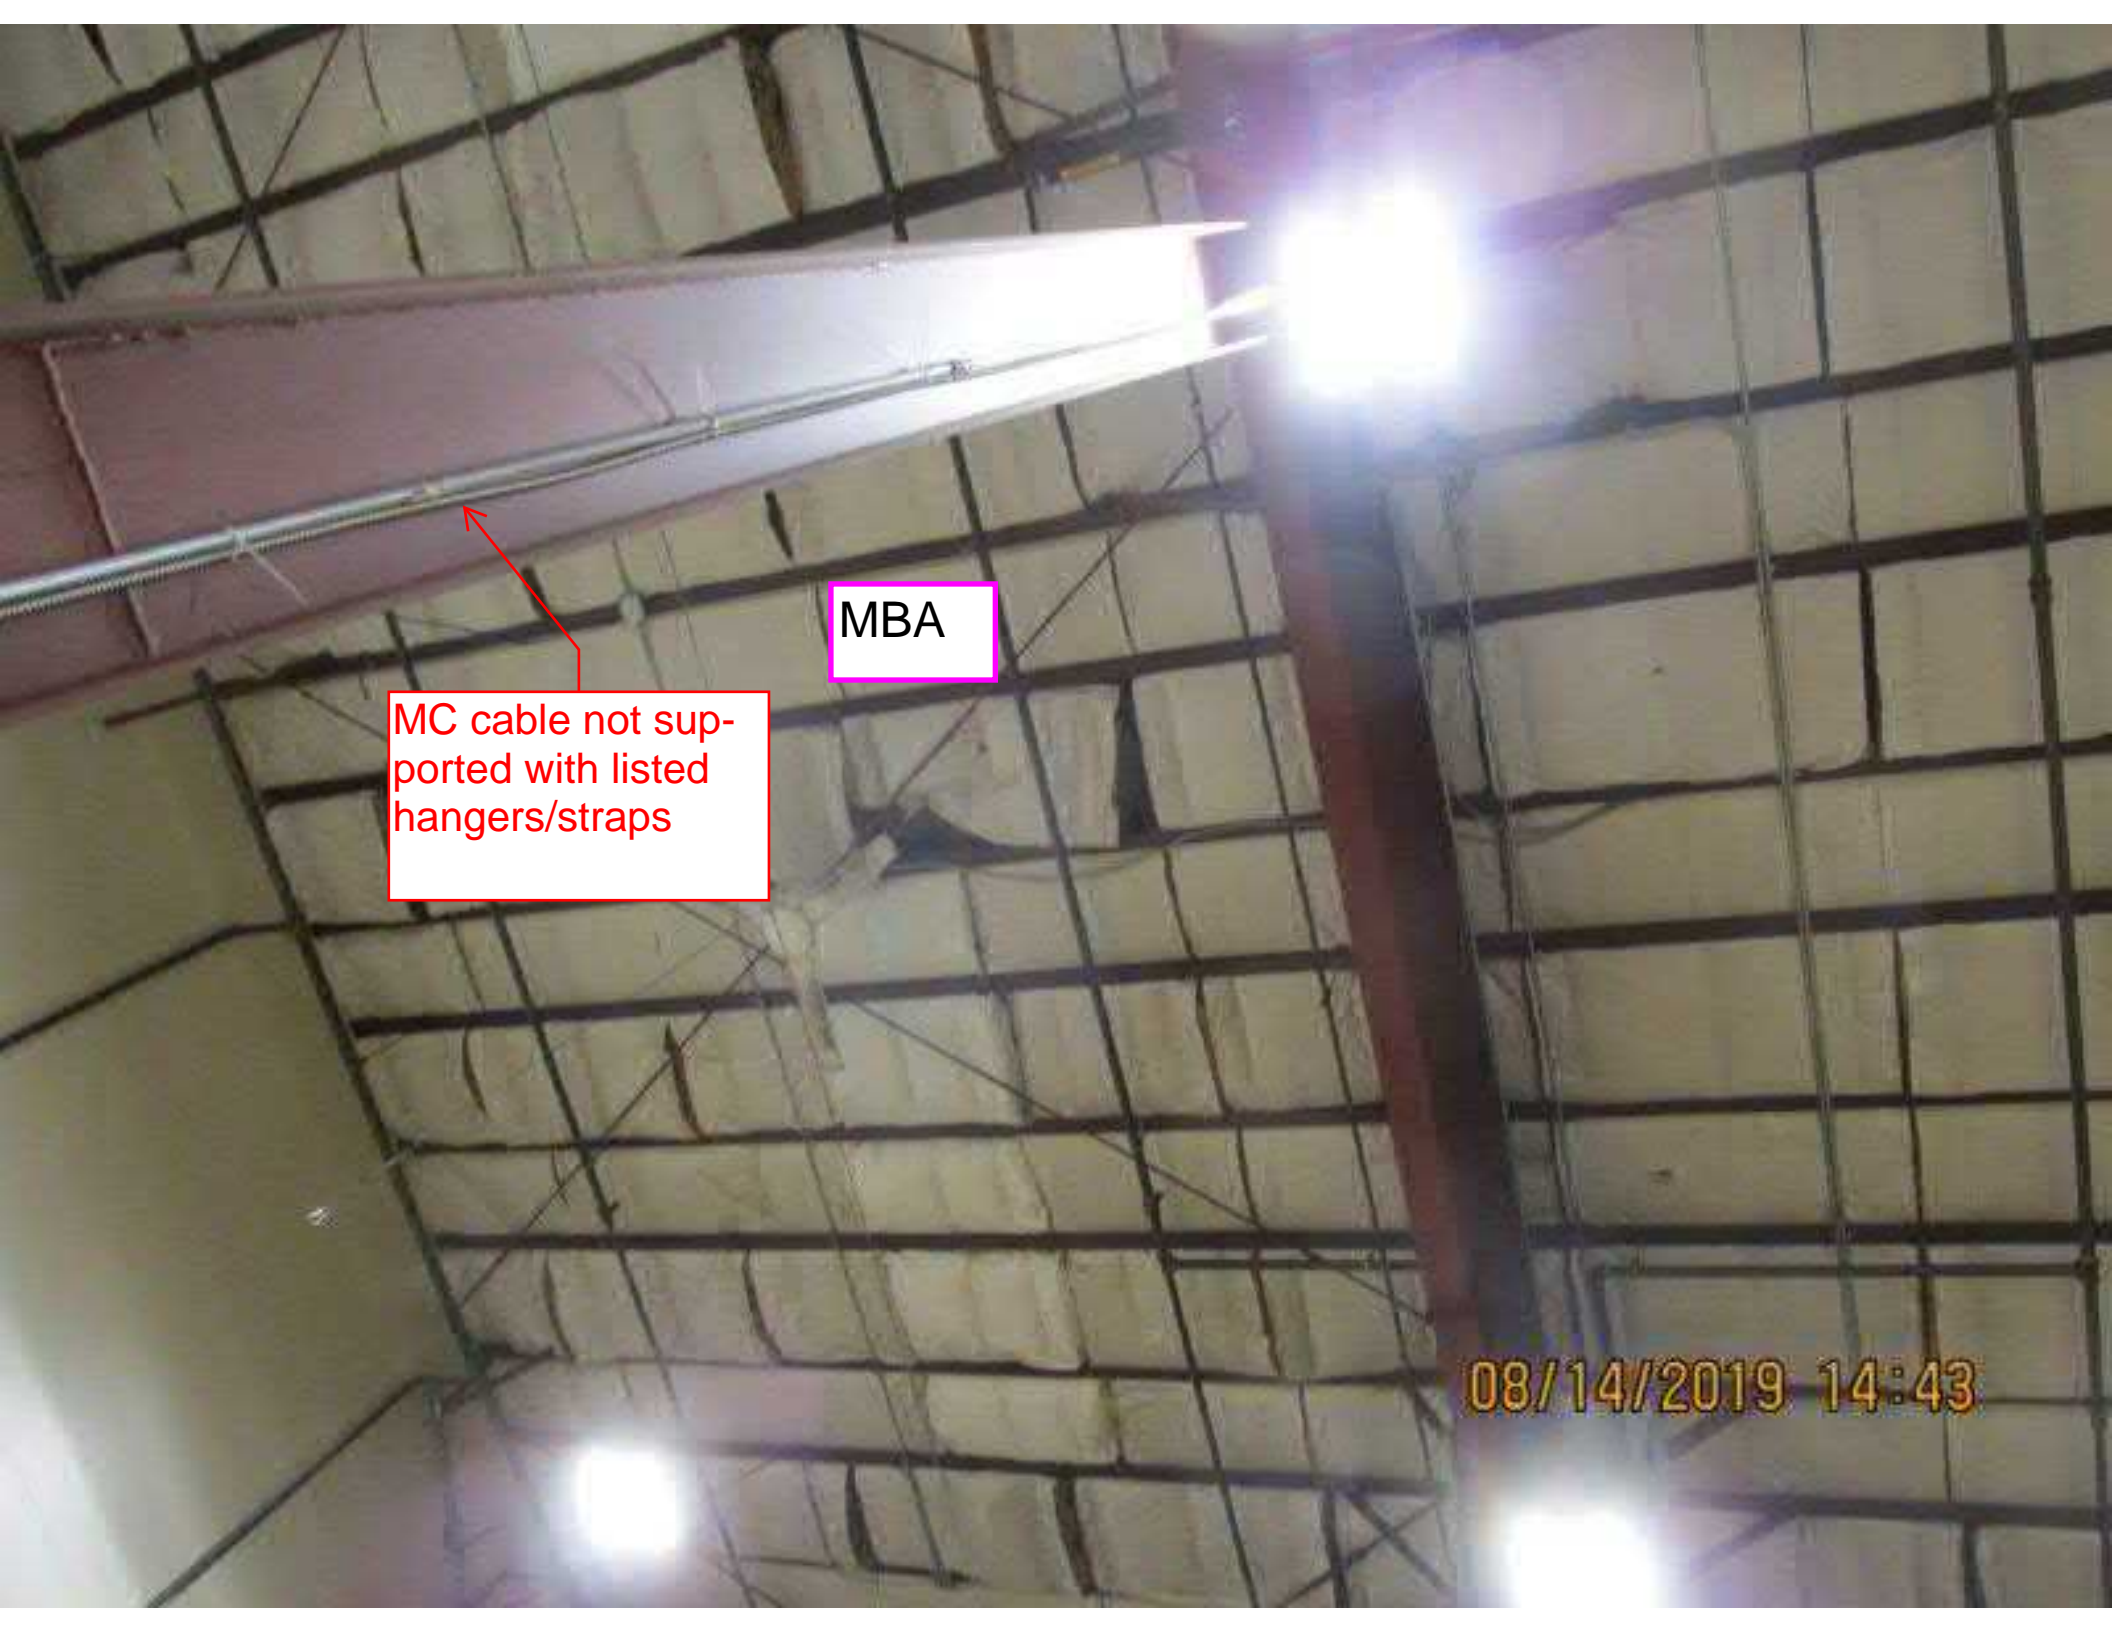
MBA

MC cable not supported with listed hangers/straps

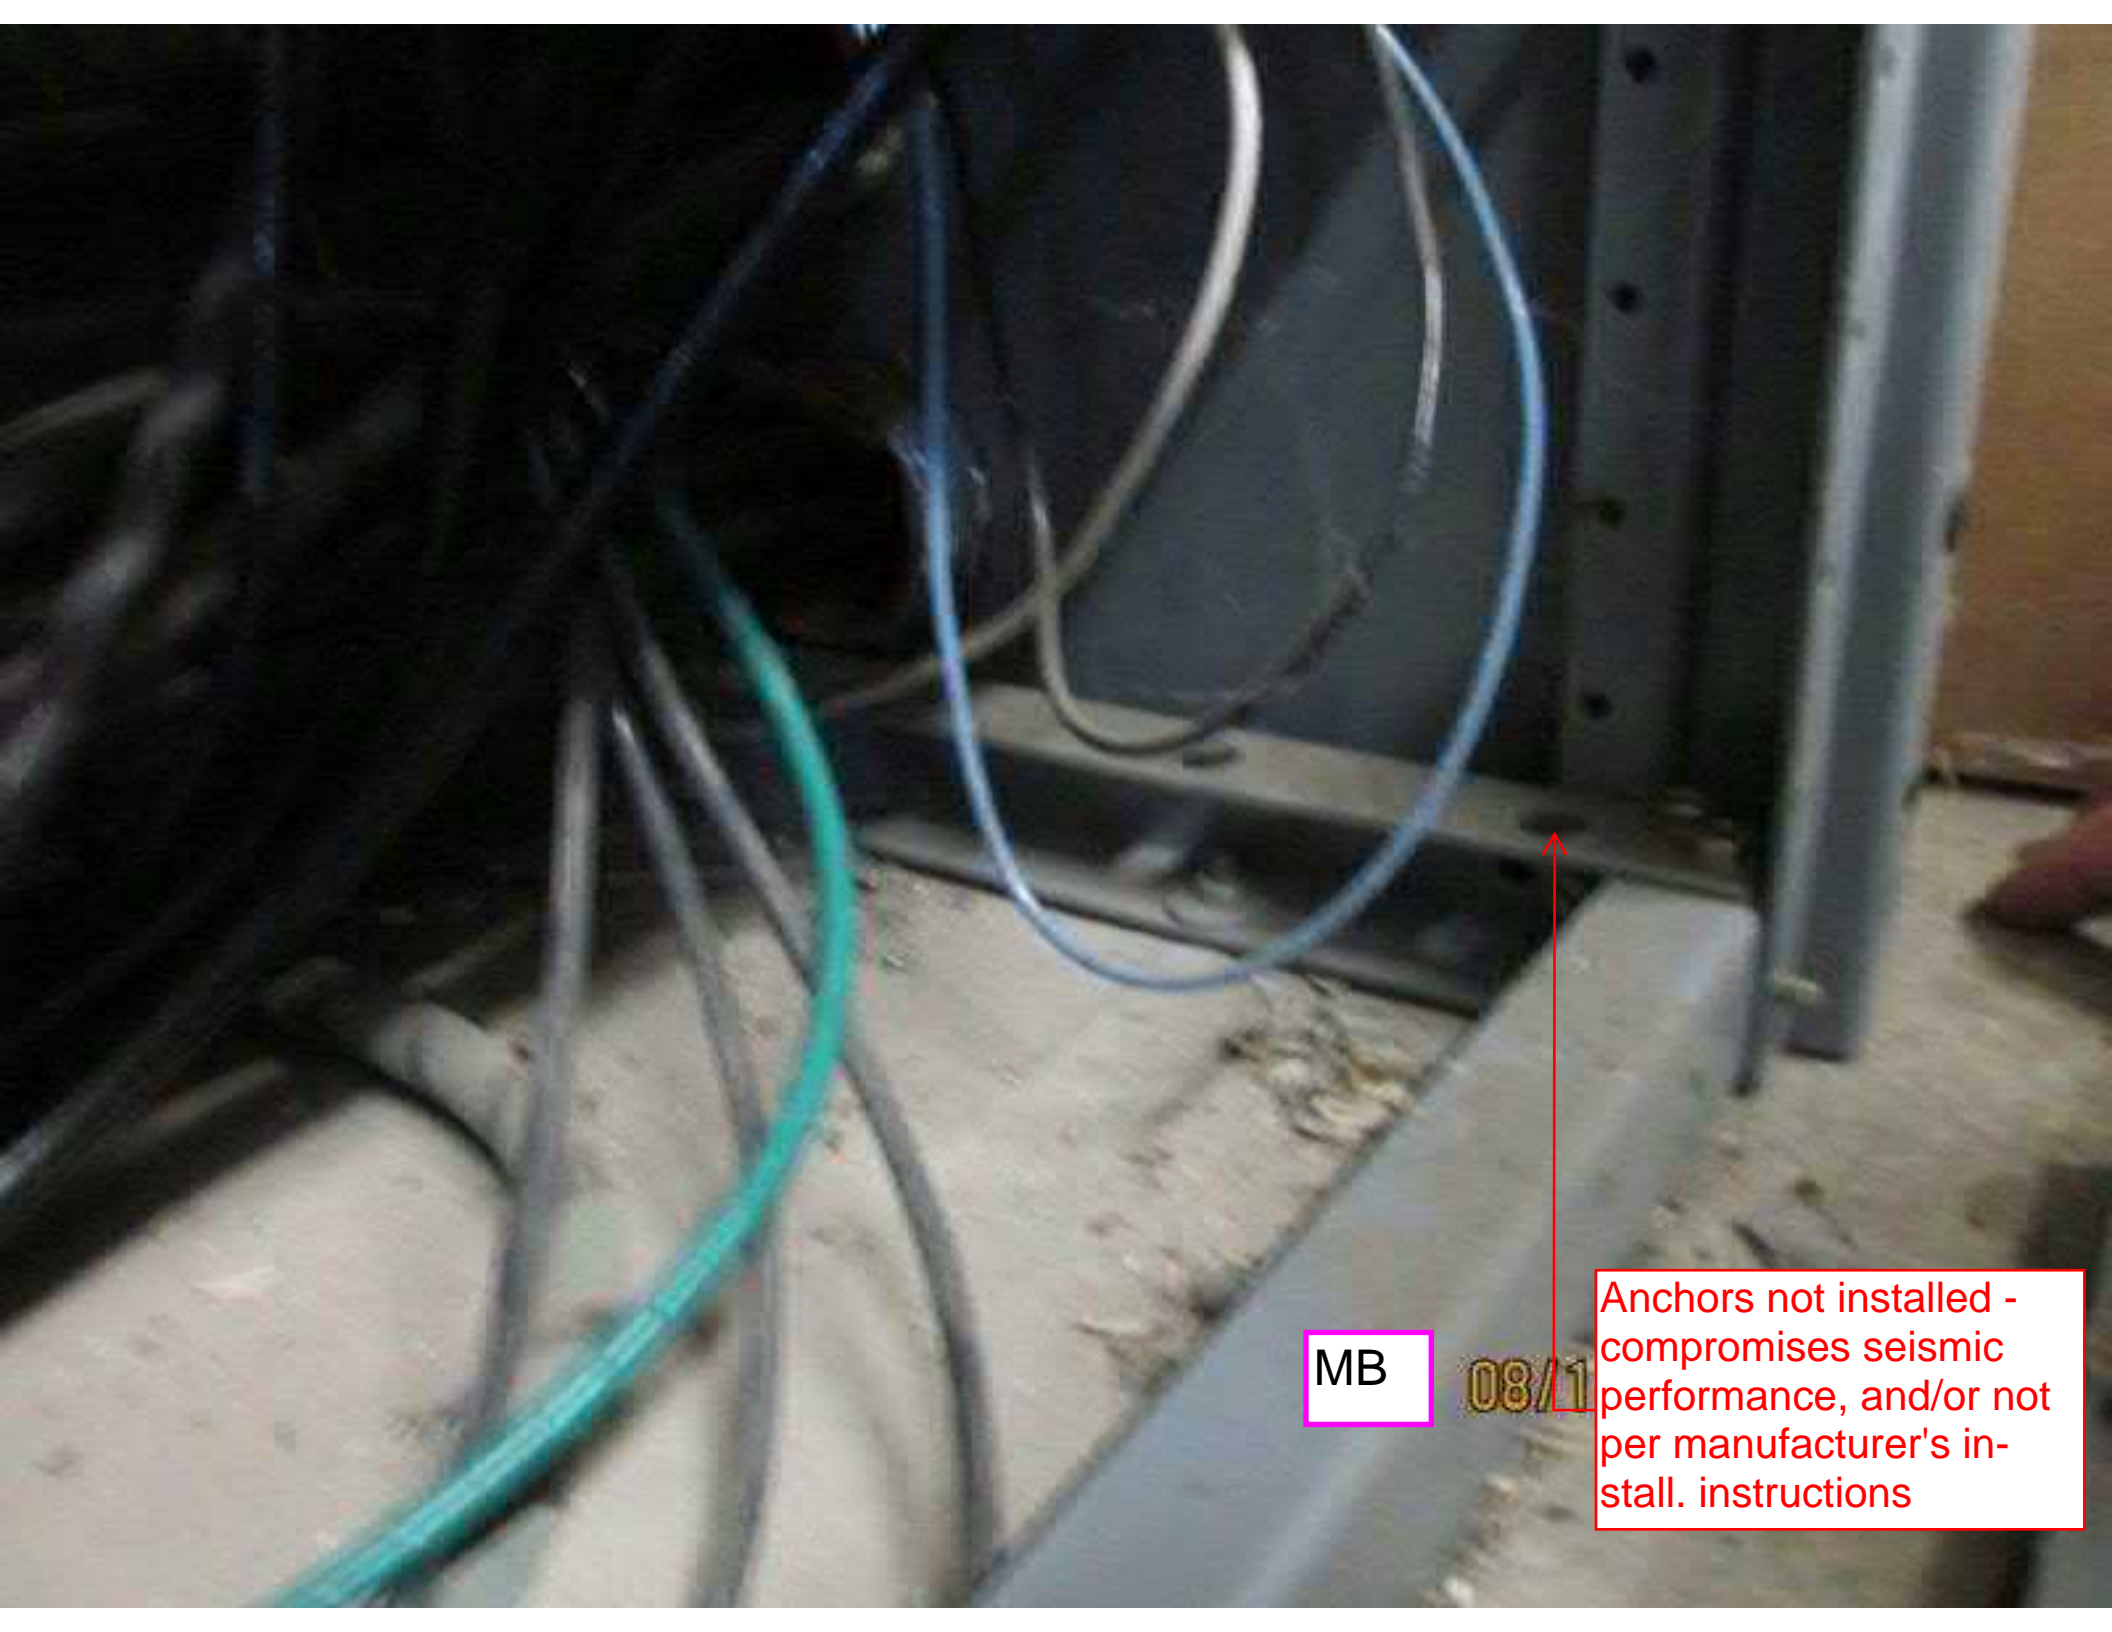
MB

Paint not removed beneath ground terminal

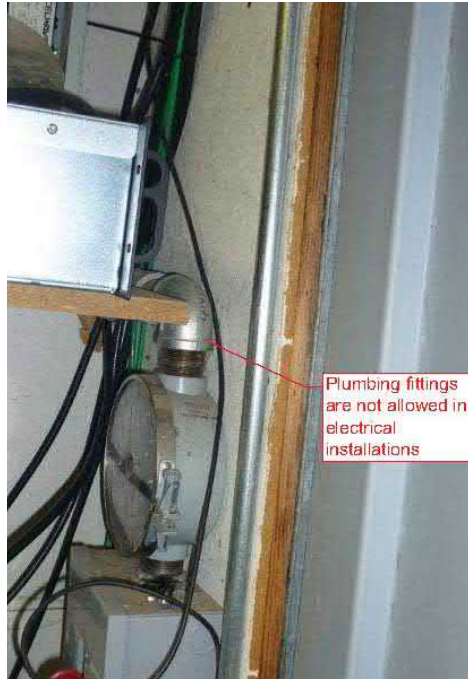
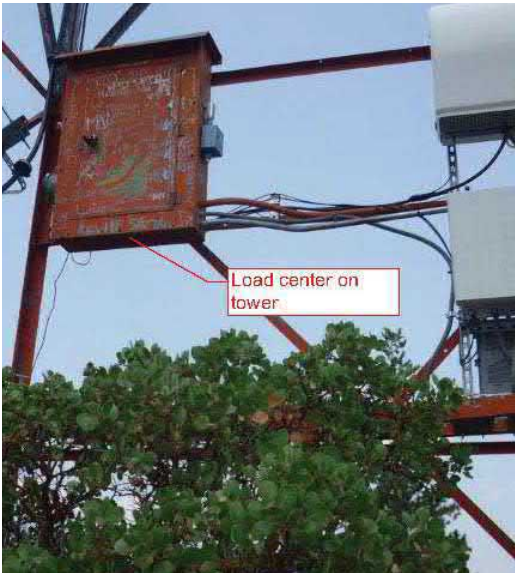
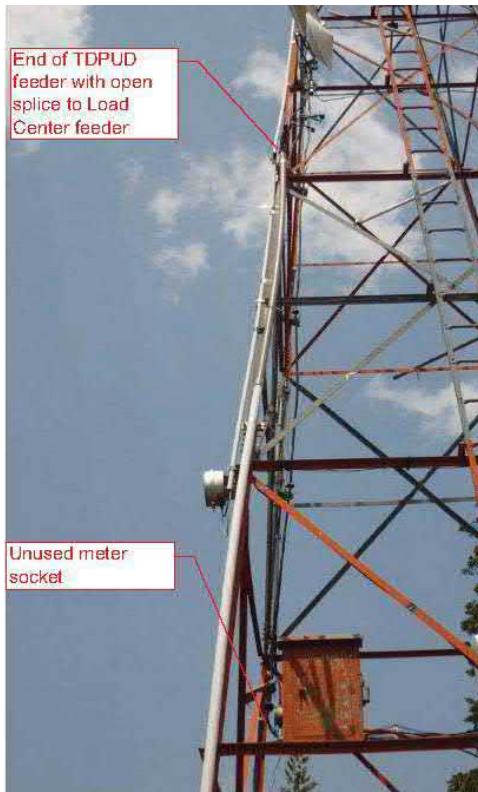
There are many NEC compliance issues that require work to make the beacon sites safe for maintenance employees. Specifics: 1. There are equipment locations that do not meet the working space requirements required by the NEC and OSHA. 2. There are extremely old conductors and apparatus (load centers) still in use that should be replaced. 3. There are installations where maintenance personnel used unlisted products when reconfiguring the electrical distribution wiring - these need to be removed from the system. 4. There are many raceways without required supports. In short, the electrical systems for all three towers should be replaced.

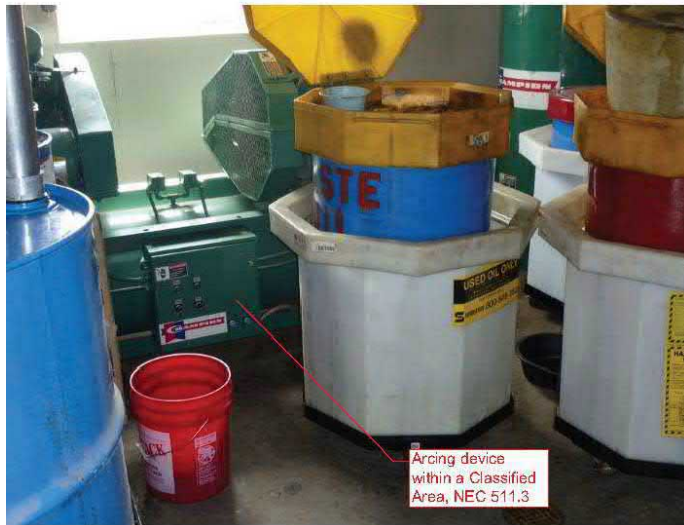
Arcing device within a Classified Area, NEC 511.3

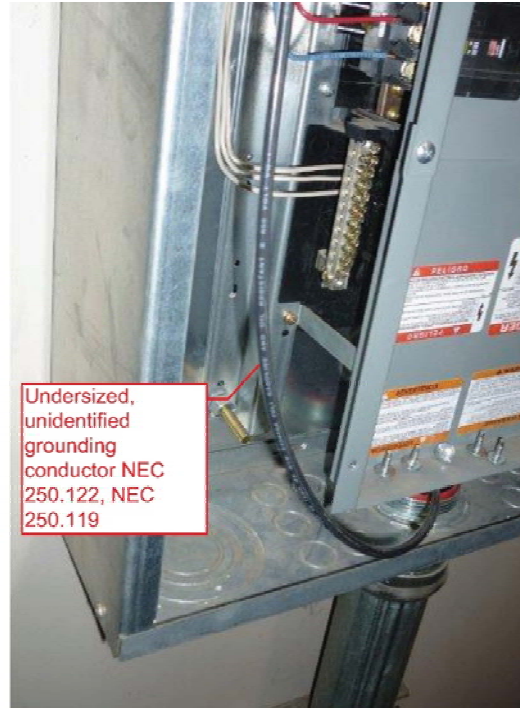
Undersized, unidentified grounding conductor NEC 250.122, NEC 250.119

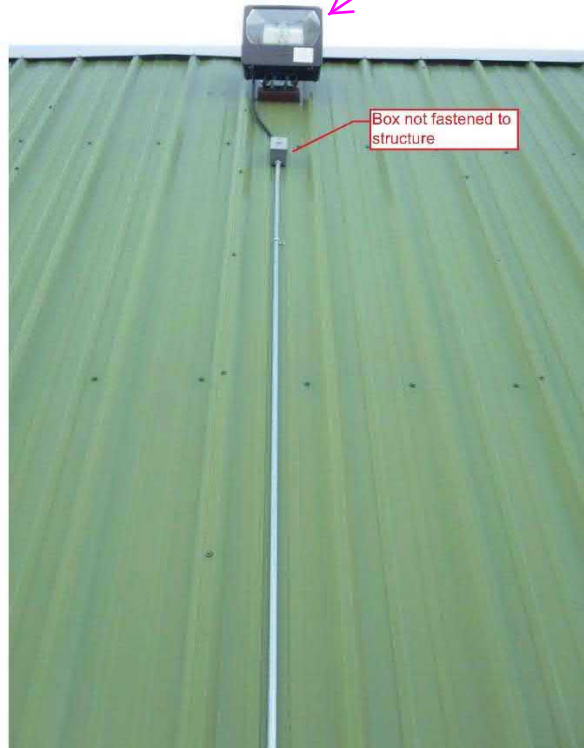
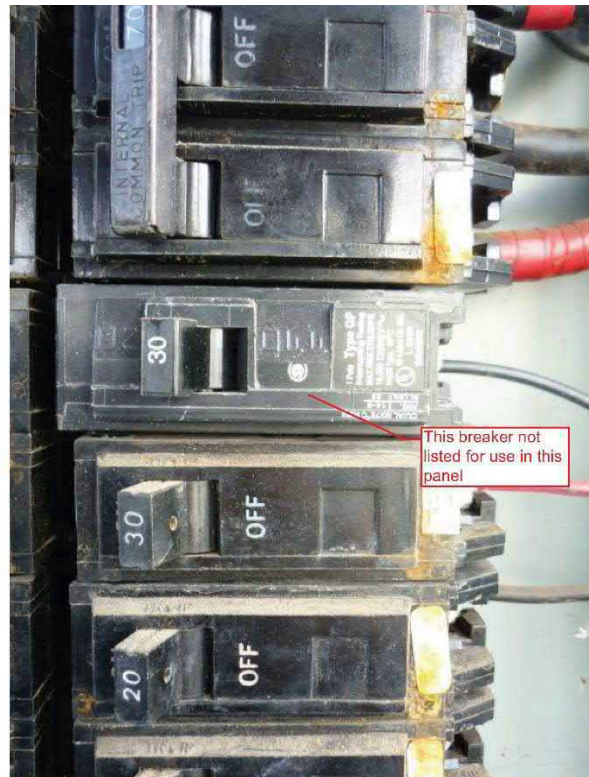
Hangar A

Now replaced with LED fixtures
